**Contract No. HY/2012/08
Tuen Mun – Chek Lap Kok Link –
Northern Connection Sub-sea Tunnel
Section**

*Nineteenth Quarterly Environmental Monitoring
& Audit (EM&A) Report*

**Contract No. HY/2012/08
TM-CLKL – Northern Connection Sub-sea Tunnel Section
19th Quarterly EM&A Summary Report for June to August 2018**

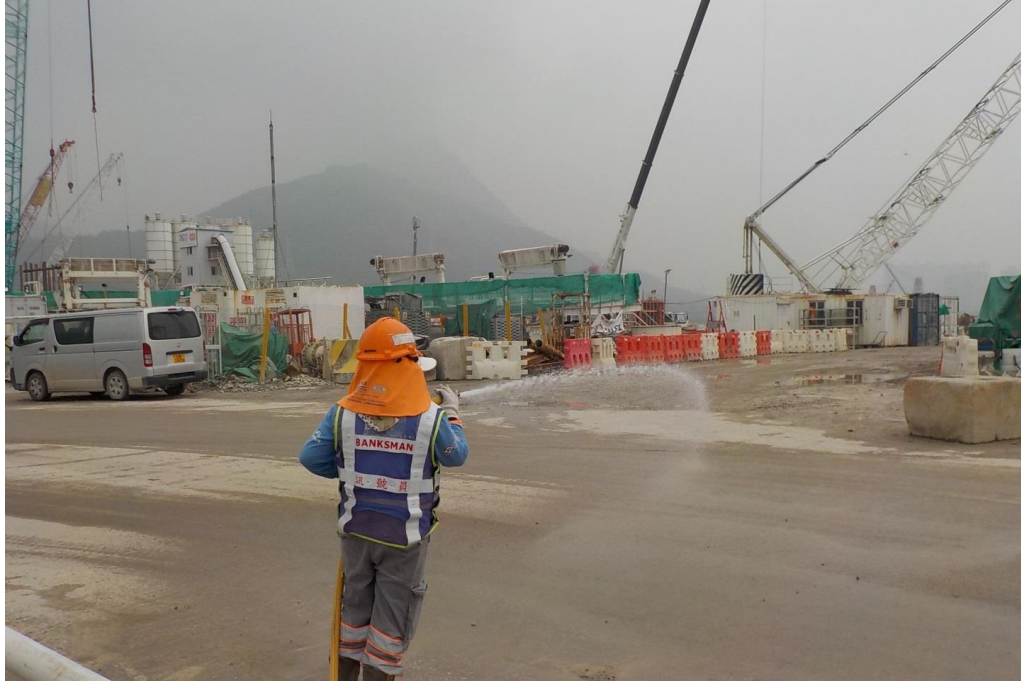
Water spraying was applied frequently on site. (Works Area Portion N-A)

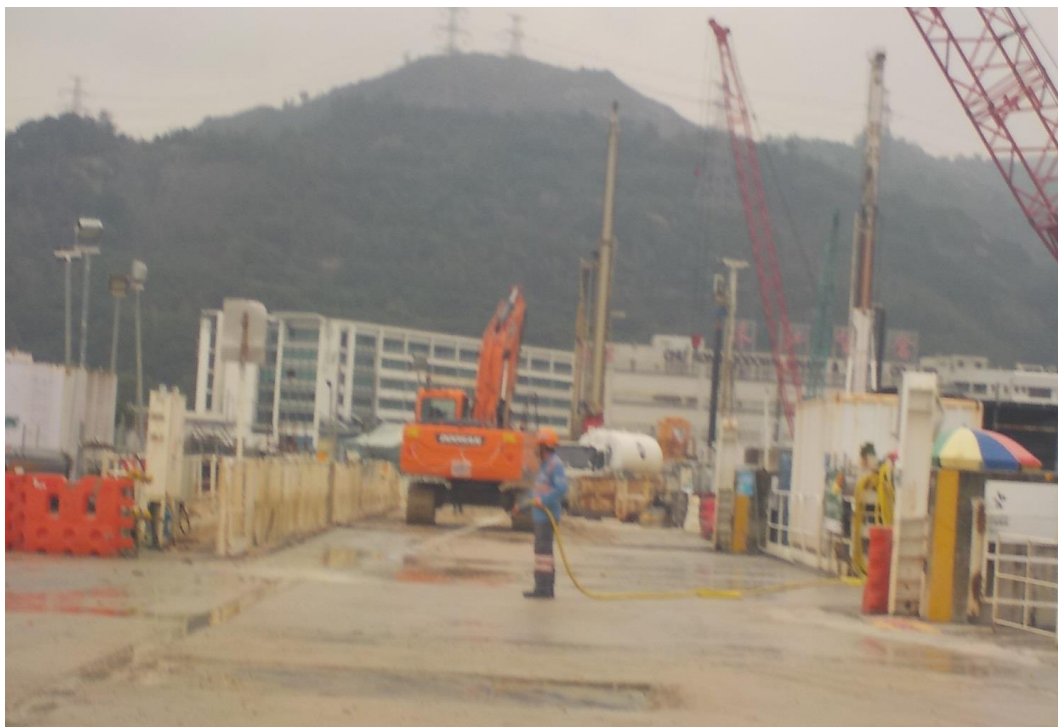
Water spraying was applied frequently on site. (Works Area Portion N-A)

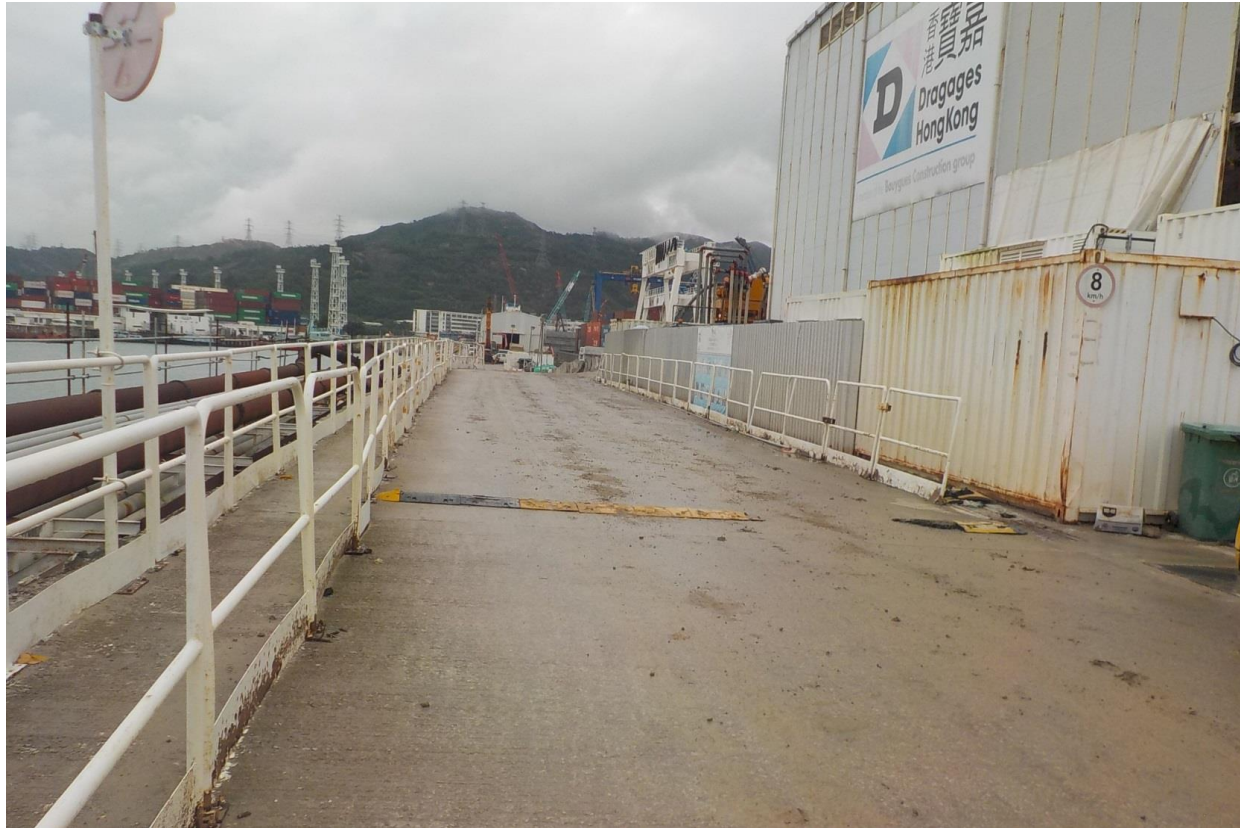
Water spraying was applied to prevent dust.

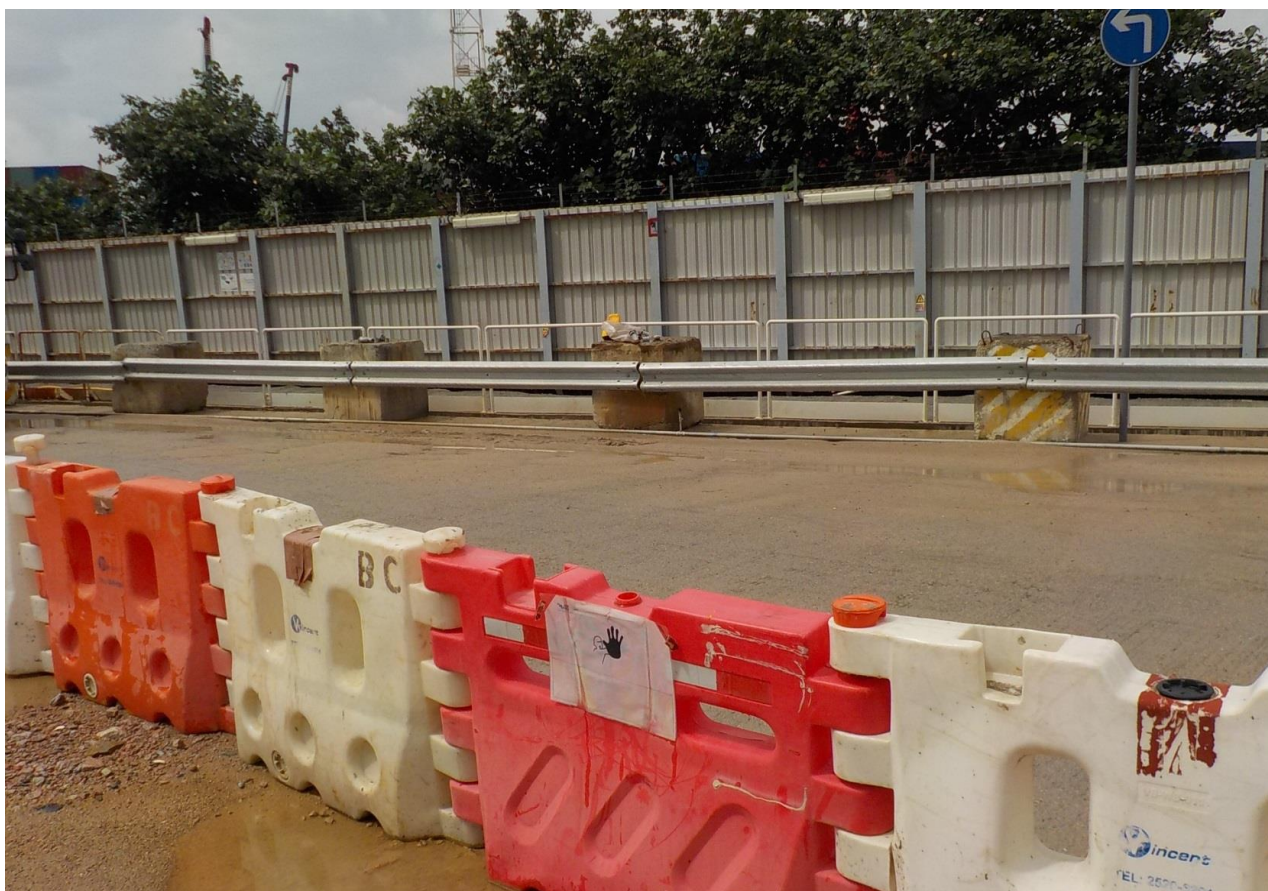
Water spraying was applied to prevent dust.
