**Contract No. HY/2012/08
Tuen Mun - Chek Lap Kok Link -
Northern Connection Sub-sea Tunnel
Section**

***Twenty-fourth Quarterly Environmental
Monitoring & Audit (EM&A) Report***

20 February 2020

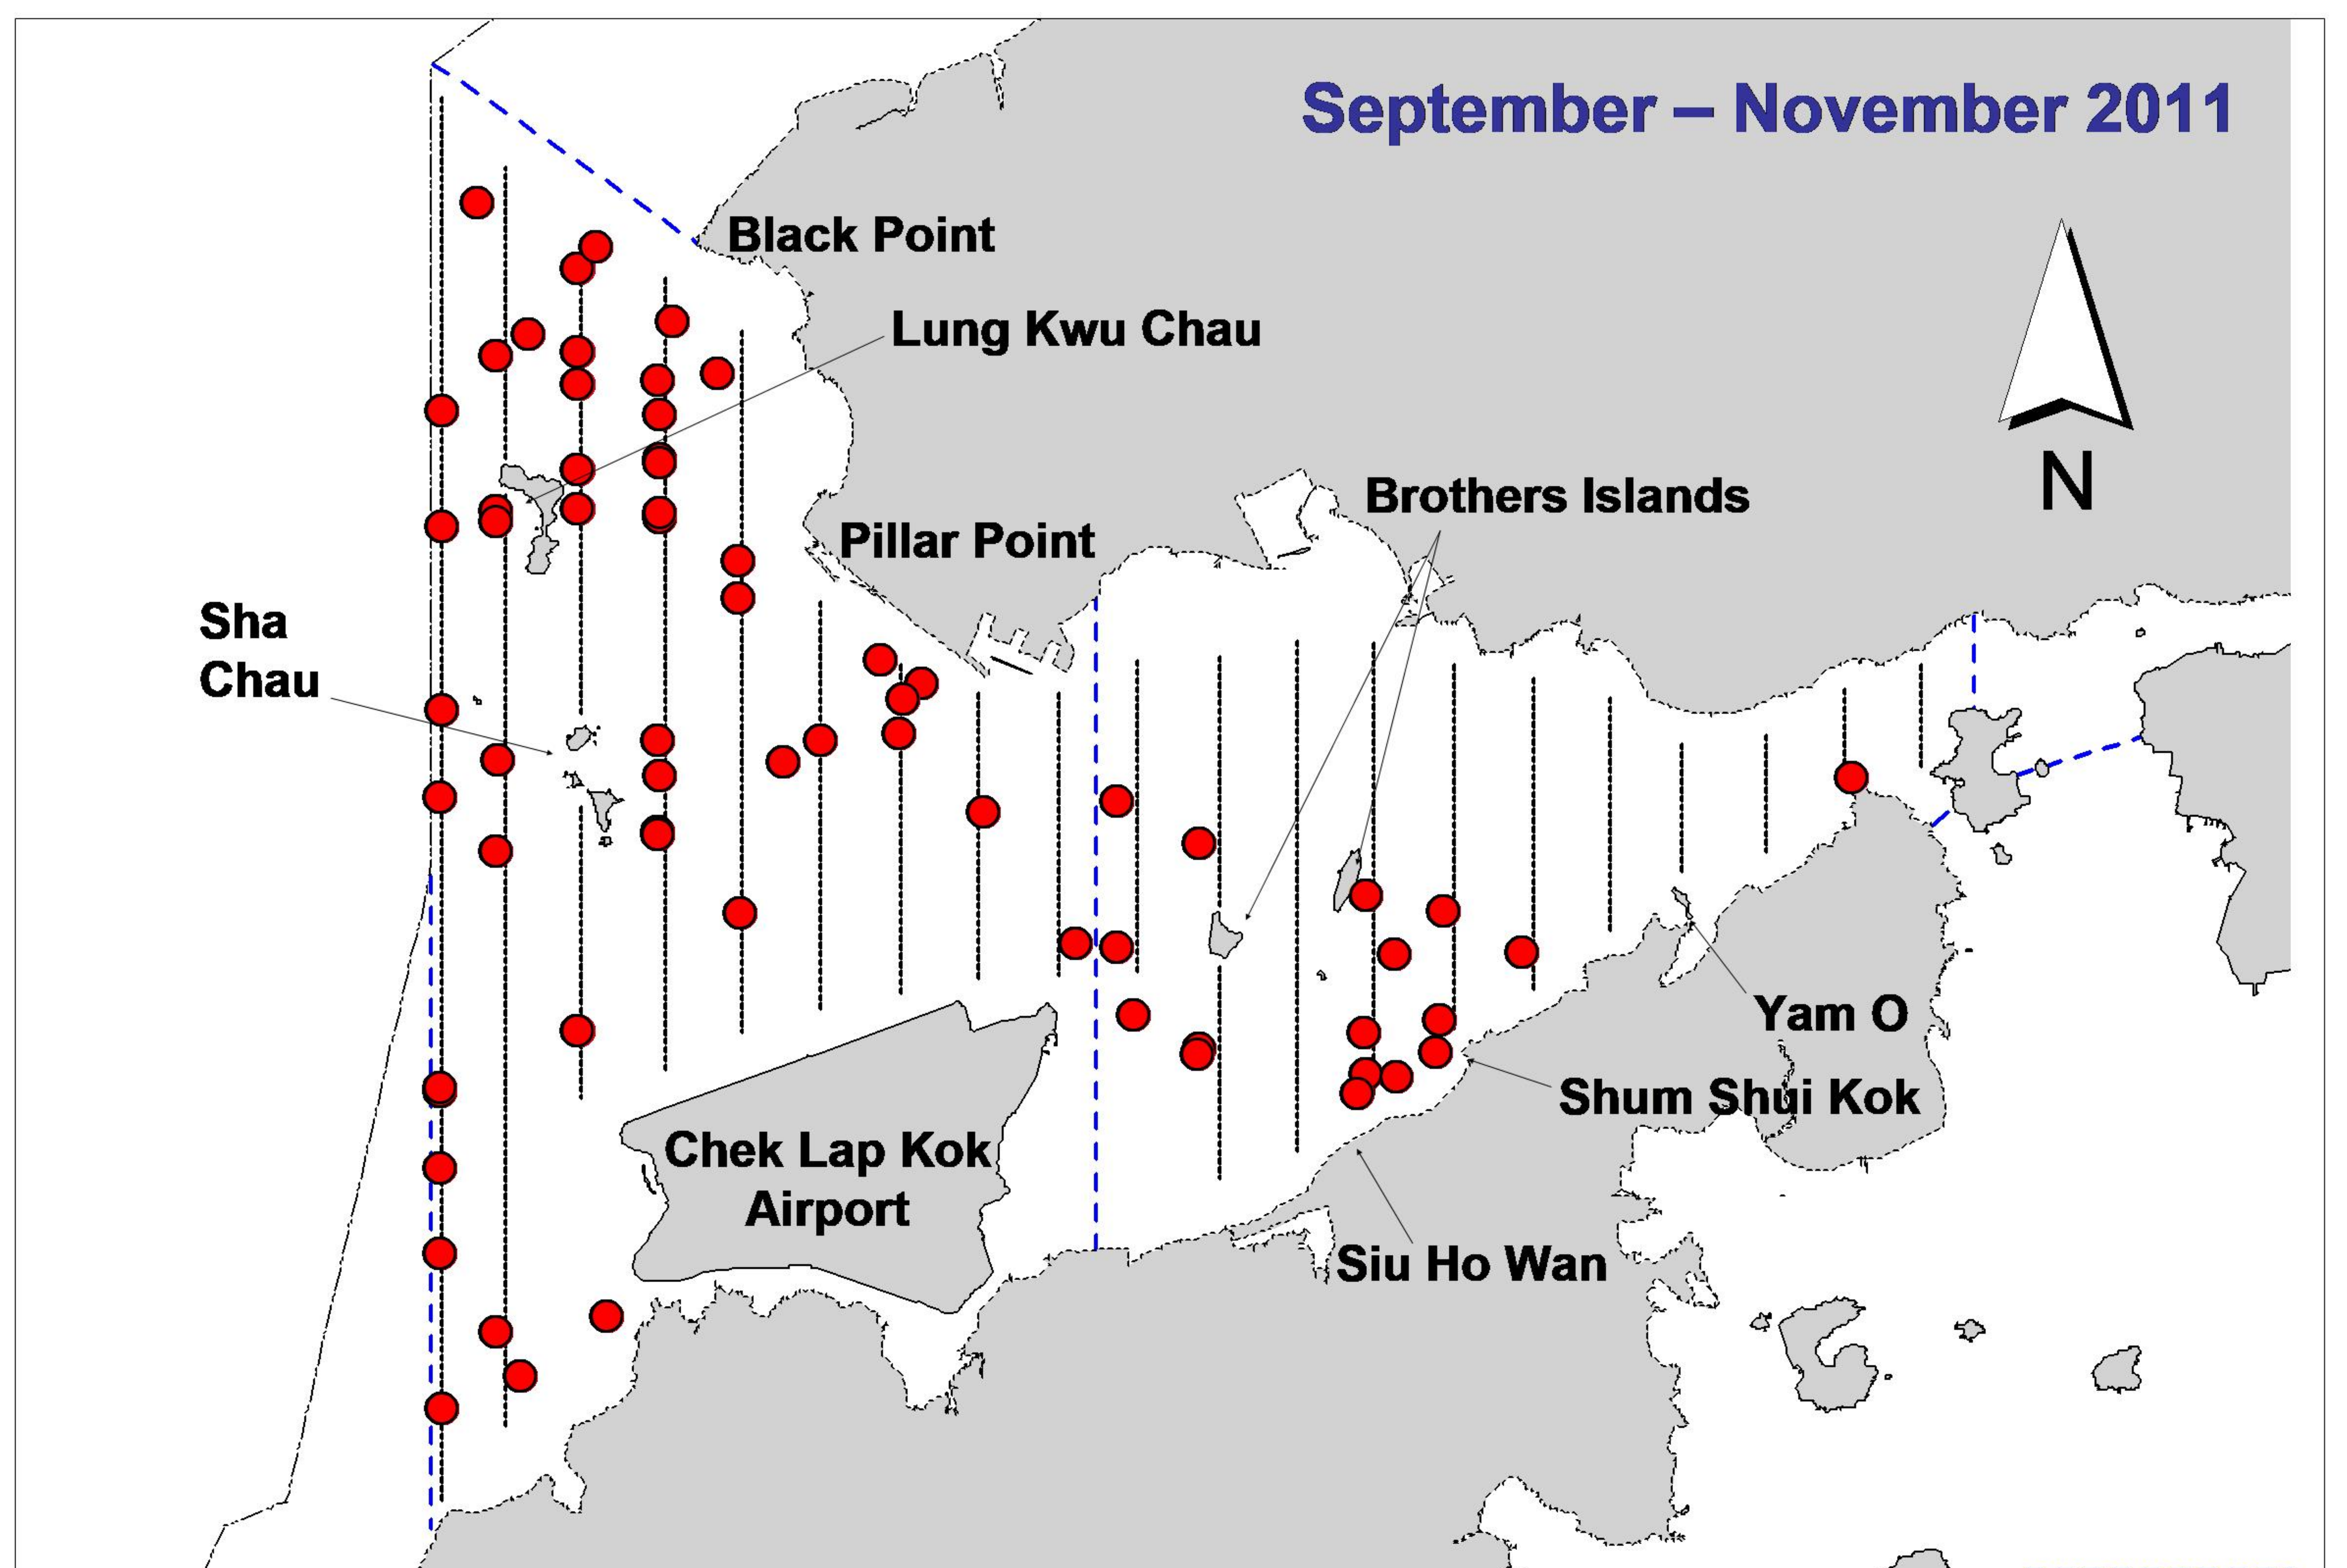
Figure 1. Distribution of Chinese white dolphin sighting in Northwest and Northeast Lantau during TMCLKL impact phase (top) and baseline monitoring surveys (bottom)

A total of 4 groups of 7 Chinese White Dolphins sightings were recorded during the six sets of surveys in this reporting quarter. All four dolphin sightings were made during on-effort search, and three of the four on-effort dolphin sightings were made on primary lines. Whilst one limit level exceedance was observed for the quarterly dolphin monitoring data between September to November 2019, no unacceptable impact from the construction activities of this Contract was recorded from the general observations. Although the dolphins infrequently occurred along the alignment of TM-CLKL Northern Connection Sub-Sea Tunnel Section in the past and during the baseline monitoring period, it is apparent that dolphin usage has been significantly reduced in NEL. It is critical to monitor the dolphin usage in North Lantau region in the upcoming quarters, to determine whether the dolphins are continuously affected by the various construction activities in relation to the construction works of the Contract, and whether suitable mitigation measure can be applied to improve the situation.
