Contract No. HY/2017/10 Tuen Mun – Chek Lap Kok Link – Northern Connection Tunnel Buildings, Electrical and Mechanical Works

Twenty-seventh Monthly EM&A Report

14 September 2020

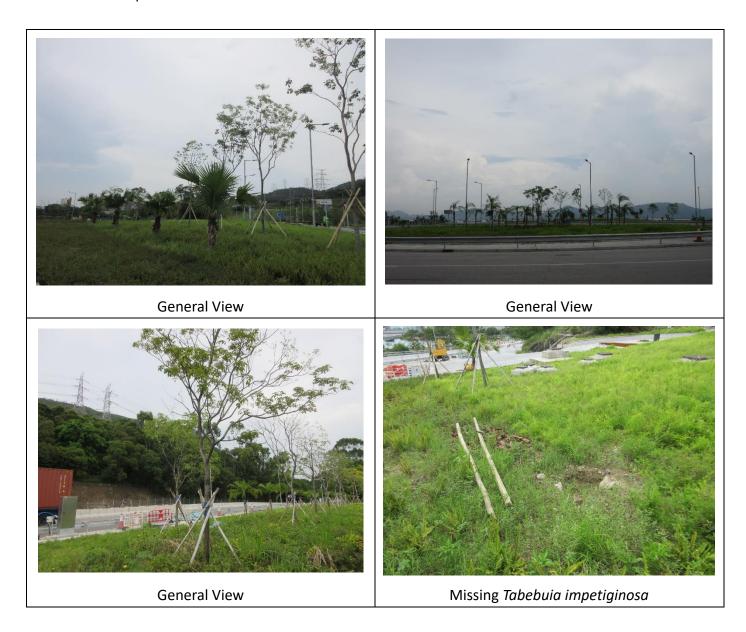
Lung Mun Road/Lung Fu Road Roundabout area

One heavy standard *Tabebuia impetiginosa* was missing, Aecom said the tree was fallen and removed, and there will be a replacement.

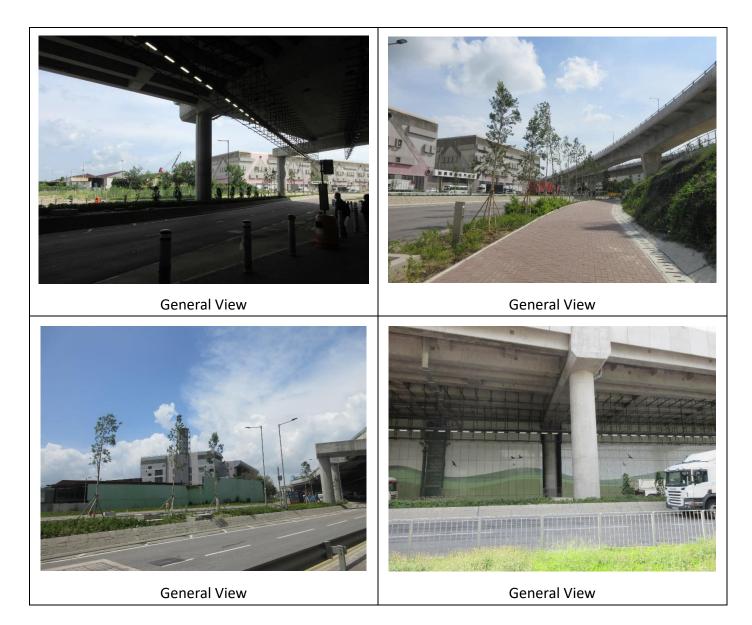
Lung Mun Road

Two light standard *Garcinia subelliptica* was missing, Aecom said the tree was dead and removed, and there will be a replacement.

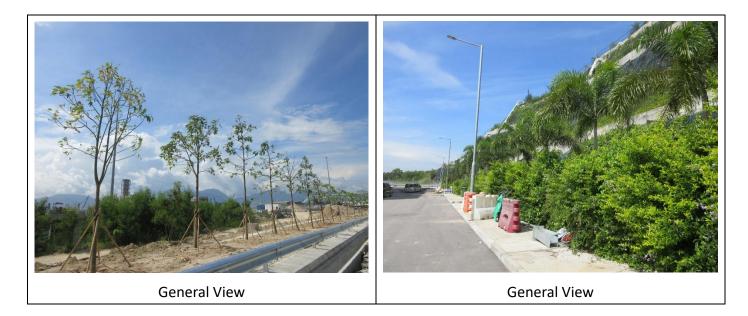
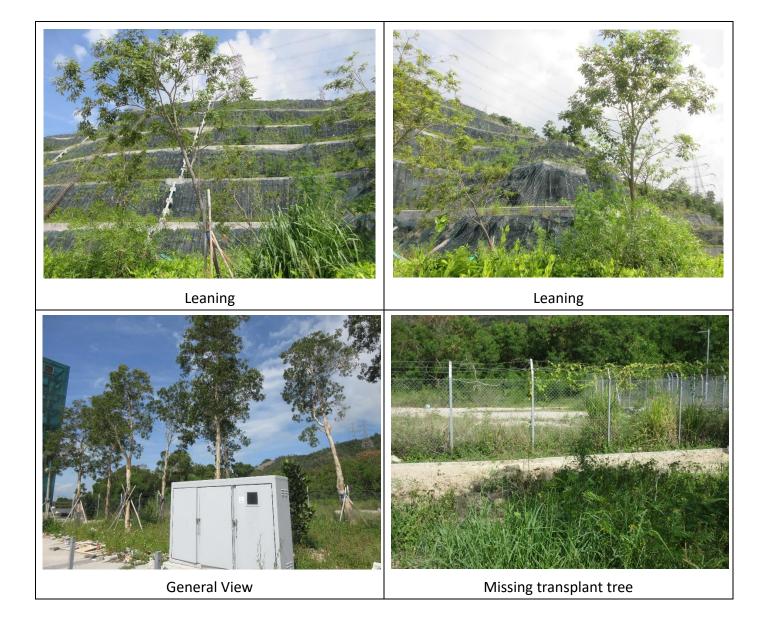
Zone 2 Lung Mun Road

Some *Tabebuia chrysantha* were leaning, Aecom said it will be re-staked.

One transplanted *Melaleuca cajuputi* subsp. *Cumingiana* (T2820) was missing, Aecom said the tree was fallen and removed, and there will be a replacement.

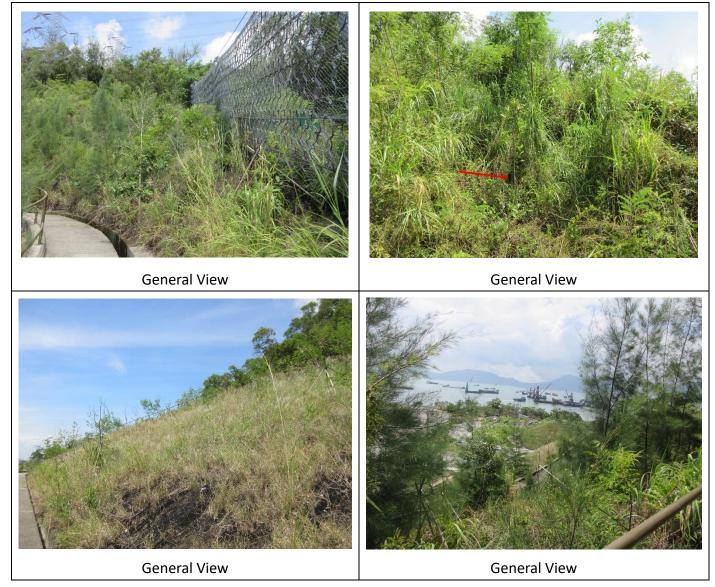
Slope TP A and TP B

One light standard *Sterculia lanceolata* was missing. Accom said the tree was fallen and removed, and there will be a replacement.

Some trees were in poor health condition and dead and Aecom said there will be a replacement. Some whips were dead and Aecom said it will be replaced.

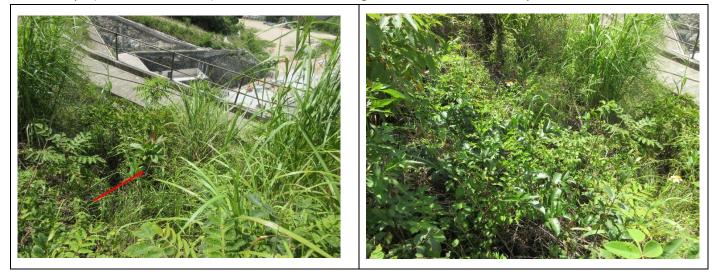
Slope TP D

Some whips (Gordonia axillaris) were dead and missing. Aecom said it will be replaced.

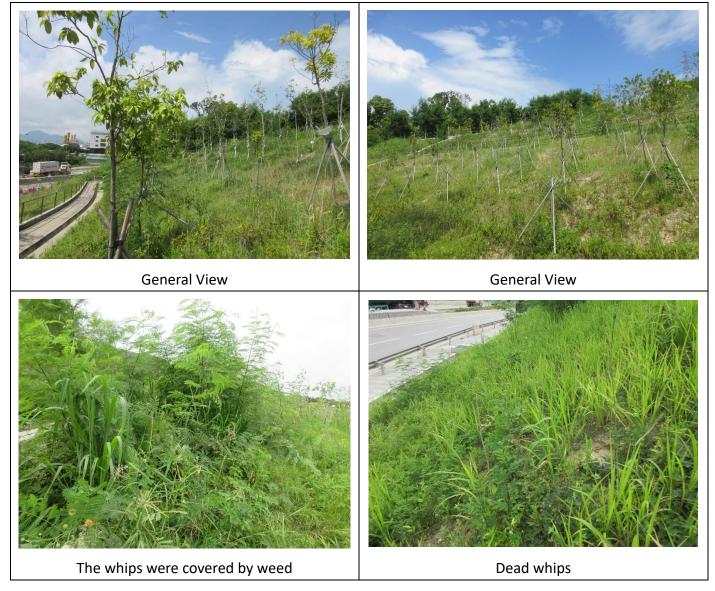
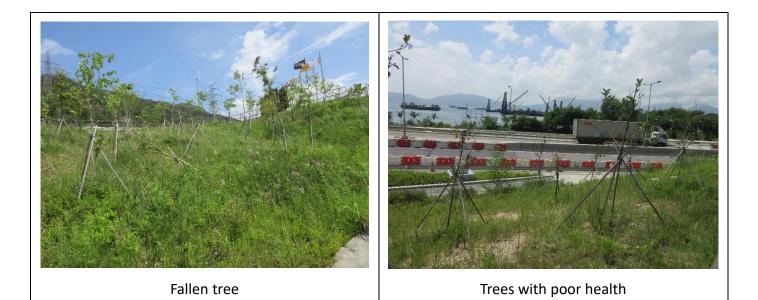
<u>55E-D/C170</u>

Four light standard *Bauhinia variegata* was missing. Accom said the trees were fallen and removed and there will be a replacement.

Some trees were in poor health condition and dead and Aecom said there will be a replacement.

Some whips were dead and missing (Sapium discolor), Aecom said it will be replaced.
