Contract No. HY/2012/08 Tuen Mun – Chek Lap Kok Link – Northern Connection Sub-sea Tunnel Section

Eighty-Third Monthly Environmental Monitoring & Audit (EM&A) Report

12 October 2020

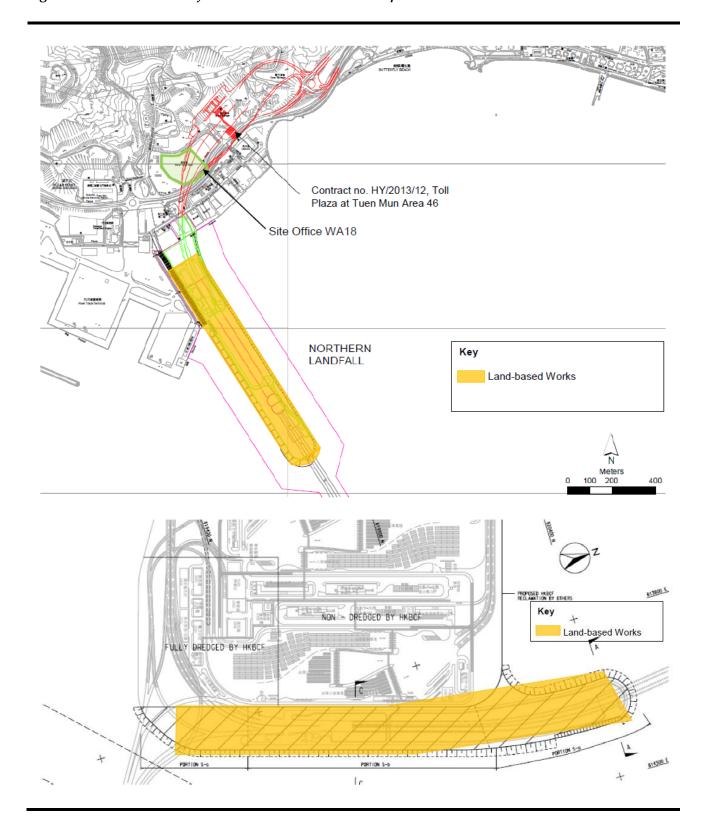
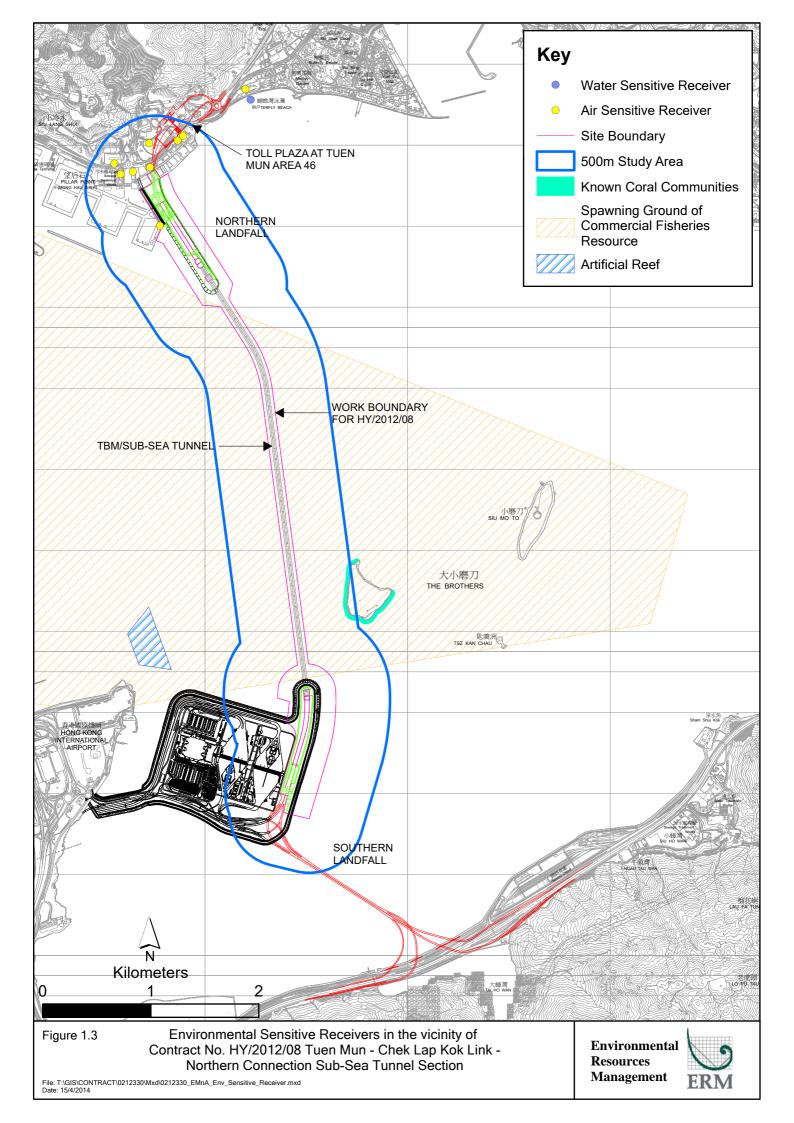
Figure 1.2 Locations of Construction Activities - September 2020

- Carpark canoples installation Portion S-A, S-B & S-C;
- Hard paving and footpath Pump Sump Area at Northern Landfall;
- Installation of green roof system South Ventiliation Building; and
- Reinstatement at Box culvert.

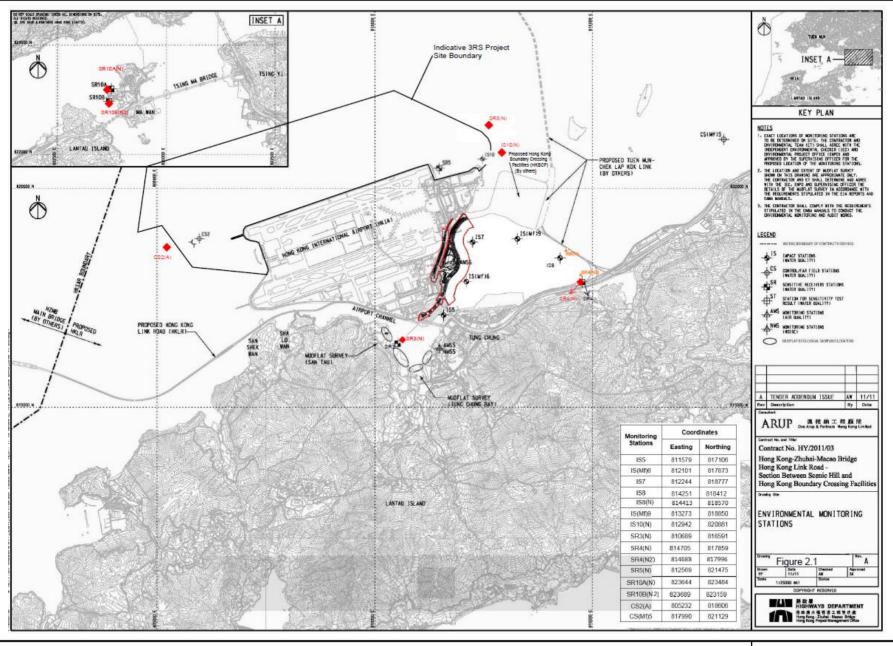
Figure 2.2 Operational Phase Water Quality Monitoring Stations SR3(N), CS2(A), SR4(N2) & CS(Mf)5

One monitoring event for operational phase water quality monitoring was conducted at all designated monitoring stations in the reporting month. Operational phase water quality monitoring results are provided in *Appendix J*.

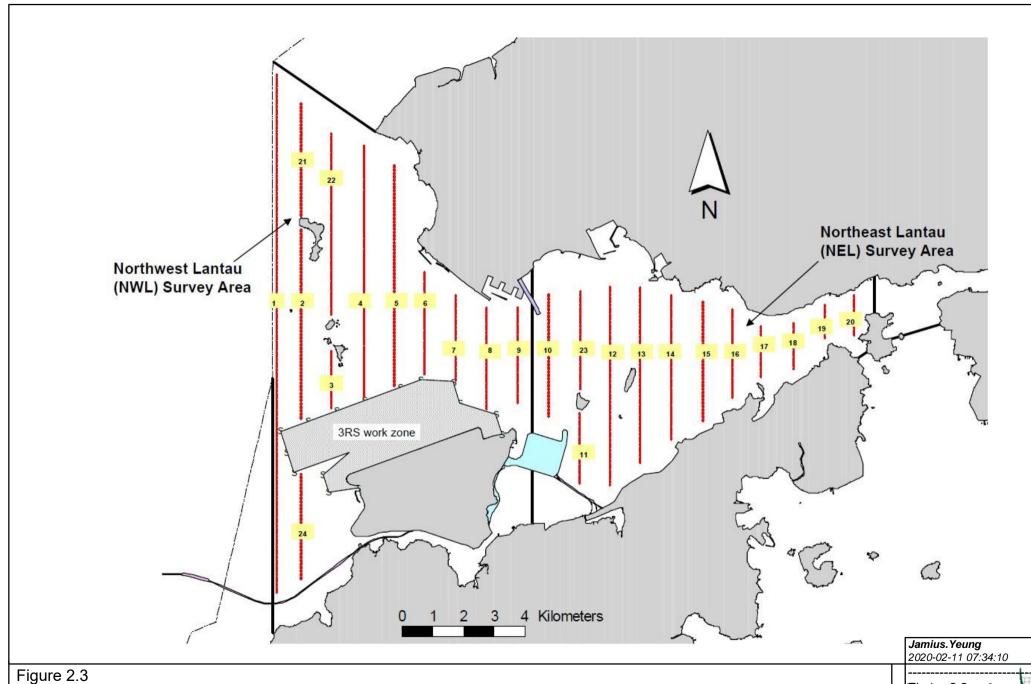
Layout of Transect Lines of Dolphin Monitoring in Northwest and Northeast Lantau Areas

The operational phase dolphin monitoring was carried out in the NEL and NWL along the line transect as depicted in *Figure 2.3*. The co-ordinates of all transect lines are shown in *Table 2.8* below.

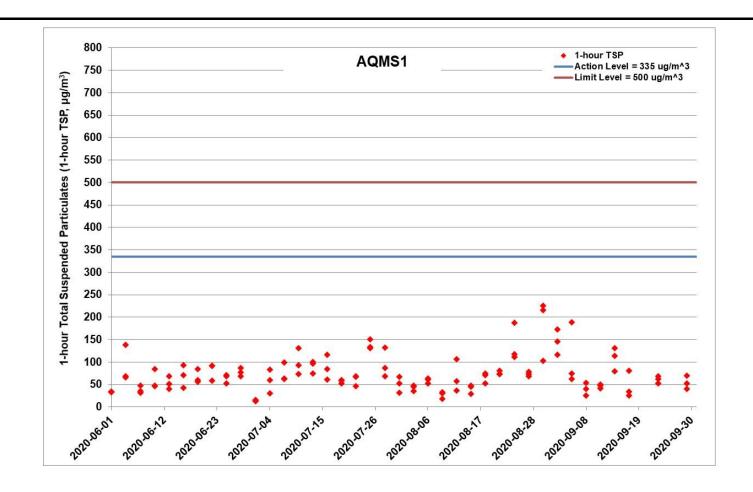
• Figure G.1 Impact Monitoring – 1-hour Total Suspended Particulates (μg/m³) at AQMS1 between 1 June 2020 and 30 September 2020 during impact monitoring period. The weather conditions during the monitoring period varied from sunny to cloudy. Major land-based construction activities included SVB green roof system & chain fence – Portion S-A, S-B & S-C; Carpark canopies installation – Portion S-A, S-B & S-C; and Hard paving and footpath, reinstatement at Box culvert - Pump Sump Area at Northern Landfall (1/6/2020 – 30/9/2020)

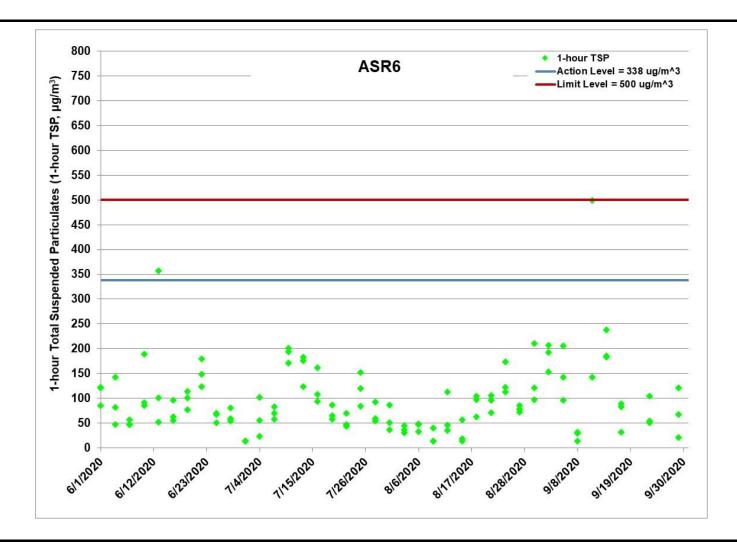
Figure G.2 Impact Monitoring – 1-hour Total Suspended Particulates (μg/m³) at ASR6 between 1 June 2020 and 30 September 2020 during impact monitoring period. The weather conditions during the monitoring period varied from sunny to cloudy. Major land-based construction activities included SVB green roof system & chain fence – Portion S-A, S-B & S-C; Carpark canopies installation - Portion S-A, S-B & S-C; and Hard paving and footpath, reinstatement at Box culvert - Pump Sump Area at Northern Landfall (1/6/2020 – 30/9/2020)

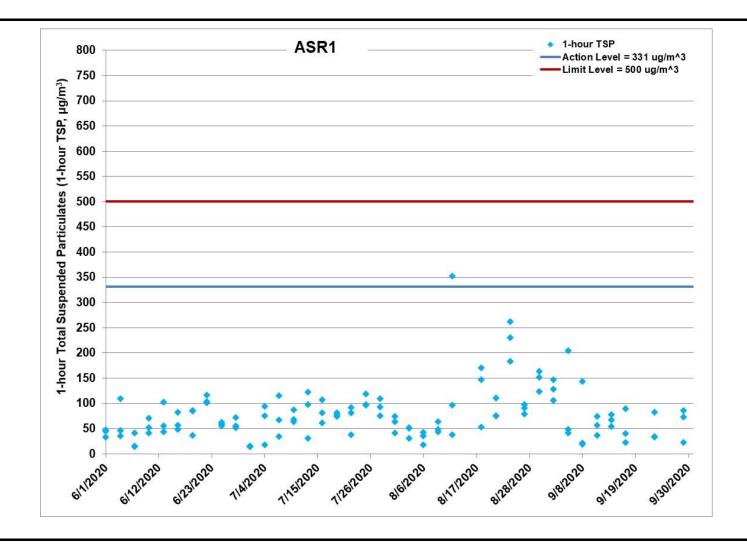
Figure G.3 Impact Monitoring – 1-hour Total Suspended Particulates (μg/m³) at ASR1 between 1 June 2020 and 30 September 2020 during impact monitoring period. The weather conditions during the monitoring period varied from sunny to cloudy. Major land-based construction activities included SVB green roof system & chain fence – Portion S-A, S-B & S-C; Carpark canopies installation - Portion S-A, S-B & S-C; and Hard paving and footpath, reinstatement at Box culvert - Pump Sump Area at Northern Landfall (1/6/2020 – 30/9/2020)

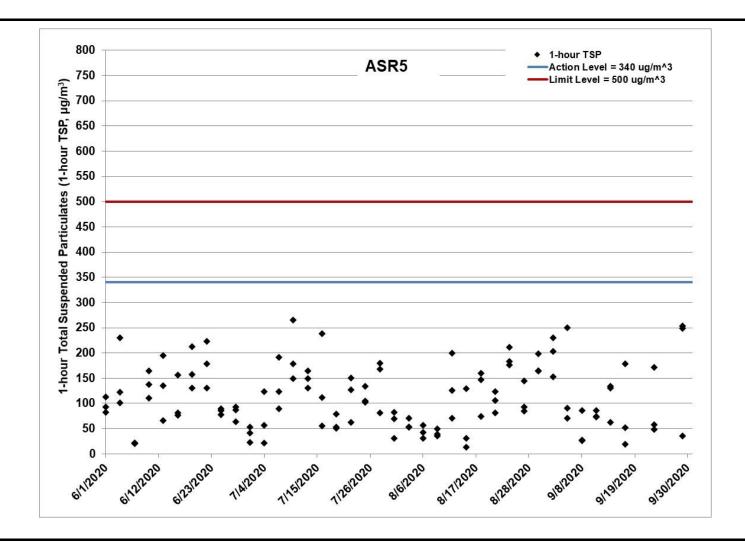
Figure G.4 Impact Monitoring – 1-hour Total Suspended Particulates (μg/m³) at ASR5 between 1 June 2020 and 30 September 2020 during impact monitoring period. The weather conditions during the monitoring period varied from sunny to cloudy. Major land-based construction activities included SVB green roof system & chain fence – Portion S-A, S-B & S-C; Carpark canopies installation - Portion S-A, S-B & S-C; and Hard paving and footpath, reinstatement at Box culvert - Pump Sump Area at Northern Landfall (1/6/2020 – 30/9/2020)

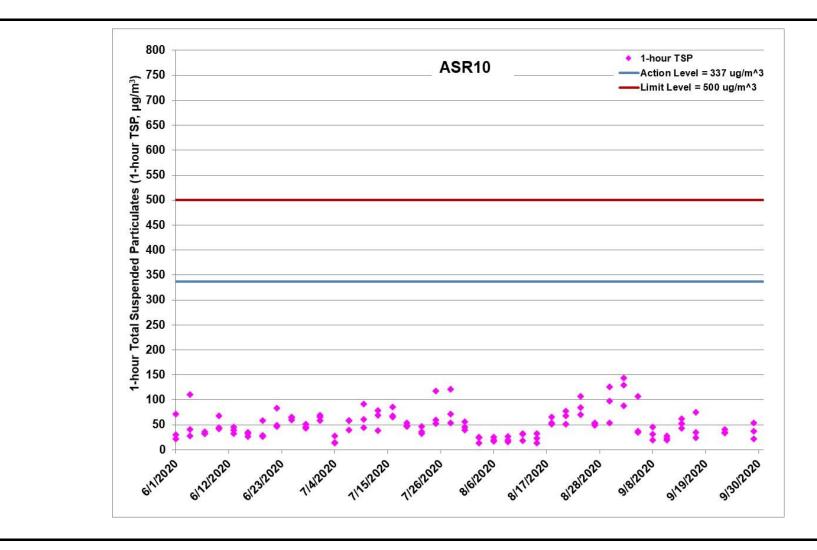
Figure G.5 Impact Monitoring – 1-hour Total Suspended Particulates (µg/m³) at ASR10 between 1 June 2020 and 30 September 2020 during impact monitoring period. The weather conditions during the monitoring period varied from sunny to cloudy. Major land-based construction activities included SVB green roof system & chain fence – Portion S-A, S-B & S-C; Carpark canopies installation – Portion S-A, S-B & S-C; and Hard paving and footpath, reinstatement at Box culvert - Pump Sump Area at Northern Landfall (1/6/2020 – 30/9/2020) Ref: 0212330_Impact AQM graphs_September 2020.xlsx

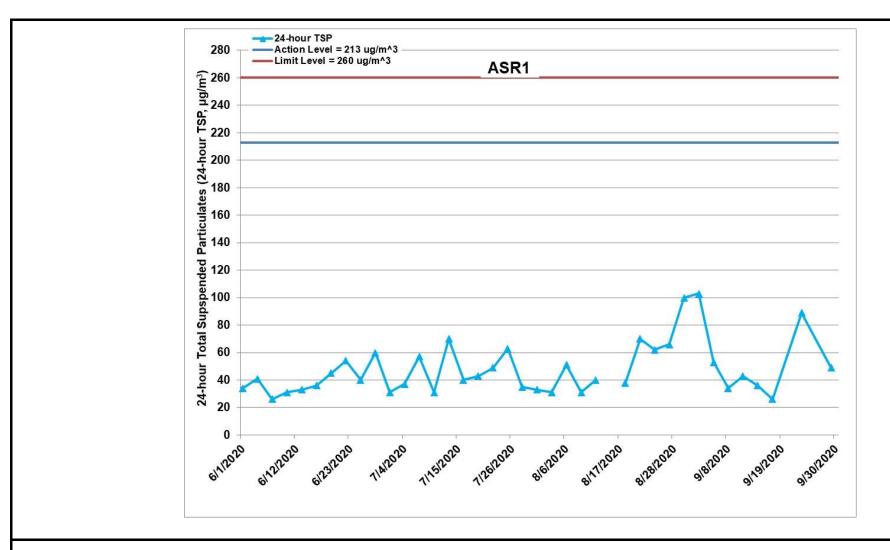
Figure G.6 Impact Monitoring – 24-hour Total Suspended Particulates (μg/m³) at ASR1 between 1 June 2020 and 30 September 2020 during impact monitoring period. The weather conditions during the monitoring period varied from sunny to cloudy. Major land-based construction activities included SVB green roof system & chain fence – Portion S-A, S-B & S-C; Carpark canopies installation – Portion S-A, S-B & S-C; and Hard paving and footpath, reinstatement at Box culvert - Pump Sump Area at Northern Landfall (1/6/2020 – 30/9/2020) Ref: 0212330_Impact AQM graphs_September 2020.xlsx

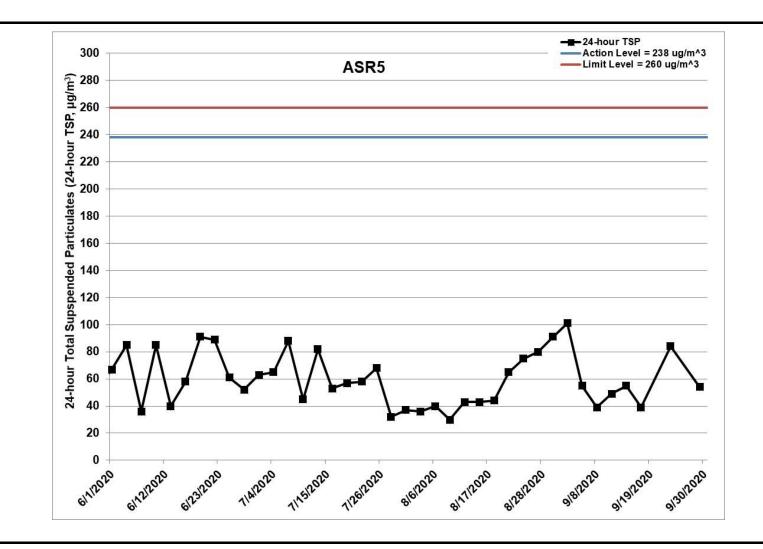
Figure G.7 Impact Monitoring – 24-hour Total Suspended Particulates (μg/m³) at ASR5 between 1 June 2020 and 30 September 2020 during impact monitoring period. The weather conditions during the monitoring period varied from sunny to cloudy. Major land-based construction activities included SVB green roof system & chain fence – Portion S-A, S-B & S-C; Carpark canopies installation – Portion S-A, S-B & S-C; and Hard paving and footpath, reinstatement at Box culvert - Pump Sump Area at Northern Landfall (1/6/2020 – 30/9/2020)

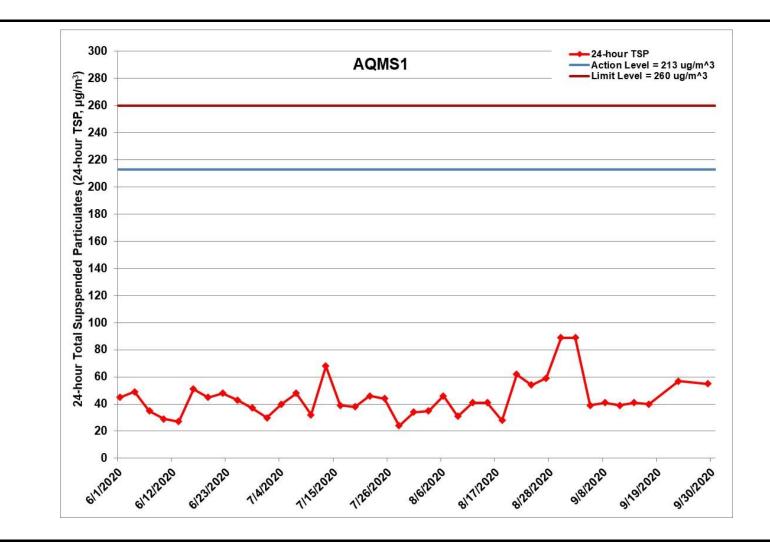
Figure G.8 Impact Monitoring – 24-hour Total Suspended Particulates (μg/m³) at AQMS1 between 1 June 2020 and 30 September 2020 during impact monitoring period. The weather conditions during the monitoring period varied from sunny to cloudy. Major land-based construction activities included SVB green roof system & chain fence – Portion S-A, S-B & S-C; Carpark canopies installation – Portion S-A, S-B & S-C; and Hard paving and footpath, reinstatement at Box culvert - Pump Sump Area at Northern Landfall (1/6/2020 – 30/9/2020) Ref: 0212330_Impact AQM graphs_September 2020.xlsx

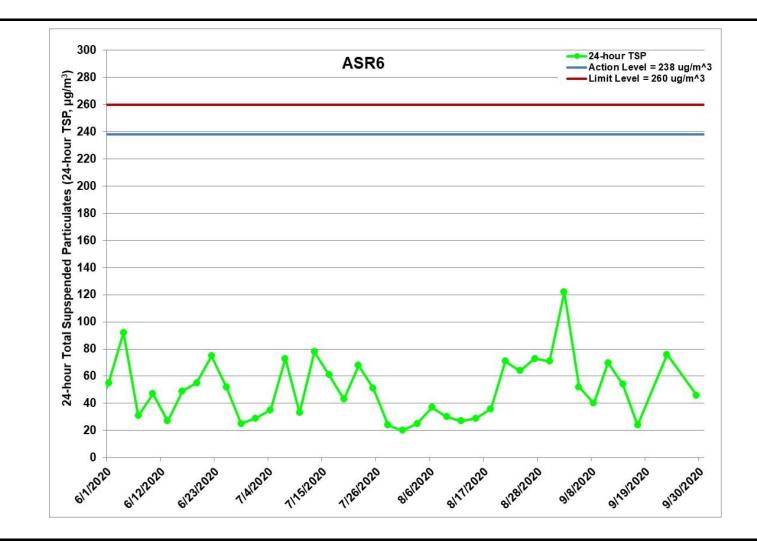
Figure G.9 Impact Monitoring – 24-hour Total Suspended Particulates (μg/m³) at ASR6 between 1 June 2020 and 30 September 2020 during impact monitoring period. The weather conditions during the monitoring period varied from sunny to cloudy. Major land-based construction activities included SVB green roof system & chain fence – Portion S-A, S-B & S-C; Carpark canopies installation – Portion S-A, S-B & S-C; and Hard paving and footpath, reinstatement at Box culvert - Pump Sump Area at Northern Landfall (1/6/2020 – 30/9/2020) Ref: 0212330_Impact AQM graphs_September 2020.xlsx

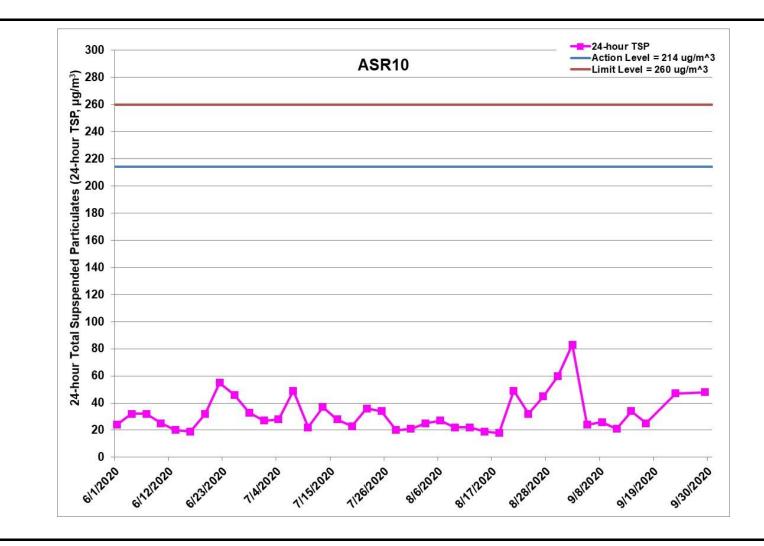
Figure G.10 Impact Monitoring – 24-hour Total Suspended Particulates (μg/m³) at ASR10 between 1 June 2020 and 30 September 2020 during impact monitoring period. The weather conditions during the monitoring period varied from sunny to cloudy. Major land-based construction activities included SVB green roof system & chain fence – Portion S-A, S-B & S-C; Carpark canopies installation – Portion S-A, S-B & S-C; and Hard paving and footpath, reinstatement at Box culvert - Pump Sump Area at Northern Landfall (1/6/2020 – 30/9/2020) Ref: 0212330_Impact AQM graphs_September 2020.xlsx

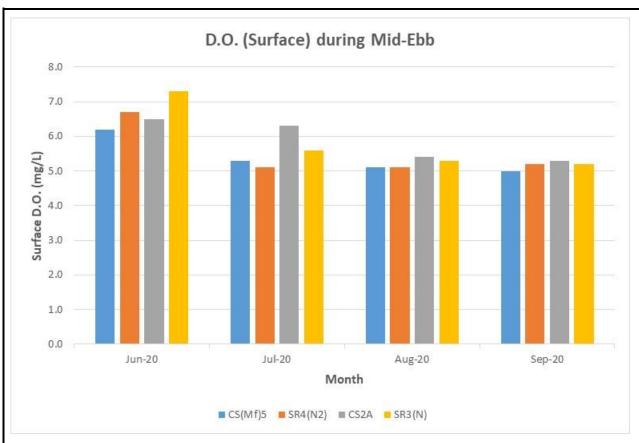
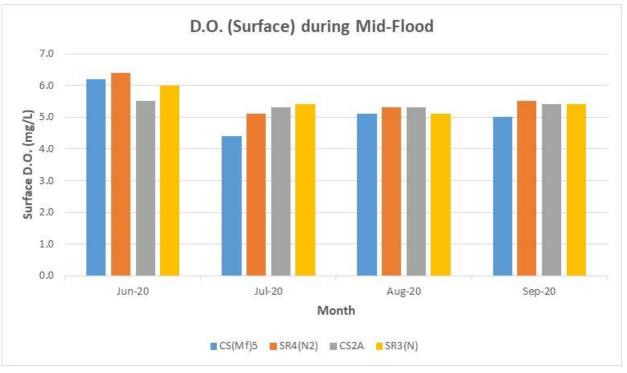
Figure J1 Operational Phase Monitoring – Mean Level of Dissolved Oxygen (mg/L) in surface waters between 1 June 2020 and 30 September 2020. The weather conditions during the monitoring period varied mostly from sunny to cloudy.

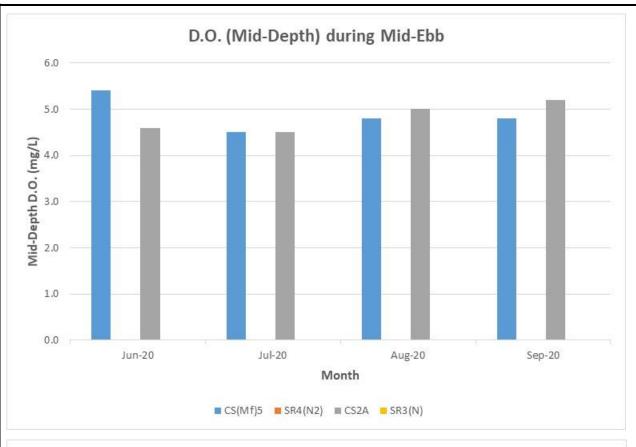
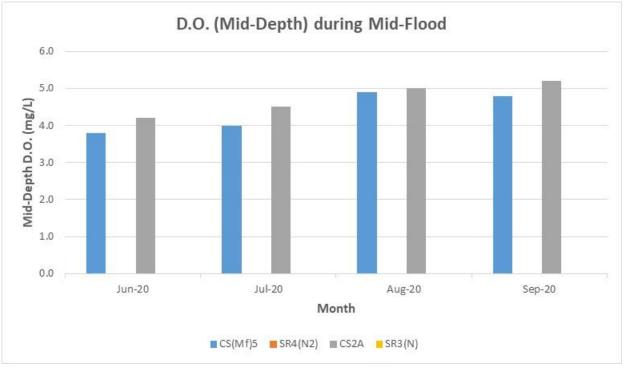
Figure J2 Operational Phase Monitoring - Mean Level of Dissolved Oxygen (mg/L) in mid-depth waters between 1 June 2020 and 30 September 2020. The weather conditions during the monitoring period varied mostly from sunny to cloudy.

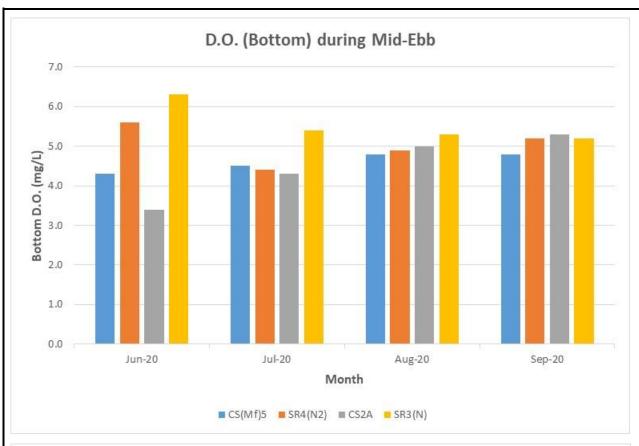
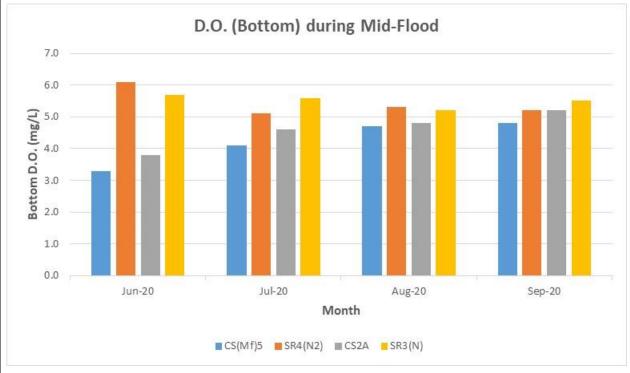
Figure J3 Operational Phase Monitoring - Mean Level of Dissolved Oxygen (mg/L) in bottom waters between 1 June 2020 and 30 September 2020. The weather conditions during the monitoring period varied mostly from sunny to cloudy.

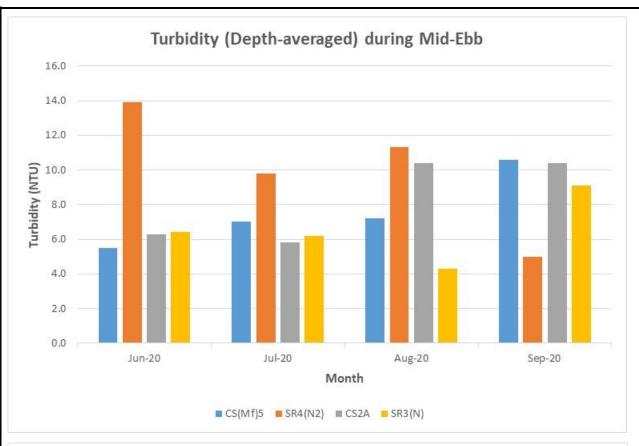
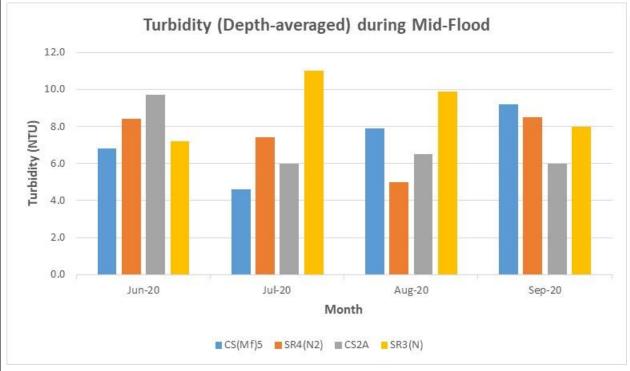
Figure J4 Operational Phase Monitoring – Mean Depth-averaged Level of Turbidity (NTU) between 1 June 2020 and 30 September 2020. The weather conditions during the monitoring period varied mostly from sunny to cloudy.

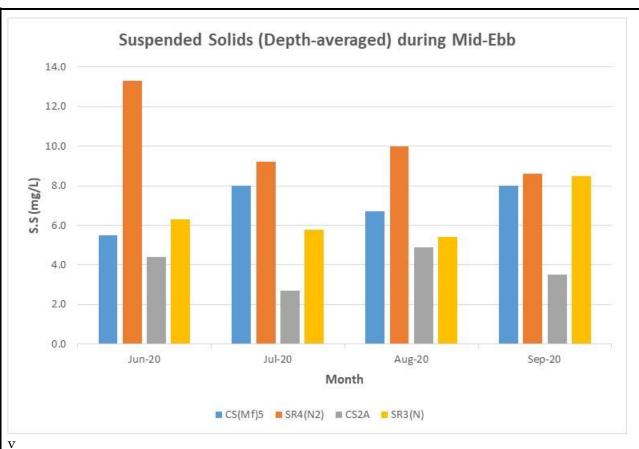
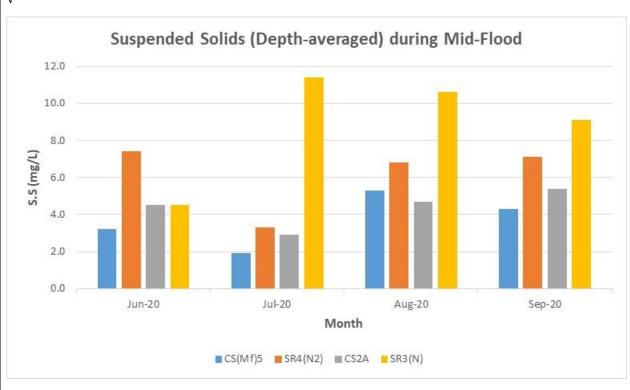
Figure J5 Operational Phase Monitoring – Mean Depth-averaged Level of Suspended Solids (mg/L) between 1 June 2020 and 30 September 2020. The weather conditions during the monitoring period varied mostly from sunny to cloudy.
