**Contract No. HY/2012/08  
Tuen Mun - Chek Lap Kok Link -  
Northern Connection Sub-sea Tunnel  
Section**

*Twenty-eighth Quarterly Environmental  
Monitoring & Audit (EM&A) Report*

19 March 2021

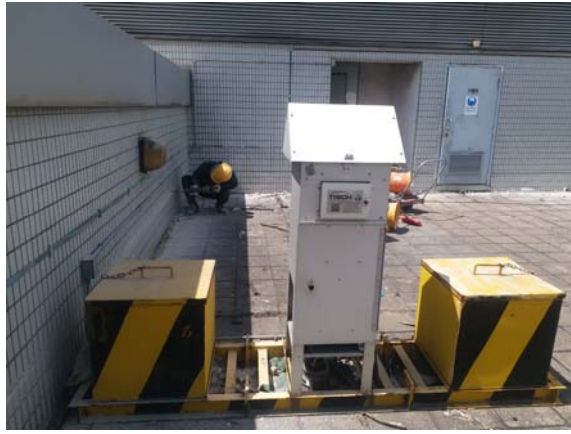
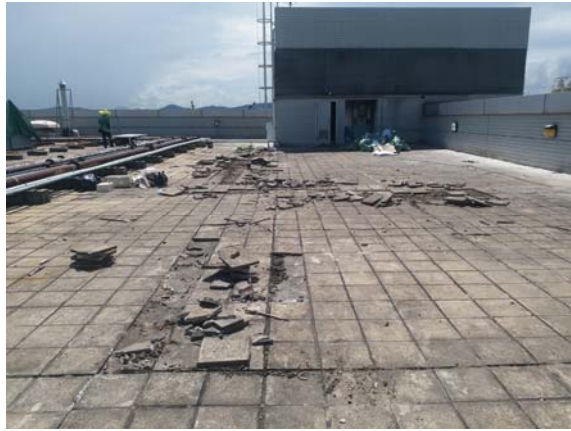
Photo 1 & 2 - Renovation works were undertaken by other contract nearby ASR6
