Contract No. HY/2012/08 Tuen Mun – Chek Lap Kok Link – Northern Connection Sub-sea Tunnel Section

Eighty-Fourth Monthly Environmental Monitoring & Audit (EM&A) Report

11 November 2020

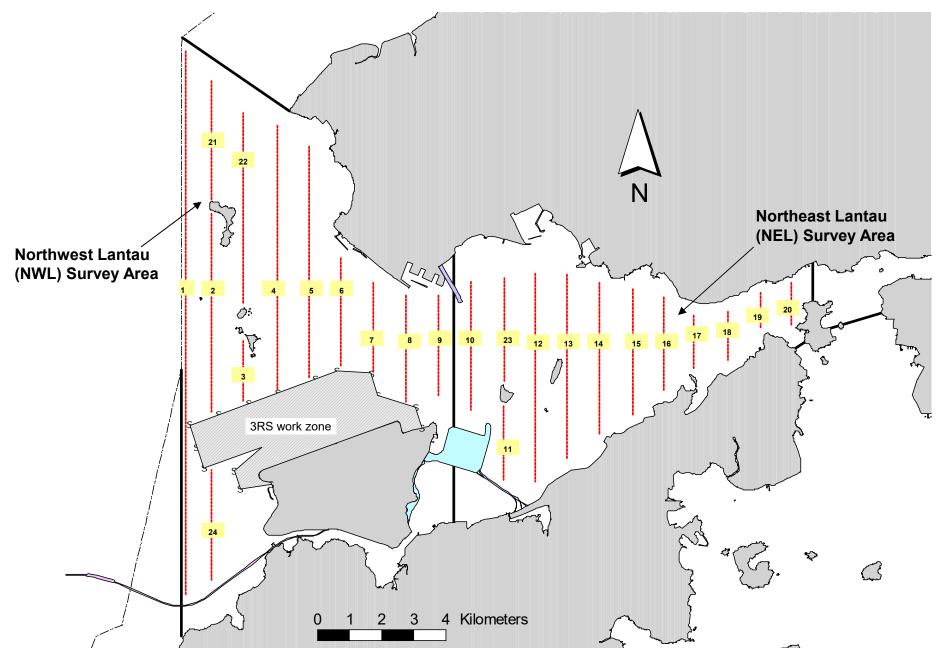
Figure 1. Transect Line Layout in Northwest and Northeast Lantau Survey Areas

The operational phase dolphin monitoring was carried out in the NEL and NWL along the line transect as depicted in *Figure 2.3*. The co-ordinates of all transect lines are shown in *Table 2.8* below.
