**Contract No. HY/2012/08
Tuen Mun - Chek Lap Kok Link -
Northern Connection Sub-sea Tunnel
Section**

***Eighty-Sixth Monthly Environmental Monitoring
& Audit (EM&A) Report***

11 January 2021

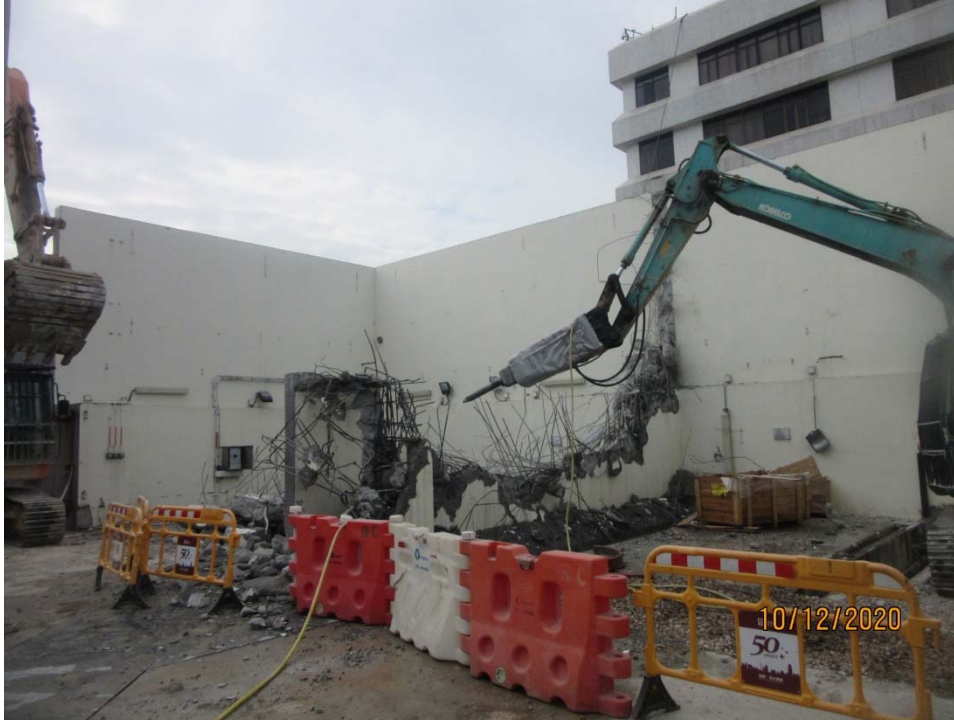
Photo 1 - Water spraying was applied during rock/cement breaking to prevent dust
