**Contract No. HY/2012/08
Tuen Mun - Chek Lap Kok Link -
Northern Connection Sub-sea Tunnel
Section**

*Twenty-ninth Quarterly Environmental
Monitoring & Audit (EM&A) Report*

09 June 2021

**Contract No. HY/2012/08
TM-CLKL – Northern Connection Sub-sea Tunnel Section
29th Quarterly EM&A Summary Report for December 2020 to February 2021**

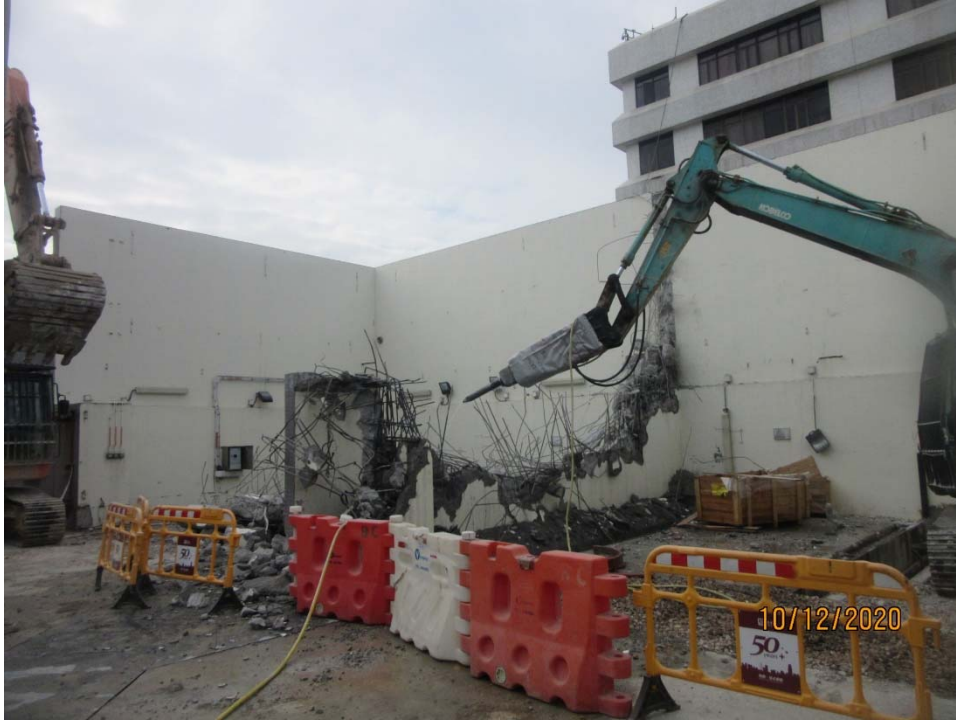
Photo 1 - Water spraying was applied during rock/cement breaking to prevent dust
