**Contract No. HY/2012/08
Tuen Mun – Chek Lap Kok Link –
Northern Connection Sub-sea Tunnel
Section**

***Eighty-Eighth Monthly Environmental
Monitoring & Audit (EM&A) Report***

11 March 2021

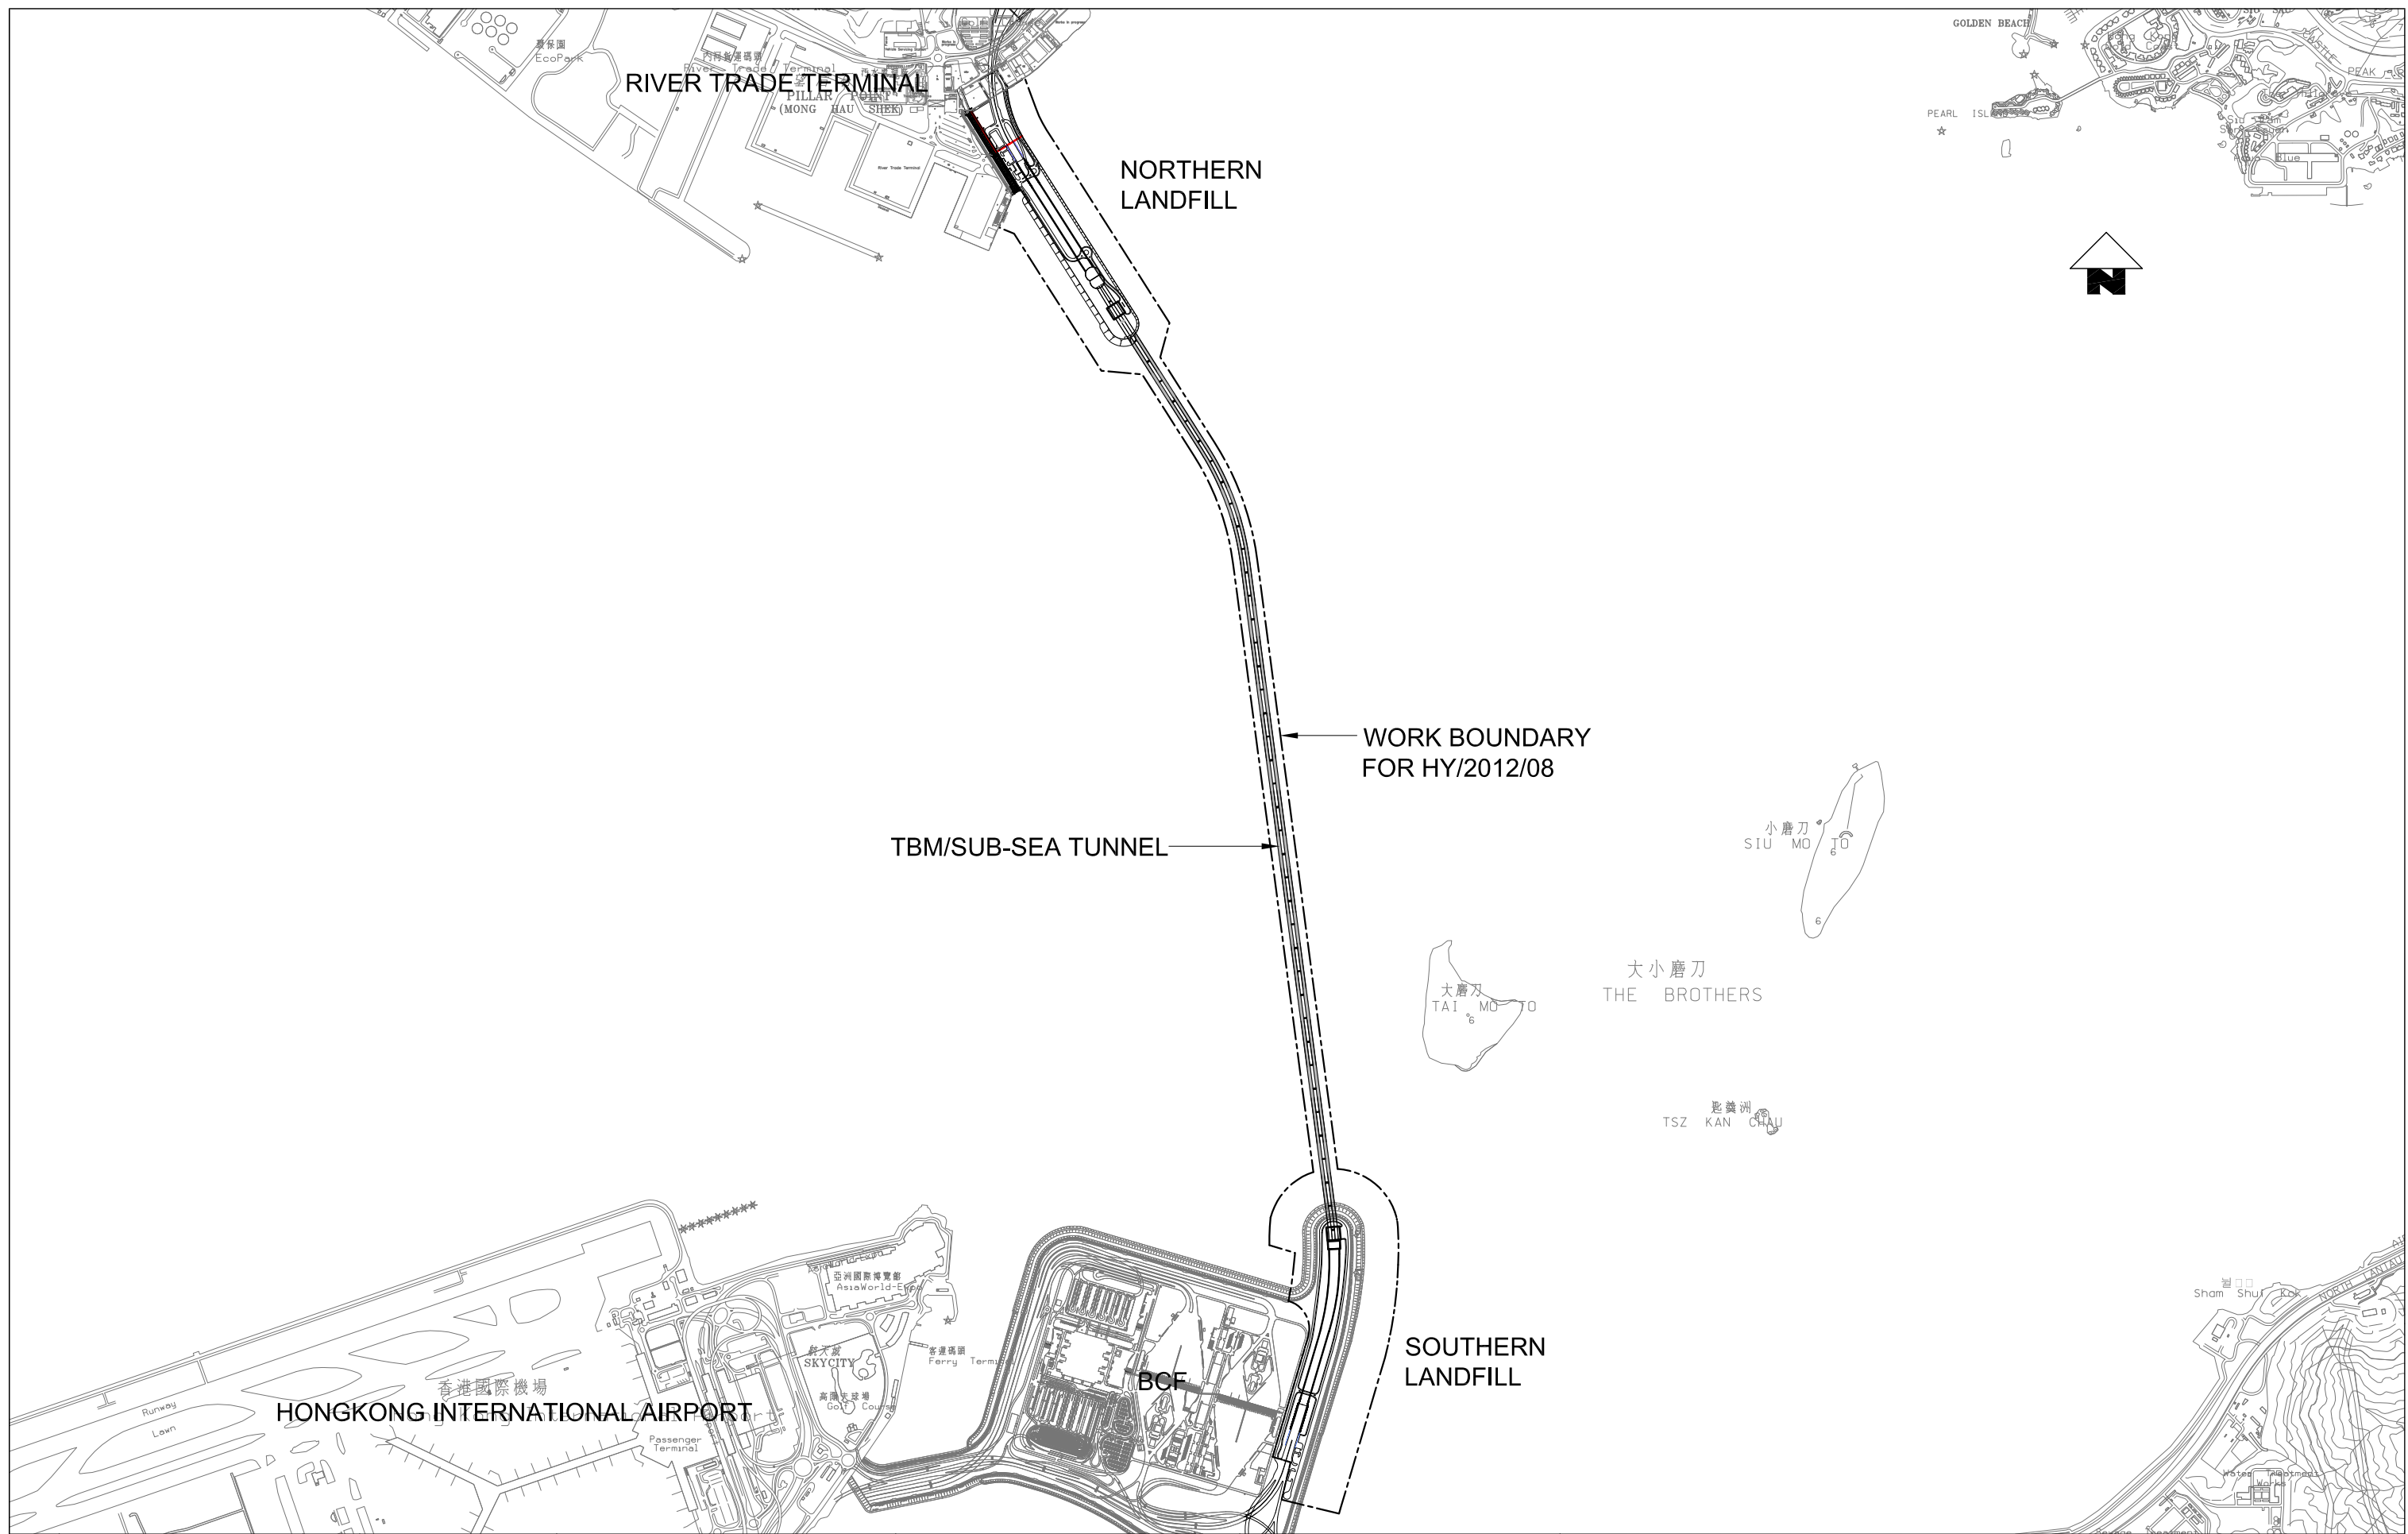
Layout of the Contract components is presented in *Figure 1.1*.

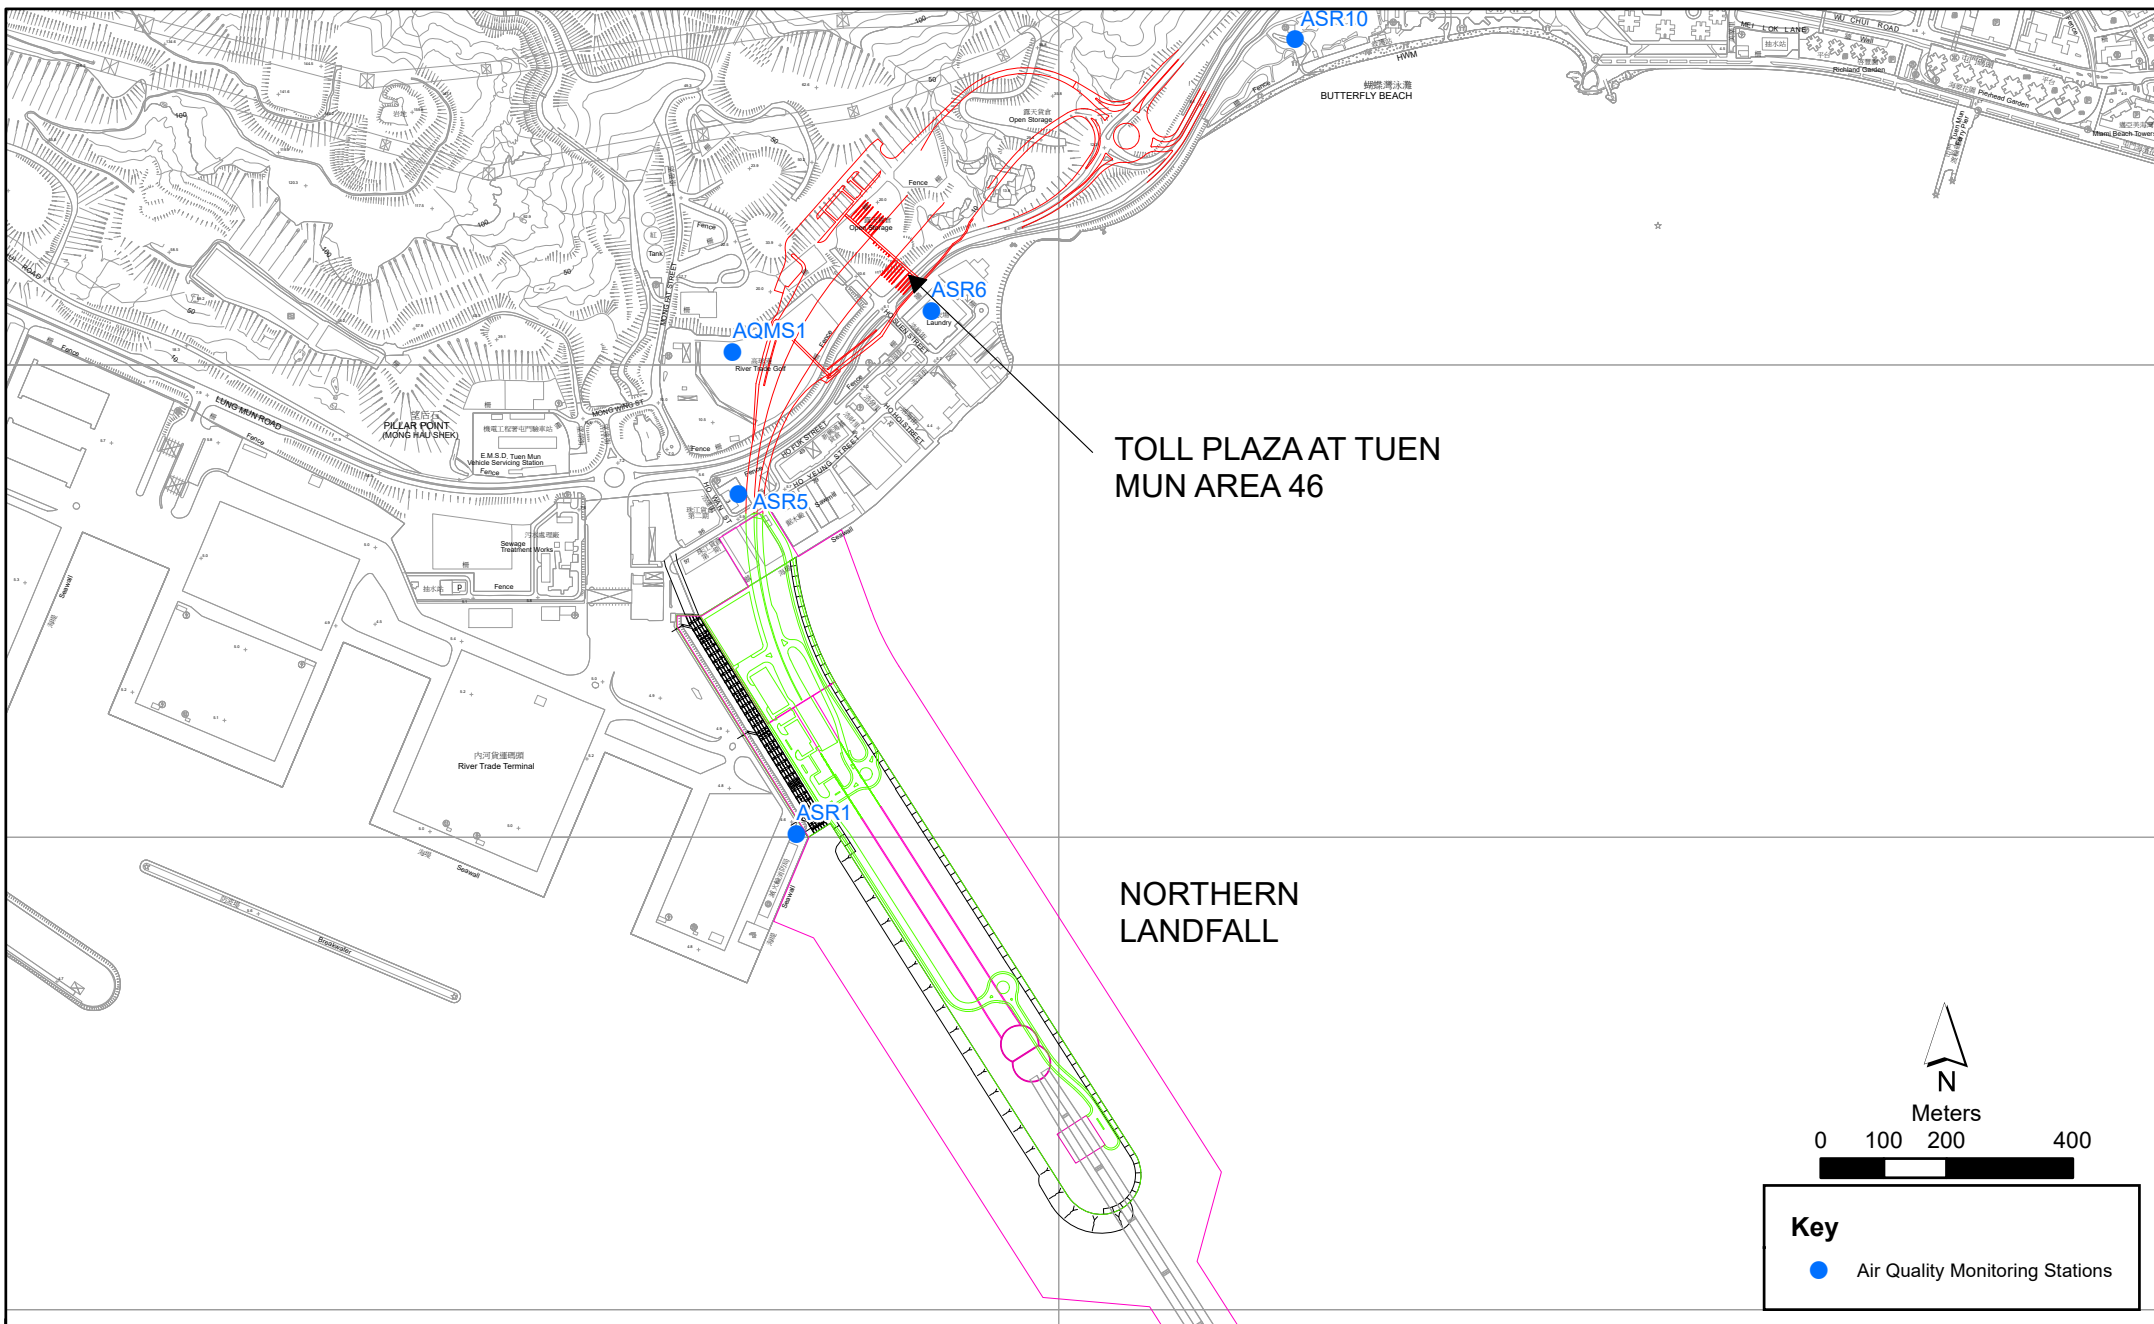
Figure 2.1

Air Quality Monitoring Stations for the Enhanced TSP Monitoring

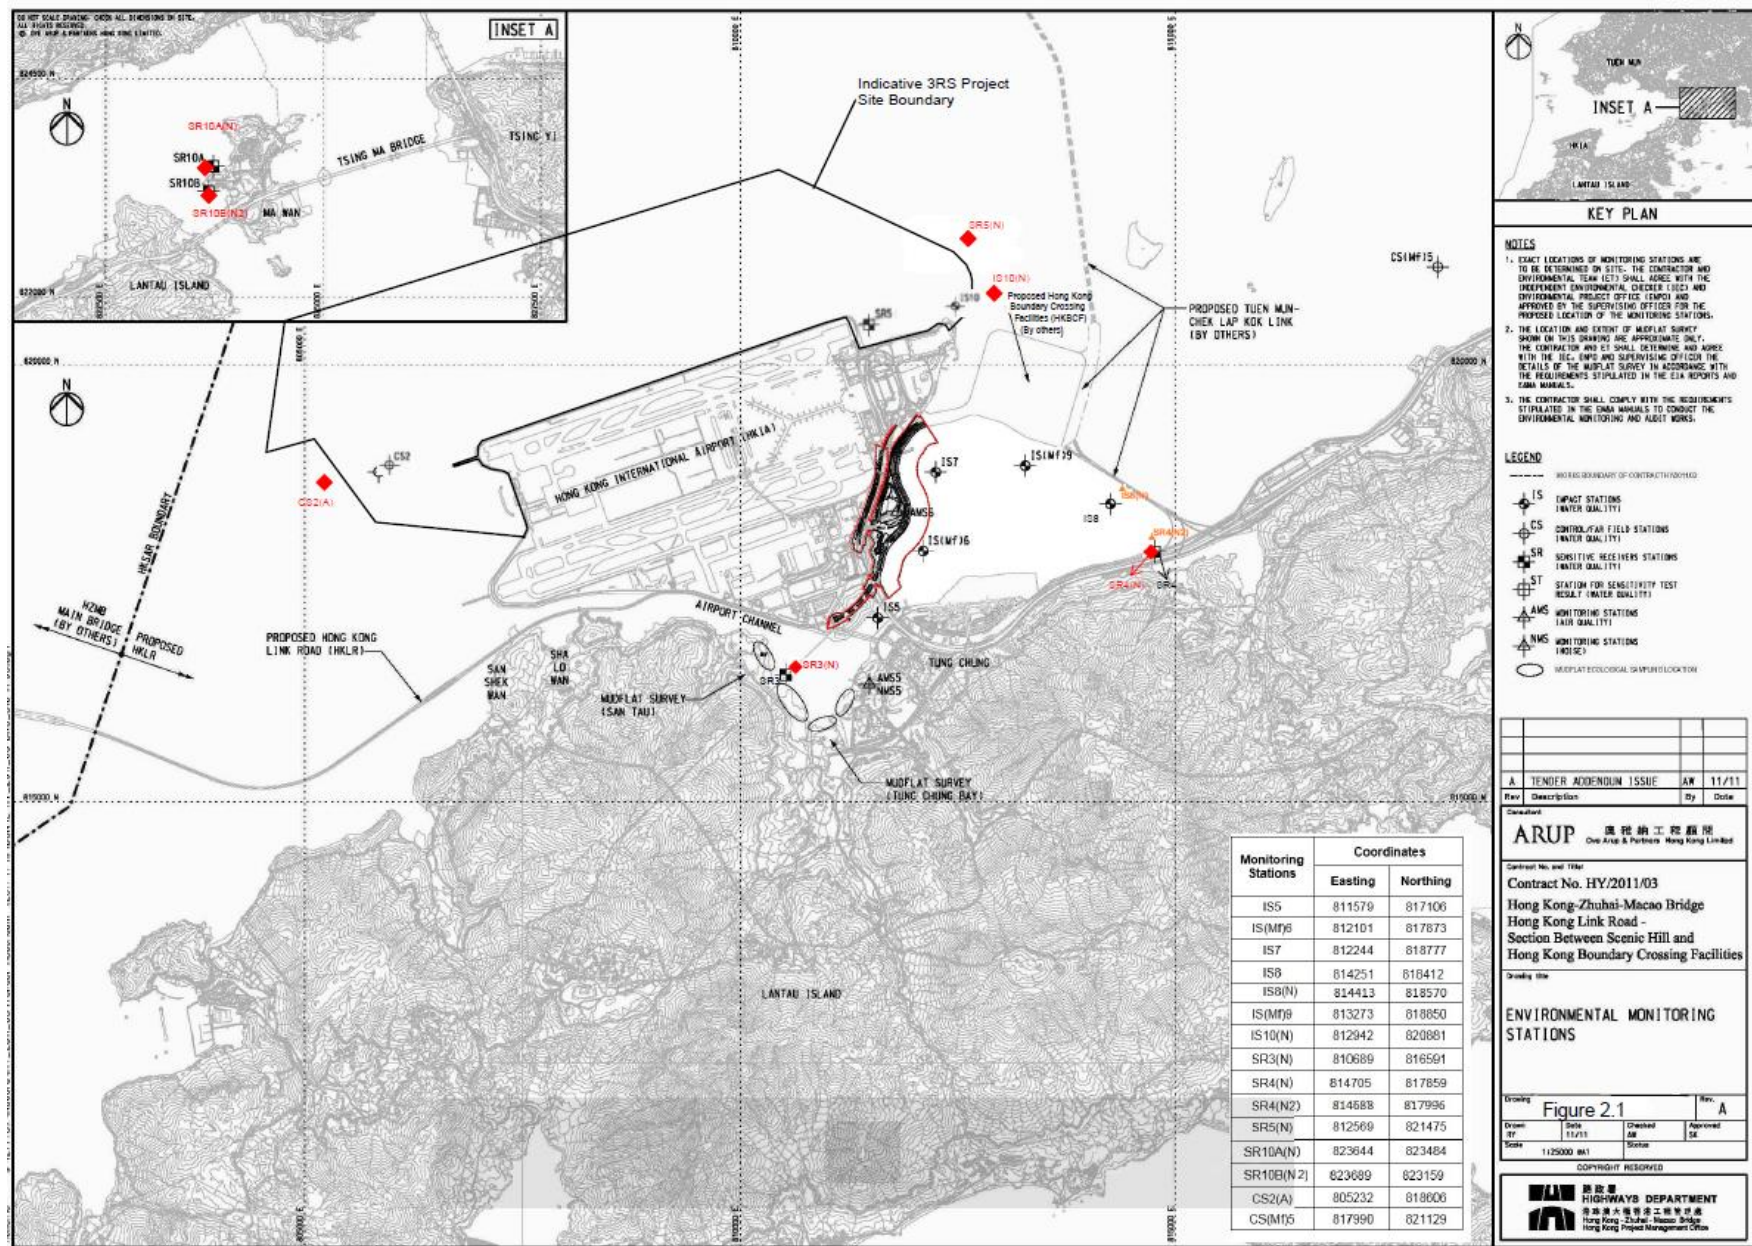
Figure 2.2

Operational Phase Water Quality Monitoring Stations SR3(N), CS2(A), SR4(N2) & CS(Mf)5

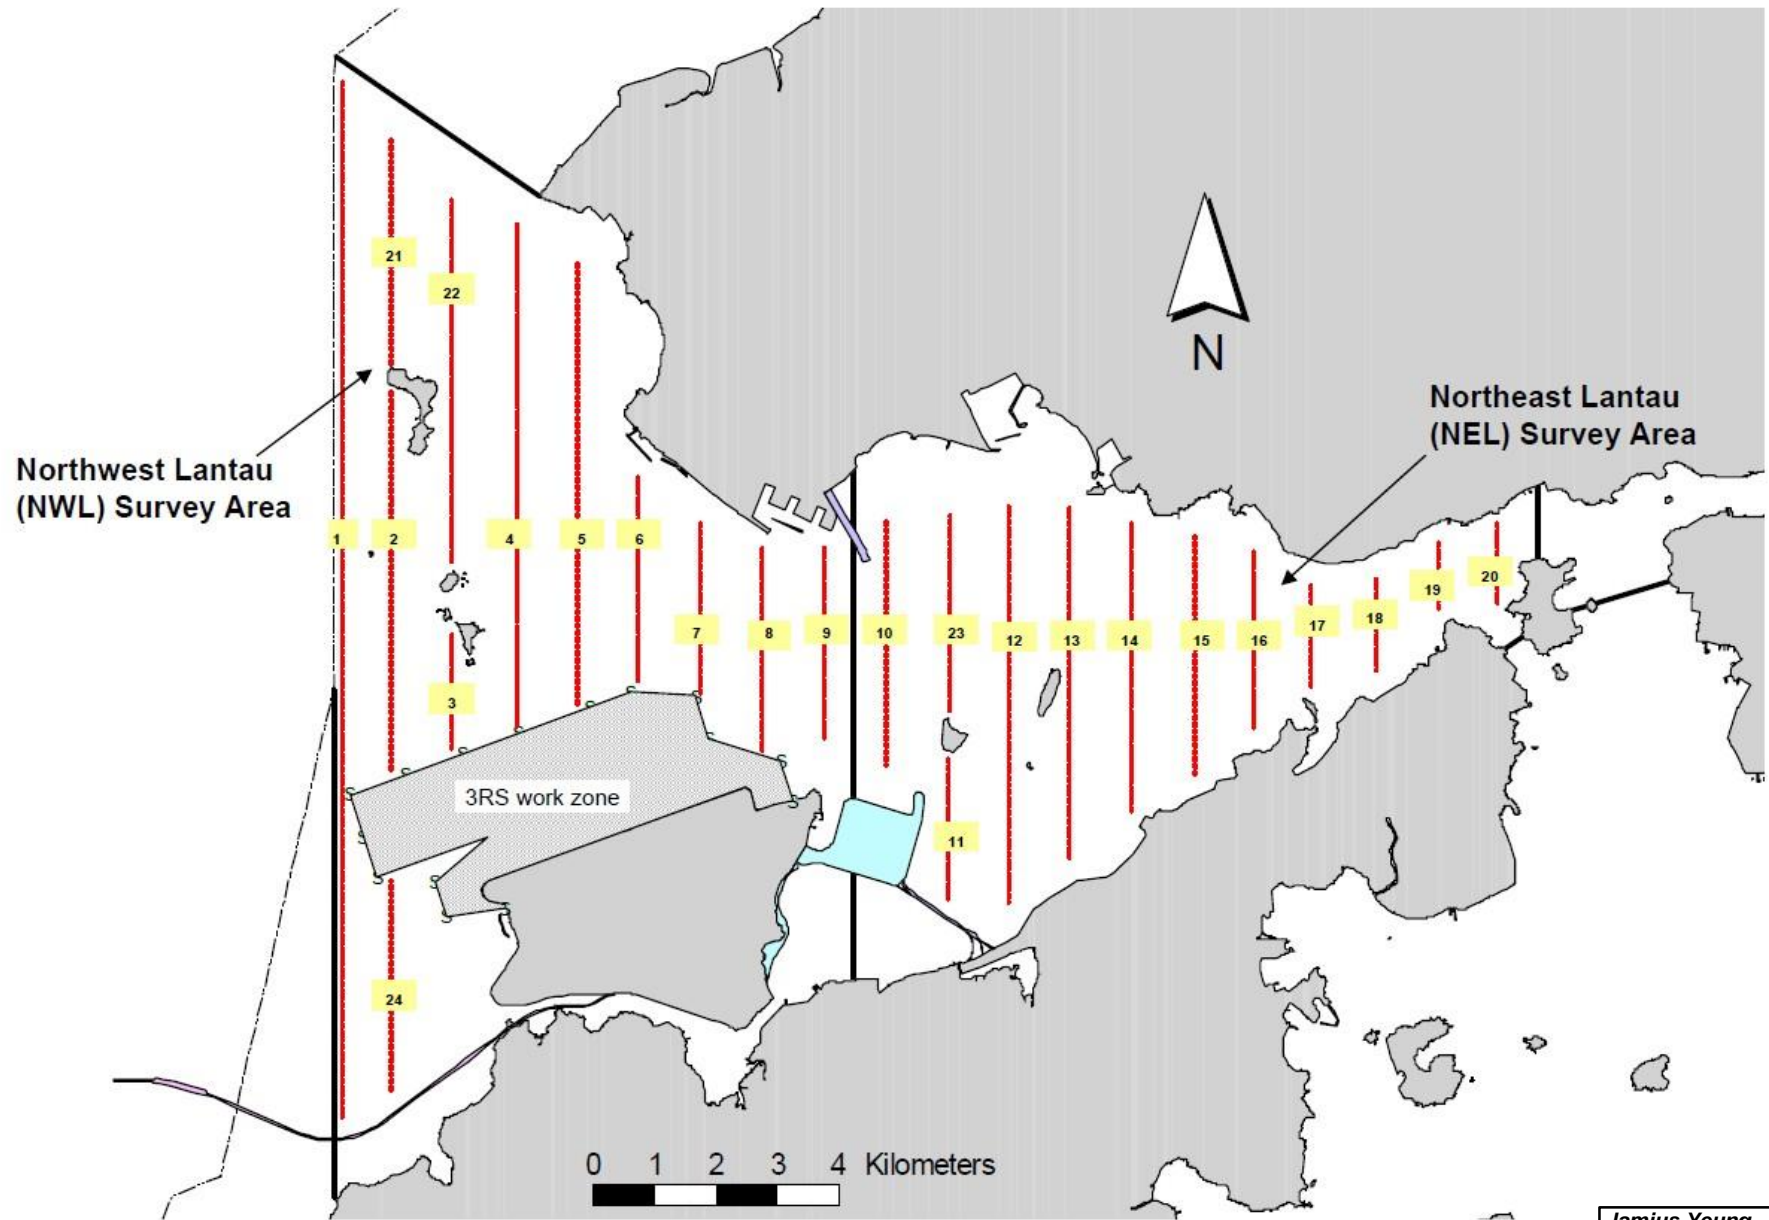
Figure 2.3

The operational phase dolphin monitoring was carried out in the NEL and NWL along the line transect as depicted in Figure 2.3. The co-ordinates of all transect lines are shown in Table 2.8 below.

Layout of Transect Lines of Dolphin Monitoring in Northwest and Northeast Lantau Areas

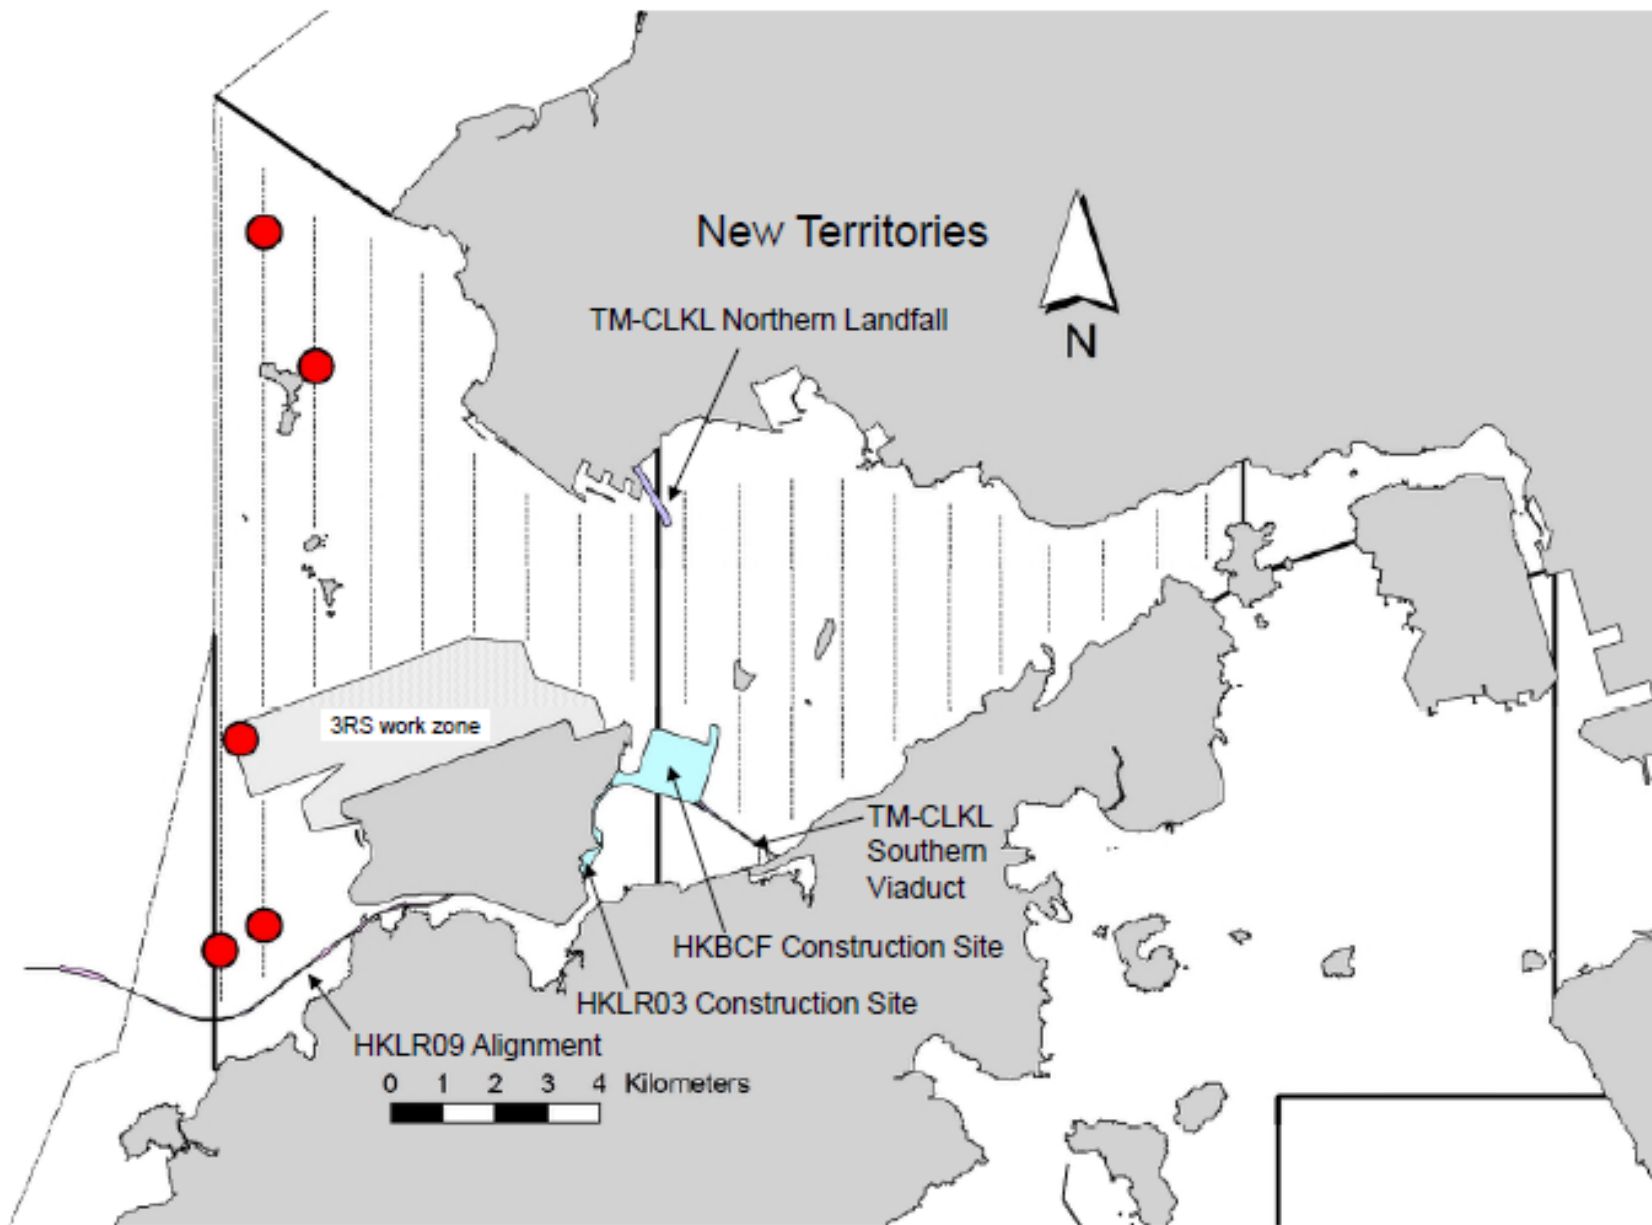
Figure 2.4

HY/2012/08 TM-CLKL Northern Connection Sub-sea Tunnel Section
 The distribution of dolphin sightings during the reporting period

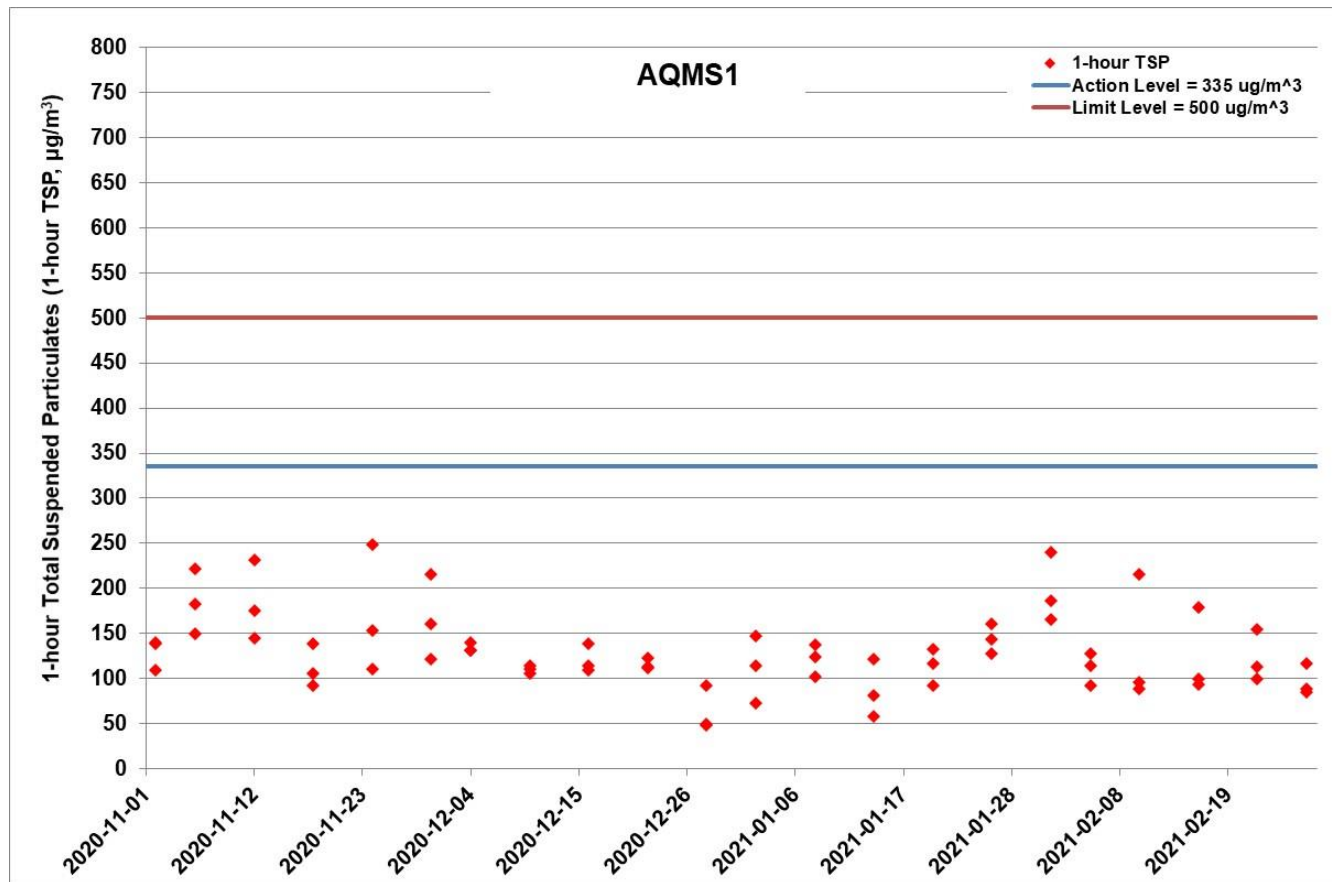
• **Figure G.1 Impact Monitoring – 1-hour Total Suspended Particulates ($\mu\text{g}/\text{m}^3$) at AQMS1 between 1 November 2020 and 28 February 2021 during impact monitoring period. The weather conditions during the monitoring period were sunny and hazy. No major land-based construction activities was conducted in the reporting period (1/11/2020 – 28/2/2021)**

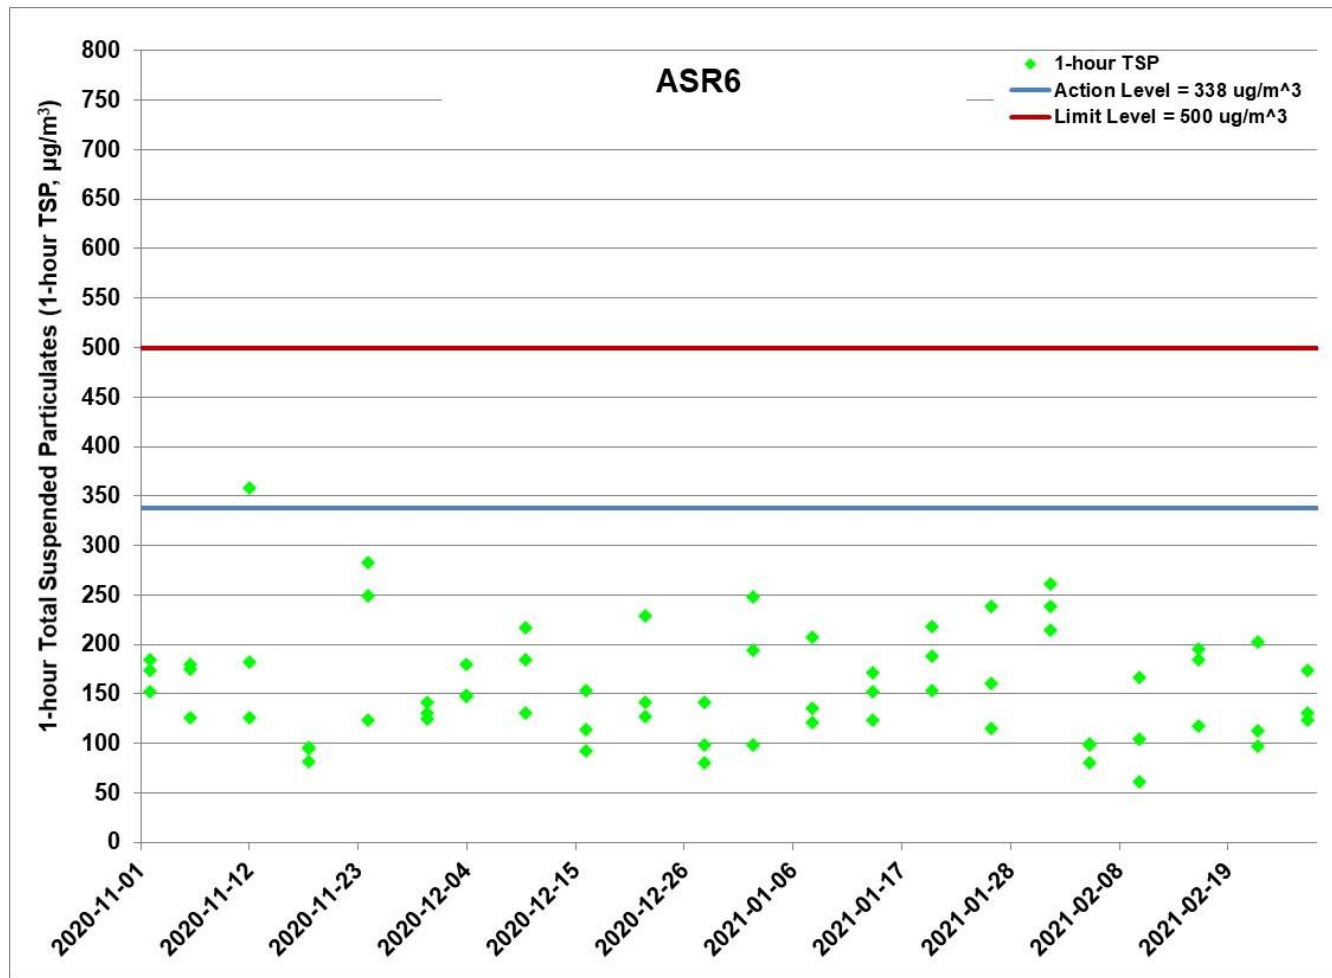
Figure G.2 Impact Monitoring – 1-hour Total Suspended Particulates ($\mu\text{g}/\text{m}^3$) at ASR6 between 1 November 2020 and 28 February 2021 during impact monitoring period. The weather conditions during the monitoring period were sunny and hazy. No major land-based construction activities was conducted in the reporting period (1/11/2020 – 28/2/2021)

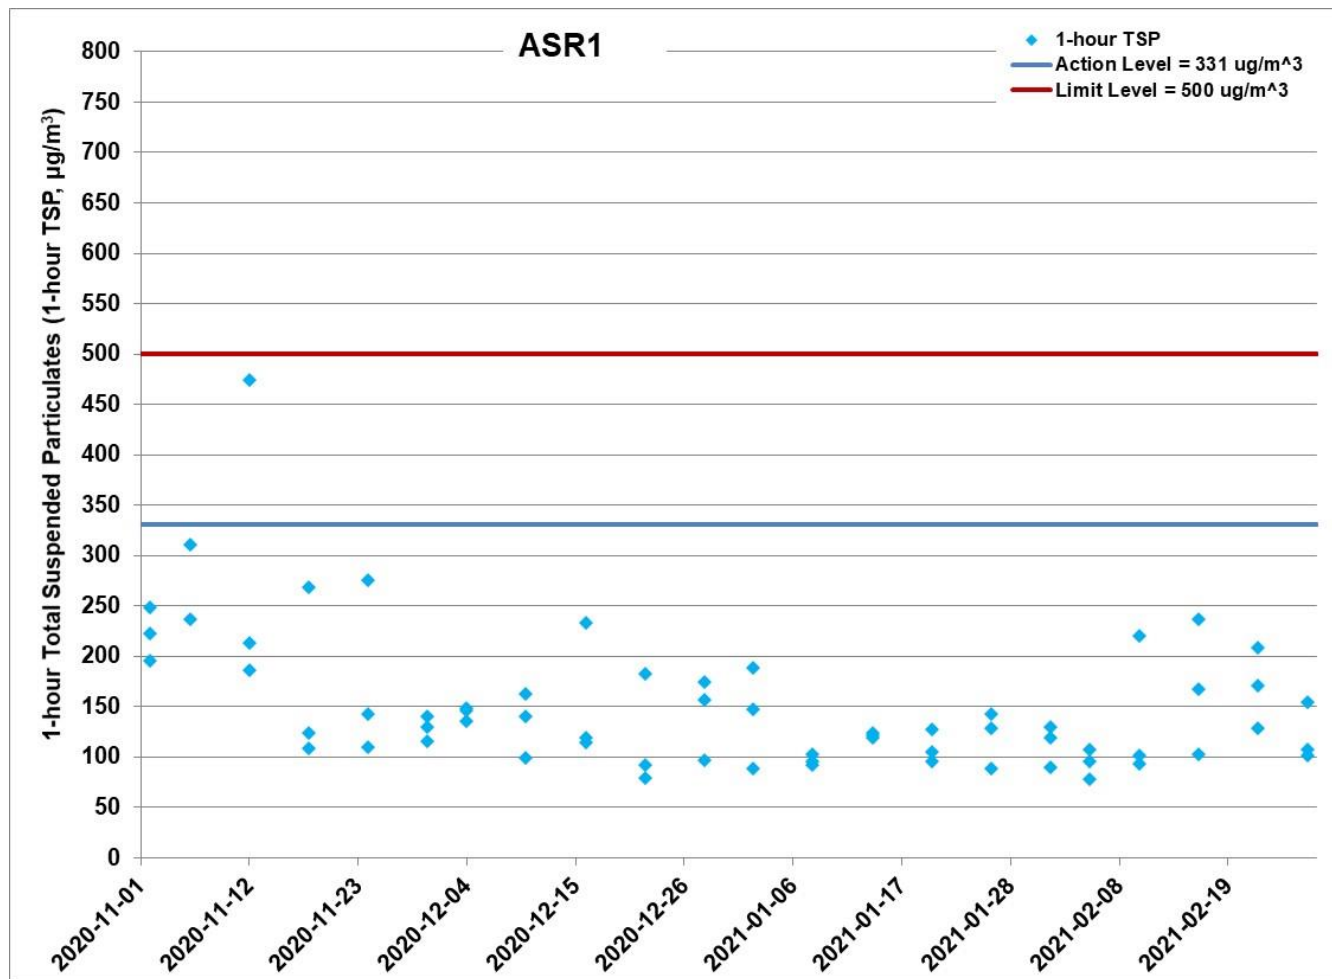
Figure G.3 Impact Monitoring – 1-hour Total Suspended Particulates ($\mu\text{g}/\text{m}^3$) at ASR1 between 1 November 2020 and 28 February 2021 during impact monitoring period. The weather conditions during the monitoring period were sunny and hazy. No major land-based construction activities was conducted in the reporting period (1/11/2020 – 28/2/2021)

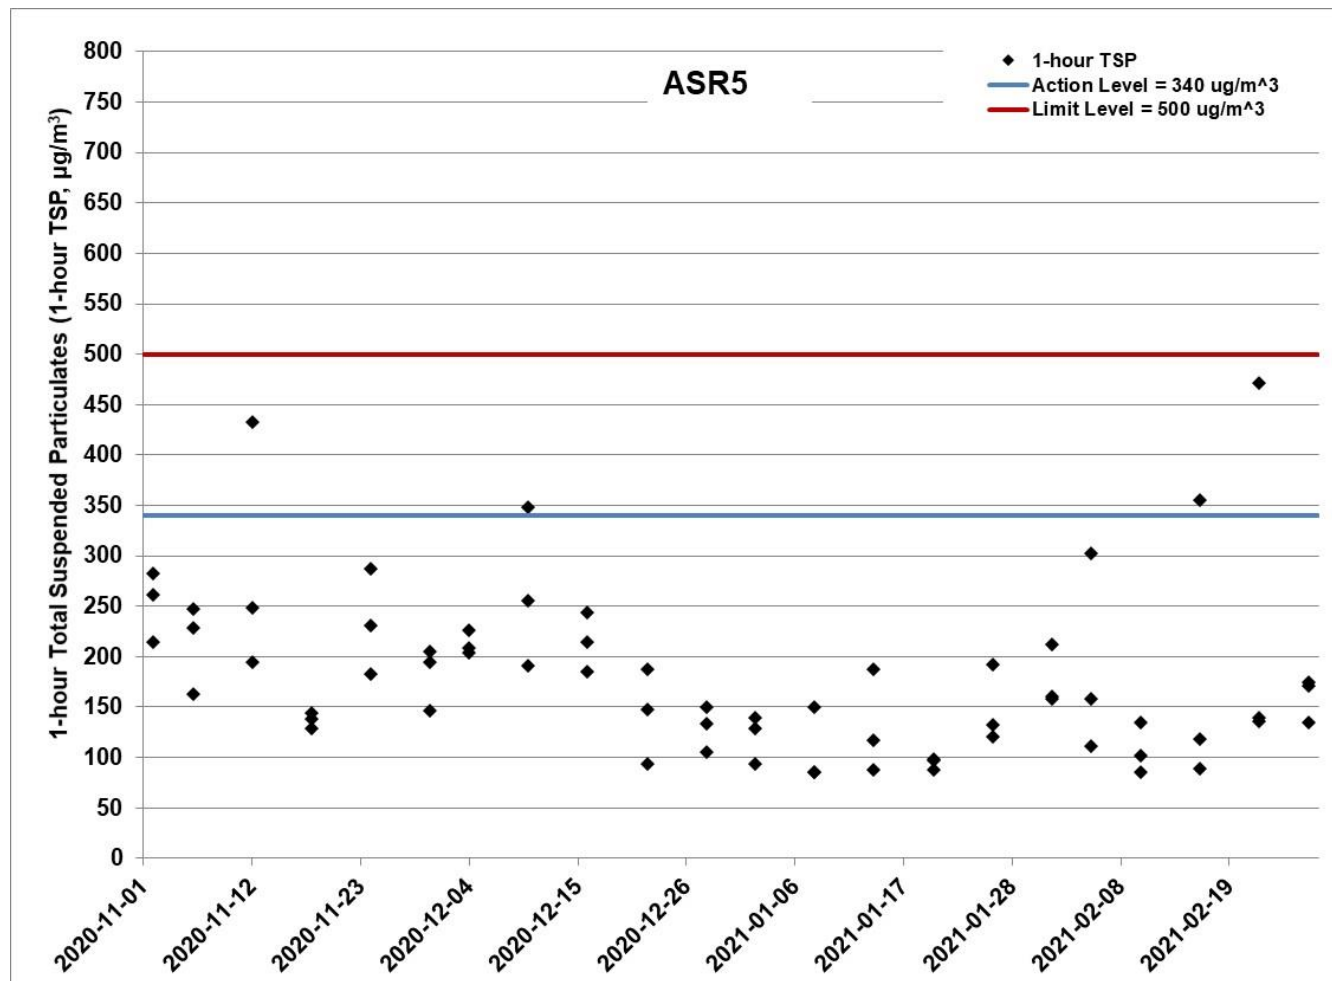
Figure G.4 Impact Monitoring - 1-hour Total Suspended Particulates ($\mu\text{g}/\text{m}^3$) at ASR5 between 1 November 2020 and 28 February 2021 during impact monitoring period. The weather conditions during the monitoring period were sunny and hazy. No major land-based construction activities was conducted in the reporting period (1/11/2020 - 28/2/2021)

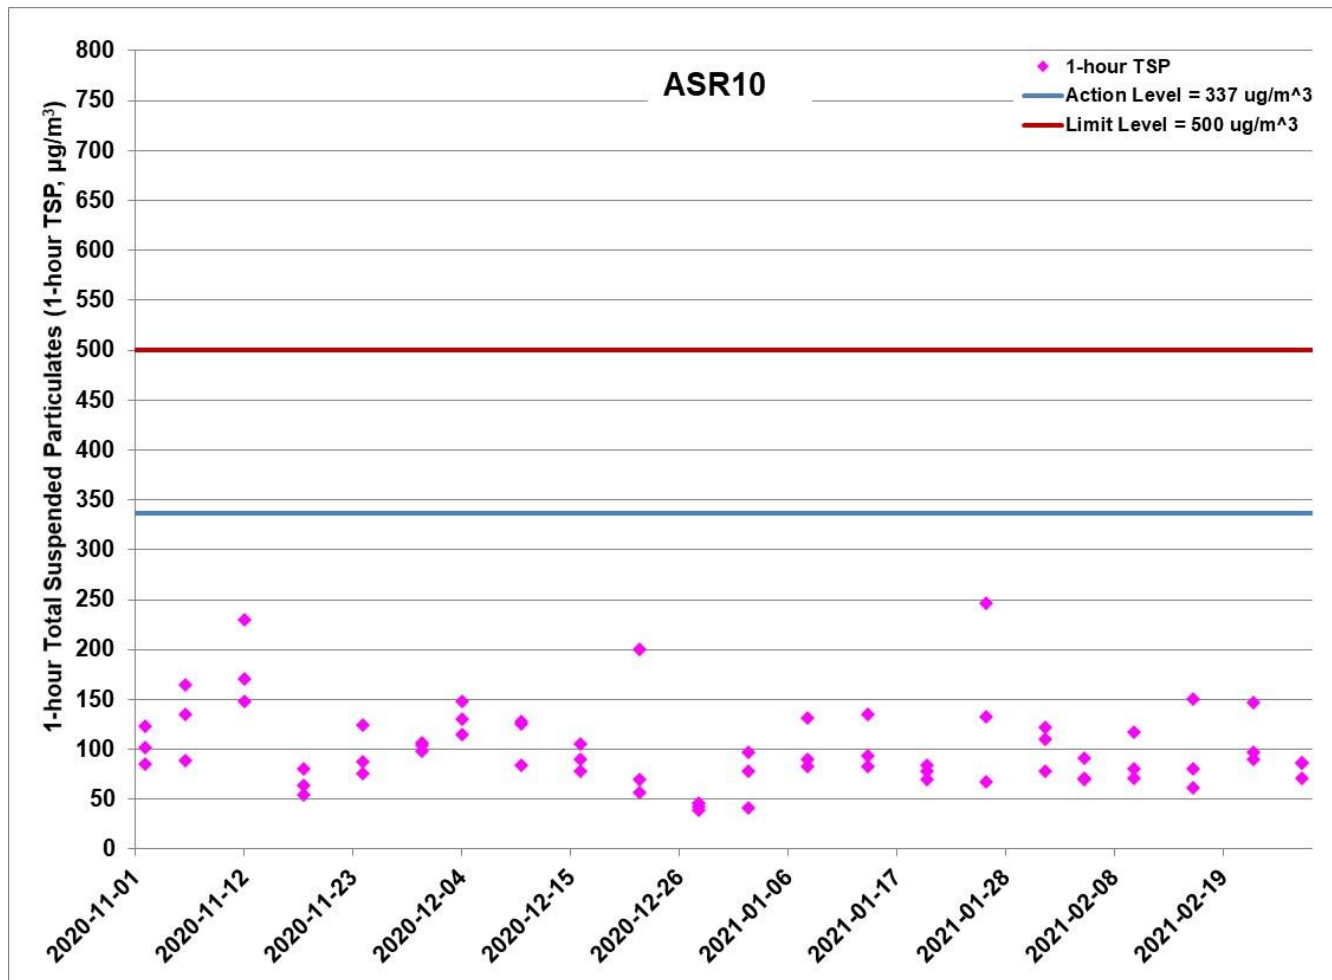
Figure G.5 Impact Monitoring - 1-hour Total Suspended Particulates ($\mu\text{g}/\text{m}^3$) at ASR10 between 1 November 2020 and 28 February 2021 during impact monitoring period. The weather conditions during the monitoring period were sunny and hazy. No major land-based construction activities was conducted in the reporting period (1/11/2020 - 28/2/2021)

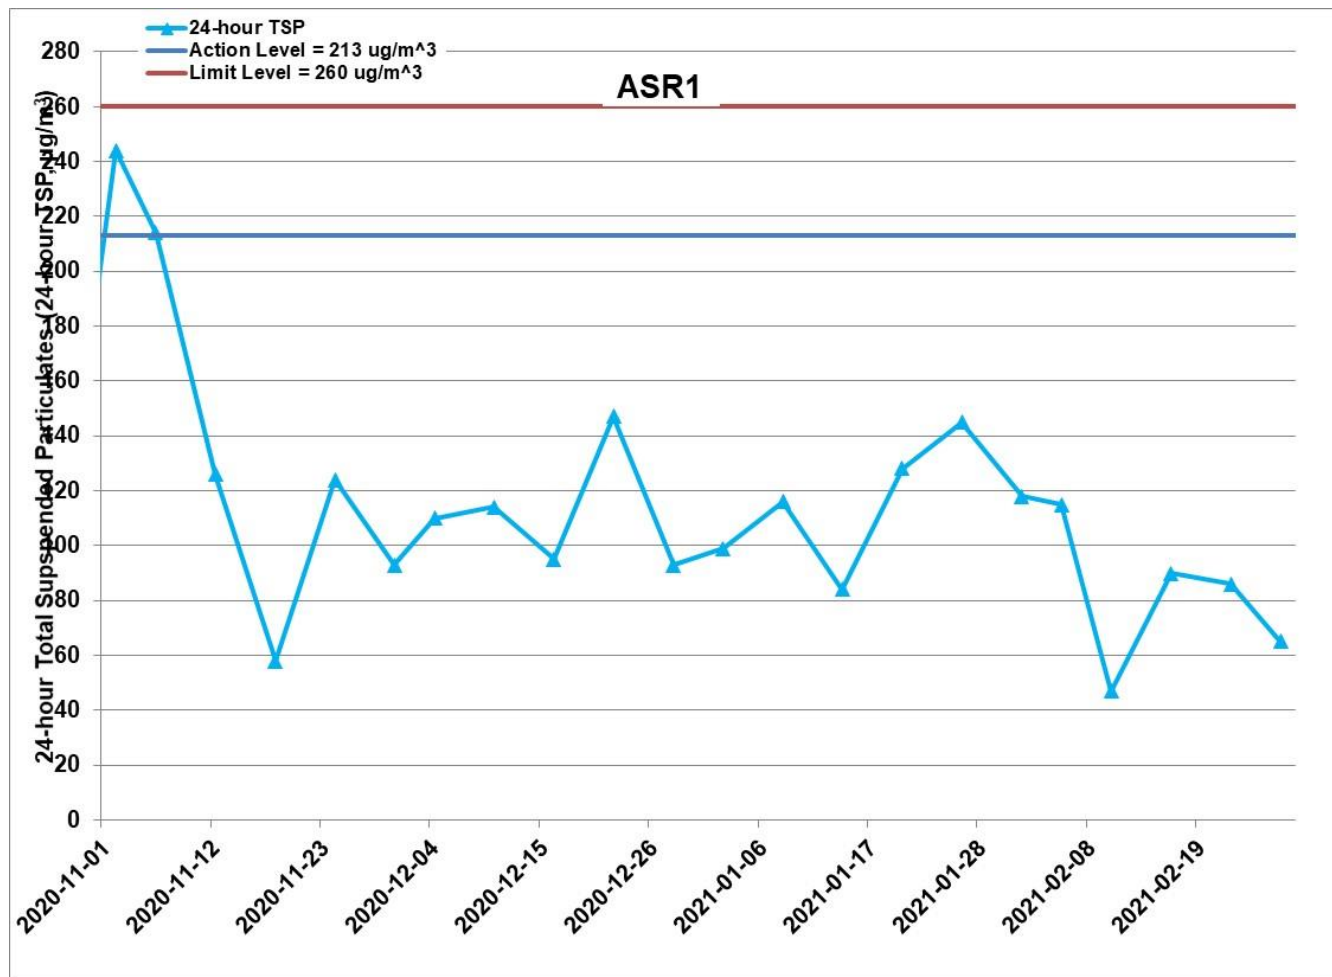
Figure G.6 Impact Monitoring – 24-hour Total Suspended Particulates ($\mu\text{g}/\text{m}^3$) at ASR1 between 1 November 2020 and 28 February 2021 during impact monitoring period. The weather conditions during the monitoring period were sunny and hazy. No major land-based construction activities was conducted in the reporting period (1/11/2020 – 28/2/2021)

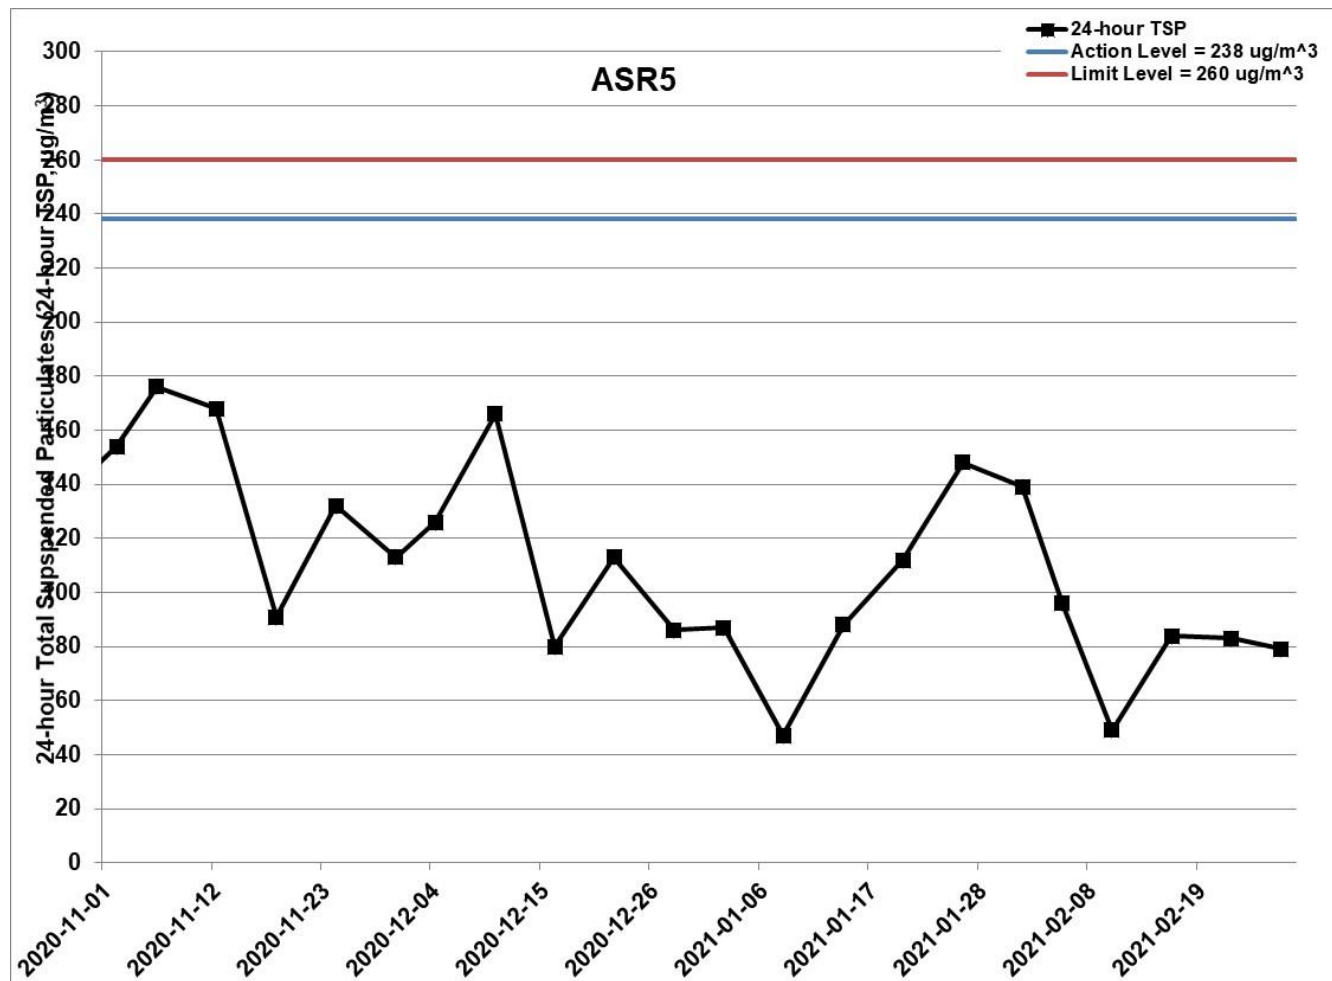
Figure G.7 Impact Monitoring - 24-hour Total Suspended Particulates ($\mu\text{g}/\text{m}^3$) at ASR5 between 1 November 2020 and 28 February 2021 during impact monitoring period. The weather conditions during the monitoring period were sunny and hazy. No major land-based construction activities was conducted in the reporting period (1/11/2020 - 28/2/2021)
