**Contract No. HY/2012/08
Tuen Mun – Chek Lap Kok Link –
Northern Connection Sub-sea Tunnel
Section**

***Eighty-Eighth Monthly Environmental
Monitoring & Audit (EM&A) Report***

11 March 2021

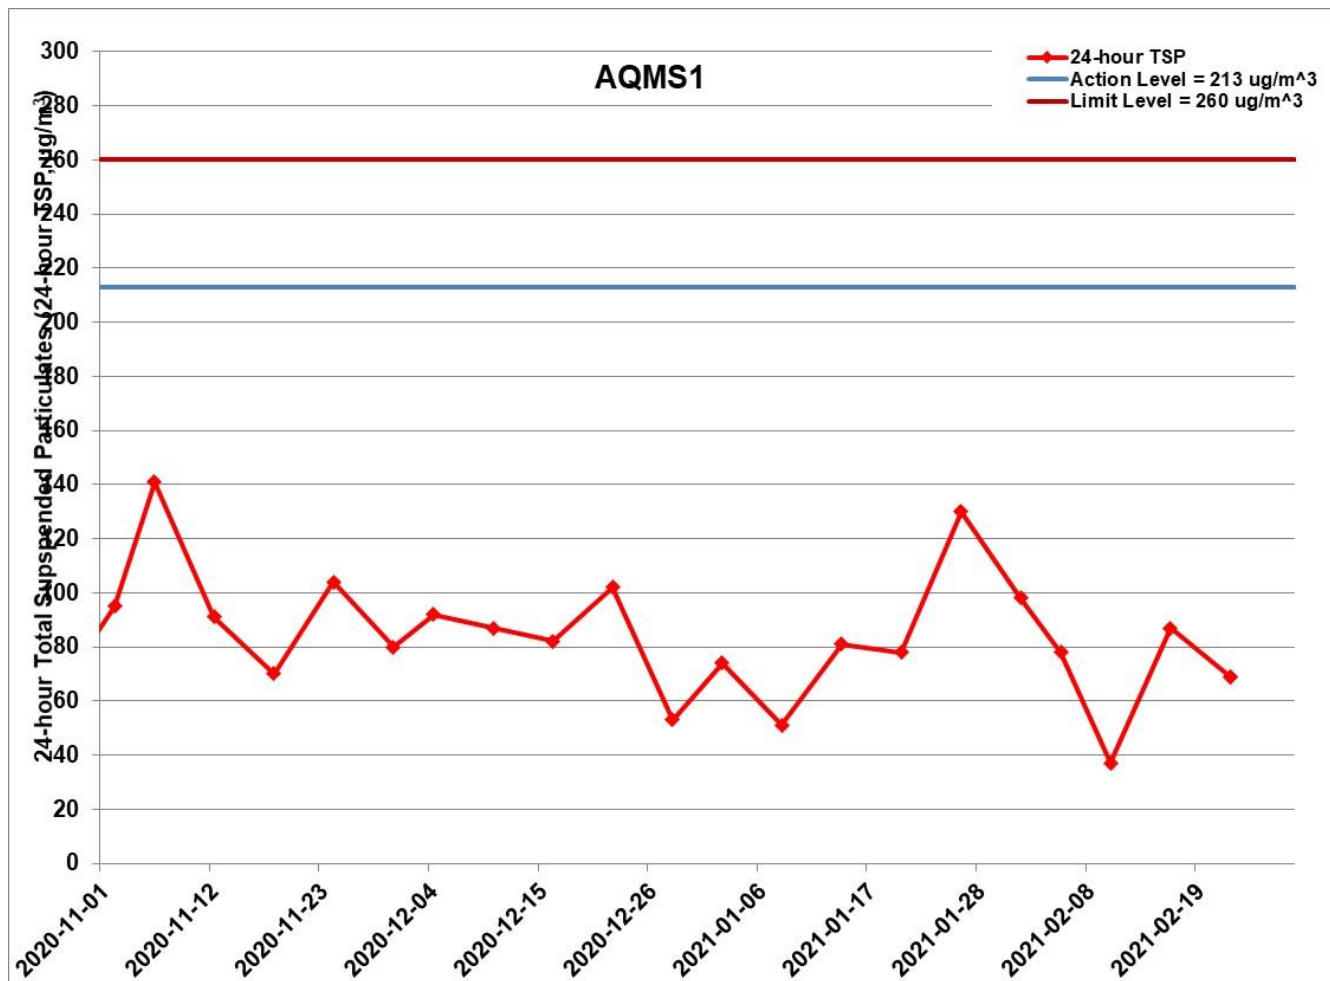
Figure G.8 Impact Monitoring - 24-hour Total Suspended Particulates ($\mu\text{g}/\text{m}^3$) at AQMS1 between 1 November 2020 and 28 February 2021 during impact monitoring period. The weather conditions during the monitoring period were sunny and hazy. No major land-based construction activities was conducted in the reporting period (1/11/2020 - 28/2/2021)

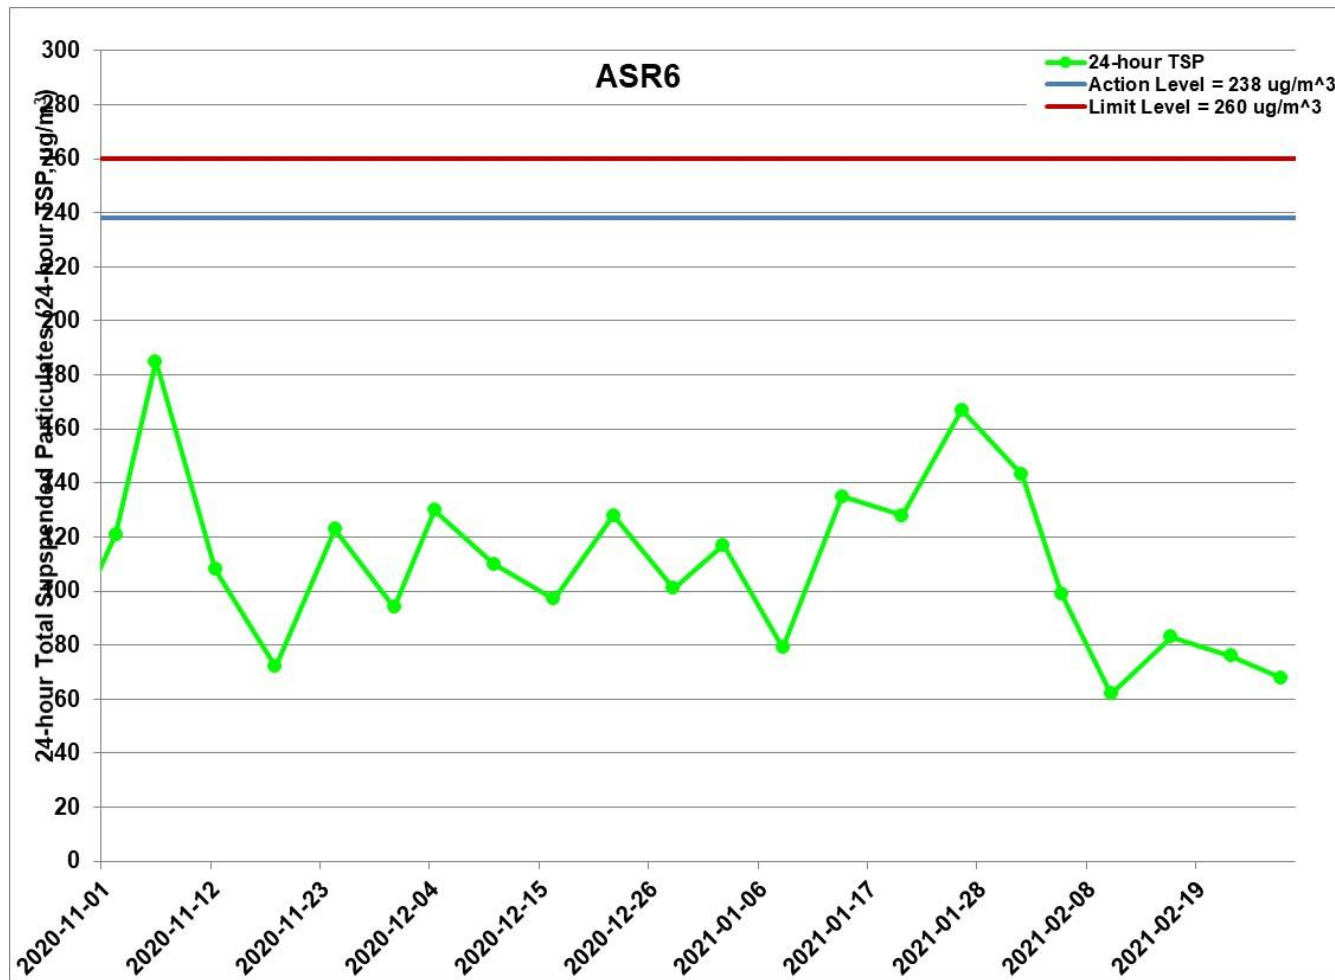
Figure G.9 Impact Monitoring - 24-hour Total Suspended Particulates ($\mu\text{g}/\text{m}^3$) at ASR6 between 1 November 2020 and 28 February 2021 during impact monitoring period. The weather conditions during the monitoring period were sunny and hazy. No major land-based construction activities was conducted in the reporting period (1/11/2020 - 28/2/2021)

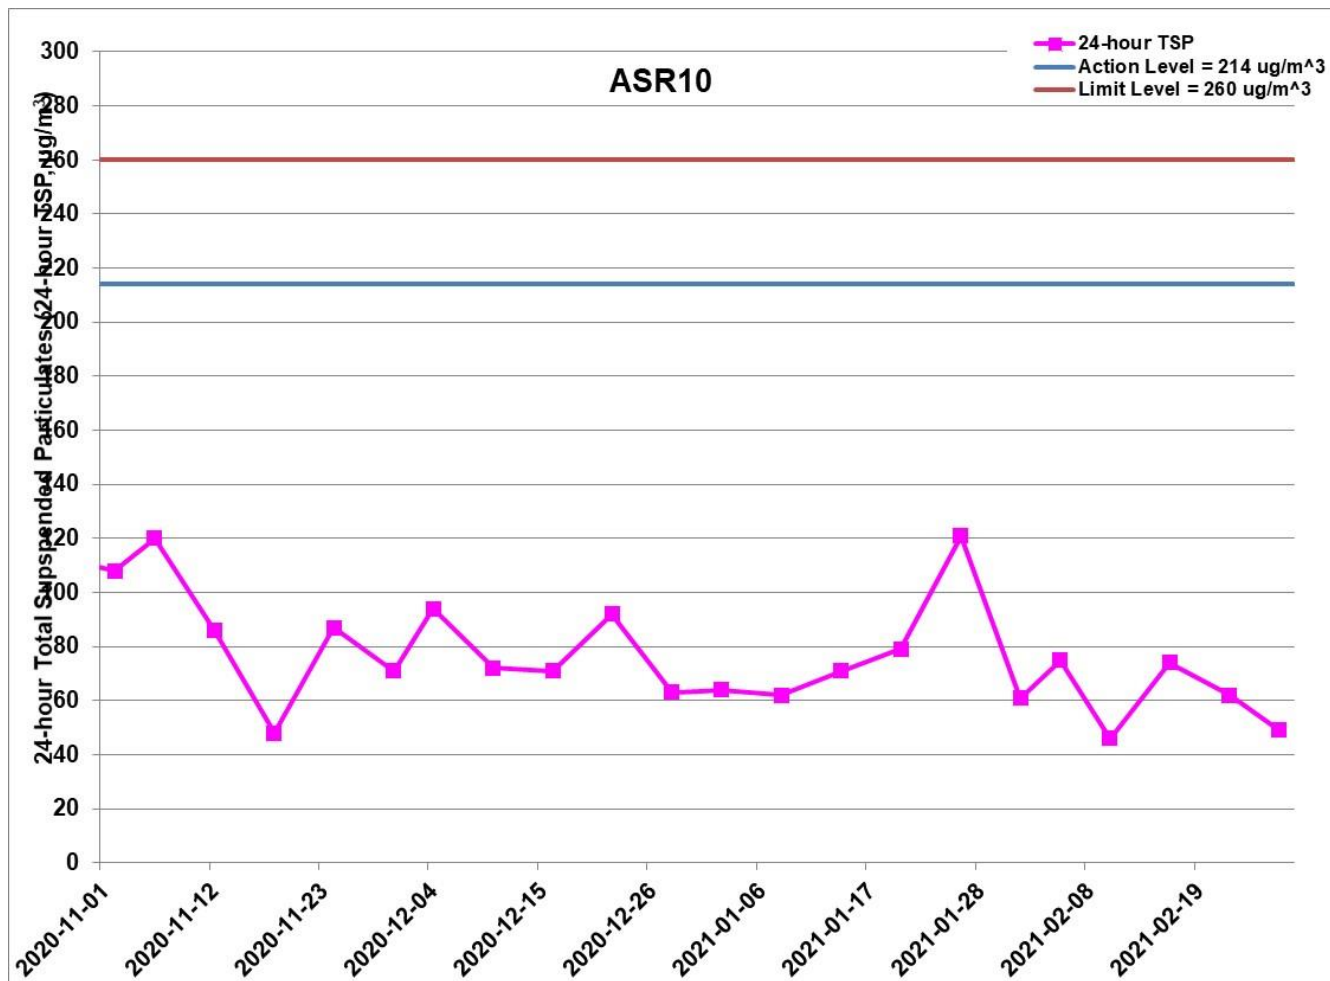
Figure G.10 Impact Monitoring - 24-hour Total Suspended Particulates ($\mu\text{g}/\text{m}^3$) at ASR10 between 1 November 2020 and 28 February 2021 during impact monitoring period. The weather conditions during the monitoring period were sunny and hazy. No major land-based construction activities was conducted in the reporting period (1/11/2020 - 28/2/2021)

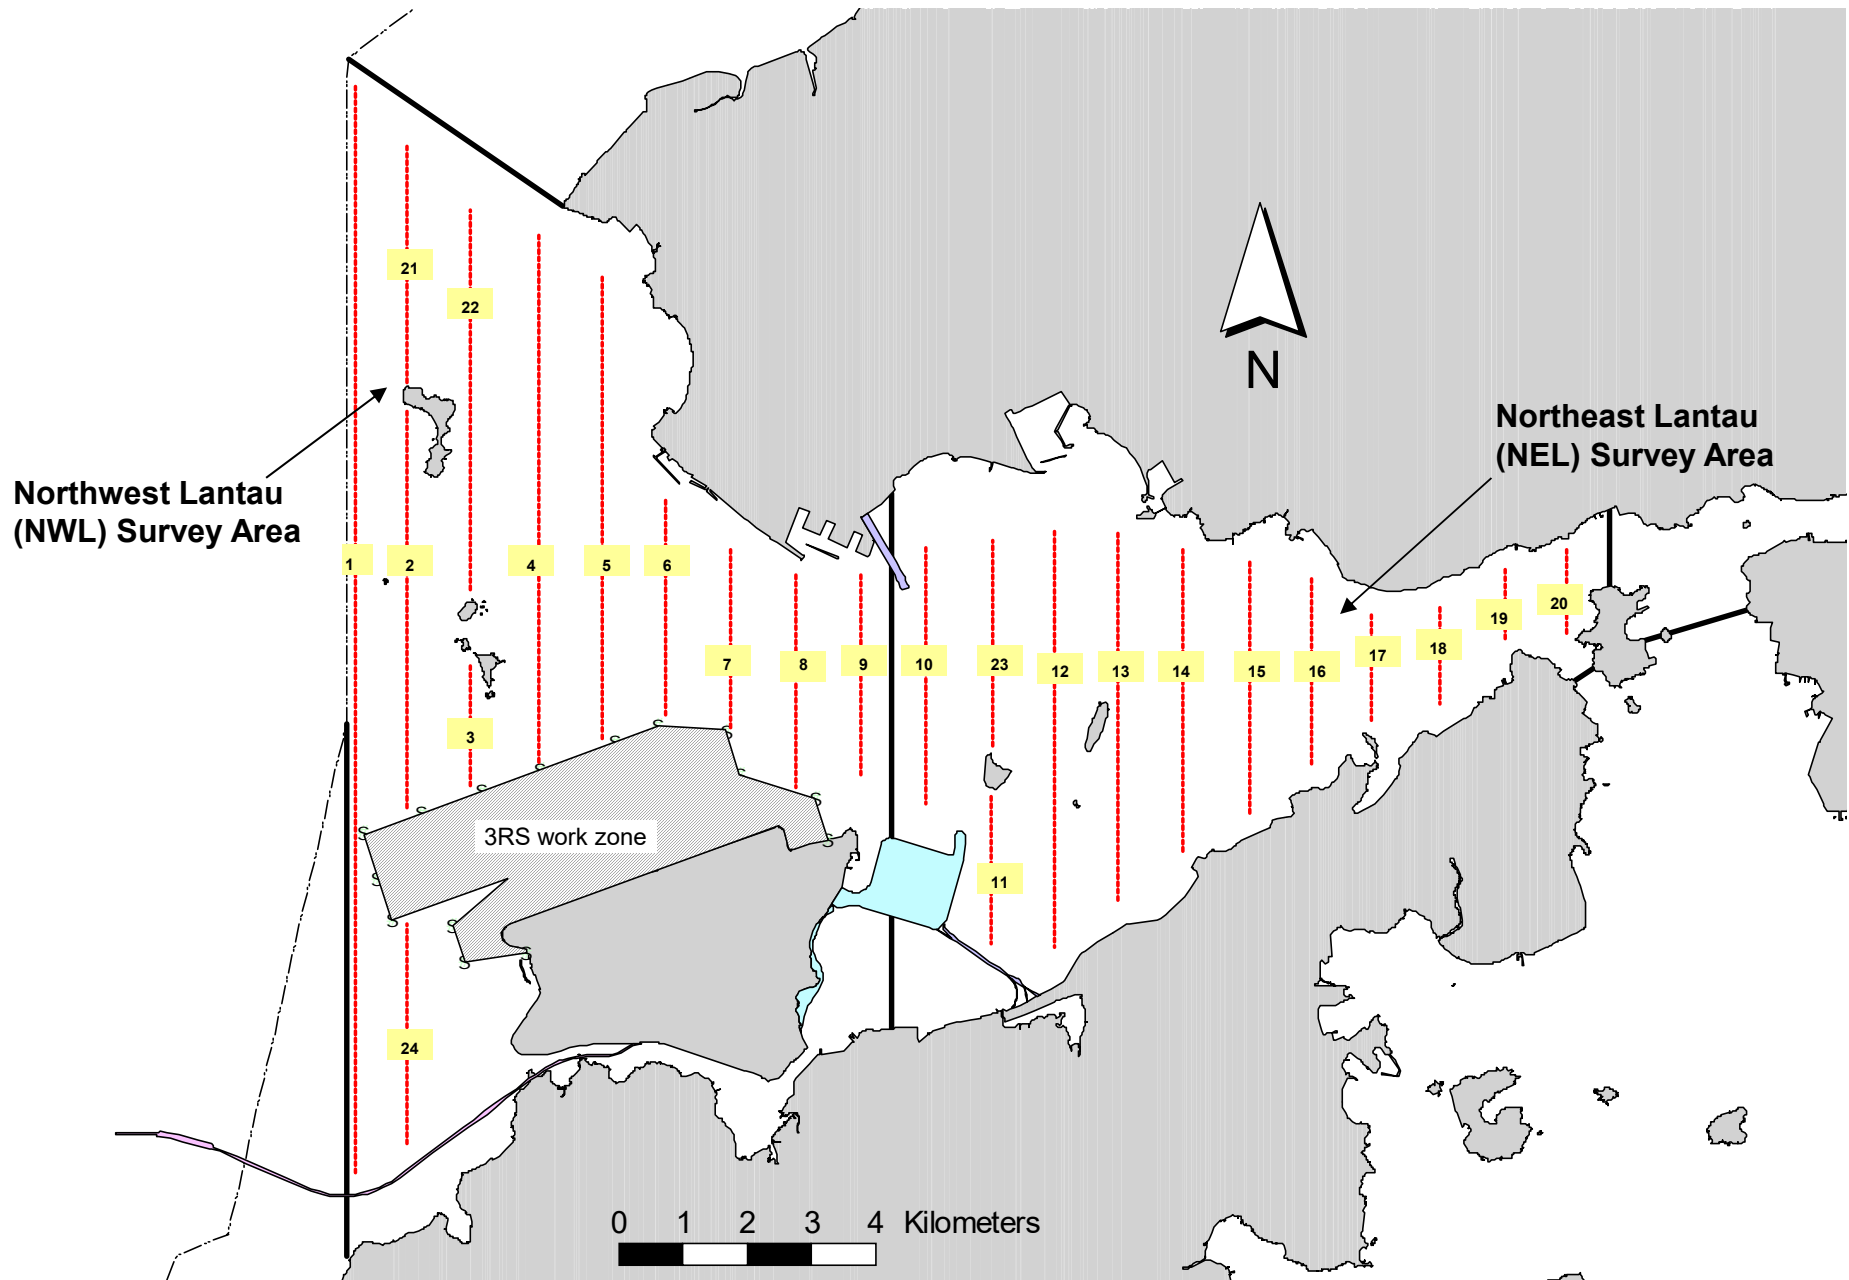
Figure 1. Transect Line Layout in Northwest and Northeast Lantau Survey Areas

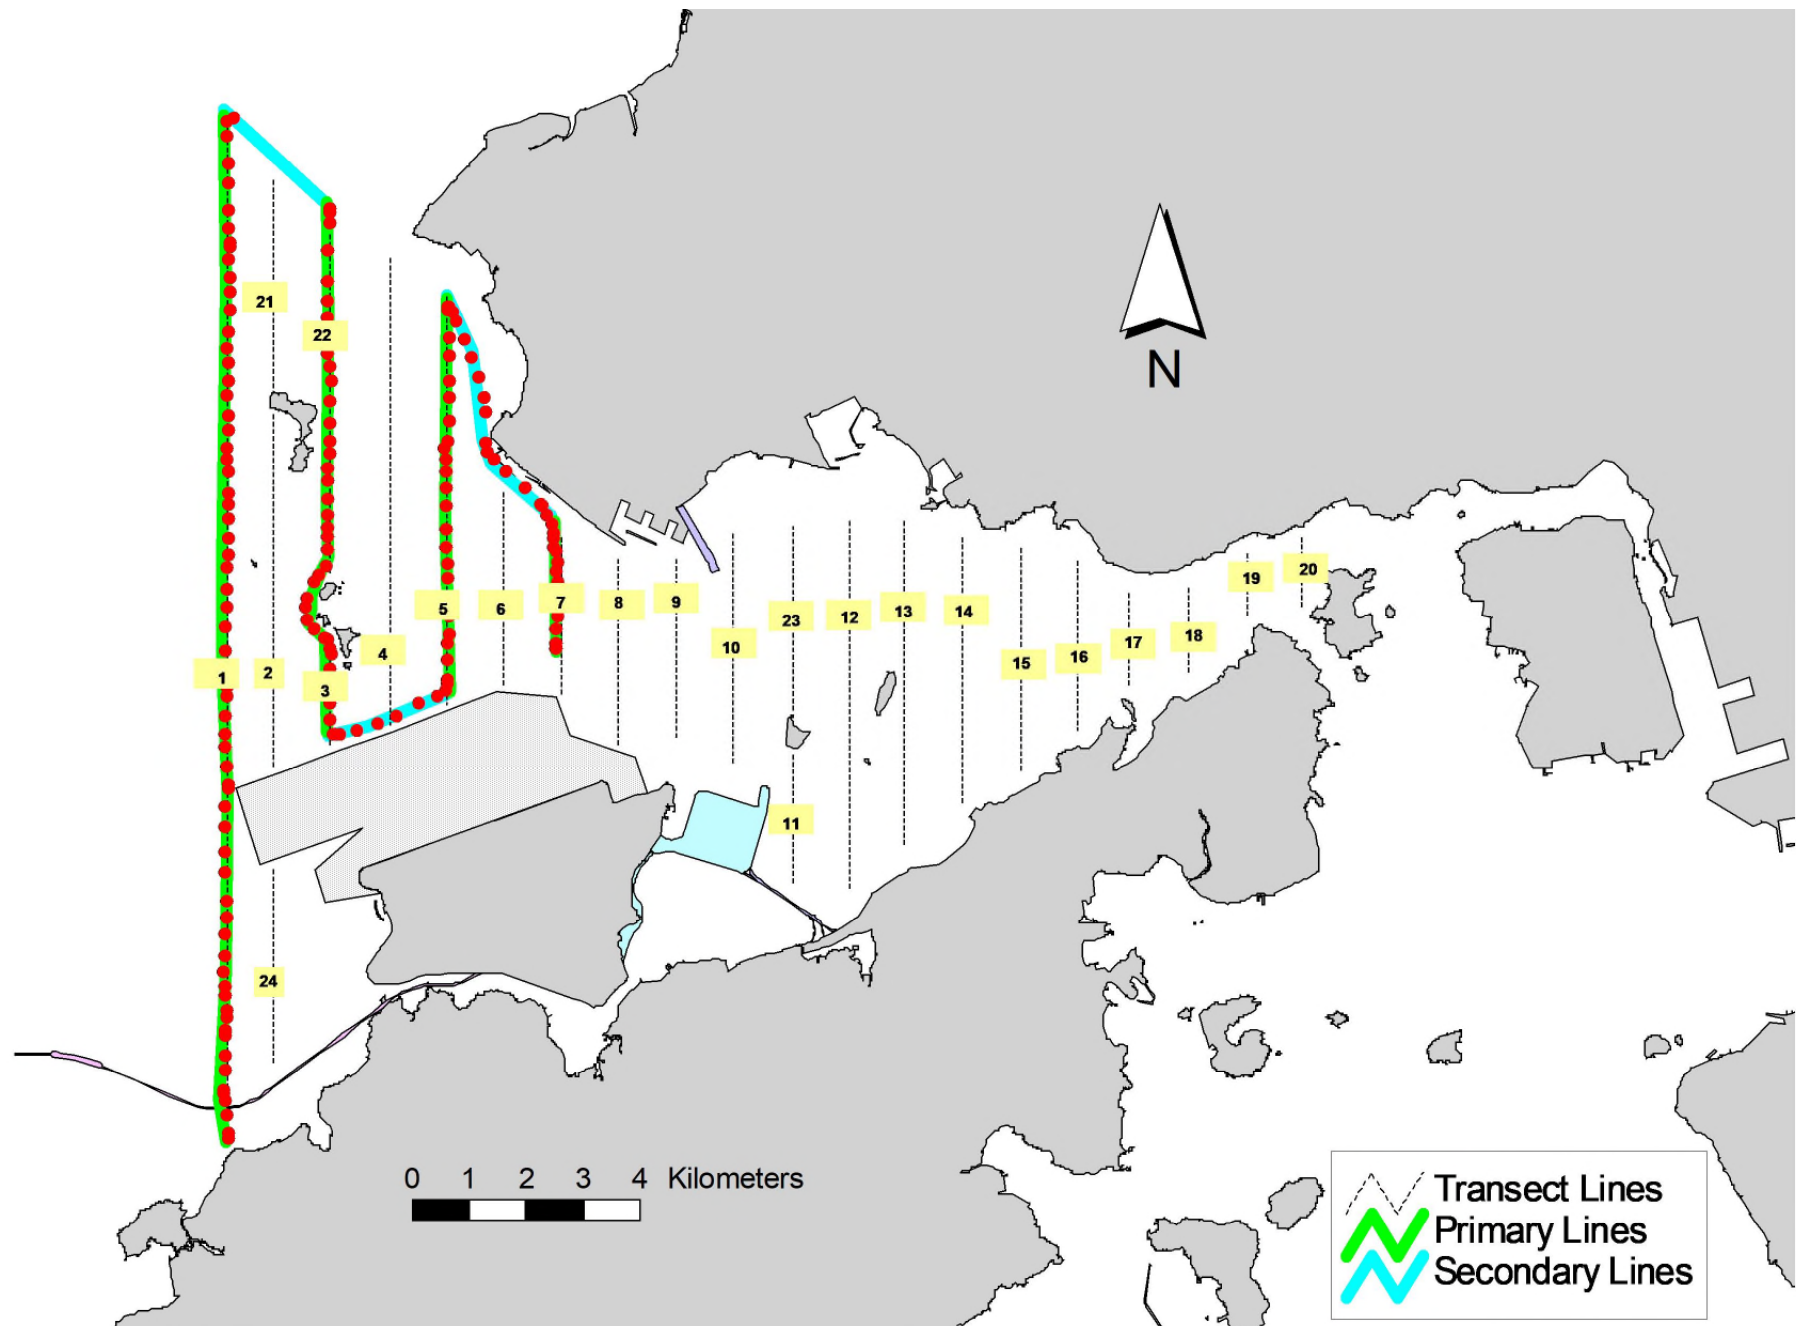
Figure 3. Survey Route on February 8th, 2021

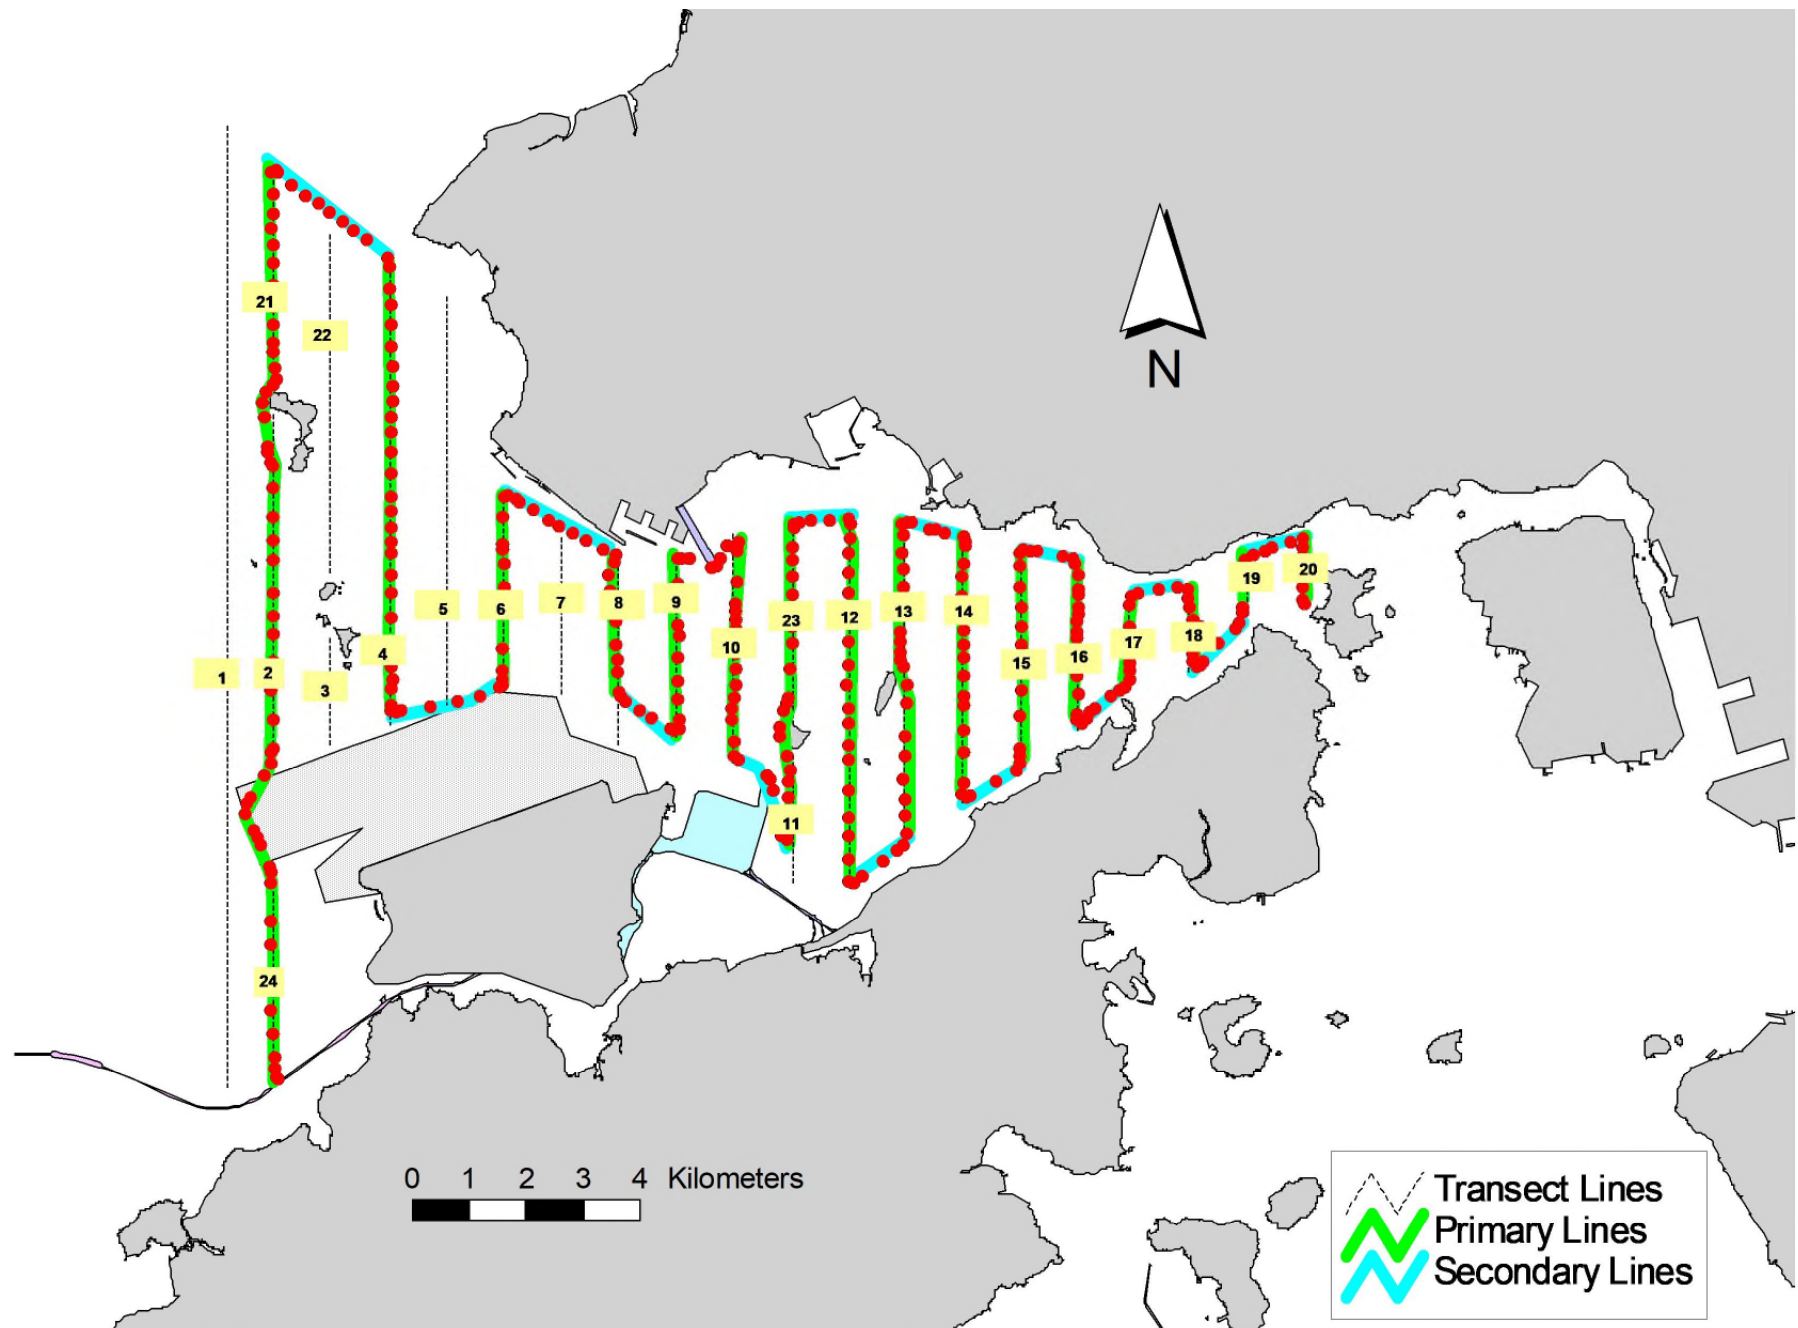
Figure 4. Survey Route on February 18th, 2021

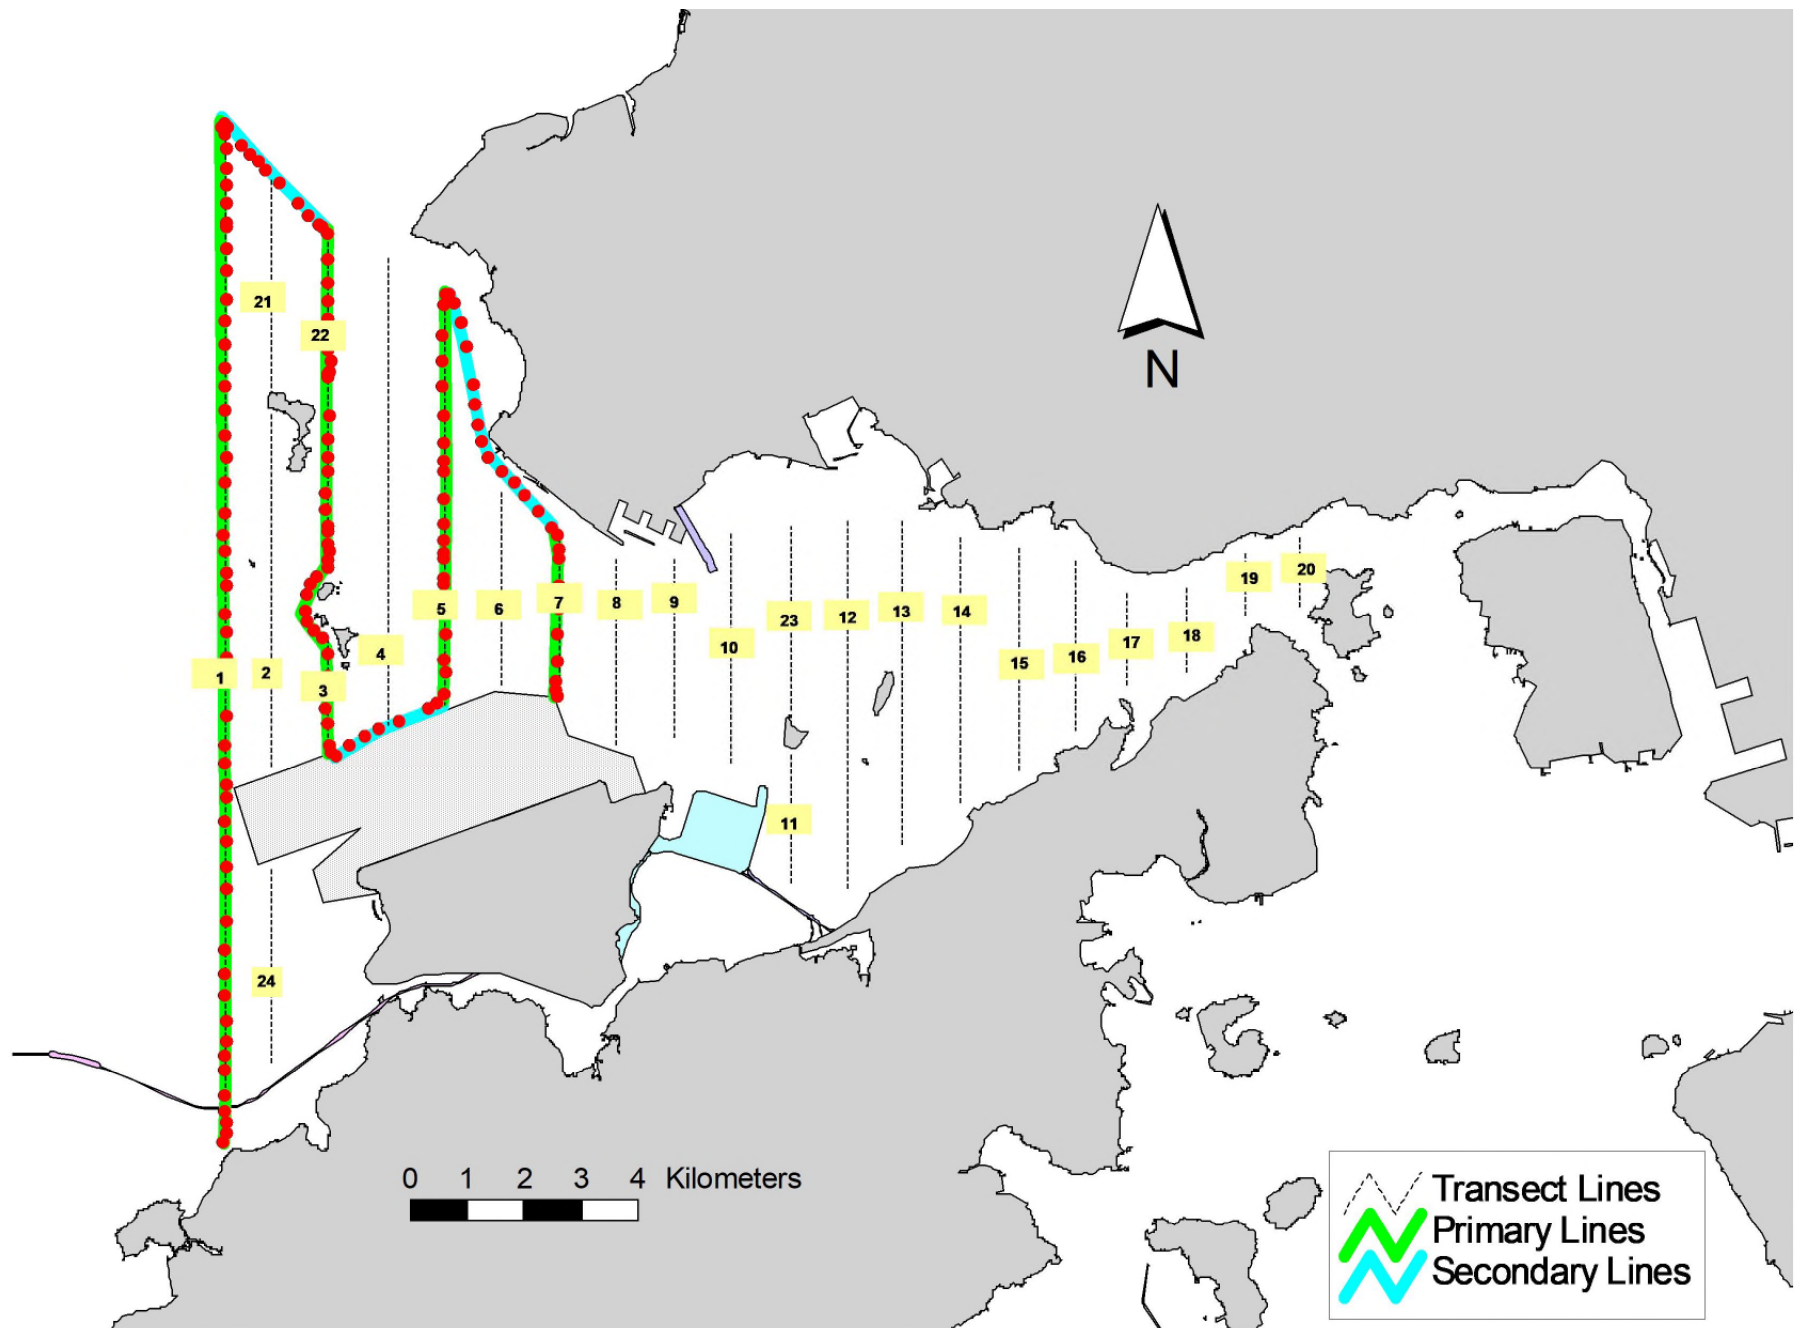
Figure 5. Survey Route on February 23rd, 2021

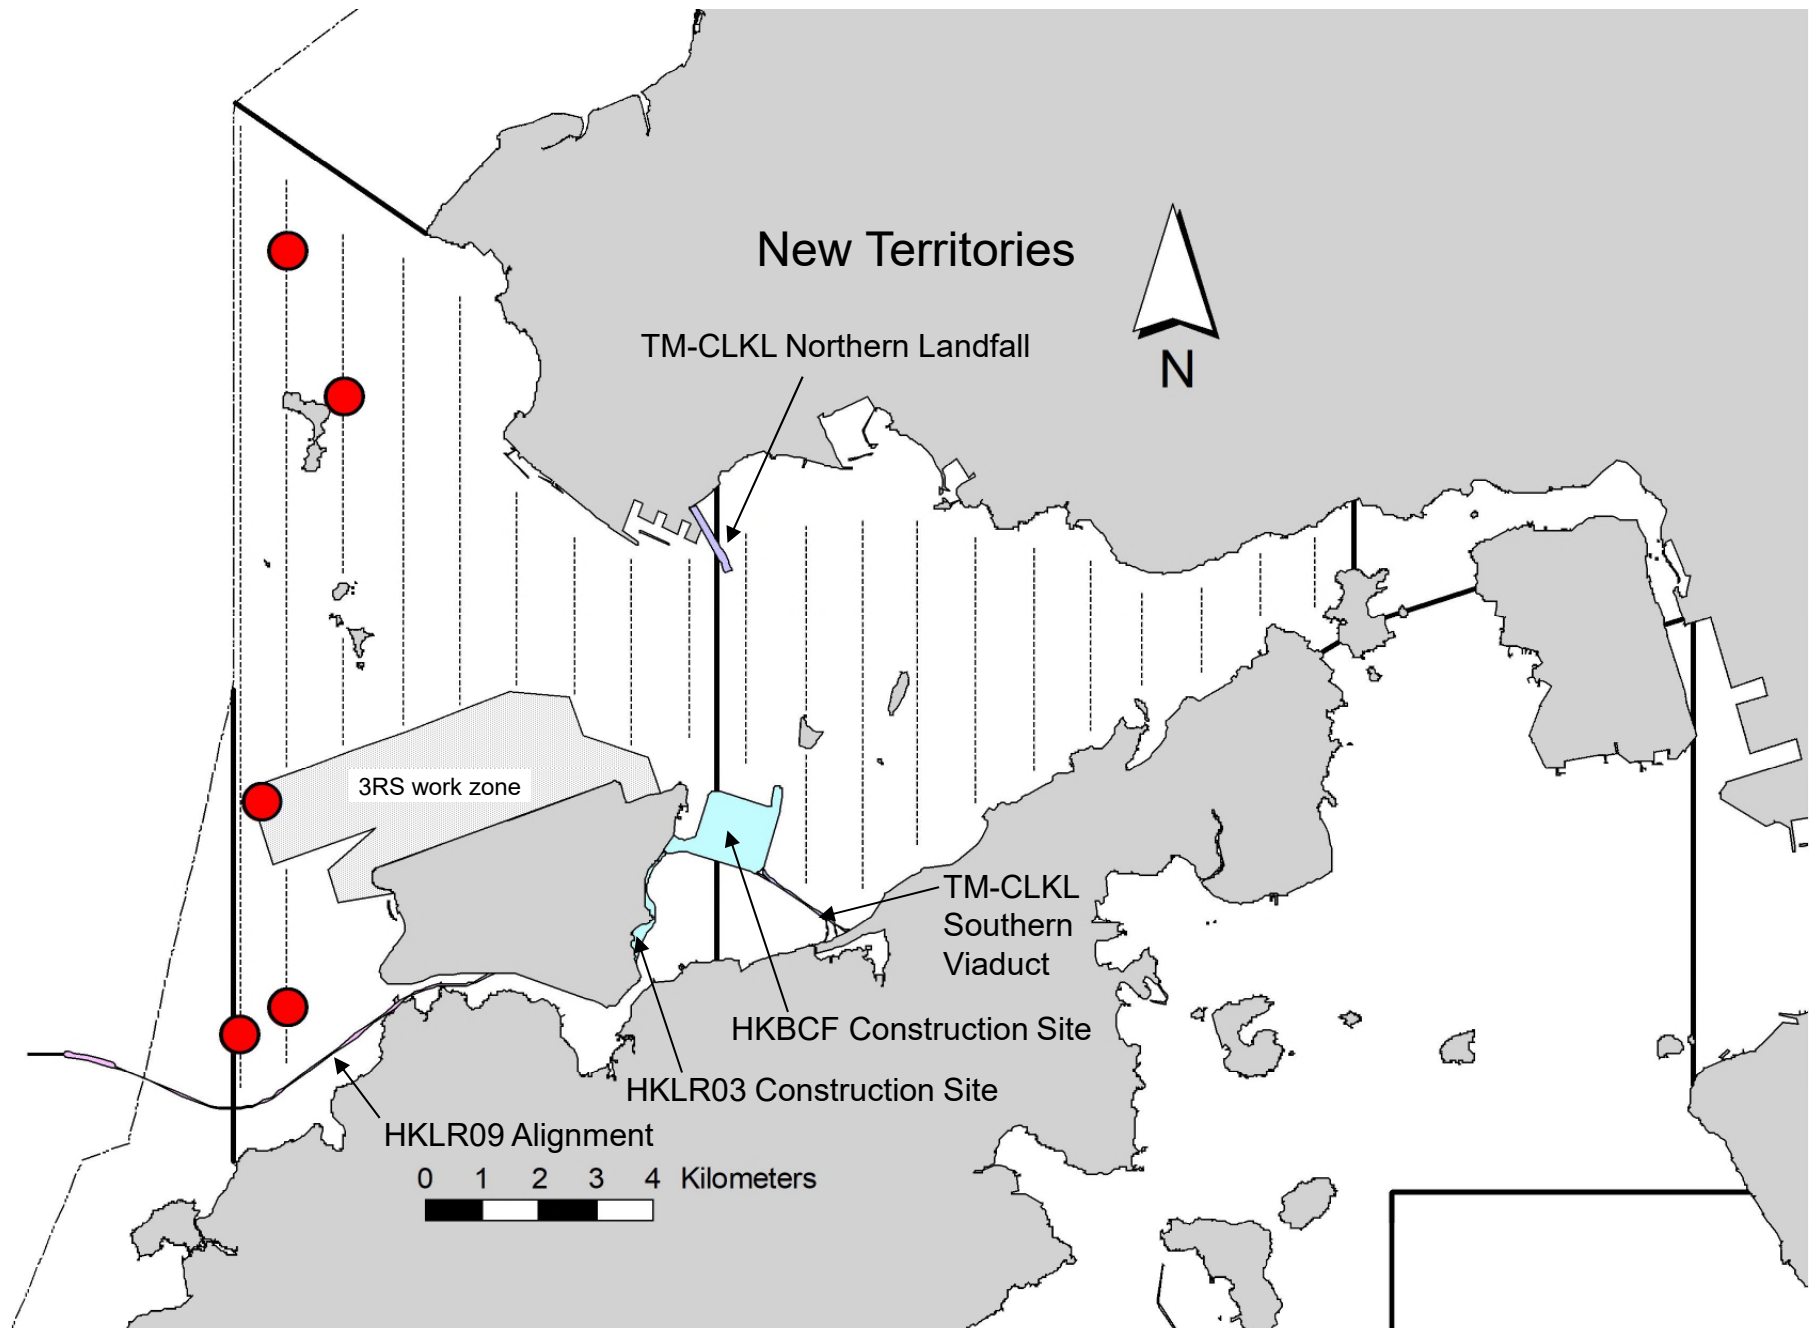
Figure 6. Distribution of Chinese White Dolphin Sightings during February 2021 Monitoring Surveys

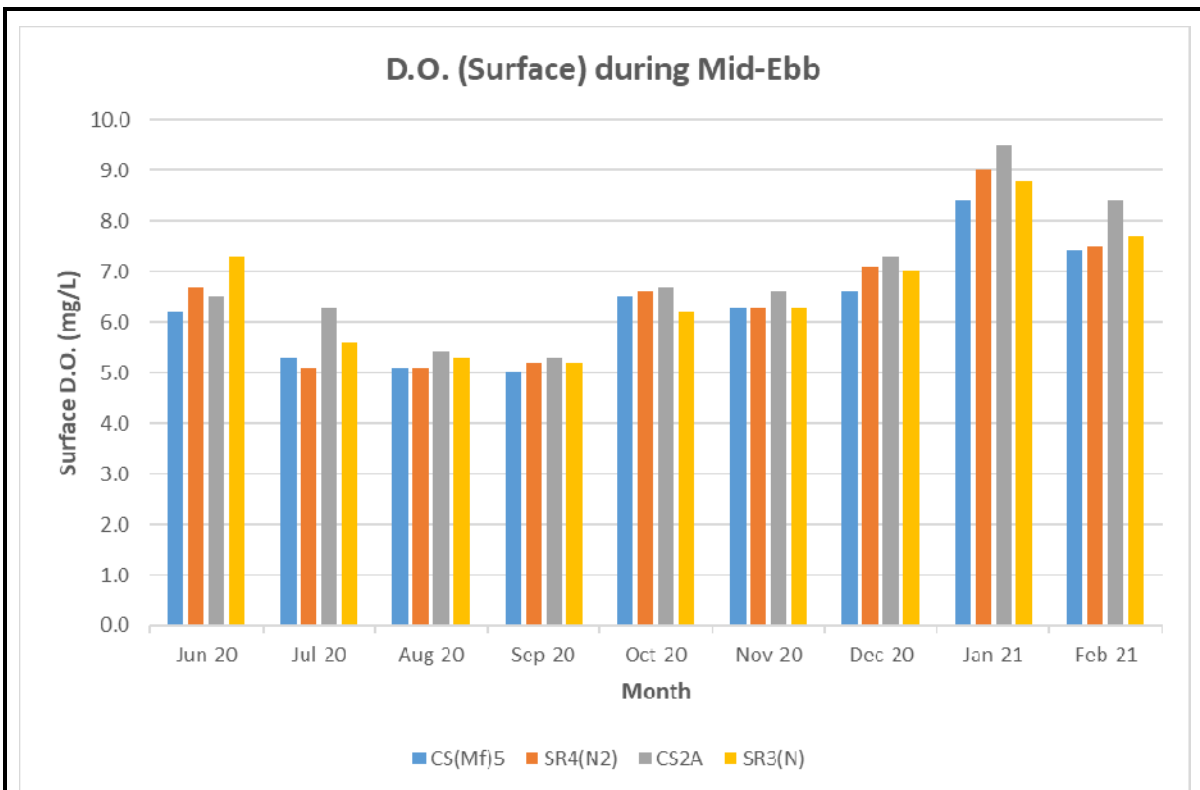
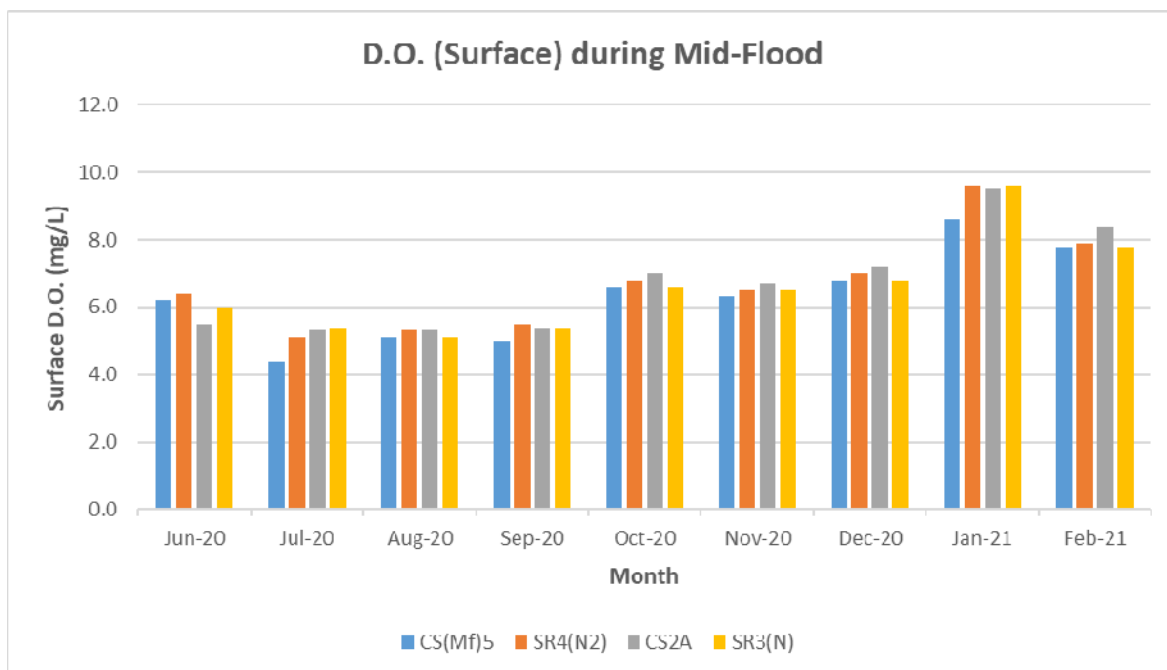
Figure J1 Operational Phase Monitoring – Mean Level of Dissolved Oxygen (mg/L) in surface waters between 1 June 2020 and 28 February 2021. The weather conditions during the monitoring period varied mostly from sunny to cloudy.

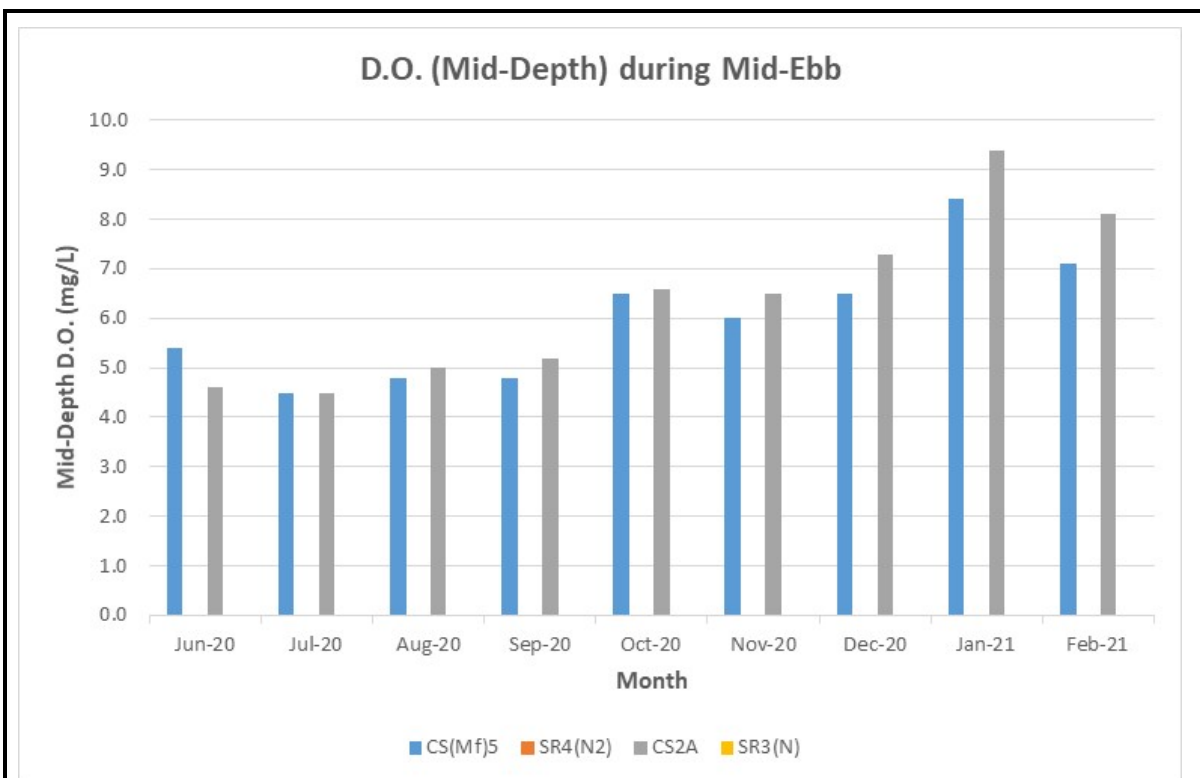
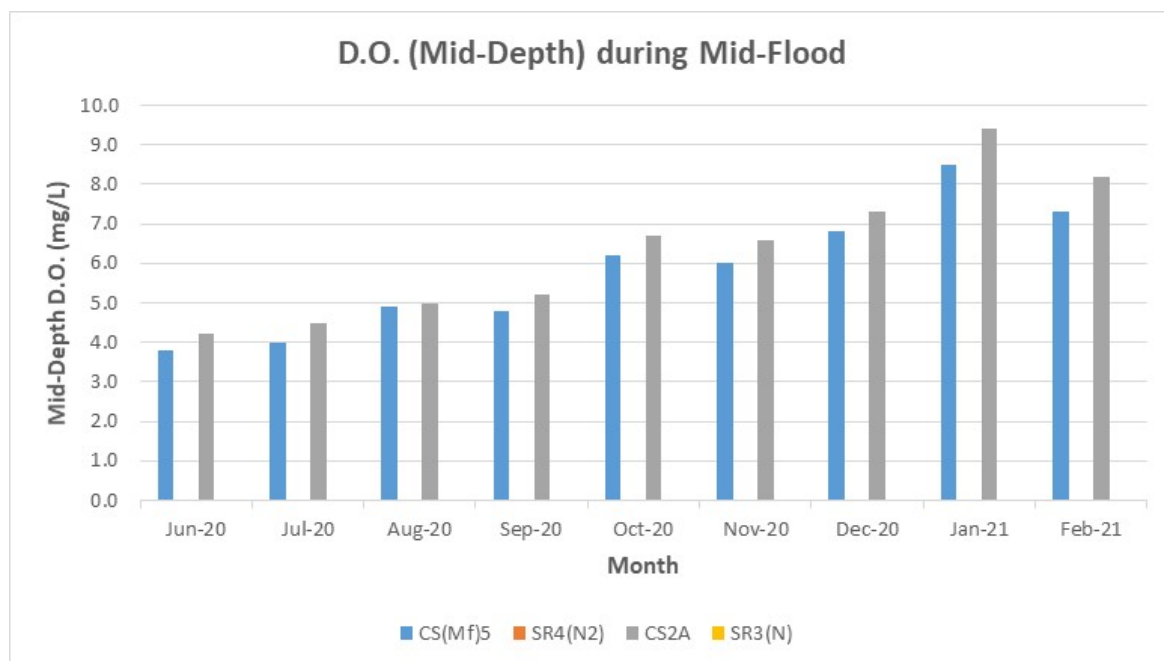
Figure J2 Operational Phase Monitoring - Mean Level of Dissolved Oxygen (mg/L) in mid-depth waters between 1 June 2020 and 28 February 2021. The weather conditions during the monitoring period varied mostly from sunny to cloudy.

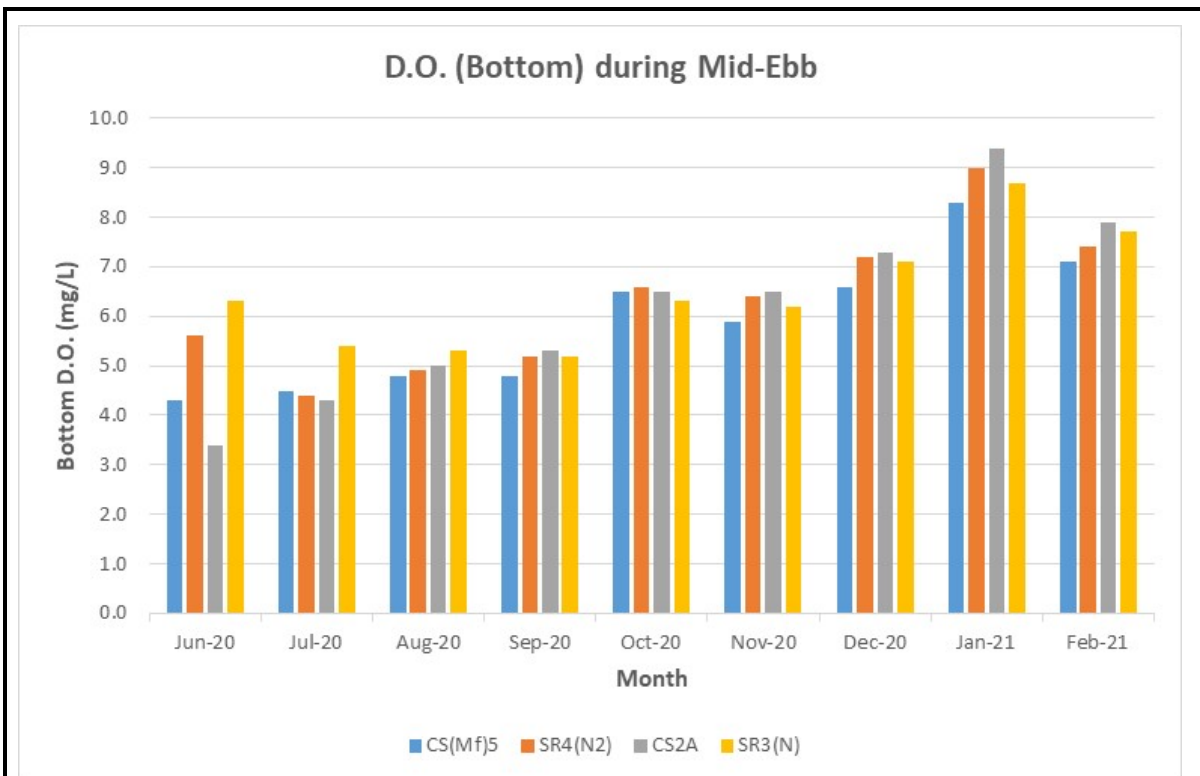
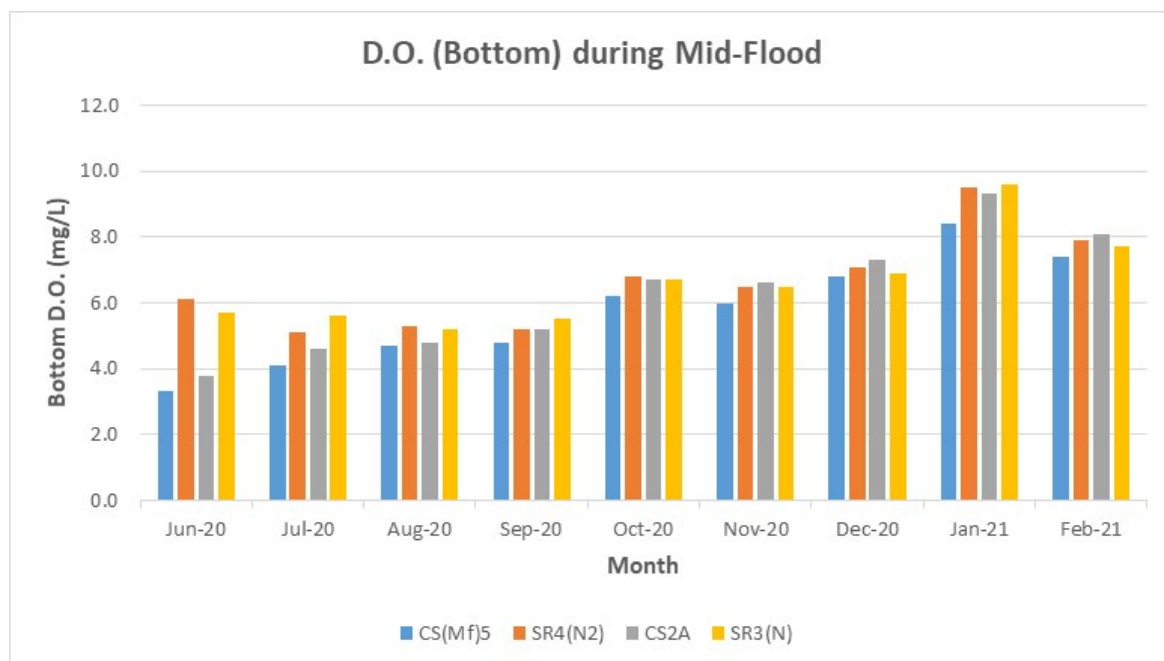
Figure J3 Operational Phase Monitoring – Mean Level of Dissolved Oxygen (mg/L) in bottom waters between 1 June 2020 and 28 February 2021. The weather conditions during the monitoring period varied mostly from sunny to cloudy.

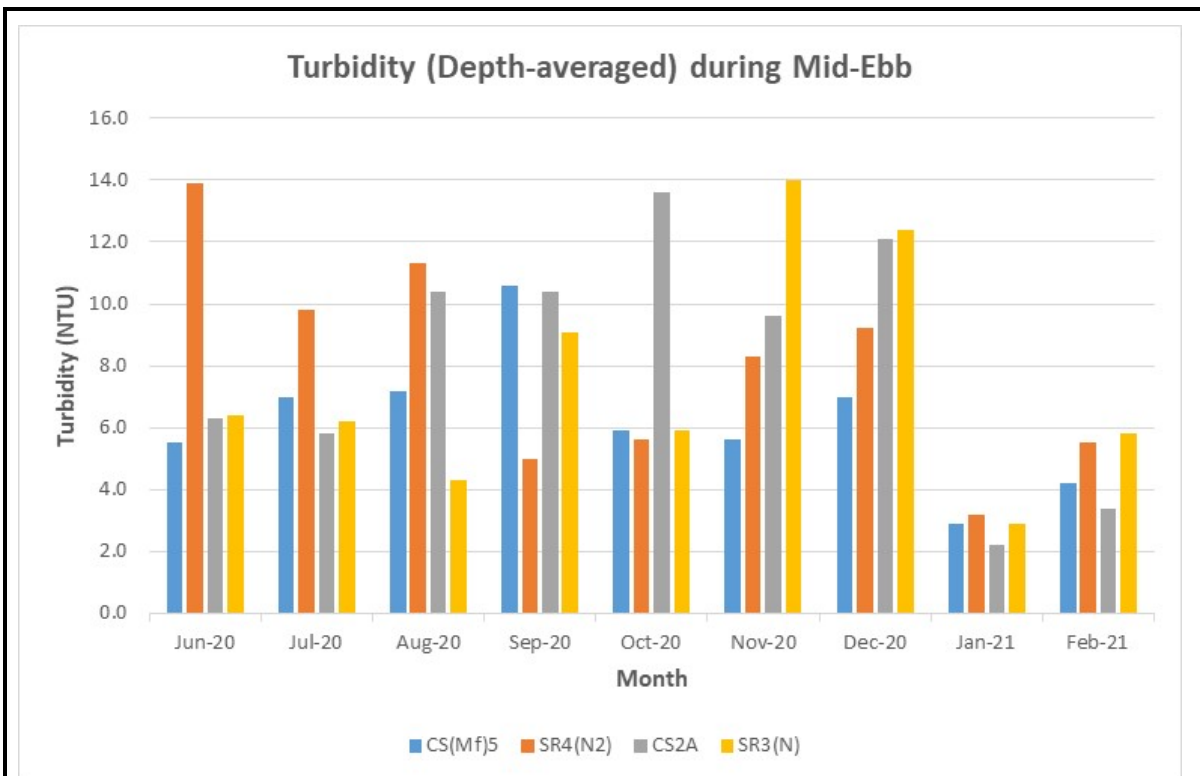
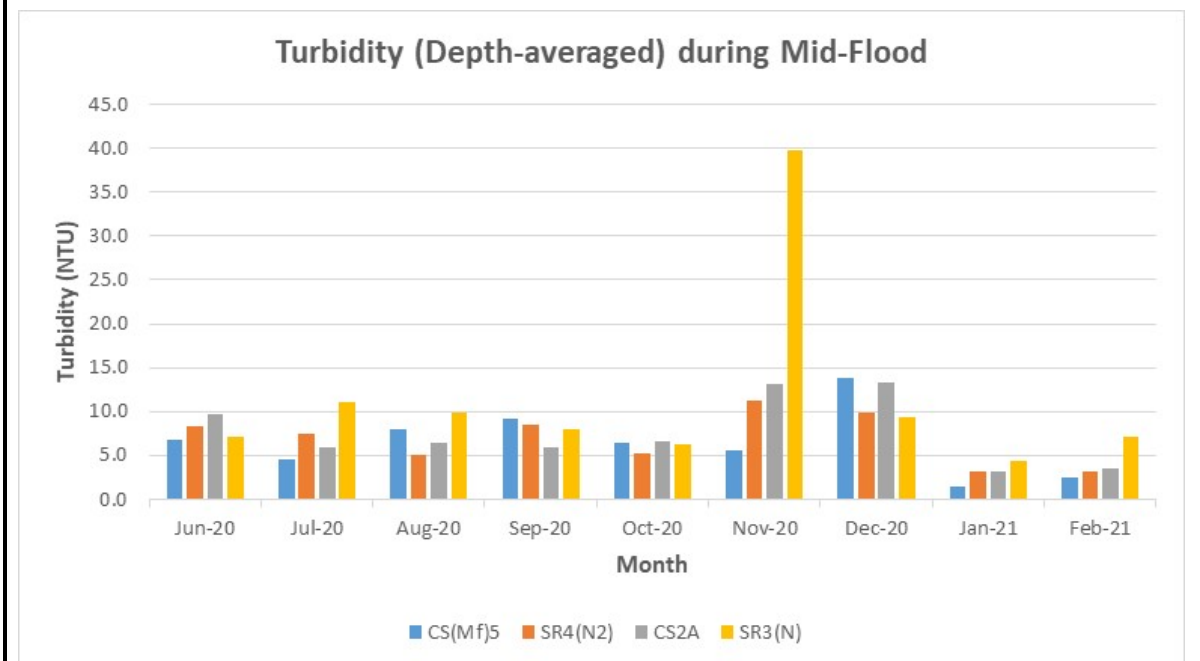
Figure J4 Operational Phase Monitoring – Mean Depth-averaged Level of Turbidity (NTU) between 1 June 2020 and 28 February 2021. The weather conditions during the monitoring period varied mostly from sunny to cloudy.
