**Contract No. HY/2012/08
Tuen Mun – Chek Lap Kok Link –
Northern Connection Sub-sea Tunnel
Section**

***Eighty-Eighth Monthly Environmental
Monitoring & Audit (EM&A) Report***

11 March 2021

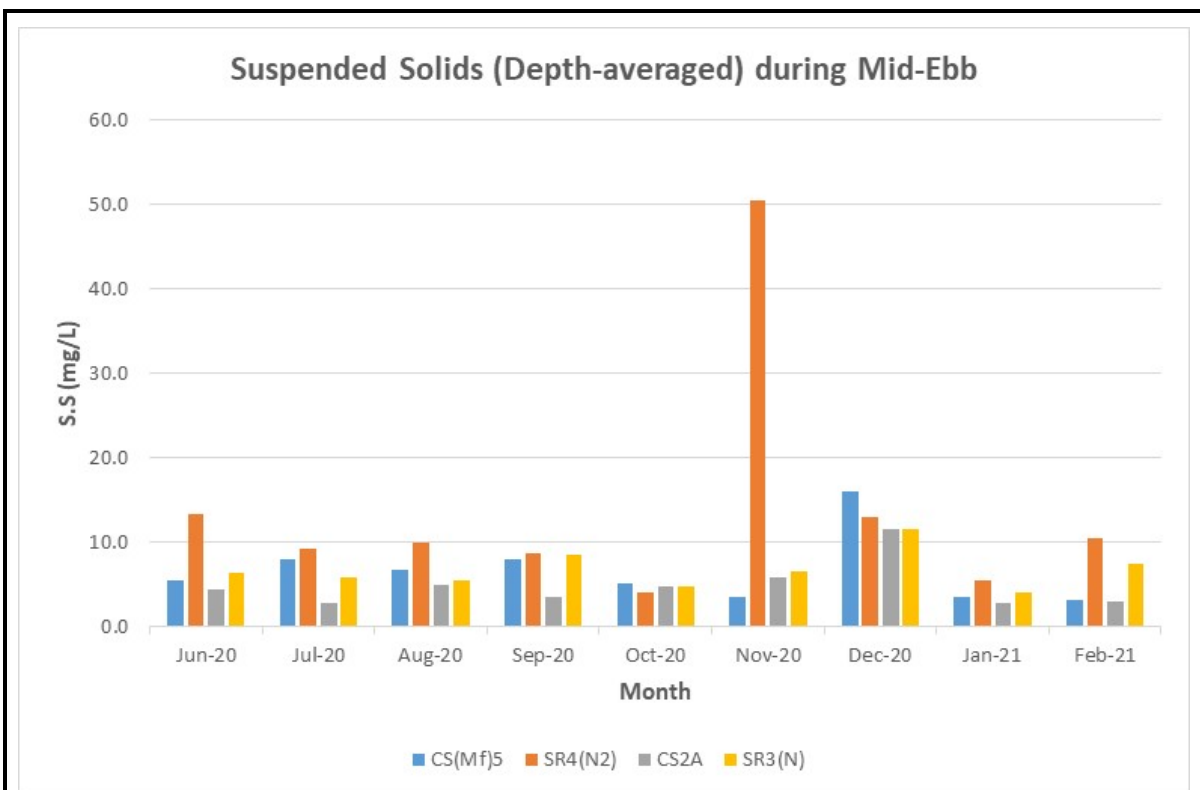
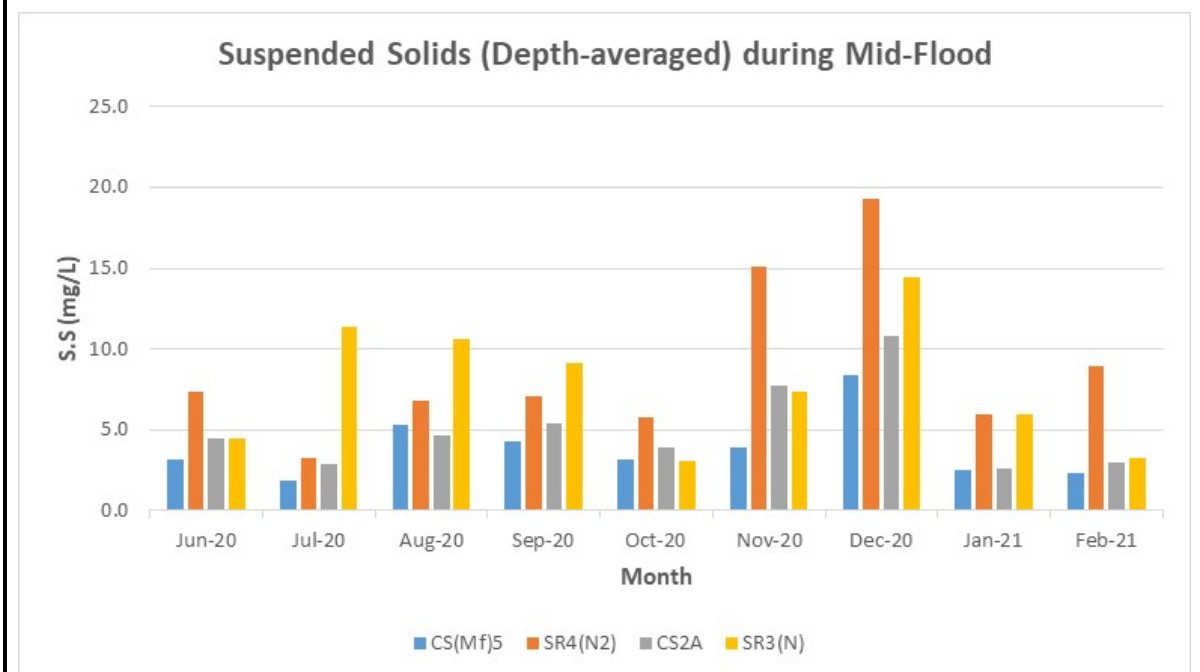
Figure J5 Operational Phase Monitoring – Mean Depth-averaged Level of Suspended Solids (mg/L) between 1 June 2020 and 28 February 2021. The weather conditions during the monitoring period varied mostly from sunny to cloudy.
