**Contract No. HY/2012/07
Tuen Mun – Chek Lap Kok Link –
Southern Connection Viaduct Section**

Sixty-Ninth Monthly EM&A Report

14 August 2019

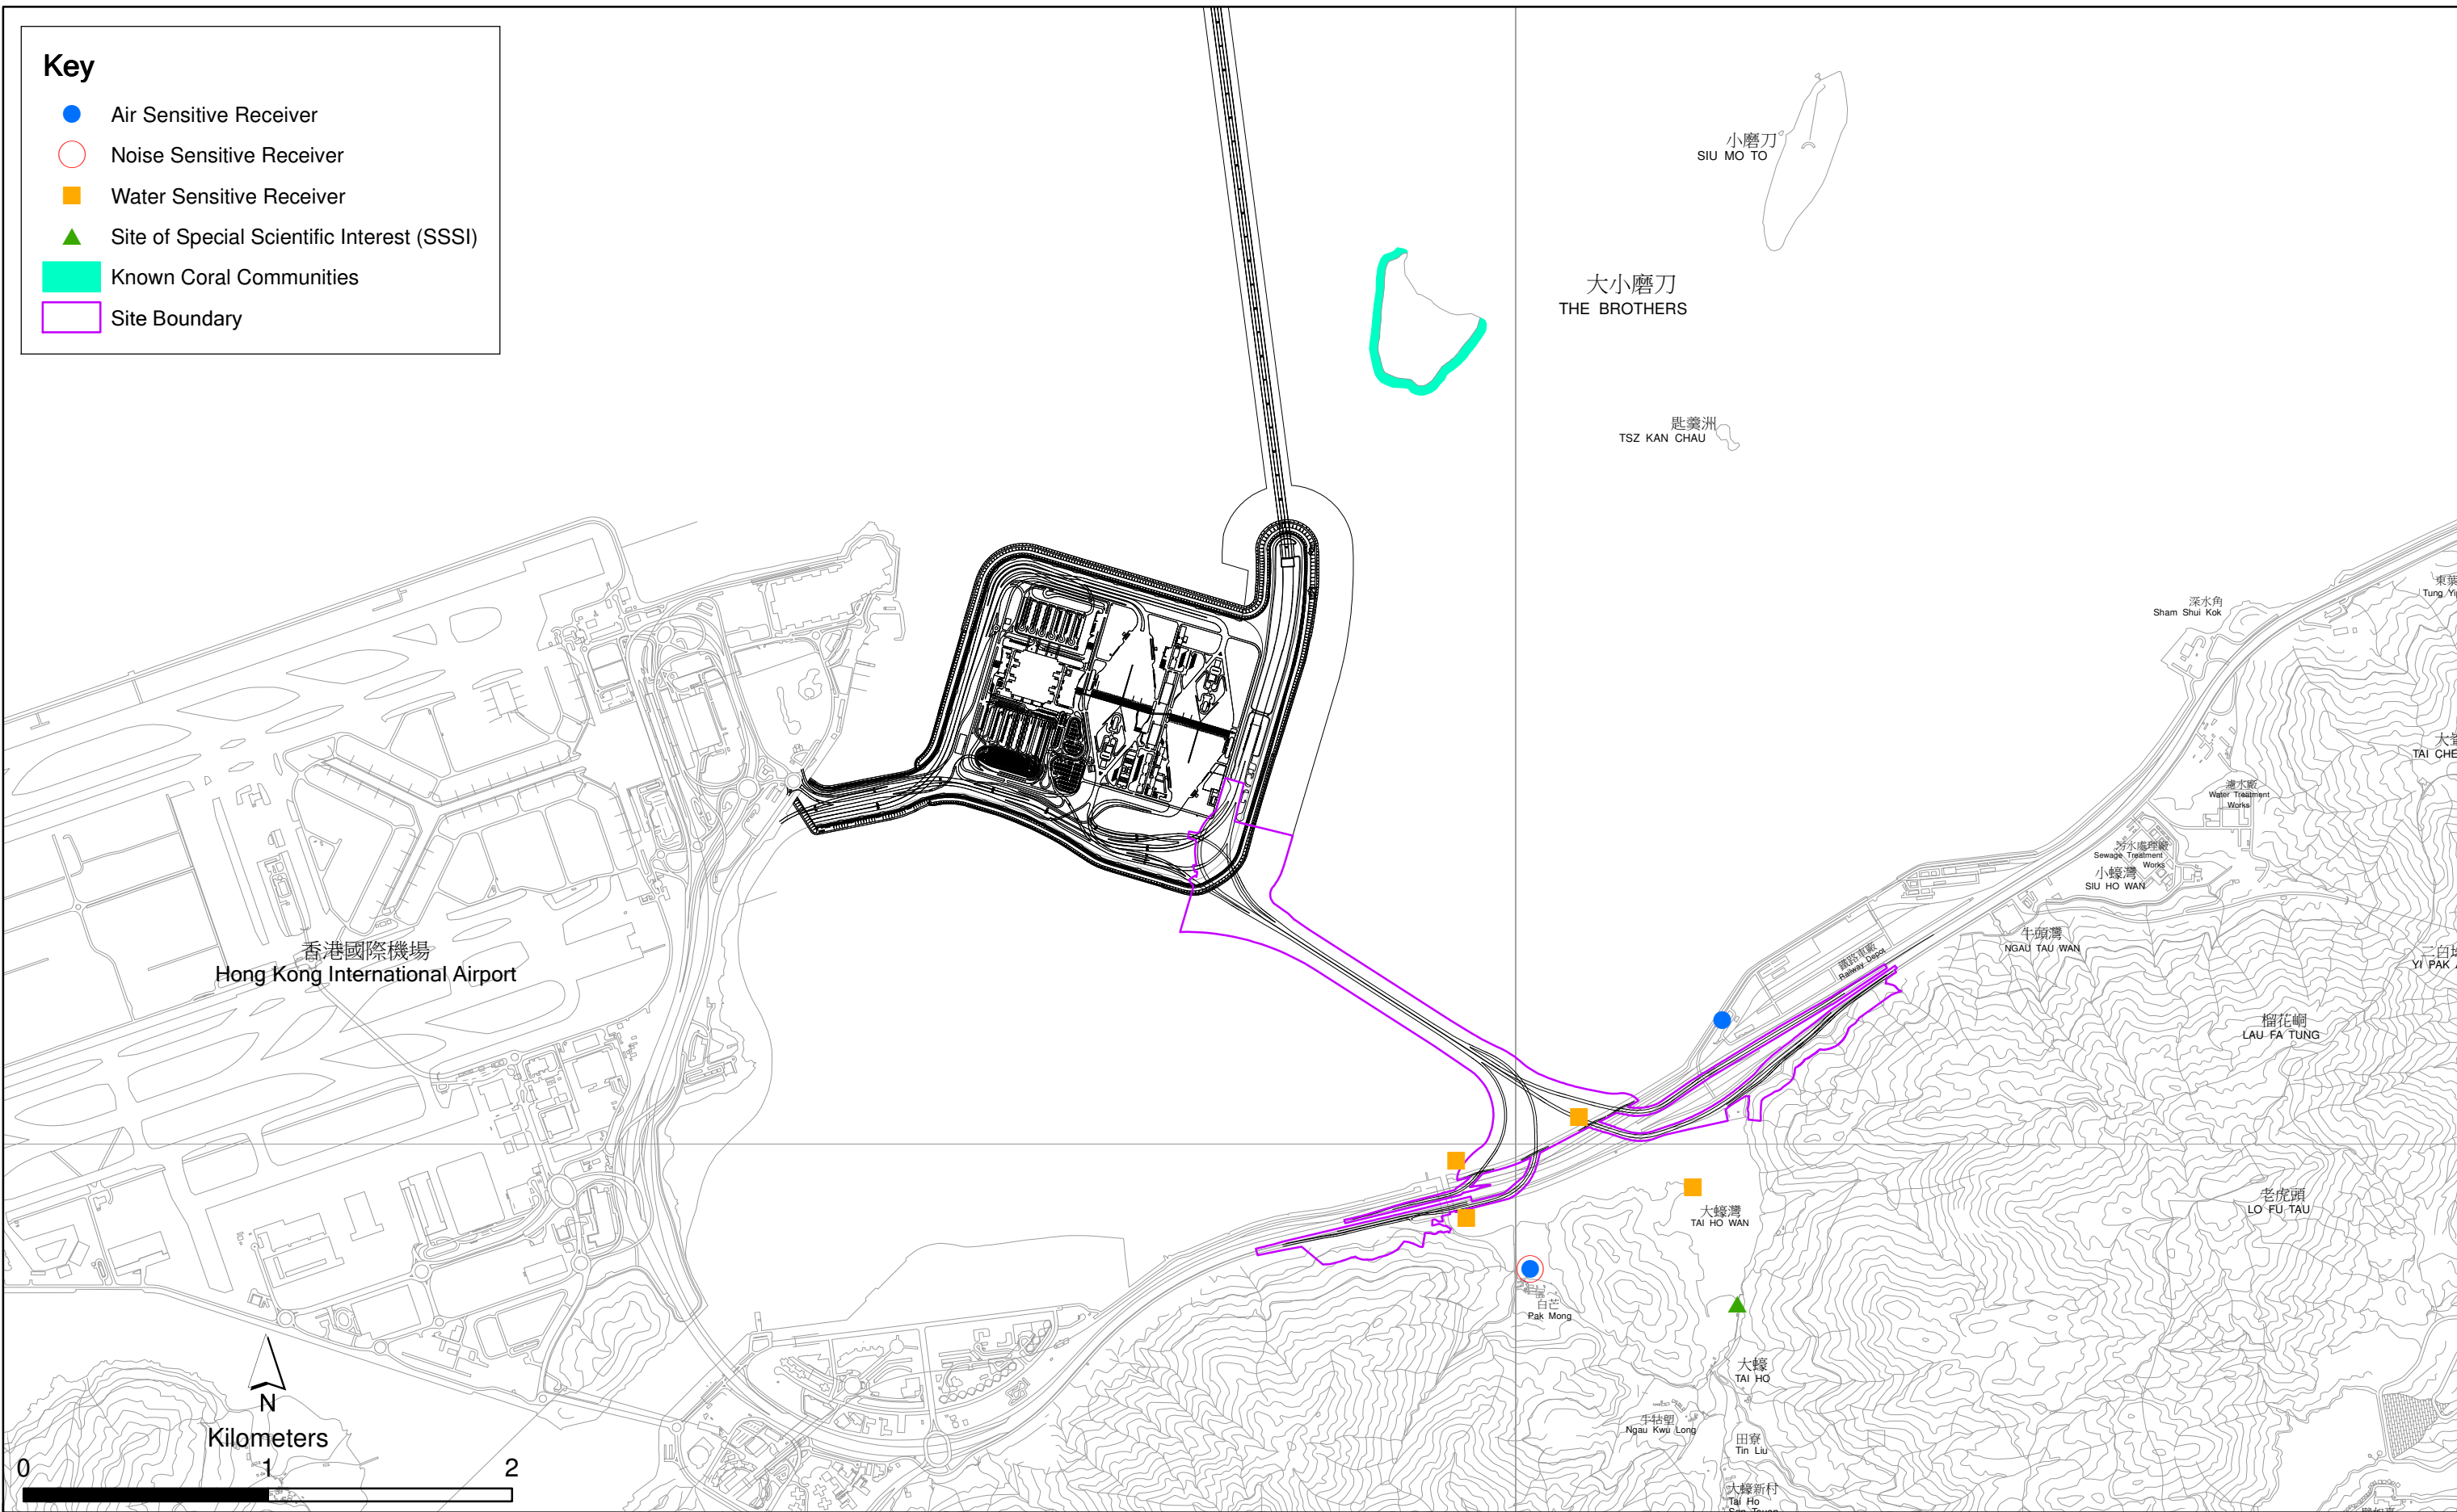
Figure 1.4

Environmental Sensitive Receivers in the Vicinity of Contract No. HY/2012/07
Tuen Mun - Chek Lap Kok Link - Southern Connection Viaduct Section

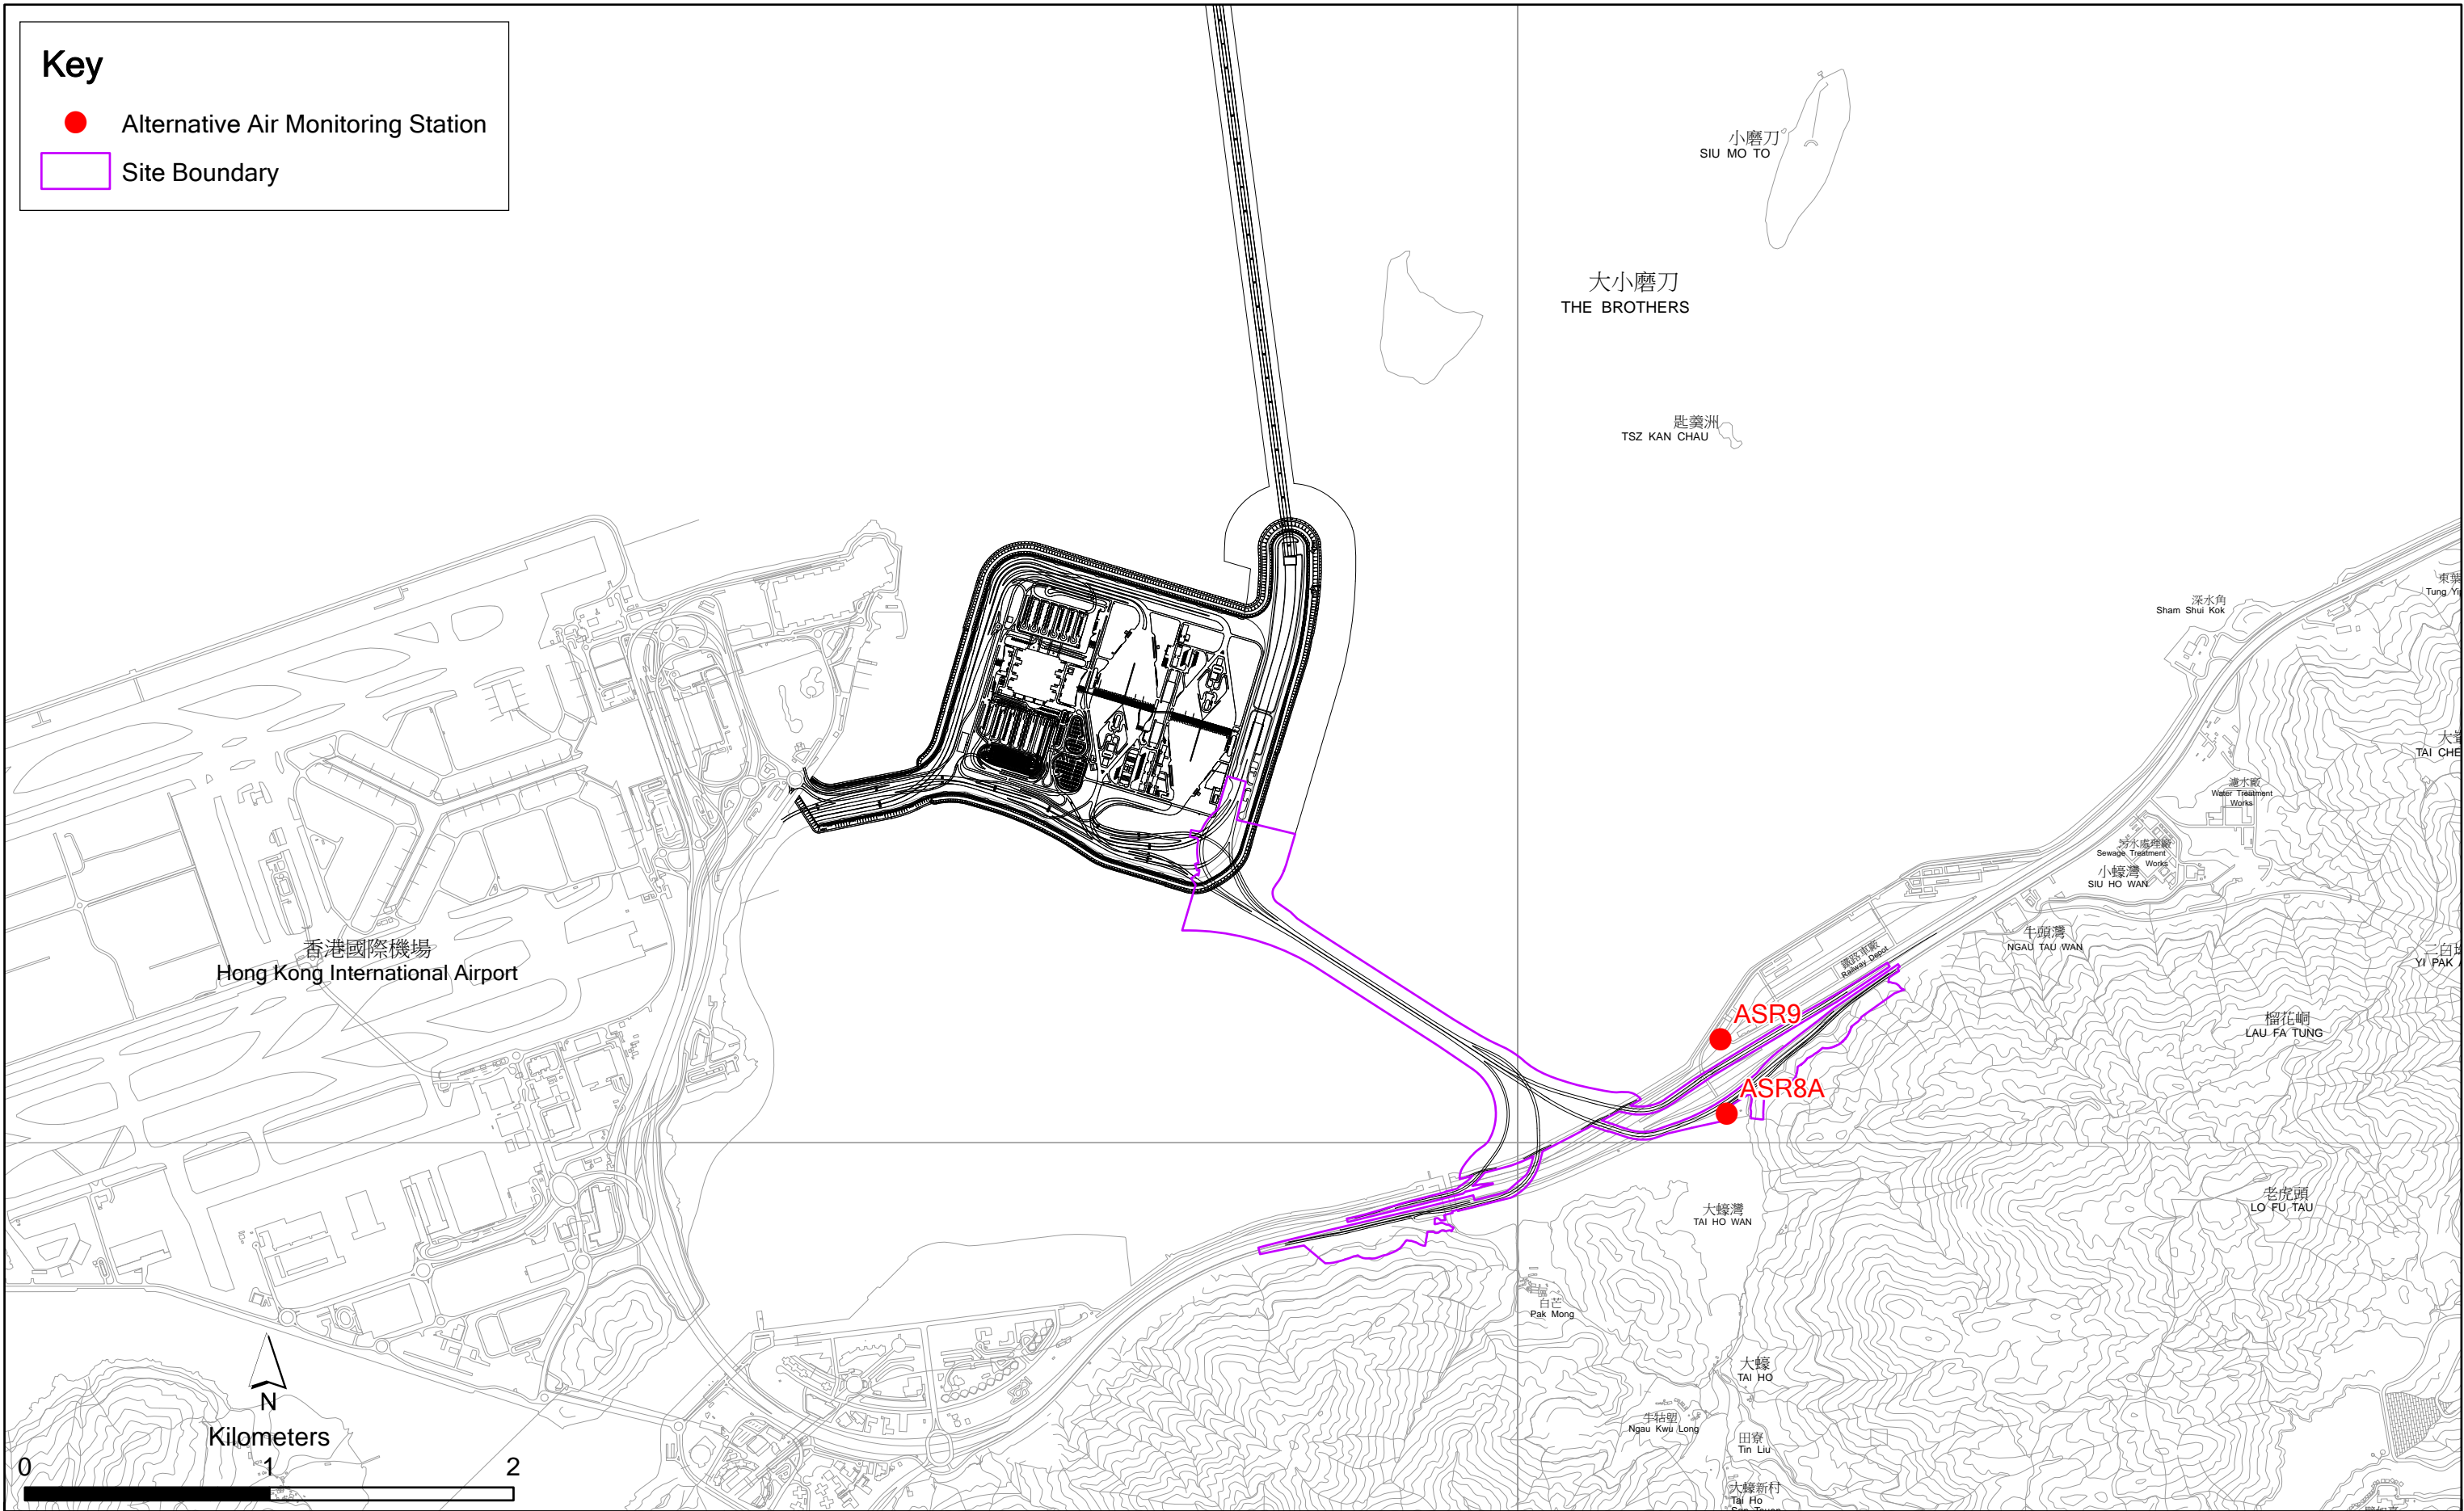
Figure 2.1

Locations of Air Quality Monitoring Stations

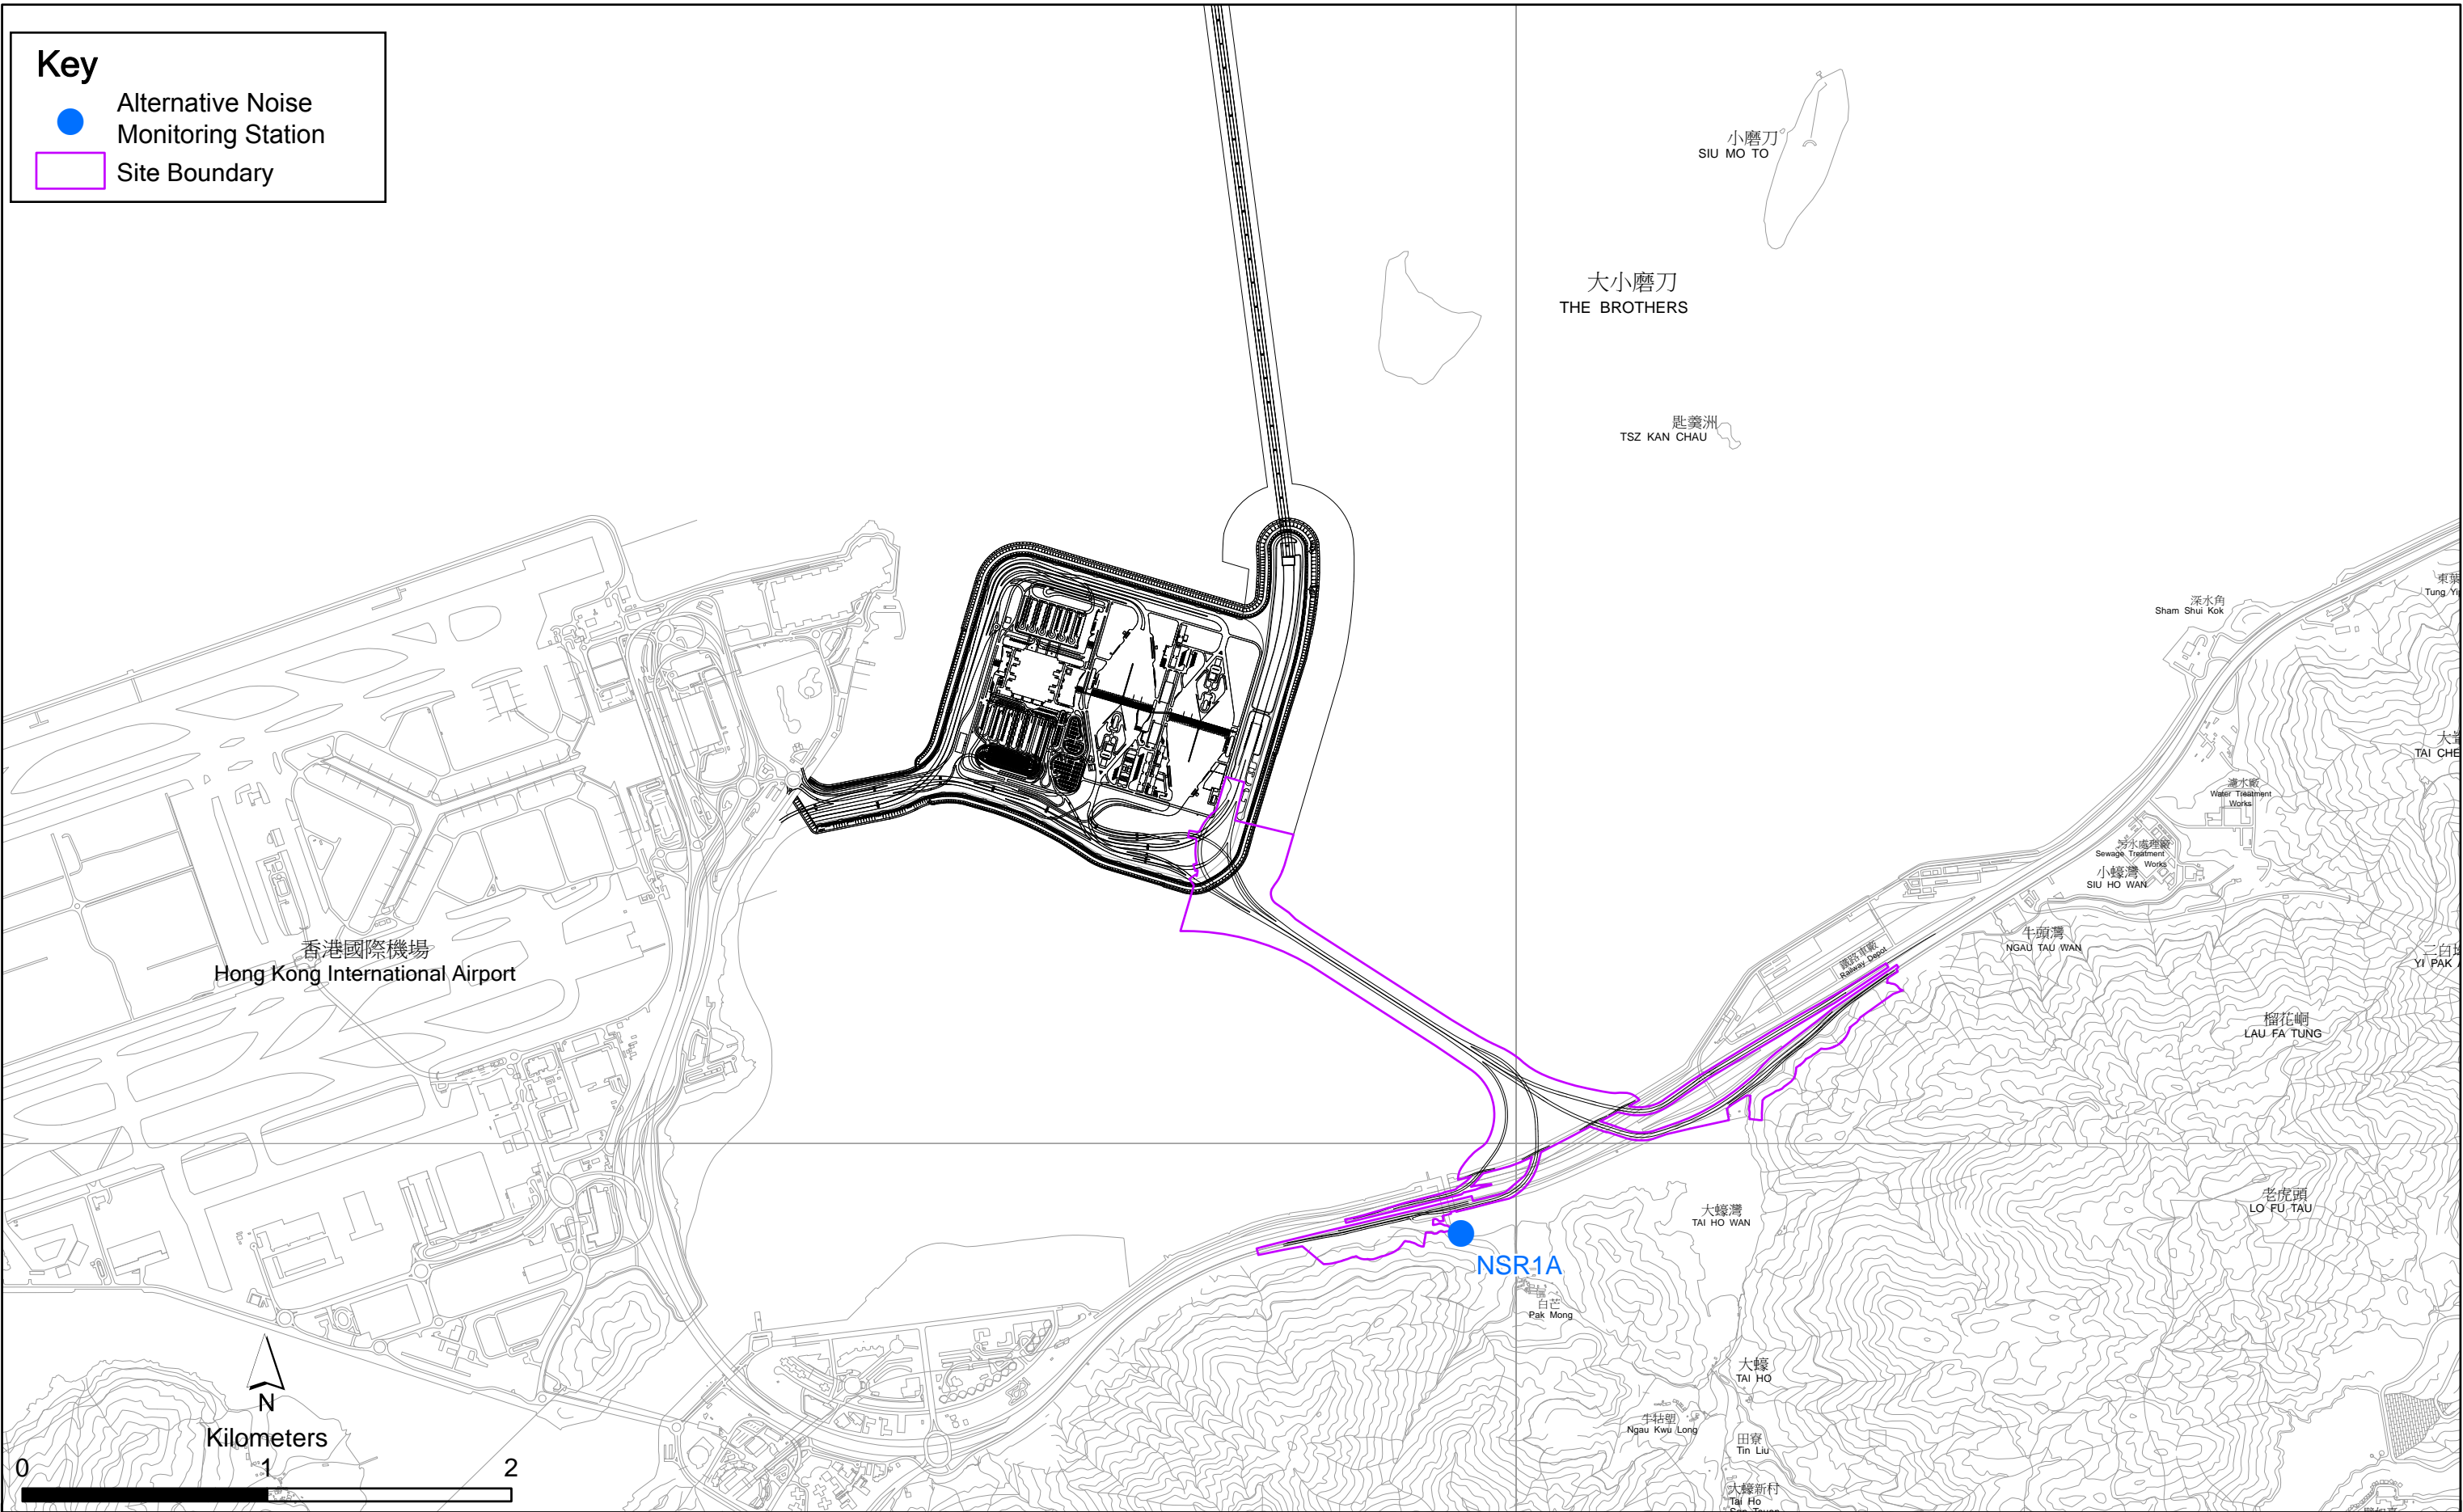
Figure 2.2

Location of Noise Monitoring Station

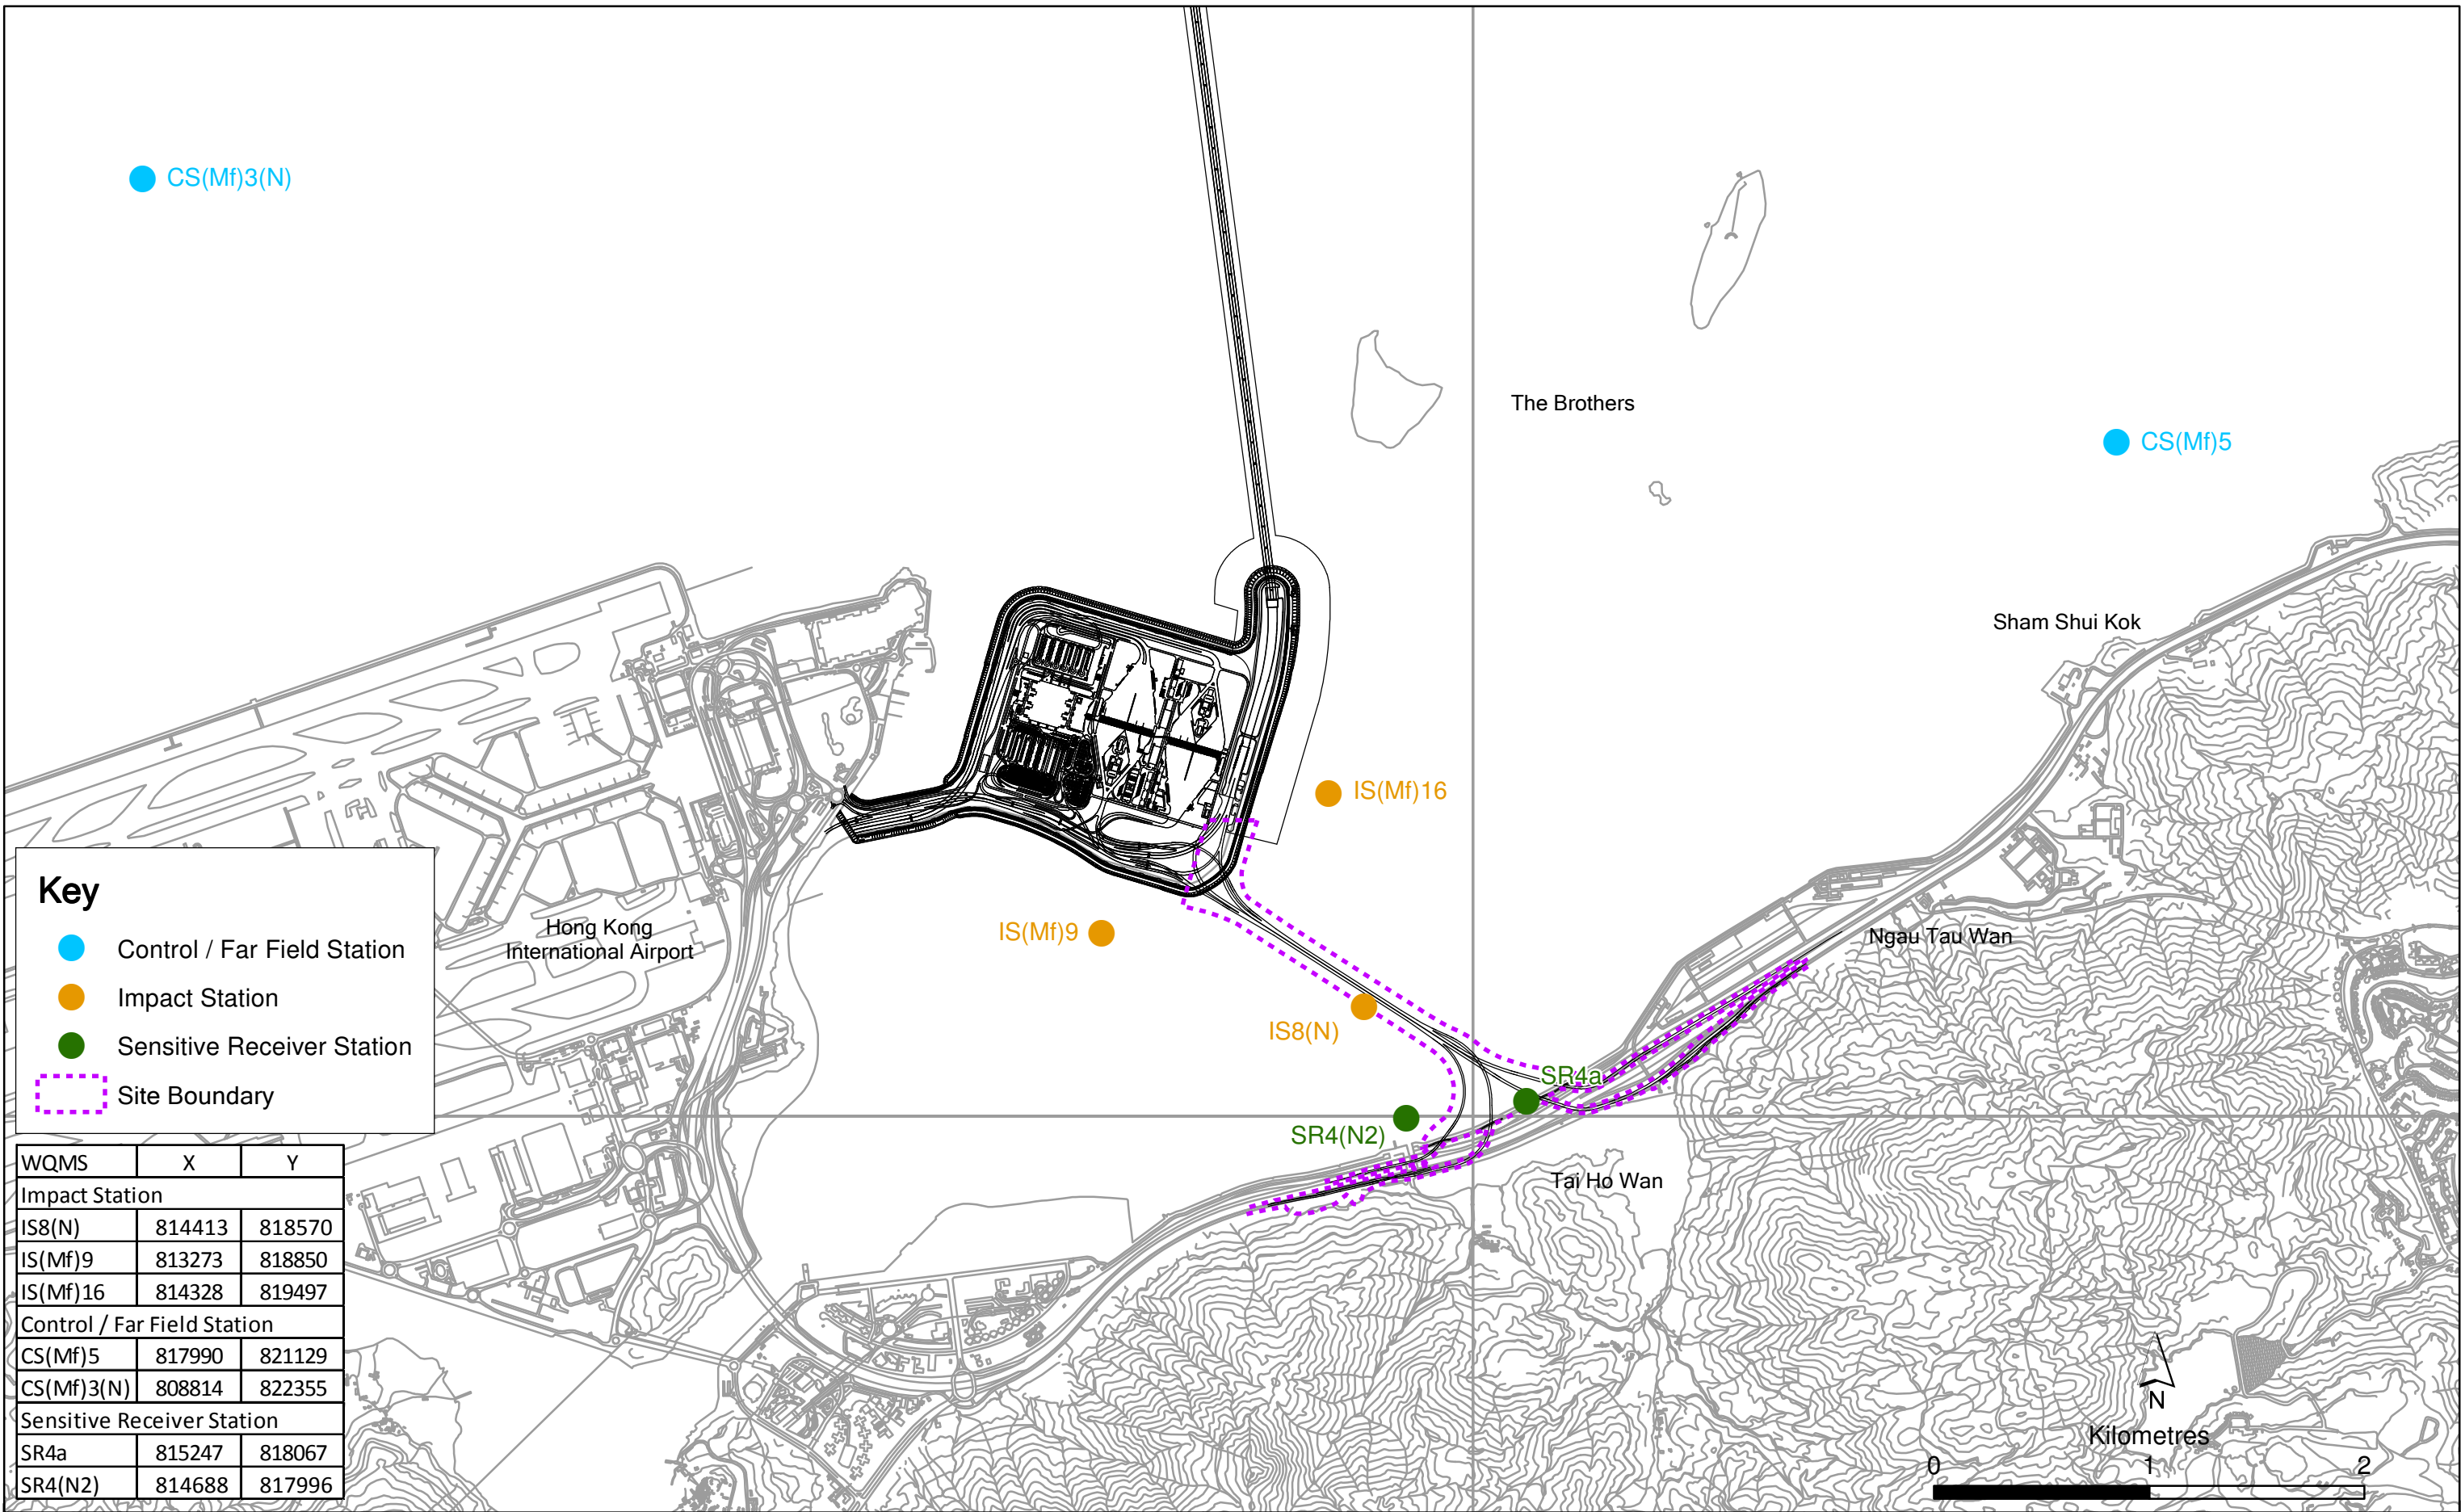
Figure 2.3

Locations of Water Quality Monitoring Stations

Station ID	Type	Coordinates	*Parameters, unit	Frequency	Depth
*Notes:					
In addition to the parameters presented monitoring location/position, time, water depth, sampling depth, tidal stages, weather conditions and any special phenomena or works underway nearby were also recorded.					
Water Quality Monitoring Station CS(Mf)3 was relocated to CS(Mf)3(N) since 2 May 2017.					
Water Quality Monitoring Station SR4 was relocated to SR4(N) since 2 March 2018.					
Water Quality Monitoring Station SR4(N) was relocated to SR4(N2) since 12 June 2019					
Water Quality Monitoring Station IS8 was relocated to IS8(N) since 12 June 2019.

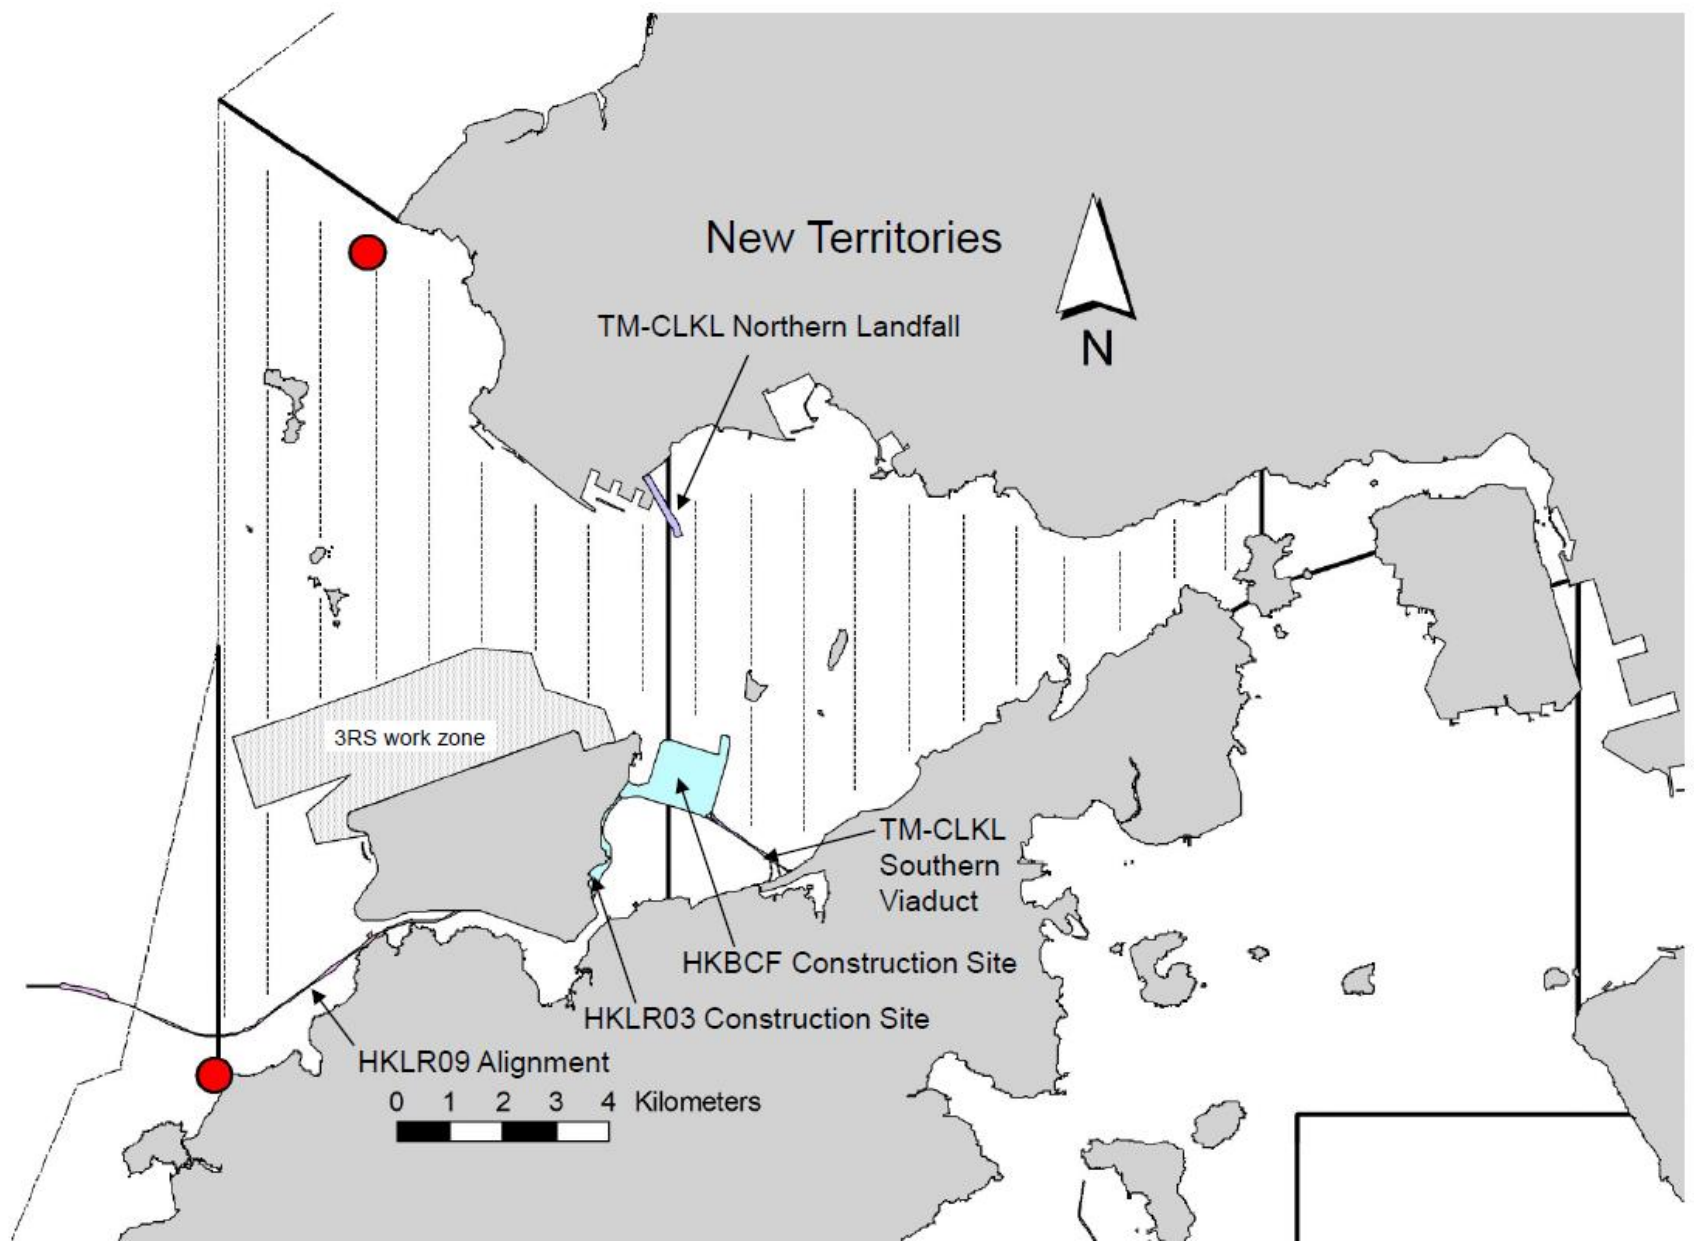
Figure 2.5

HY/2012/07 TM-CLKL Southern Connection Viaduct Section
 The distribution of dolphin sightings during the reporting period
 (Source: Adopted from HKLR03 Monitoring Survey in July 2019)

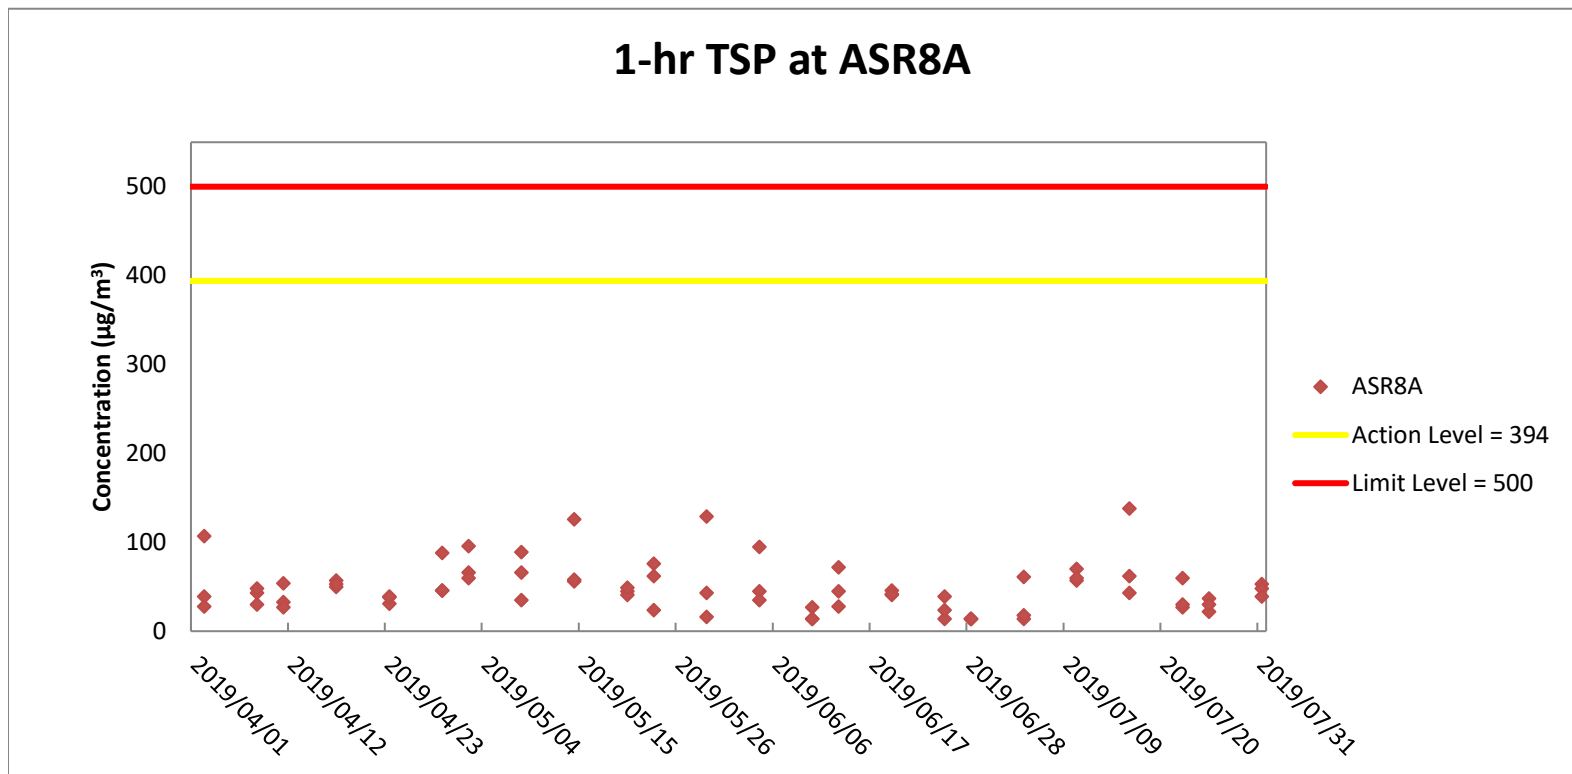
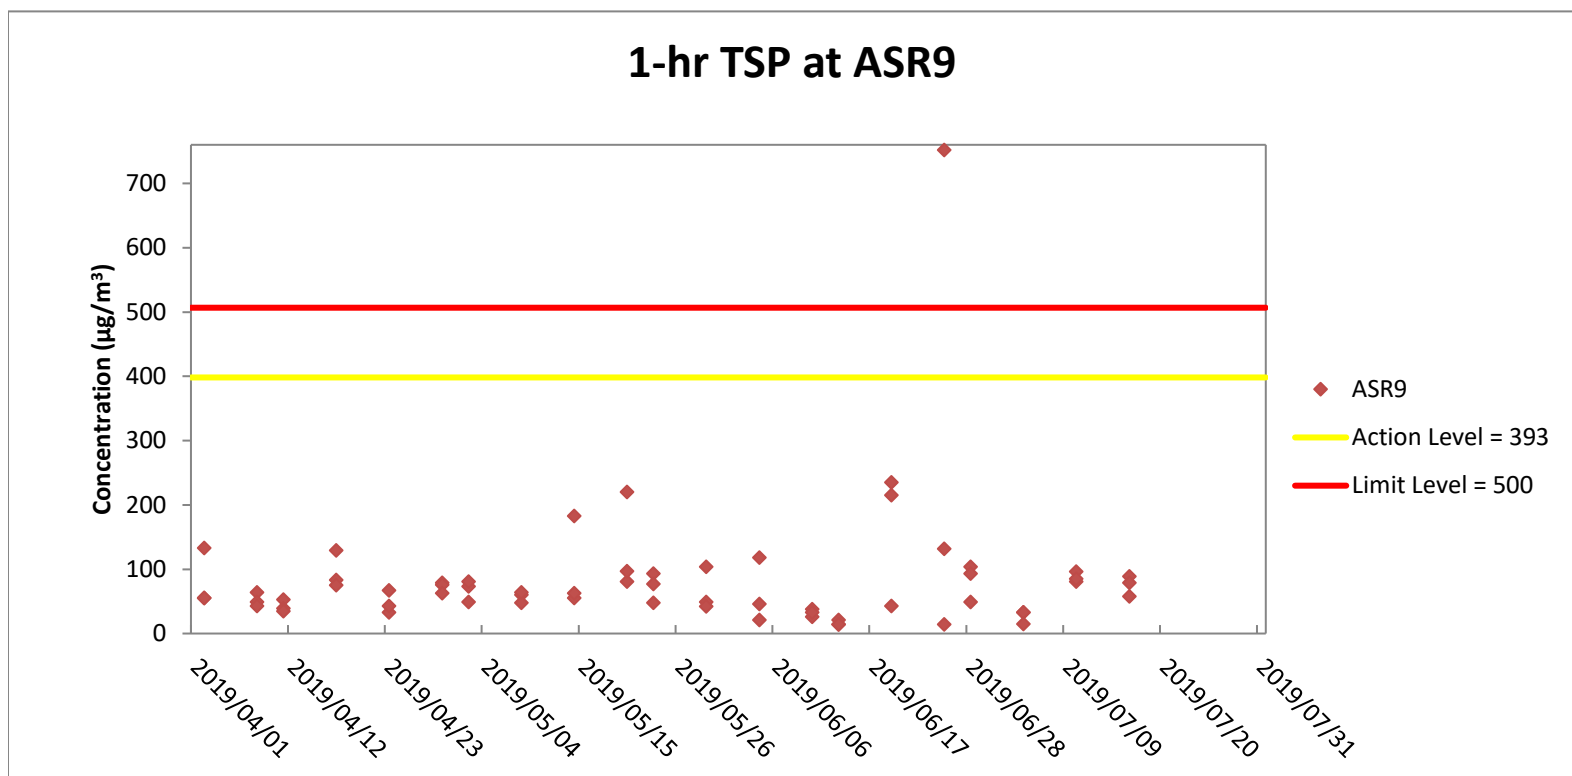
Weather condition within the reporting period varied between sunny to cloudy. 1-hr TSP monitoring on 22, 25 and 31 July 2019 at ASR9 was cancelled due to power shortage.

Major construction works undertaken within the reporting period include reinstatement of seawall at seafront.

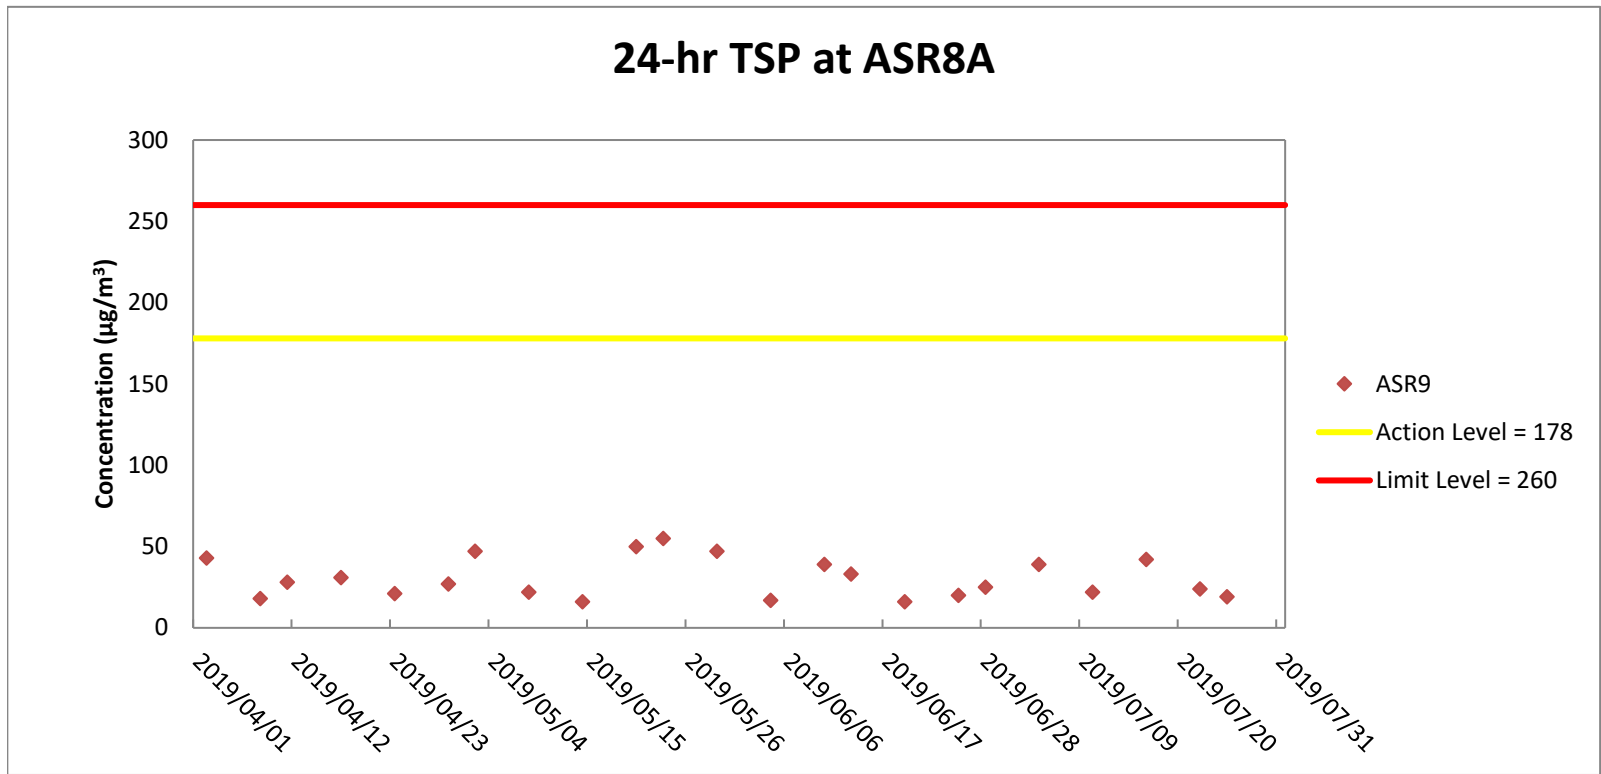
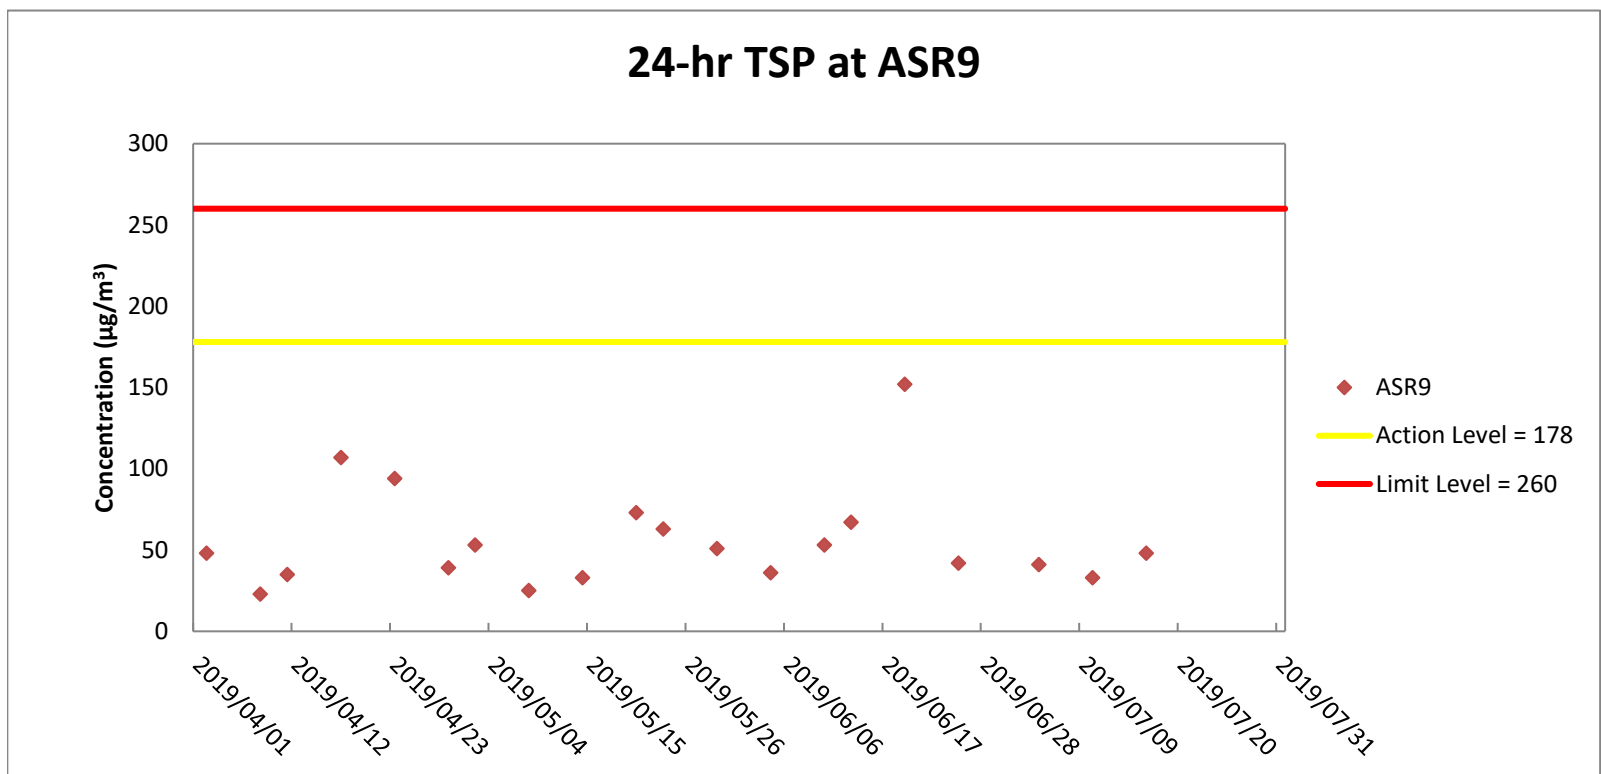
Weather condition within the reporting period varied between sunny to cloudy. 24-hr TSP monitoring at ASR8A on 31 July 2019 was cancelled due to adverse weather. 24-hr TSP monitoring at ASR9 on 22, 25 and 31 cancelled due to power shortage. Major construction works undertaken within the reporting period include reinstatement of seawall at seafront.
