**Contract No. HY/2012/07
Tuen Mun – Chek Lap Kok Link –
Southern Connection Viaduct Section**

Sixty-Ninth Monthly EM&A Report

14 August 2019

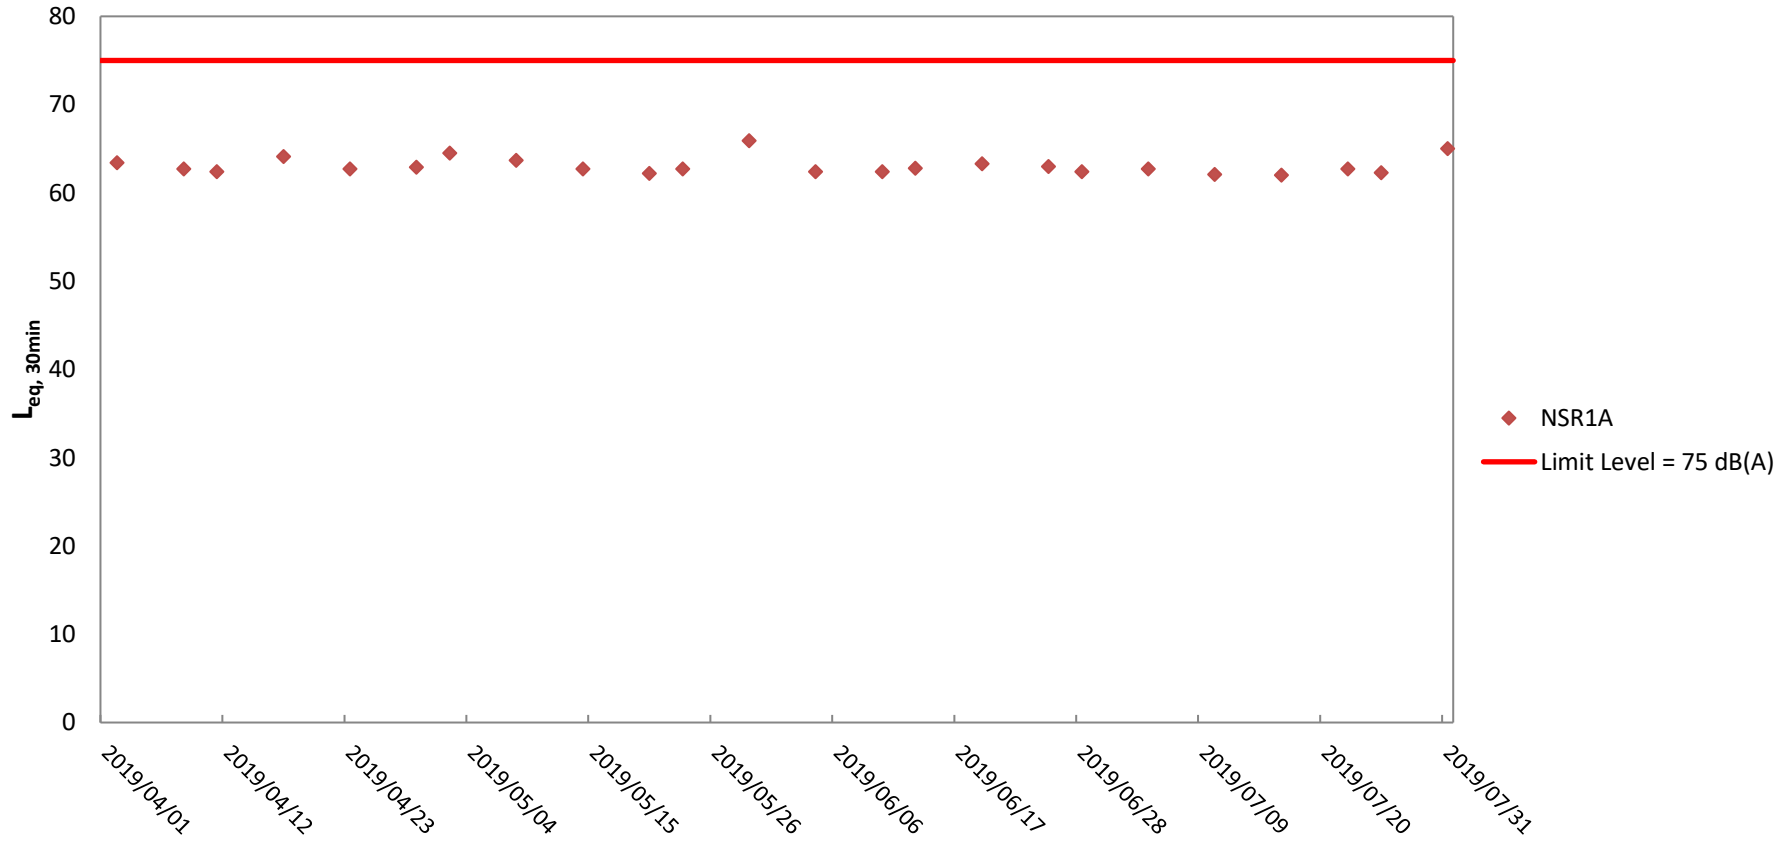
Noise Monitoring Results at NSR 1A ($L_{eq, 30min}$)

Weather condition within the reporting period varied between sunny to cloudy.

Major construction works undertaken within the reporting period include: reinstatement of seawall at seafront,

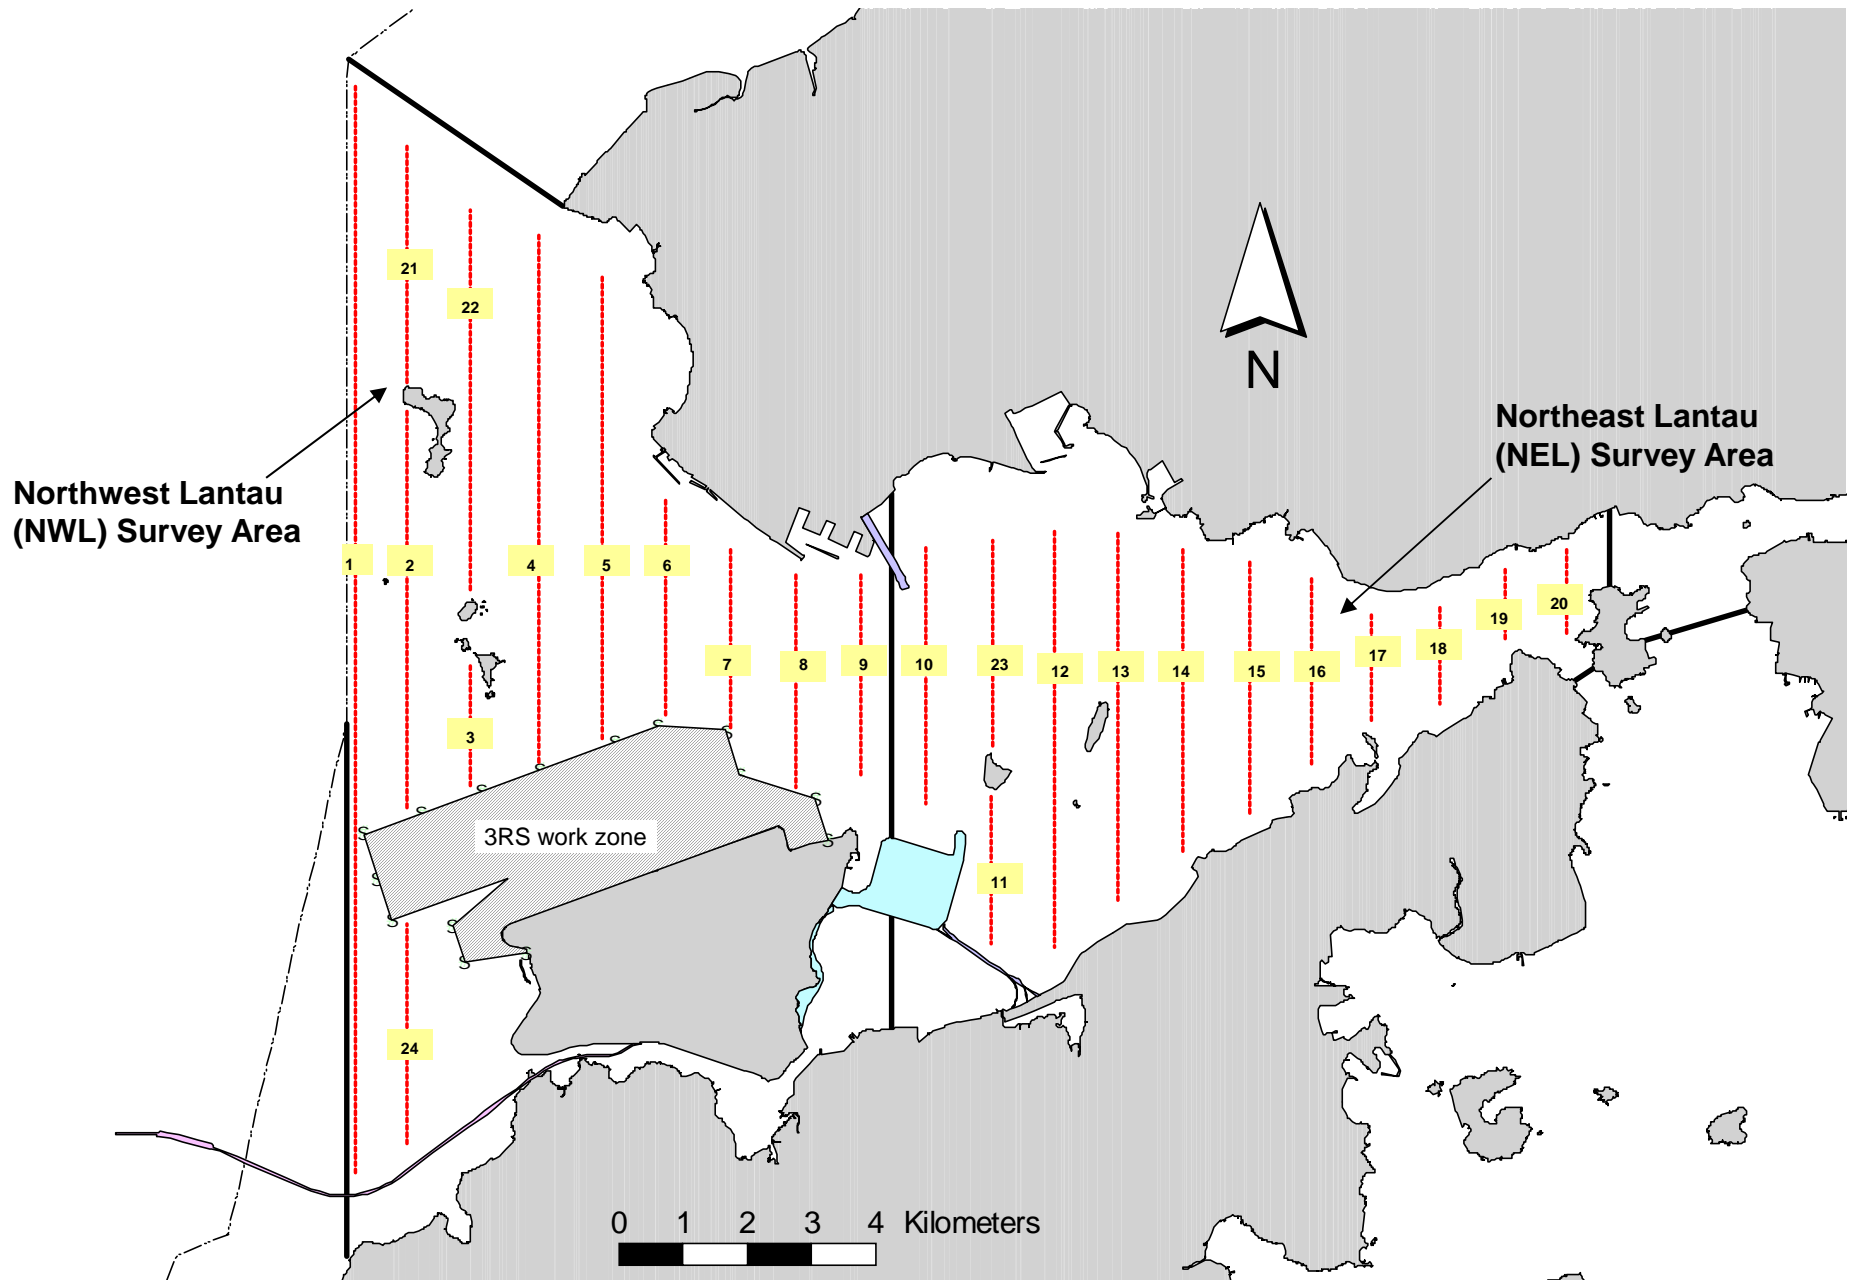
Figure 1. Transect Line Layout in Northwest and Northeast Lantau Survey Areas

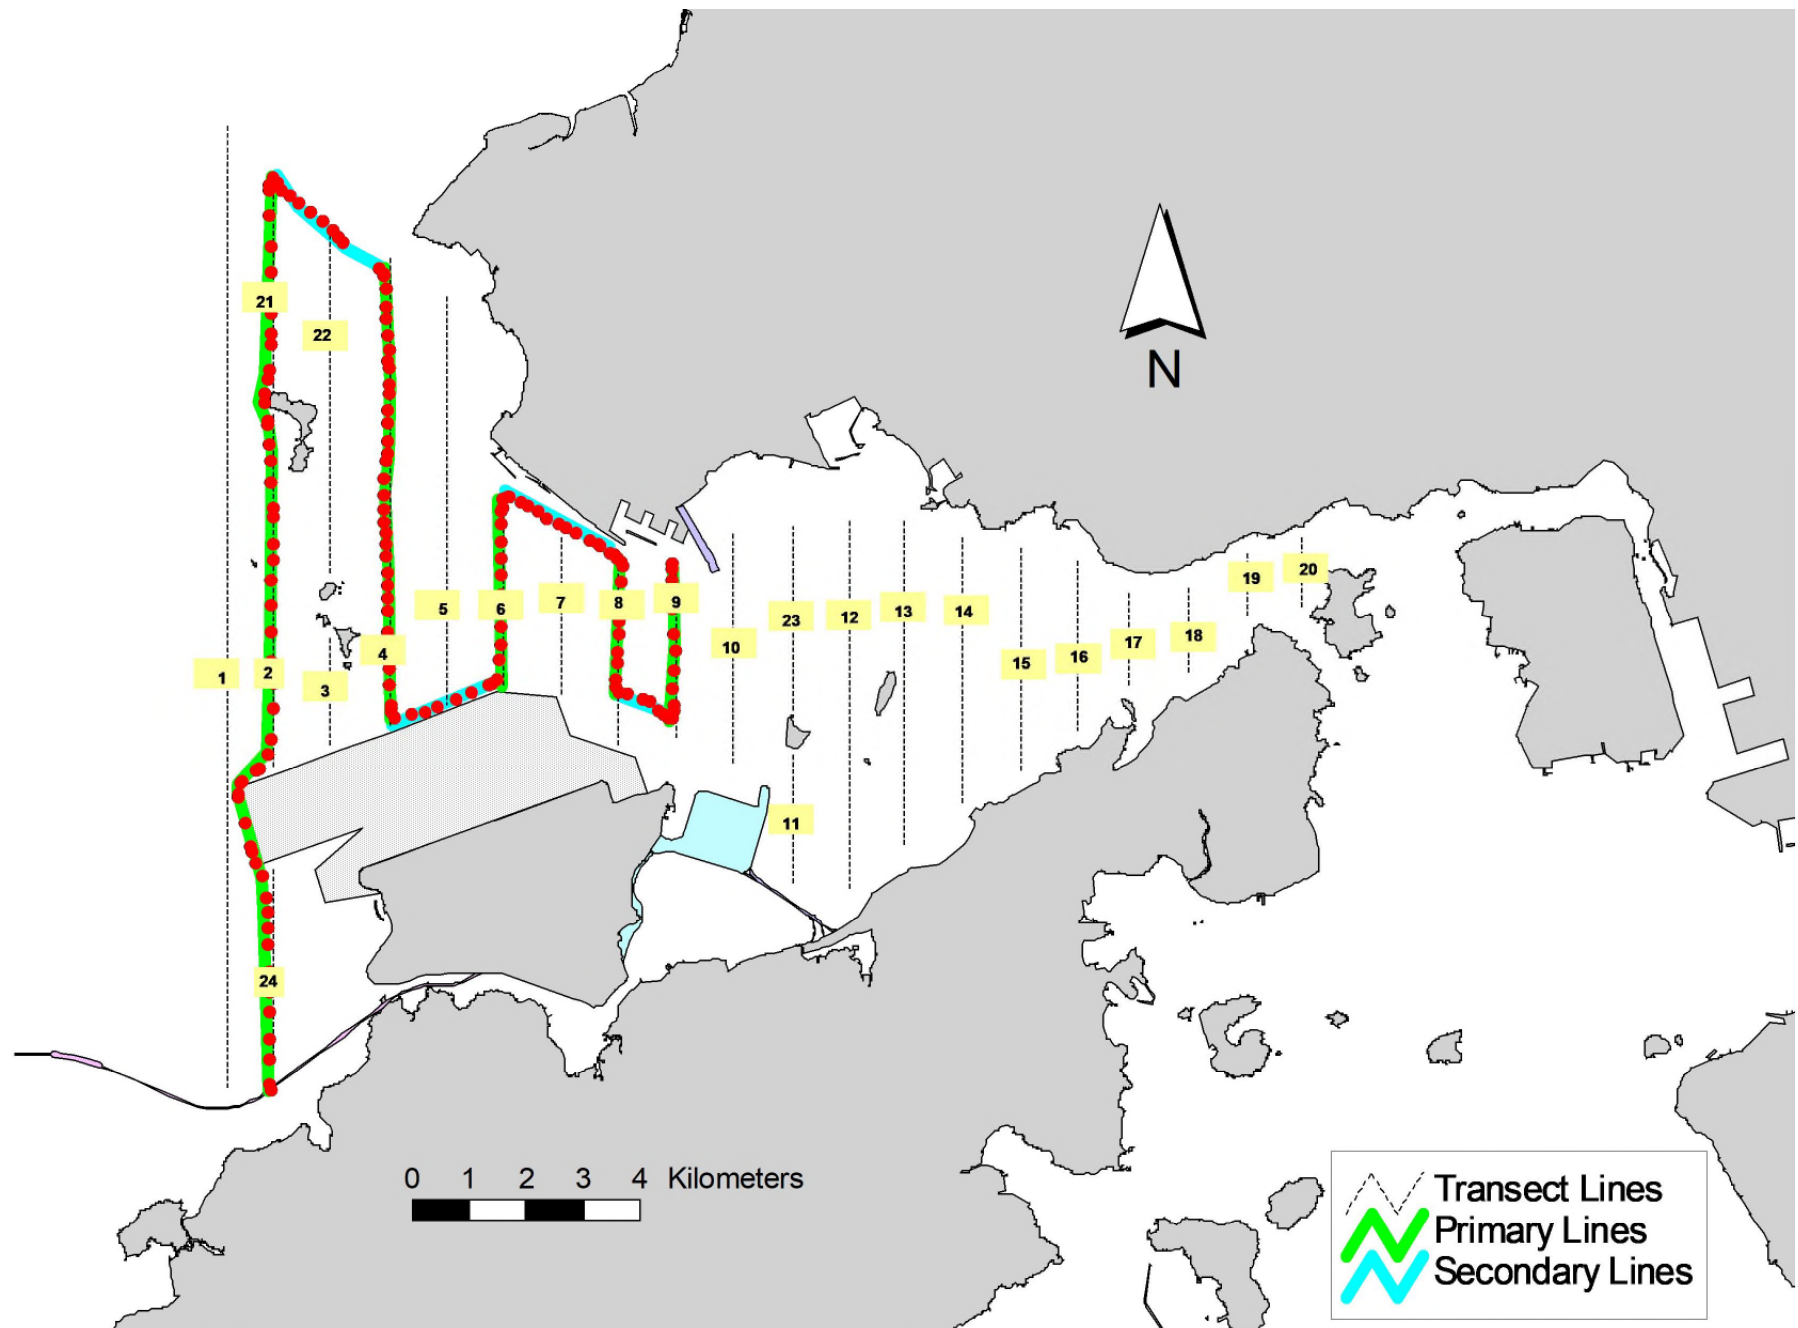
Figure 2. Survey Route on July 16th, 2019 (from HKLR03 project)

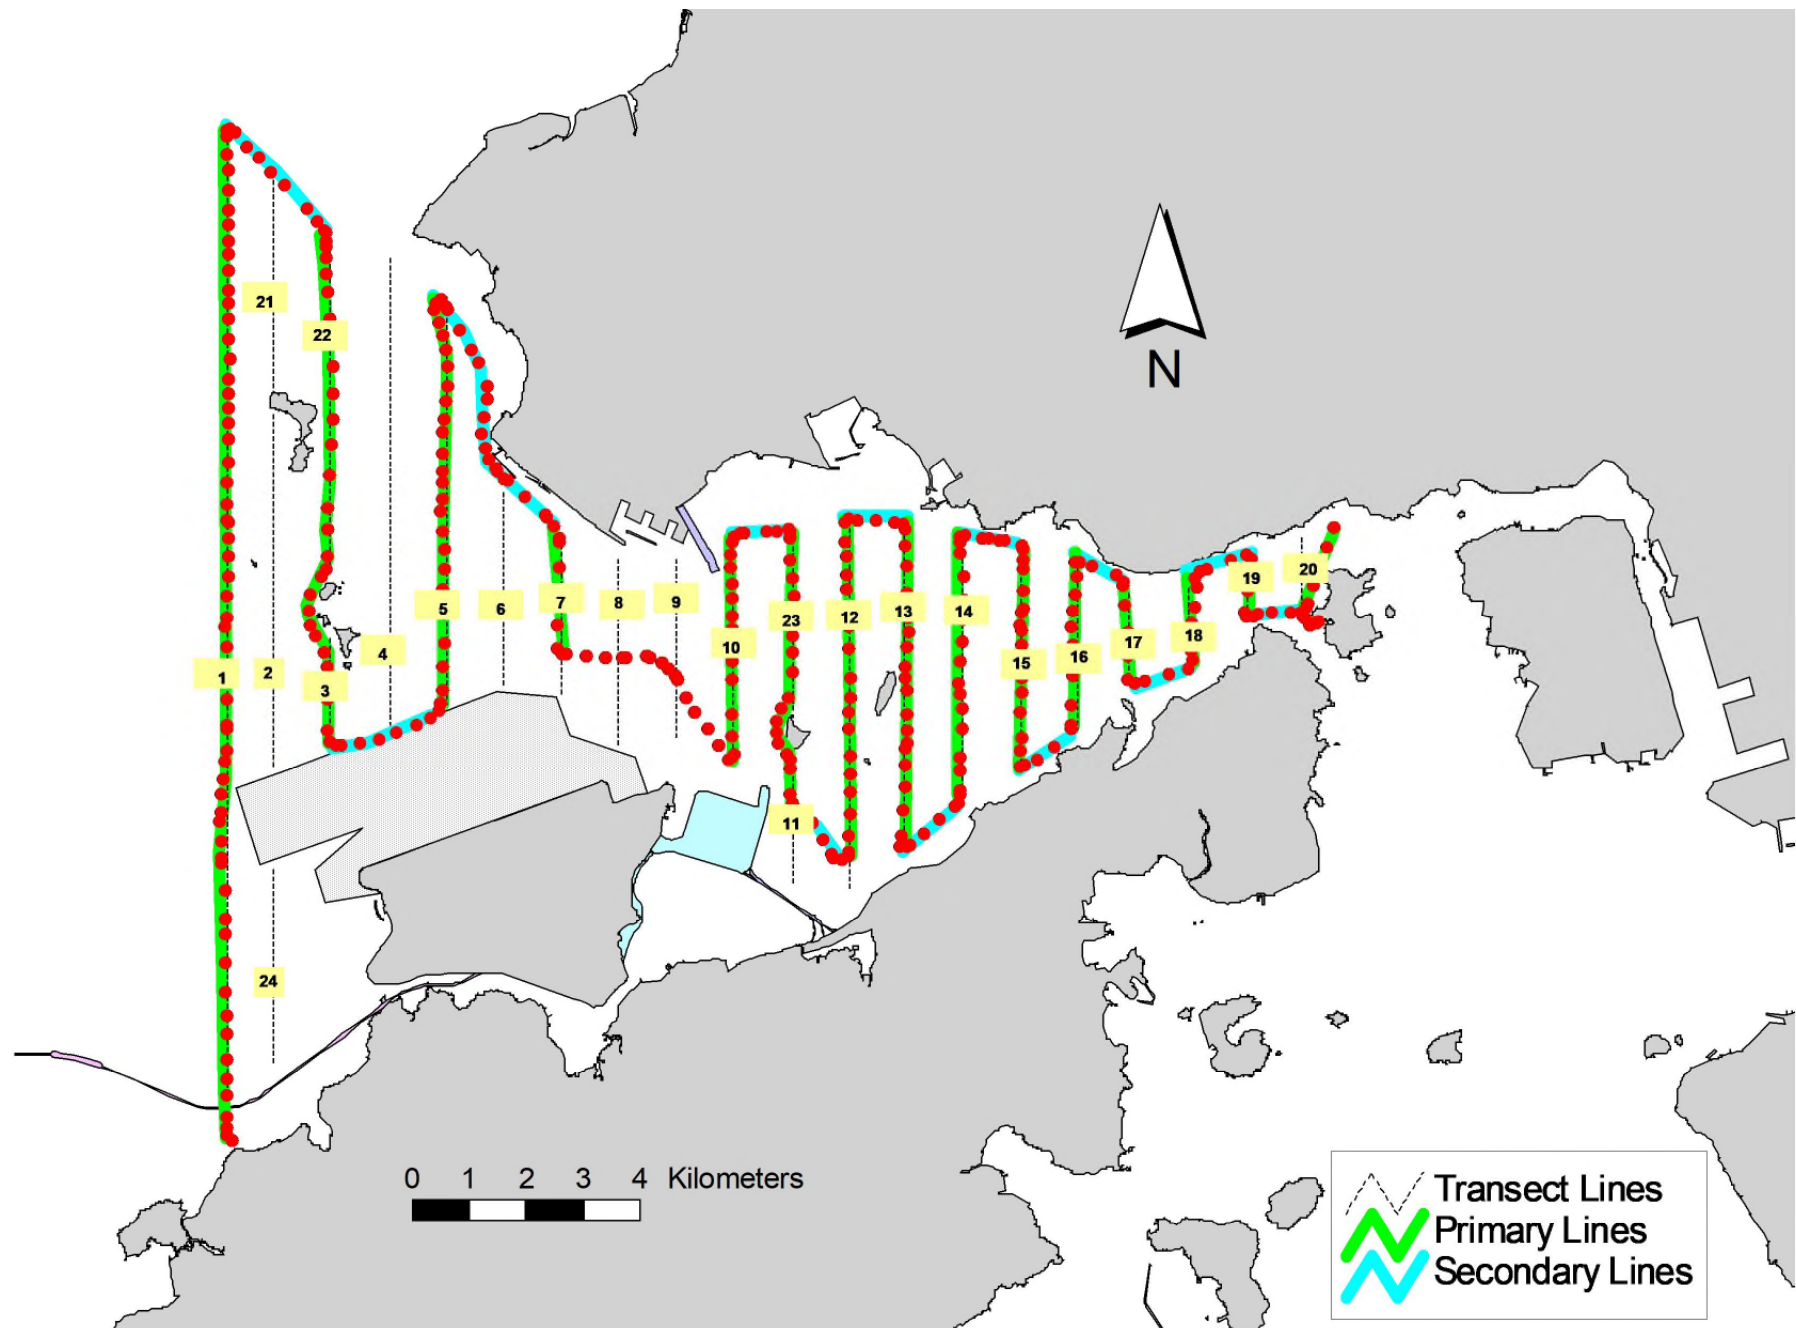
Figure 3. Survey Route on July 18th, 2019 (from HKLR03 project)

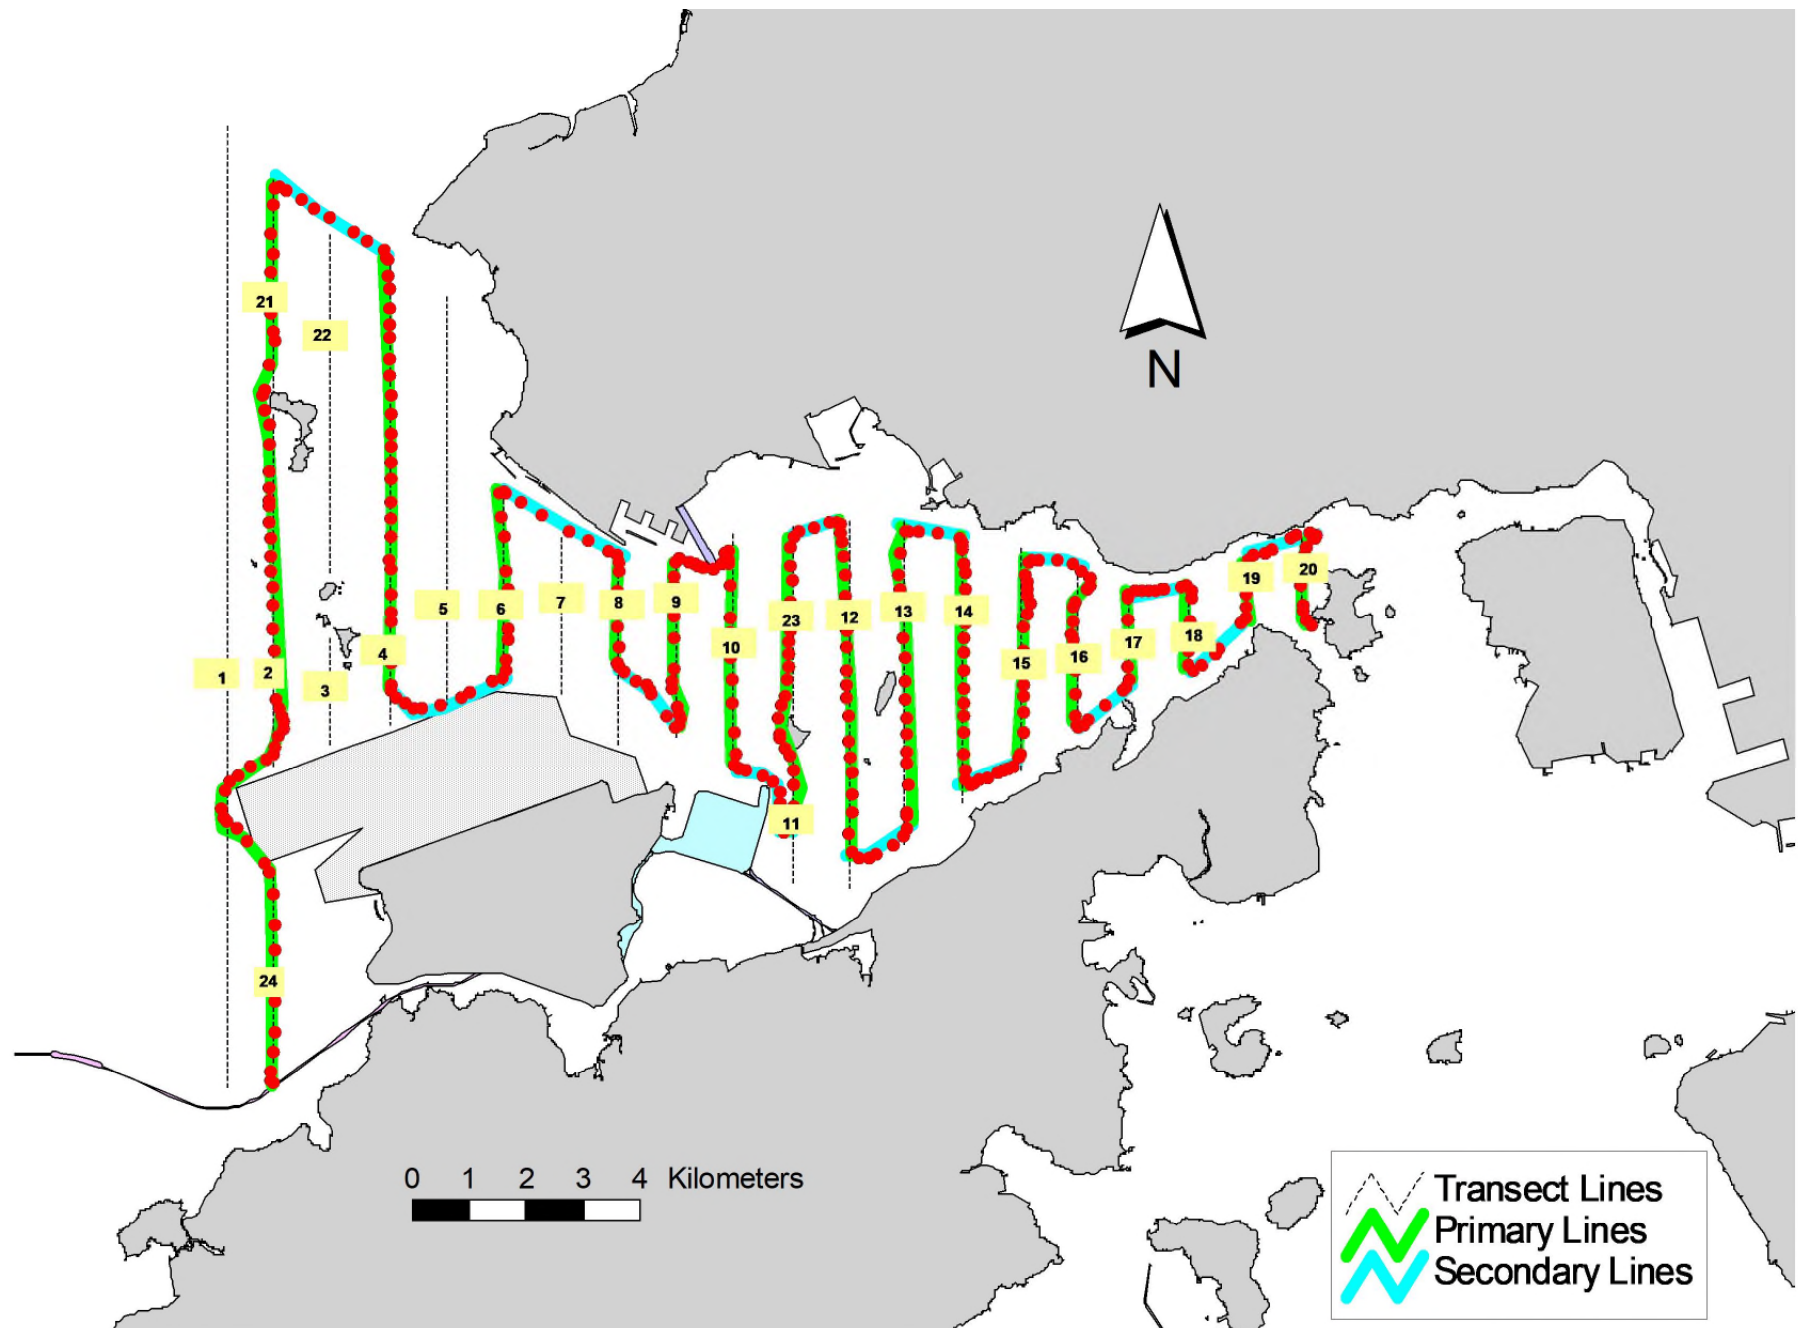
Figure 4. Survey Route on July 22nd, 2019 (from HKLR03 project)

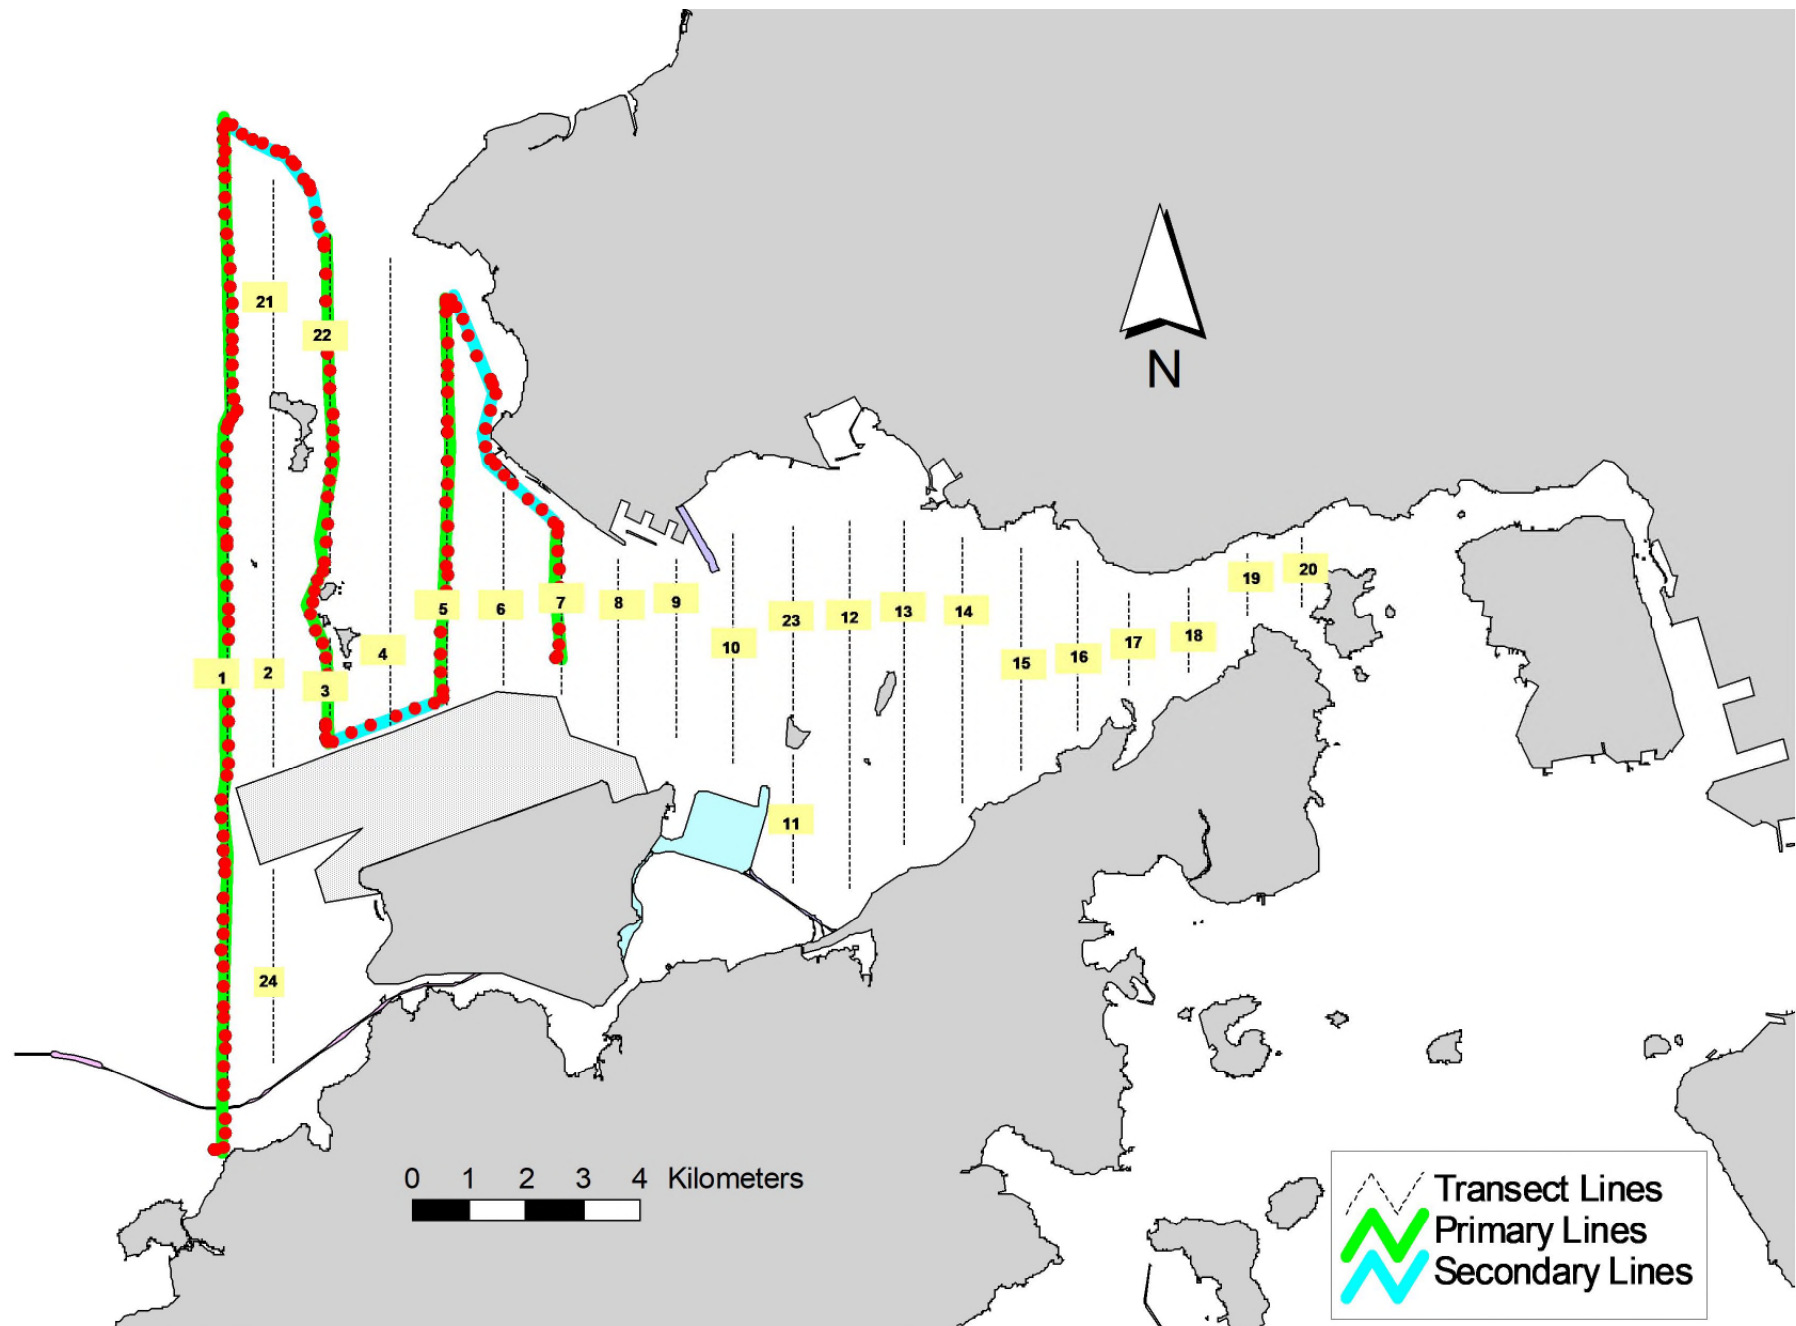
Figure 5. Survey Route on July 24th, 2019 (from HKLR03 project)

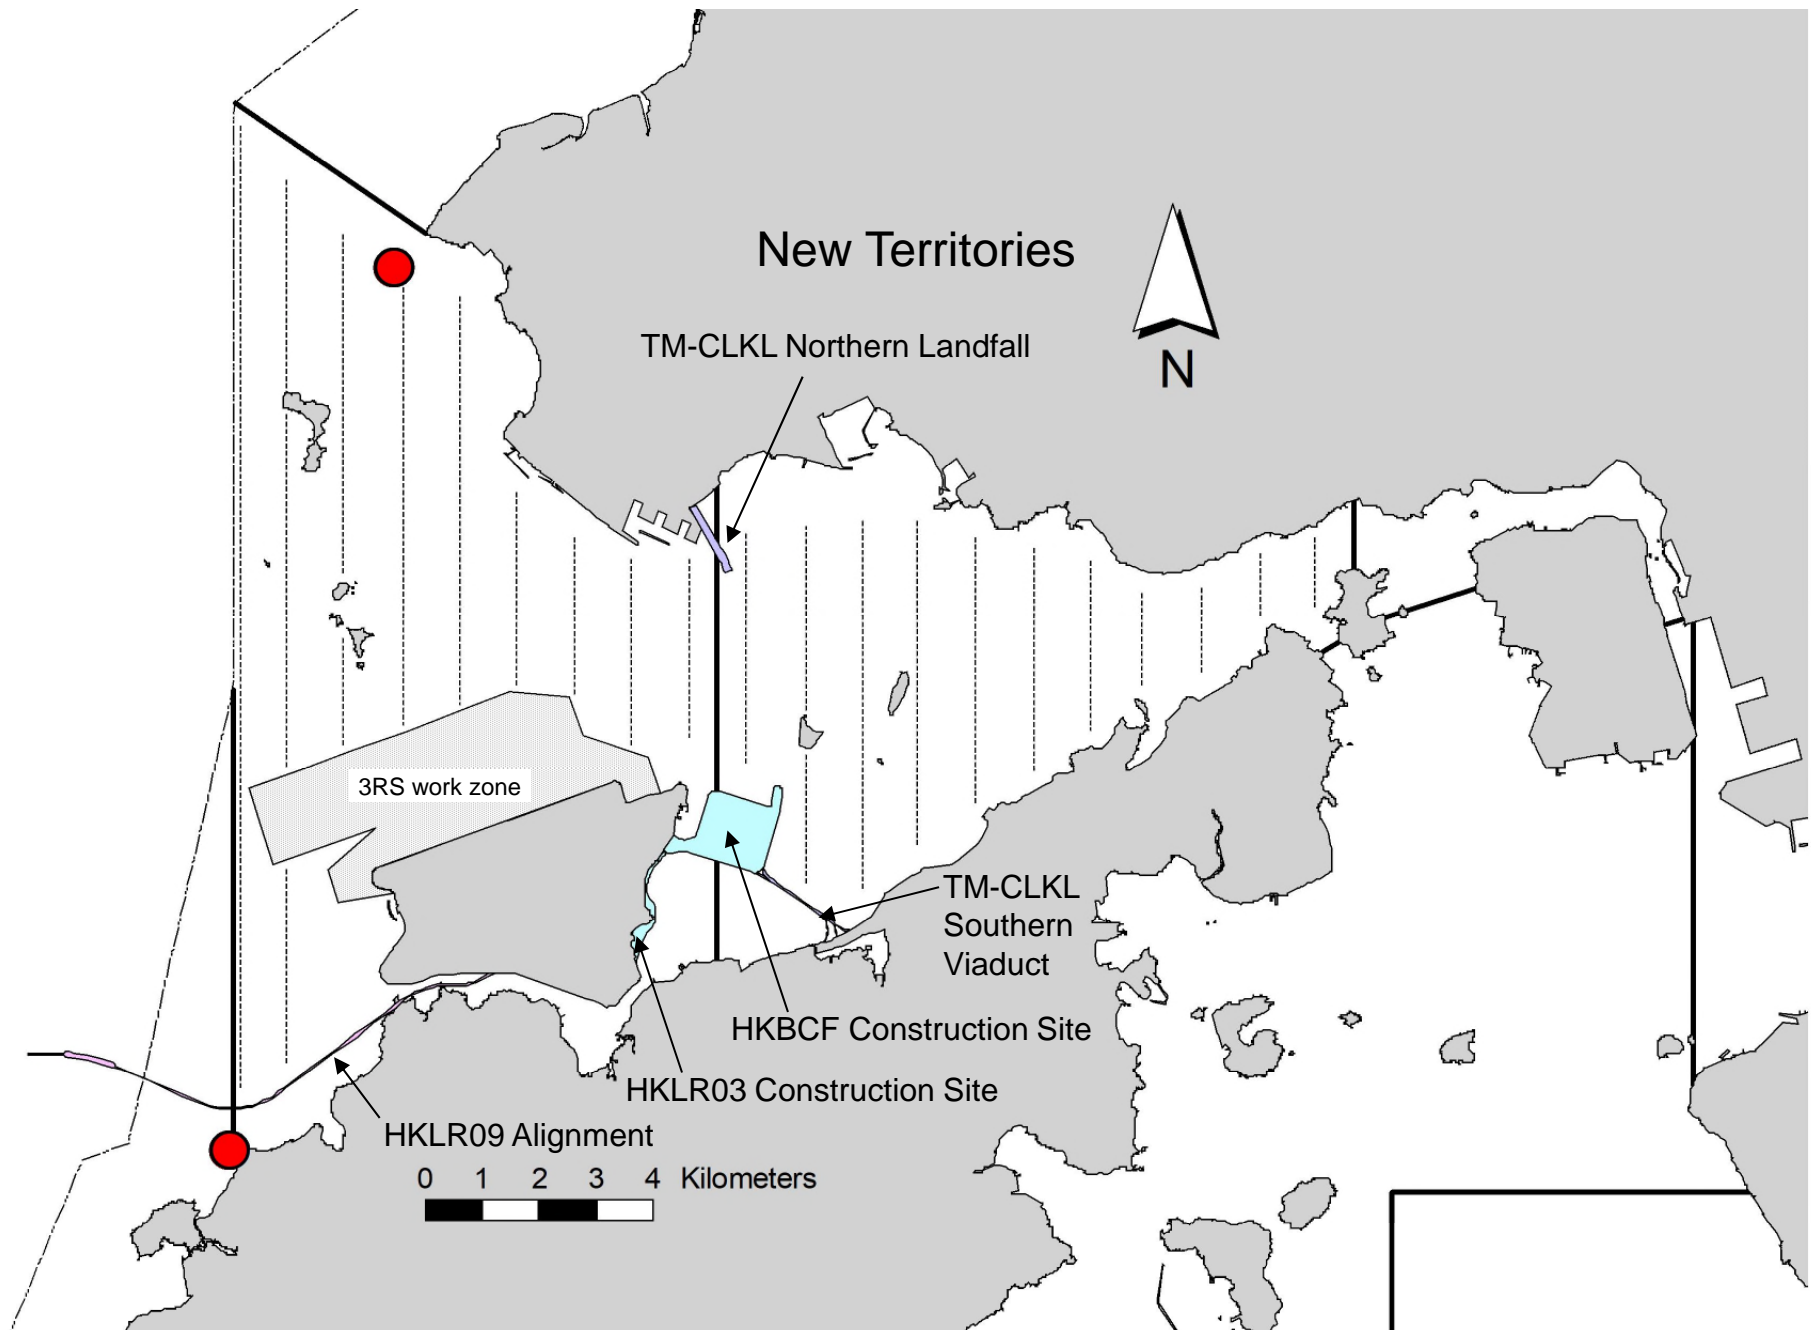
Figure 6. Distribution of Chinese White Dolphin Sightings during July 2019 HKLR03 Monitoring Surveys
