**Contract No. HY/2012/07  
Tuen Mun – Chek Lap Kok Link –  
Southern Connection Viaduct Section**

*Seventy Third Monthly EM&A Report*

11 December 2019

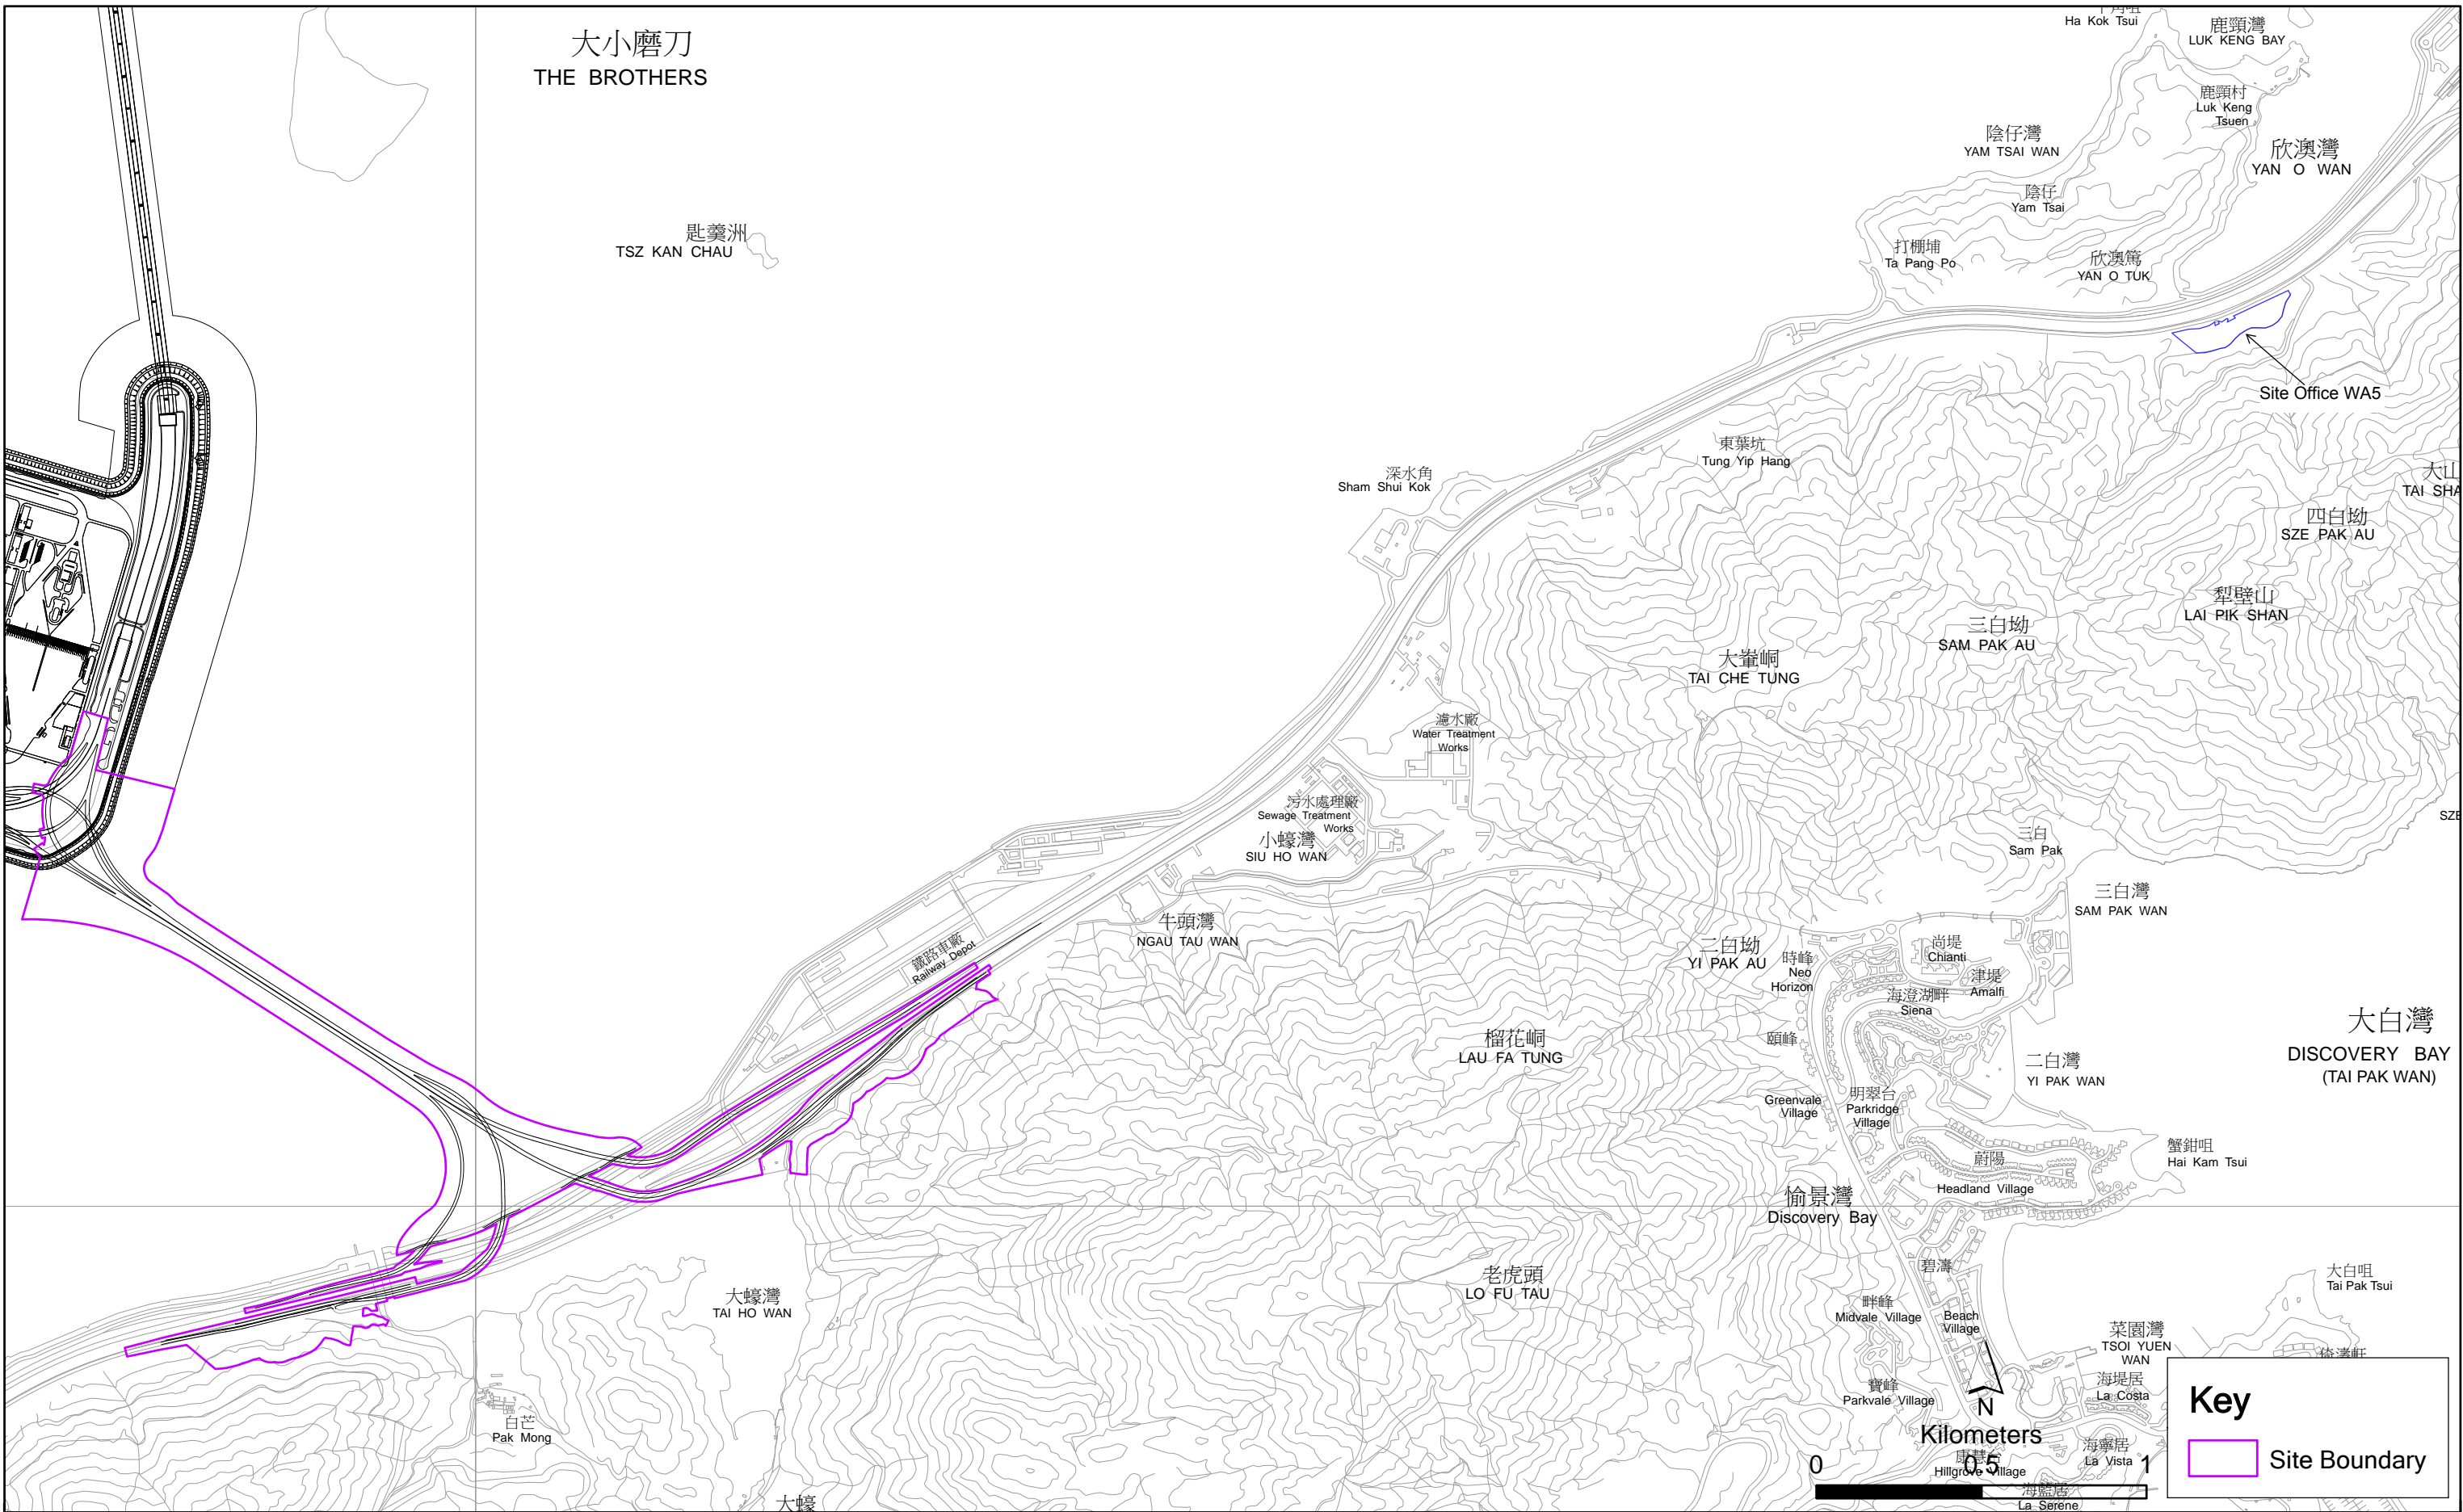
Figure 1.1

General Layout Plan of the Project

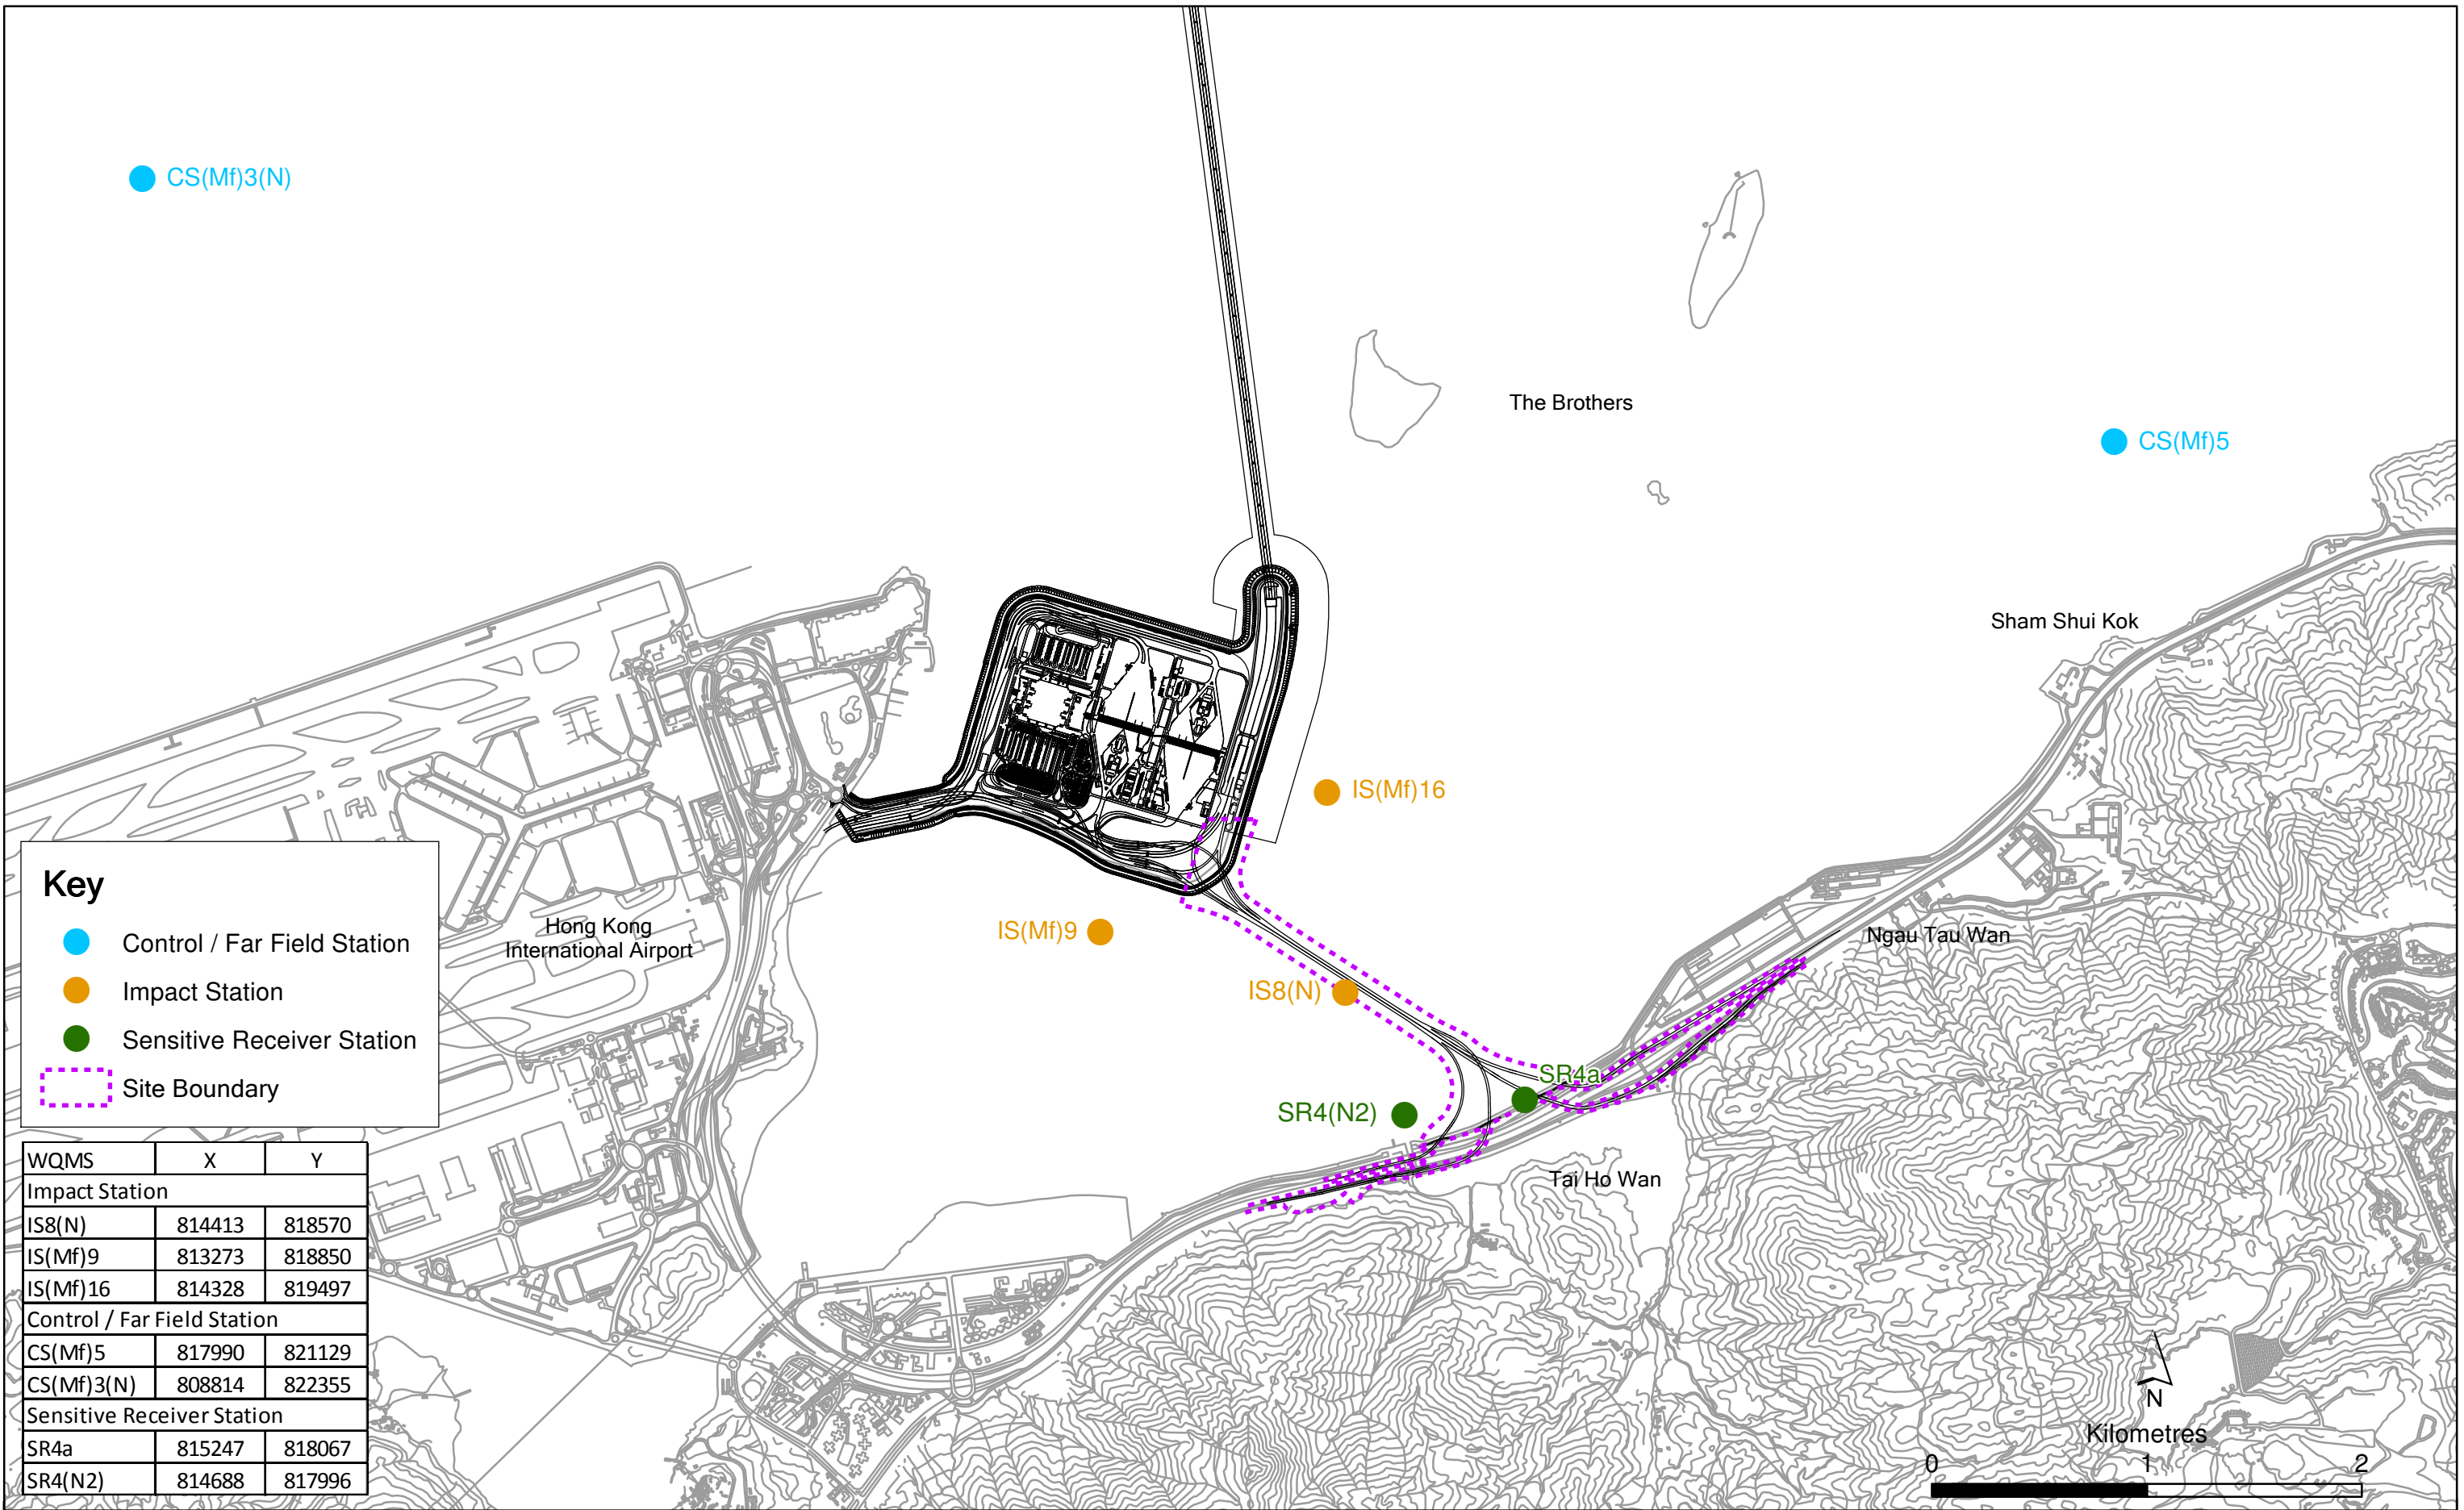
The locations of the monitoring stations under the Contract are shown in *Figure 2.1* and *Table 2.1*.

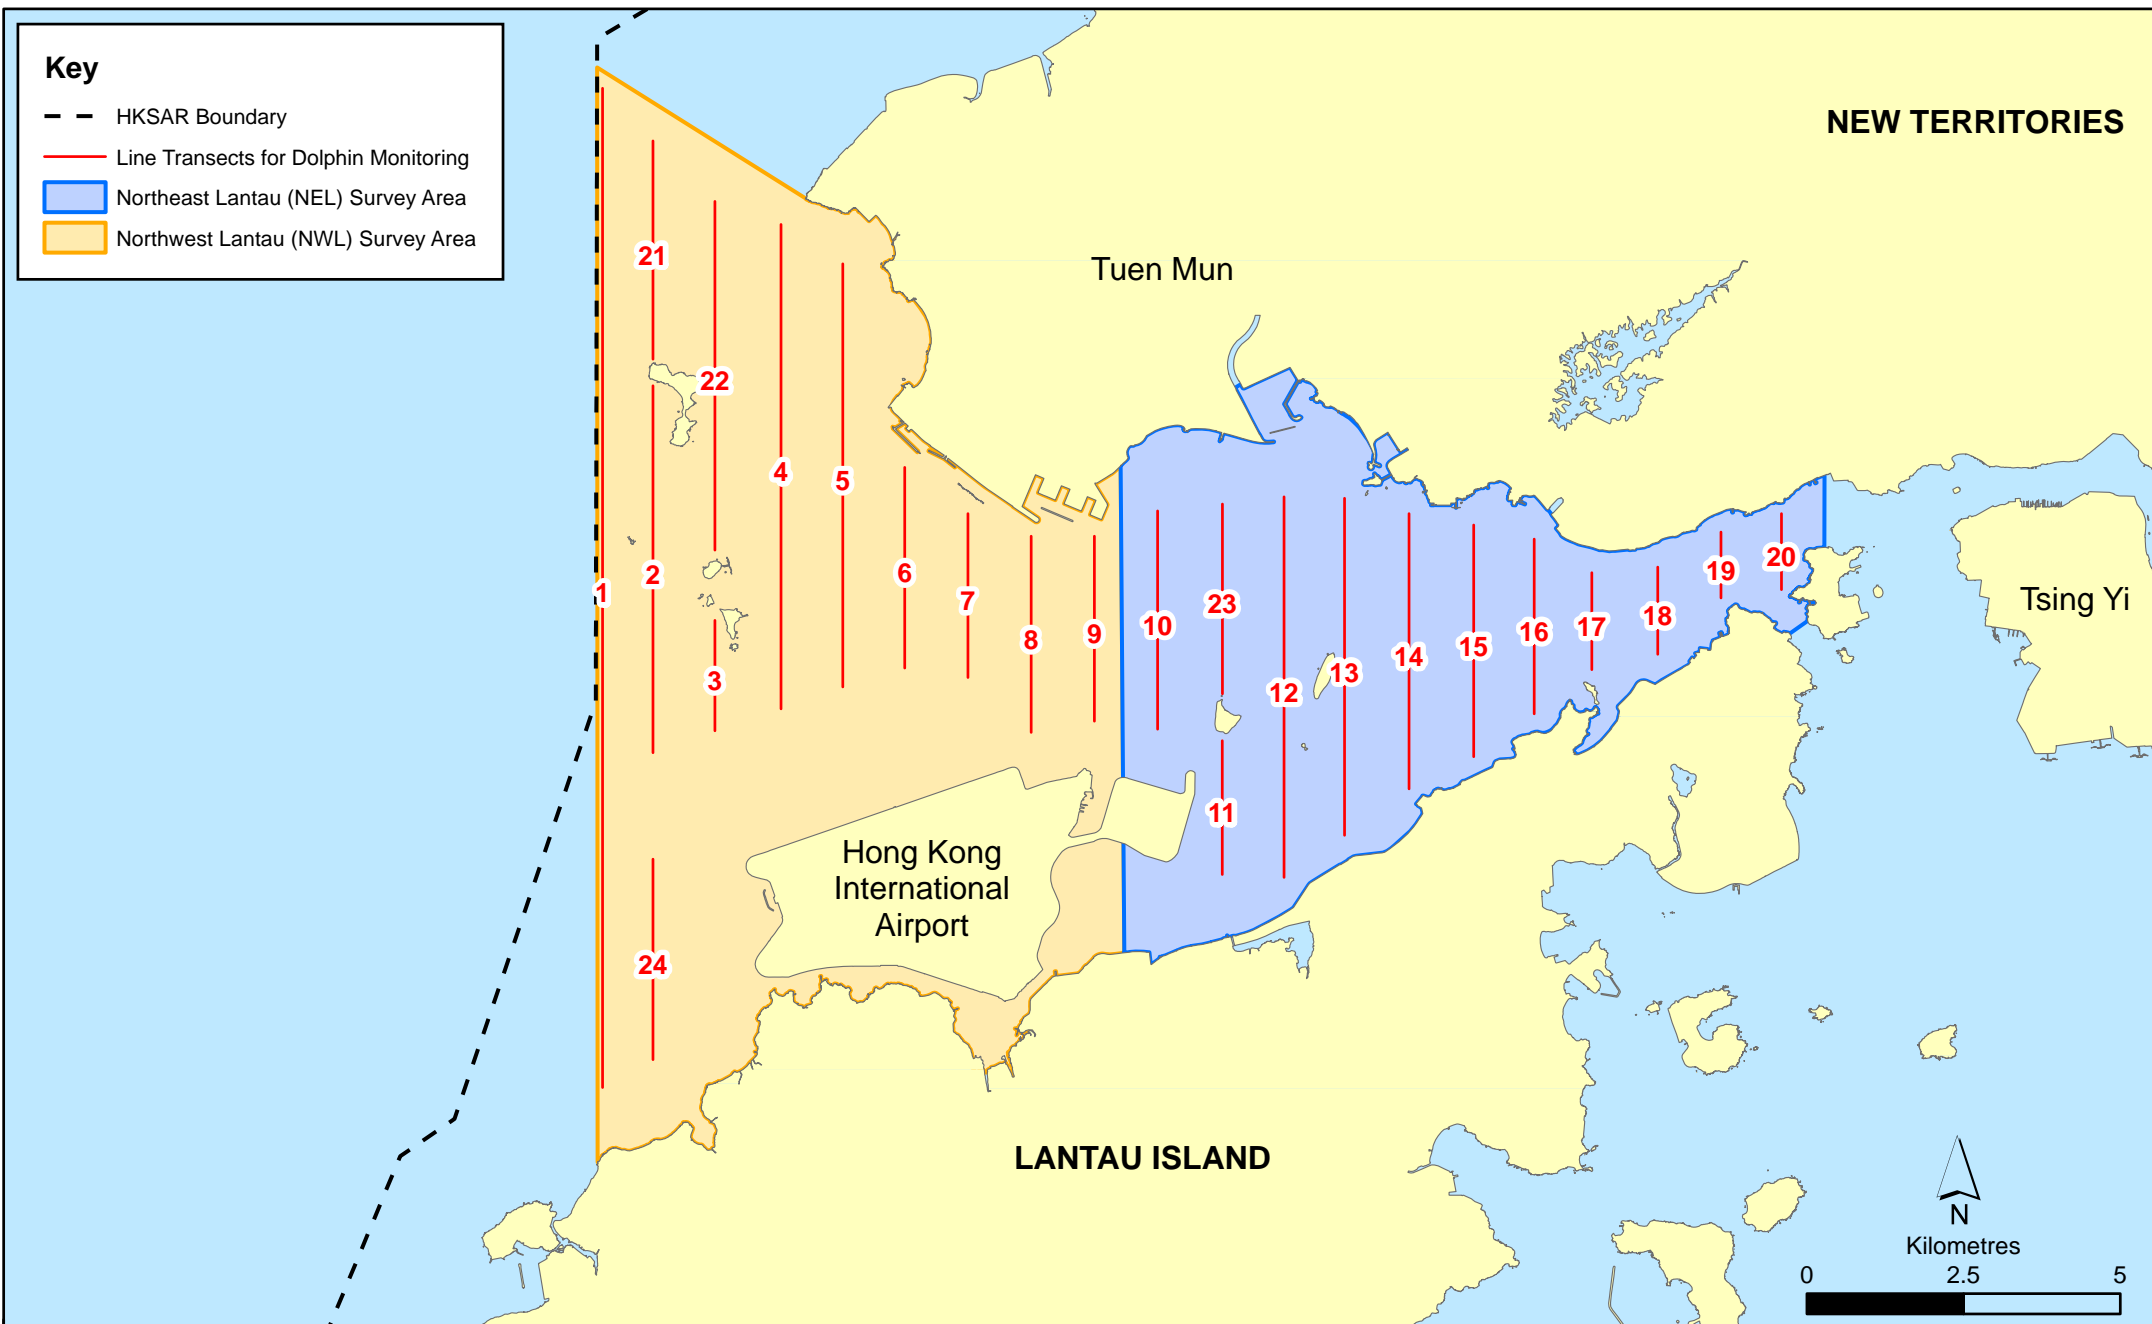
Figure 2.2

Layout of Transect Lines of Dolphin Monitoring in Northwest and Northeast Lantau Areas

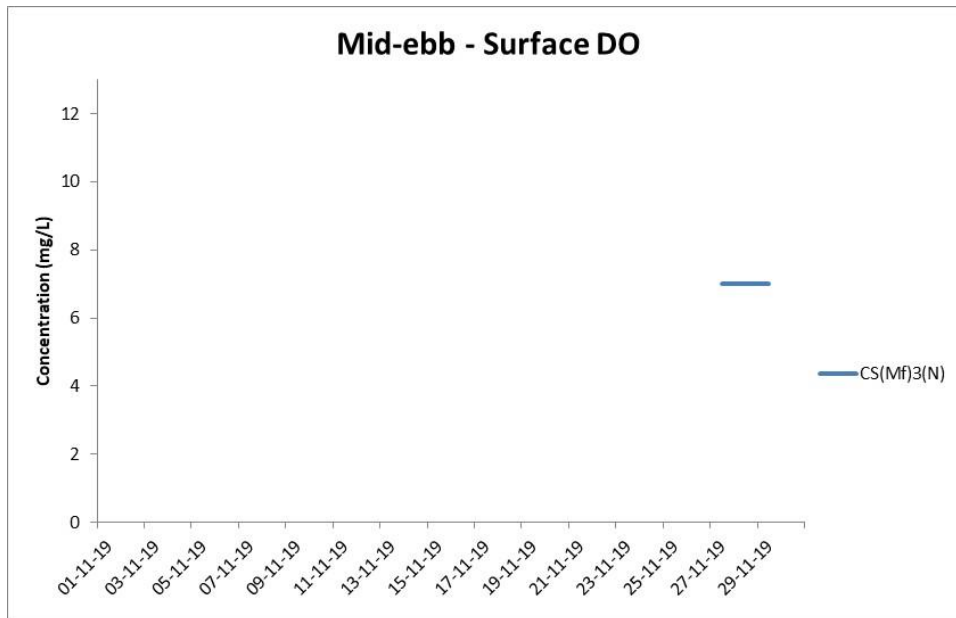
**Figure G1 Post-Construction Monitoring - Mean Level of Dissolved Oxygen (mg/L) in surface waters during mid-ebb tide between 1 November 2019 and 30 November 2019 at CS(Mf)3(N) and CS(Mf)5.**

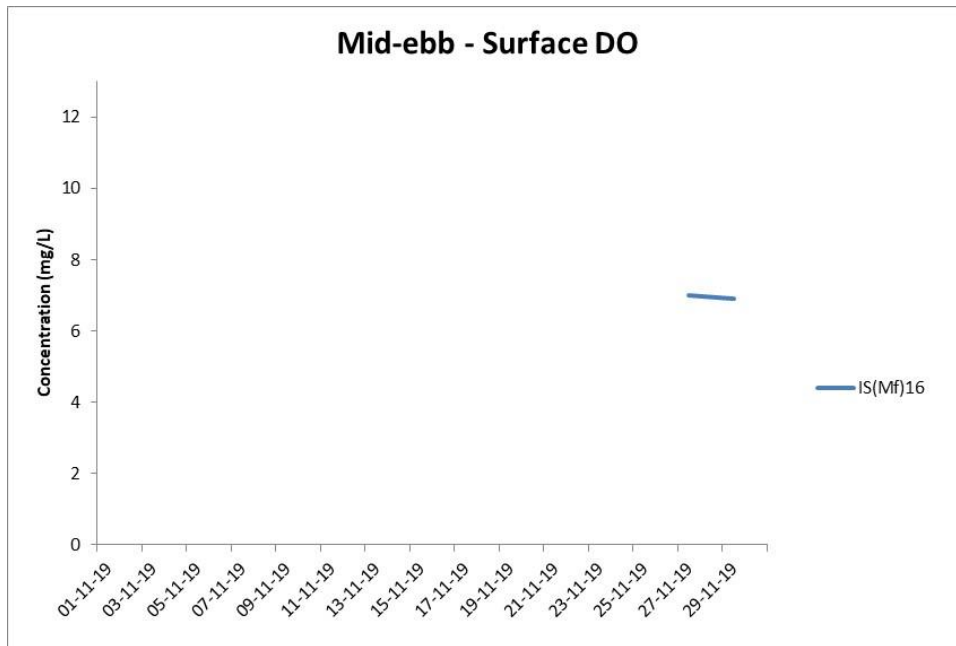
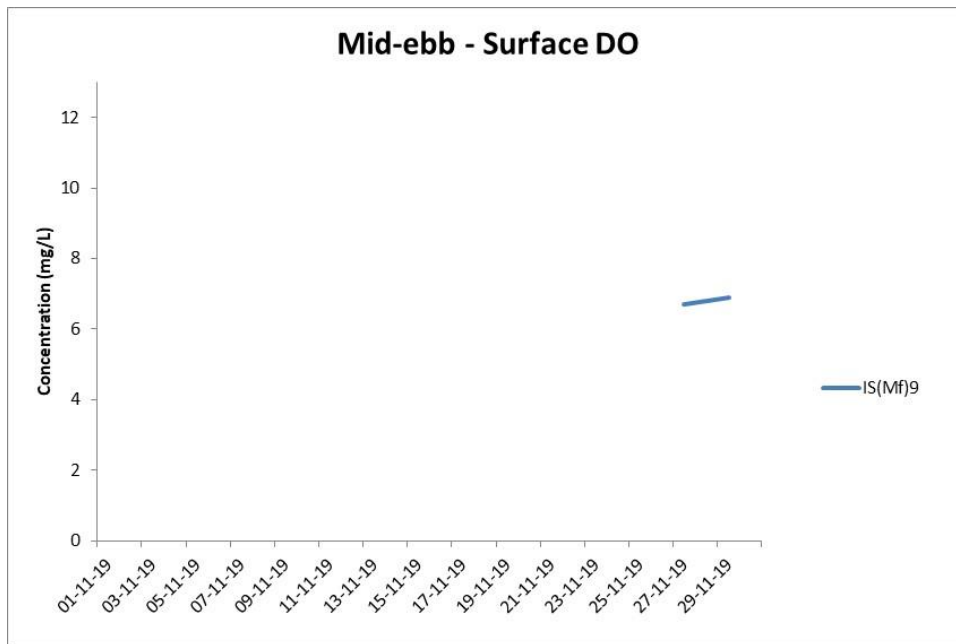
**Figure G2 Post-Construction Monitoring - Mean Level of Dissolved Oxygen (mg/L) in surface waters during mid-ebb tide between 1 November 2019 and 30 November 2019 at IS(Mf)16 and IS(Mf)9.**

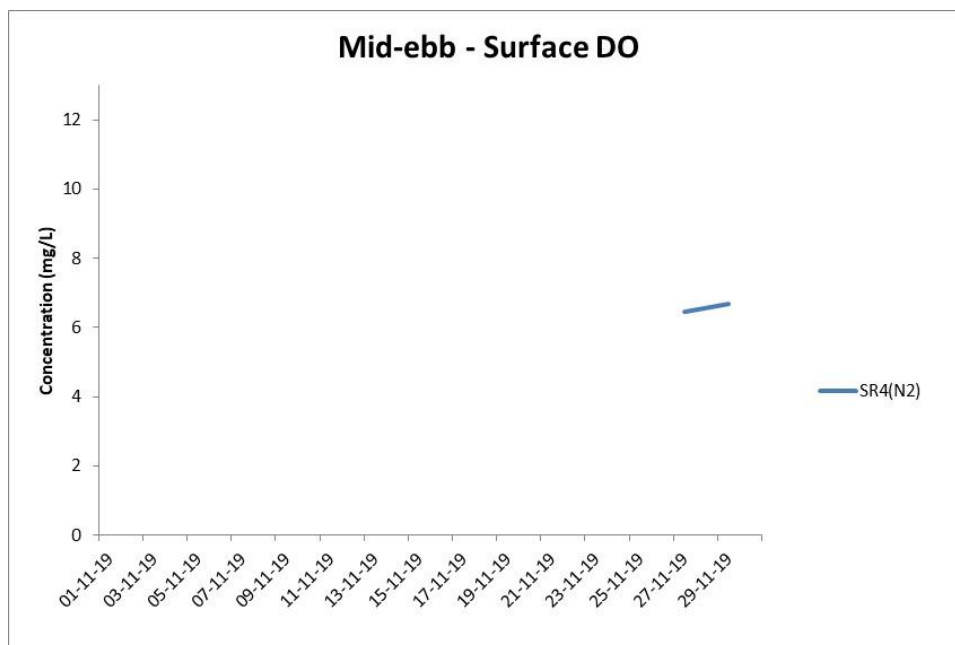
**Figure G3 Post-Construction Monitoring - Mean Level of Dissolved Oxygen (mg/L) in surface waters during mid-ebb tide between 1 November 2019 and 30 November 2019 at IS8(N) and SR4(N2).**

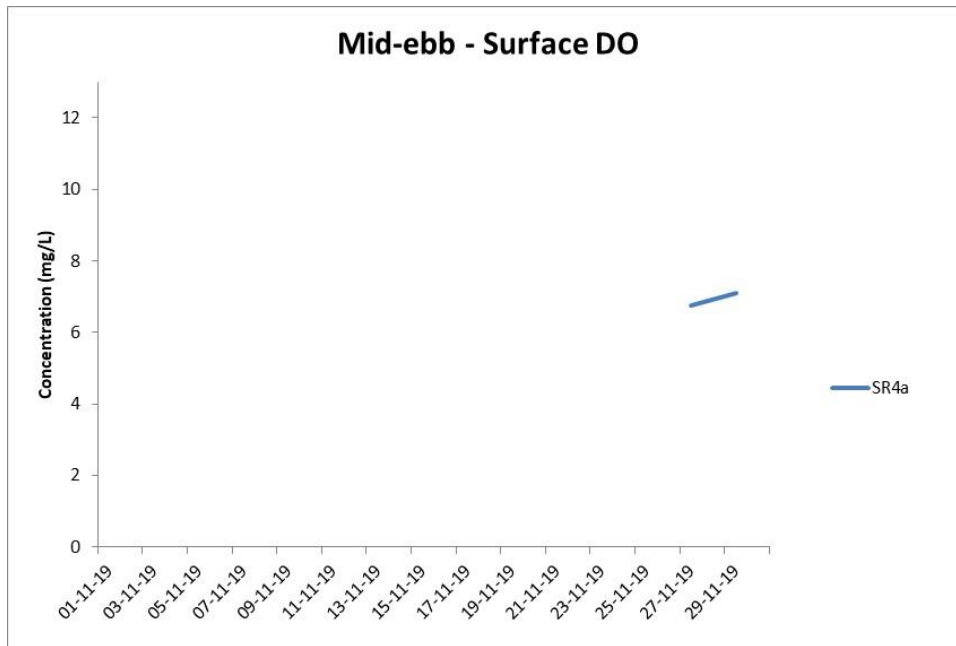
**Figure G4 Post-Construction Monitoring - Mean Level of Dissolved Oxygen (mg/L) in surface waters during mid-ebb tide between 1 November 2019 and 30 November 2019 at SR4a.**

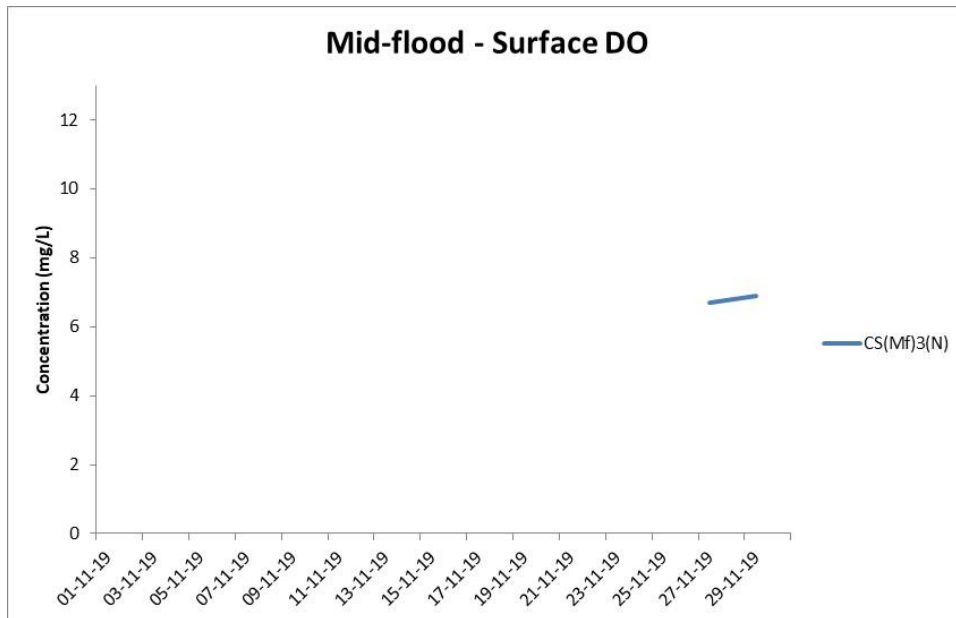
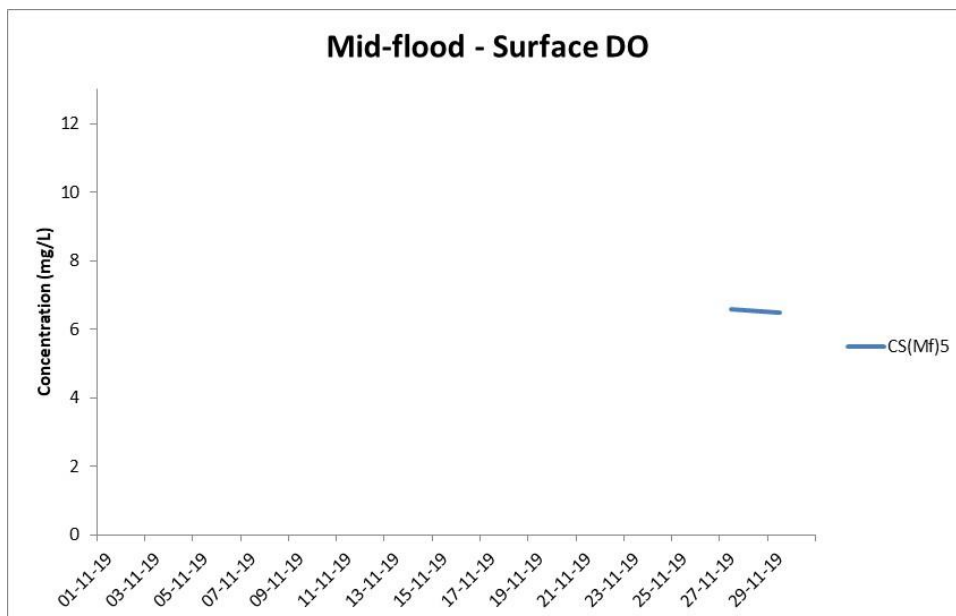
**Figure G5 Post-Construction Monitoring - Mean Level of Dissolved Oxygen (mg/L) in surface waters during mid-flood tide between 1 November 2019 and 30 November 2019 at CS(Mf)3(N) and CS(Mf)5.**

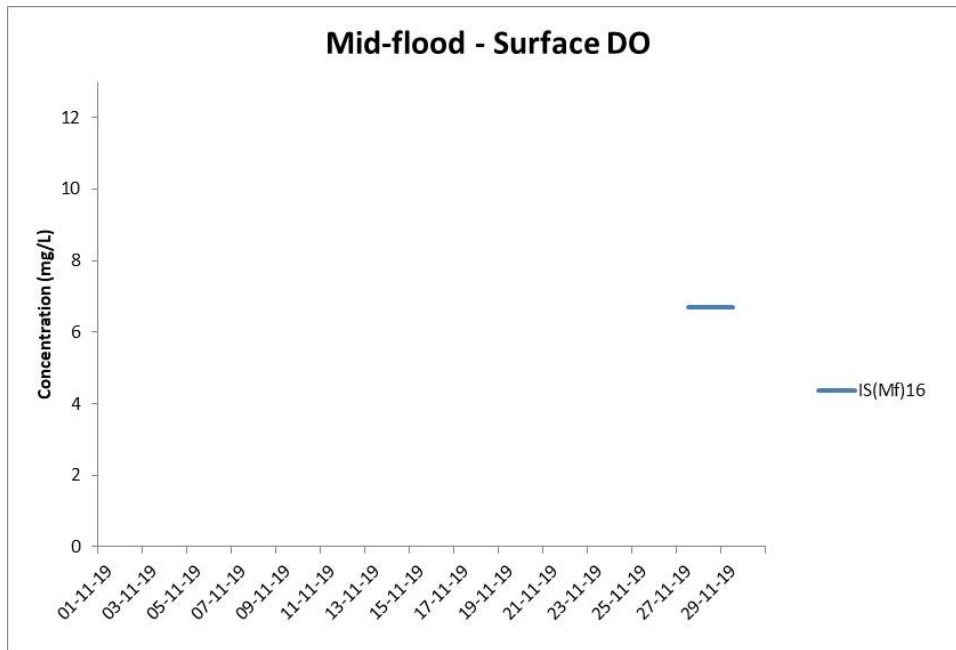
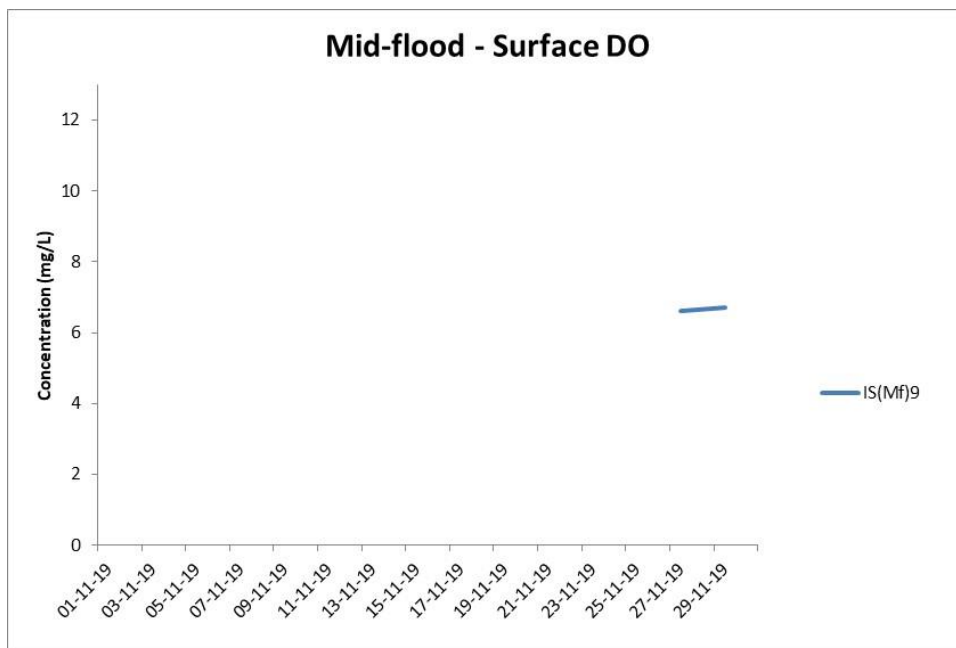
**Figure G6 Post-Construction Monitoring – Mean Level of Dissolved Oxygen (mg/L) in surface waters during mid-flood tide between 1 November 2019 and 30 November 2019 at IS(Mf)16 and IS(Mf)9.**

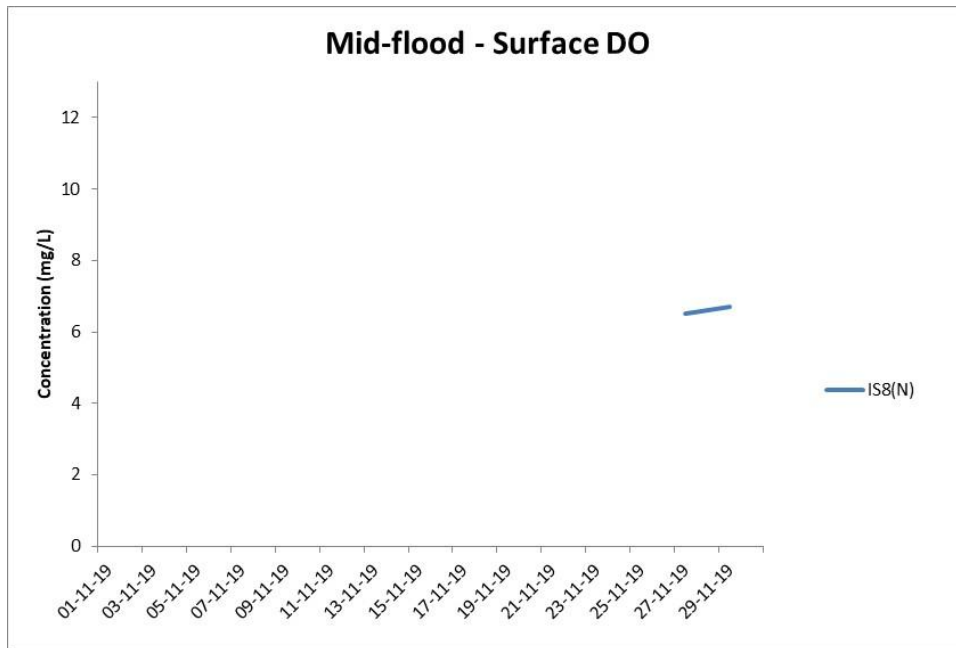
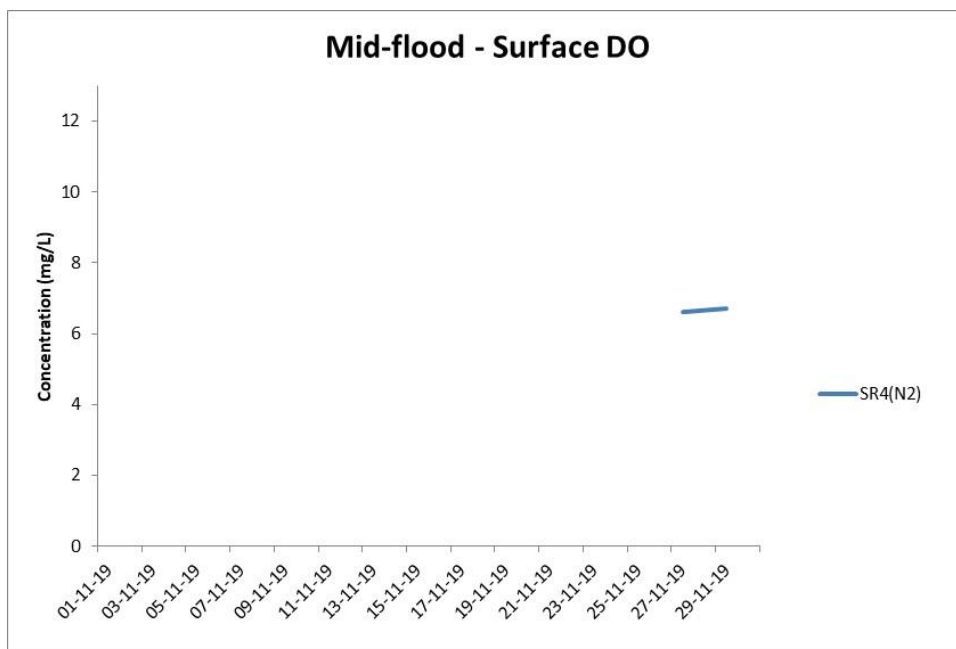
**Figure G7 Post-Construction Monitoring – Mean Level of Dissolved Oxygen (mg/L) in surface waters during mid-flood tide between 1 November 2019 and 30 November 2019 at IS8(N) and SR4(N2).**

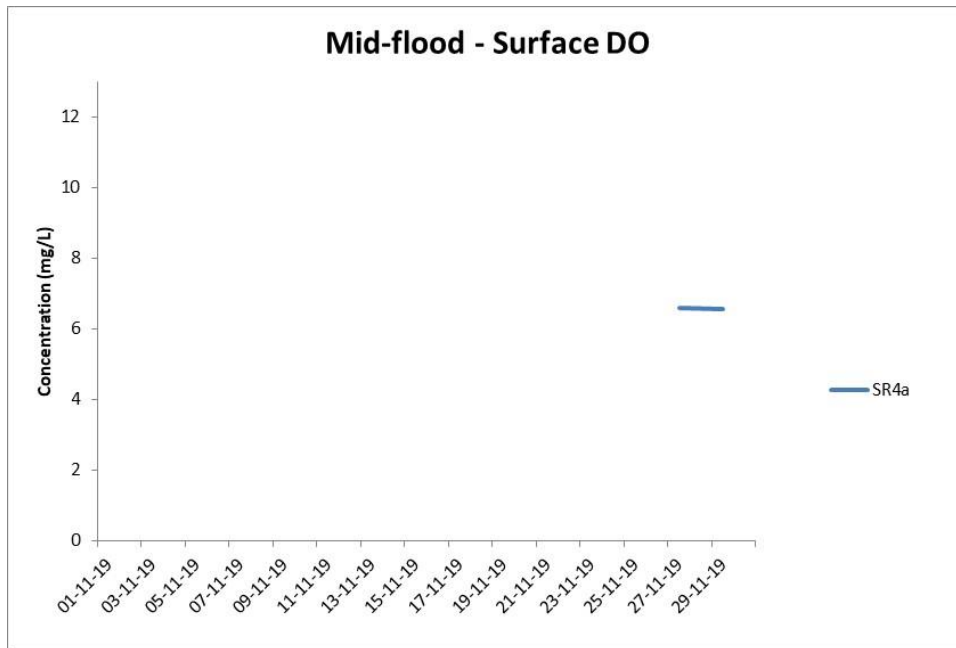
**Figure G8 Post-Construction Monitoring - Mean Level of Dissolved Oxygen (mg/L) in surface waters during mid-flood tide between 1 November 2019 and 30 November 2019 at SR4a.**

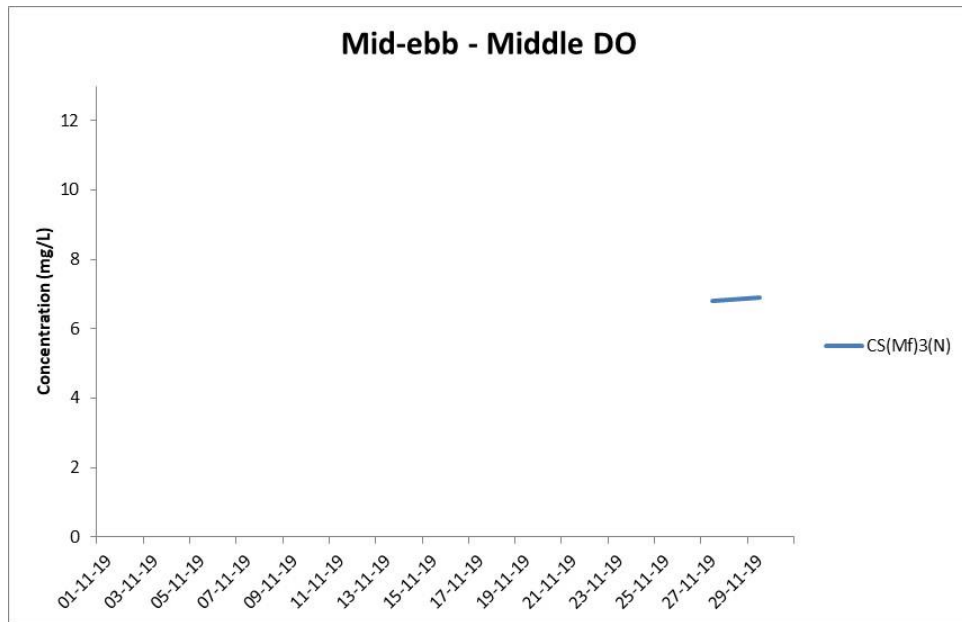
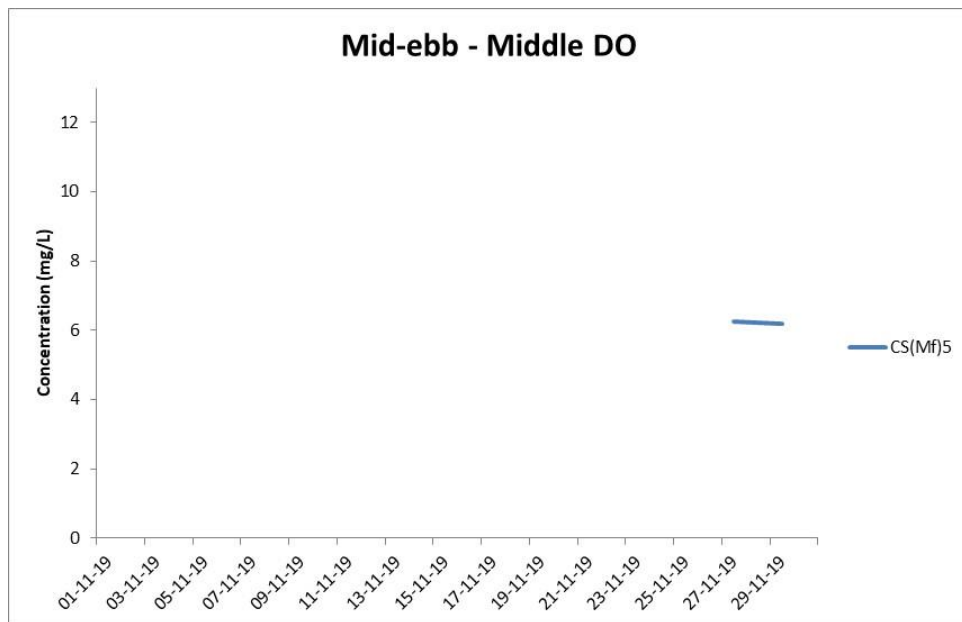
**Figure G9 Post-Construction Monitoring - Mean Level of Dissolved Oxygen (mg/L) in mid-depth waters during mid-ebb tide between 1 November 2019 and 30 November 2019 at CS(Mf)3(N) and CS(Mf)5.**

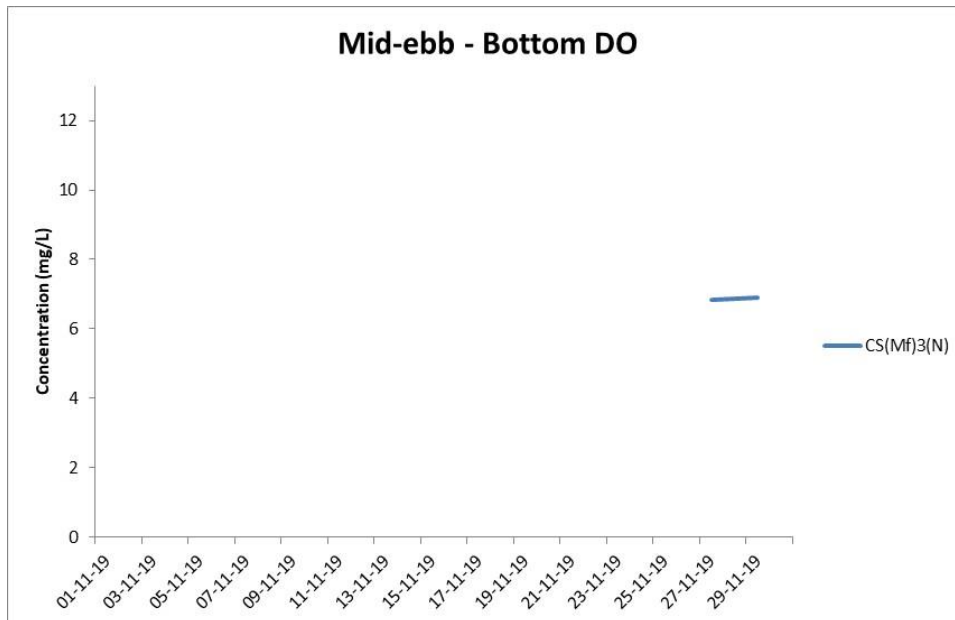
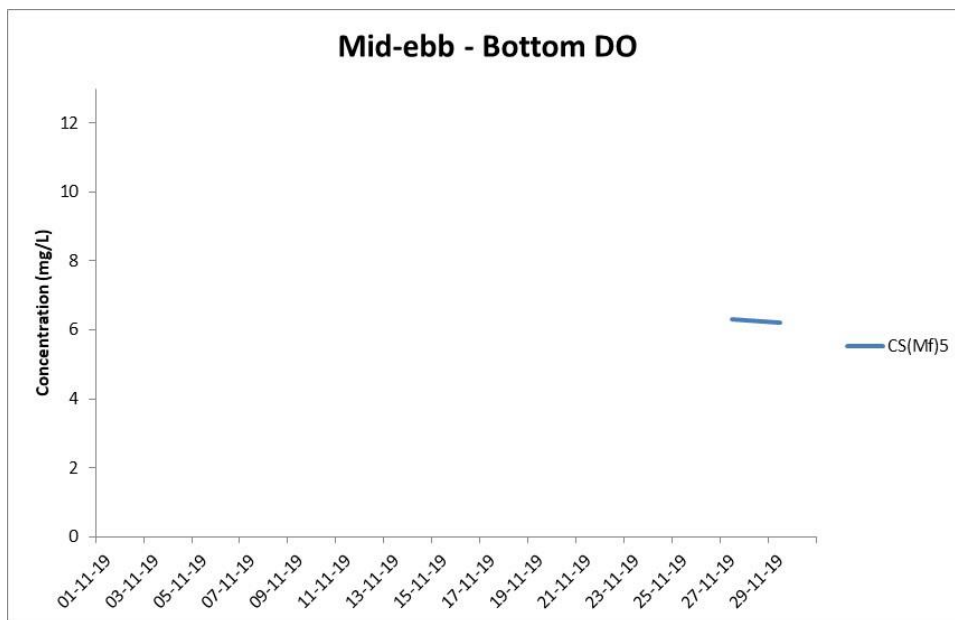
**Figure G11 Post-Construction Monitoring - Mean Level of Dissolved Oxygen (mg/L) in bottom waters during mid-ebb tide between 1 November 2019 and 30 November 2019 at CS(Mf)3(N) and CS(Mf)5.**

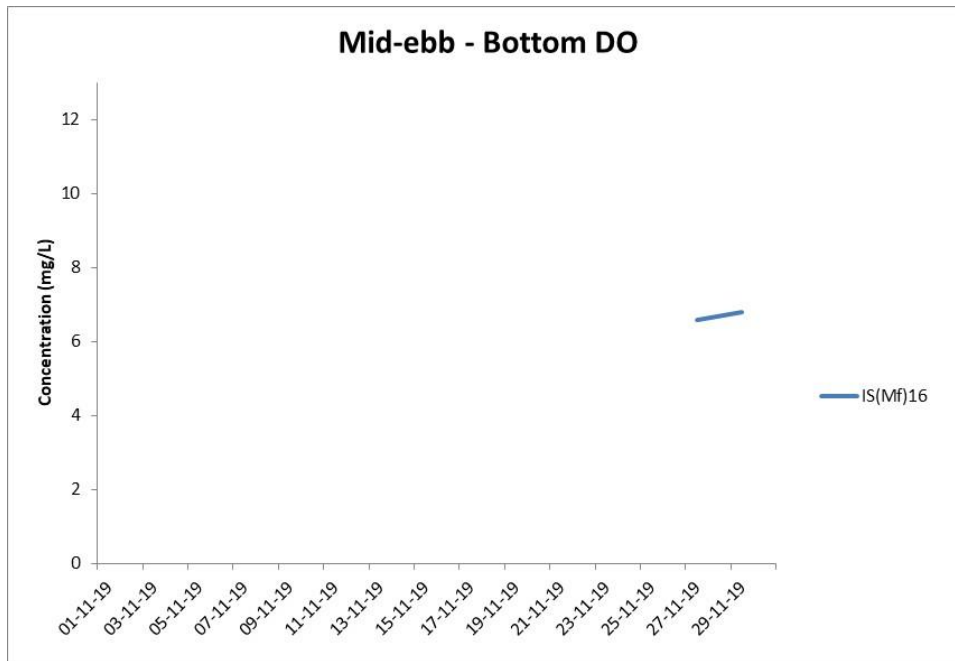
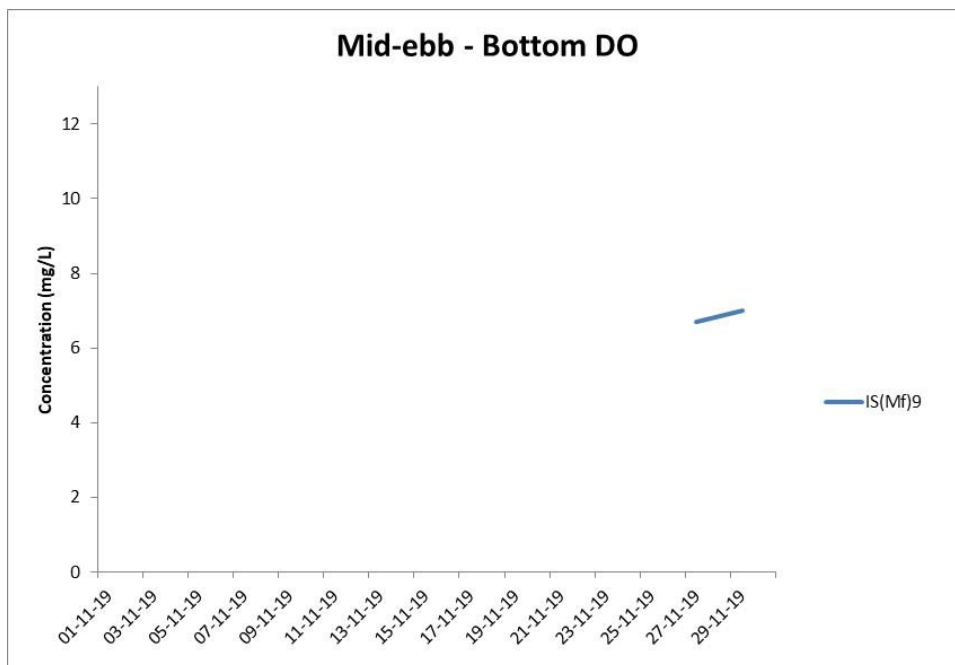
**Figure G12 Post-Construction Monitoring - Mean Level of Dissolved Oxygen (mg/L) in bottom waters during mid-ebb tide between 1 November 2019 and 30 November 2019 at IS(Mf)16 and IS(Mf)9.**

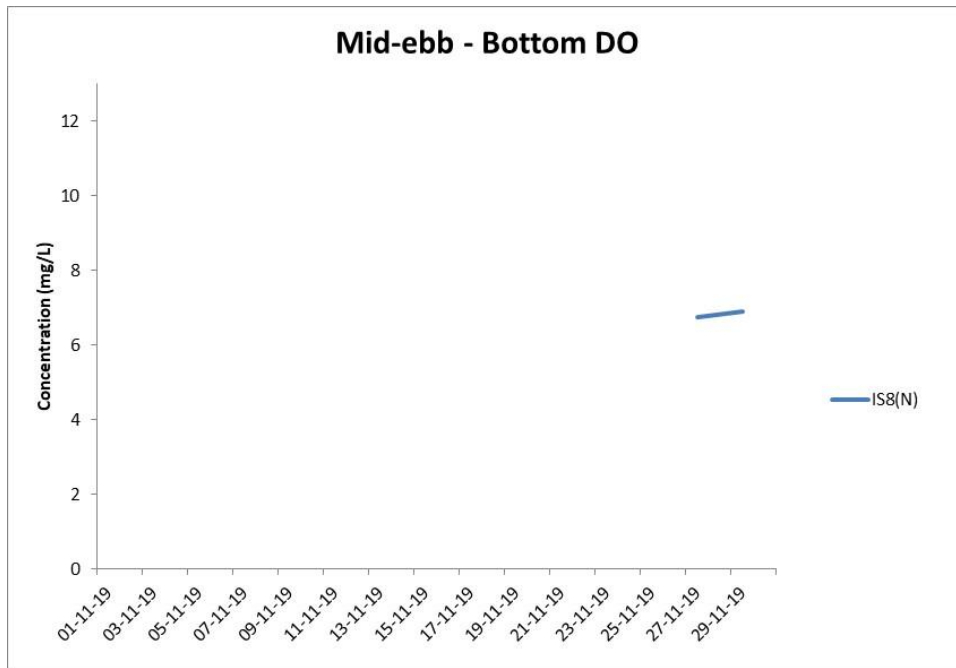
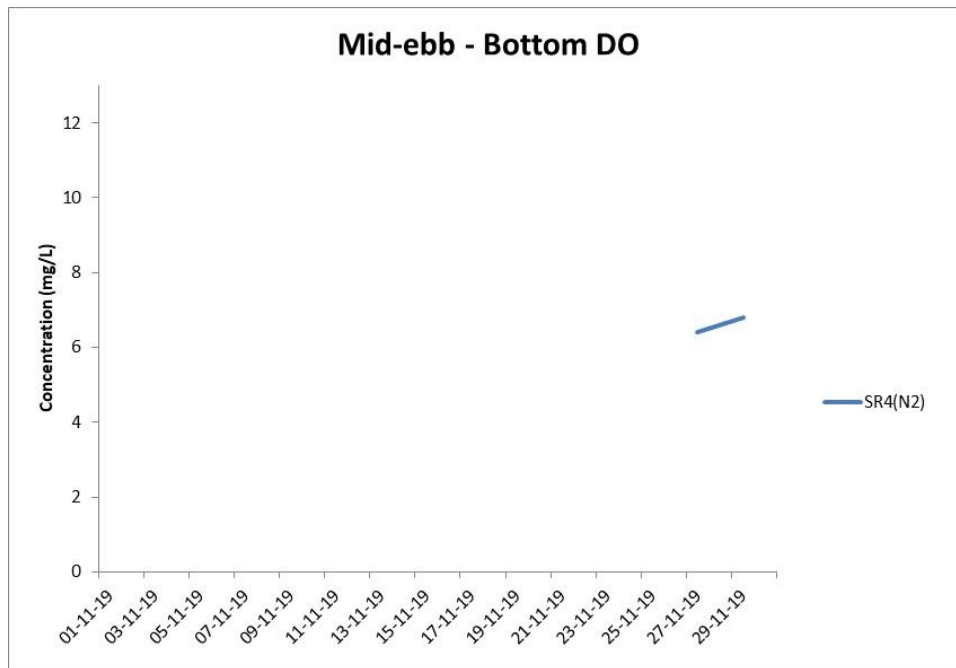
**Figure G13 Post-Construction Monitoring - Mean Level of Dissolved Oxygen (mg/L) in bottom waters during mid-ebb tide between 1 November 2019 and 30 November 2019 at IS8(N) and SR4(N2).**
