**Contract No. HY/2012/07  
Tuen Mun – Chek Lap Kok Link –  
Southern Connection Viaduct Section**

*Seventy Third Monthly EM&A Report*

11 December 2019

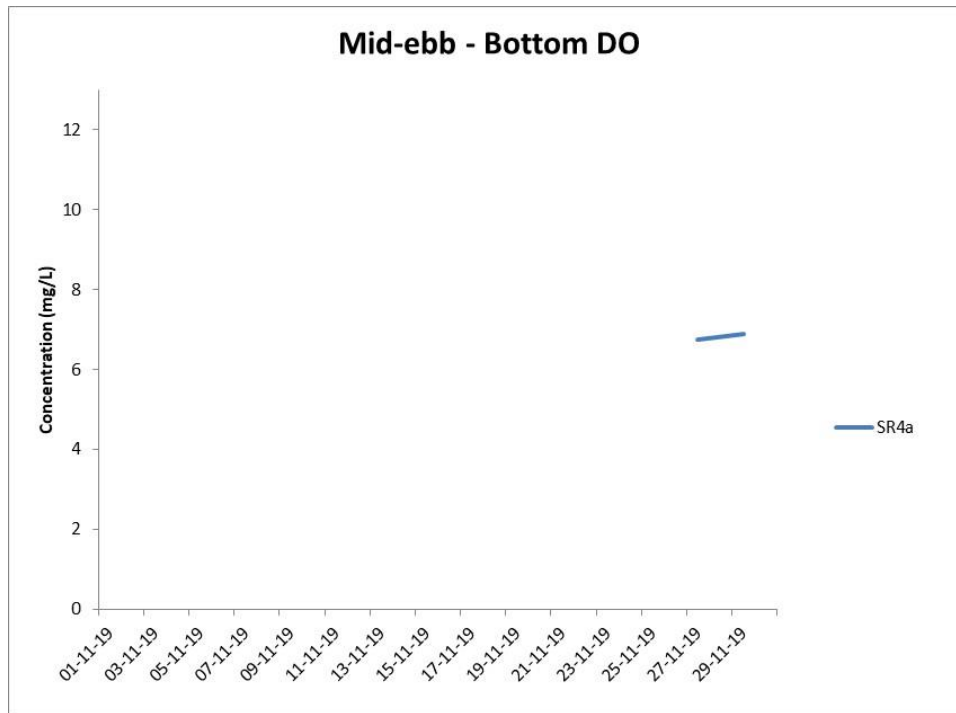
**Figure G14 Post-Construction Monitoring – Mean Level of Dissolved Oxygen (mg/L) in bottom waters during mid-ebb tide between 1 November 2019 and 30 November 2019 at SR4a.**

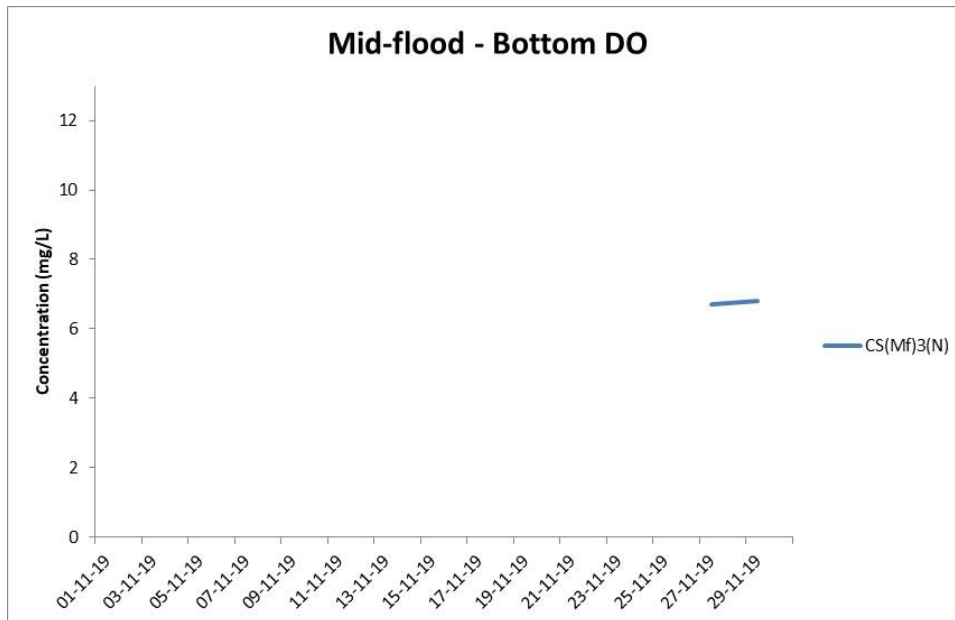
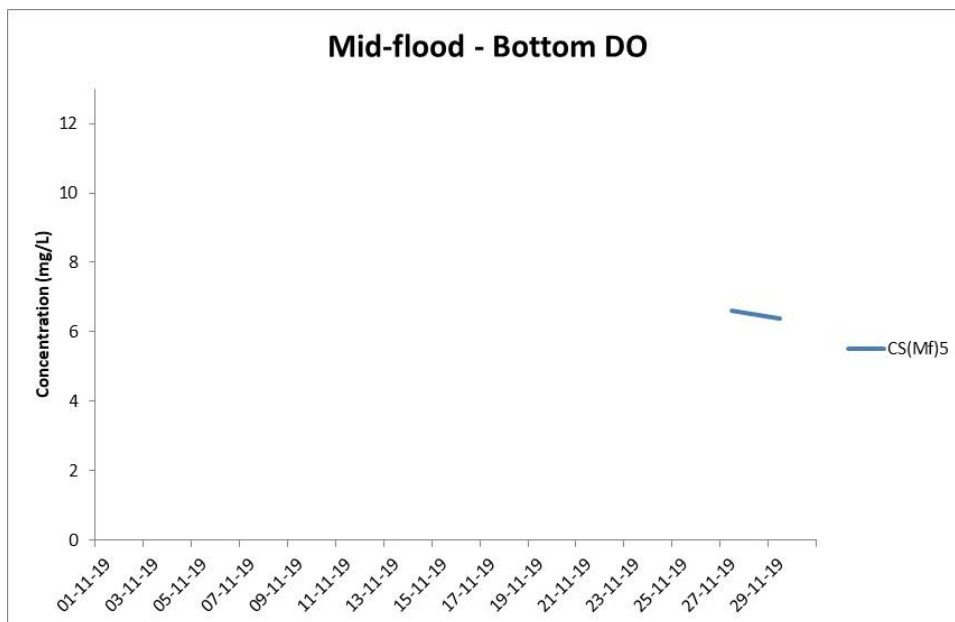
**Figure G15 Post-Construction Monitoring - Mean Level of Dissolved Oxygen (mg/L) in bottom waters during mid-flood tide between 1 November 2019 and 30 November 2019 at CS(Mf)3(N) and CS(Mf)5.**

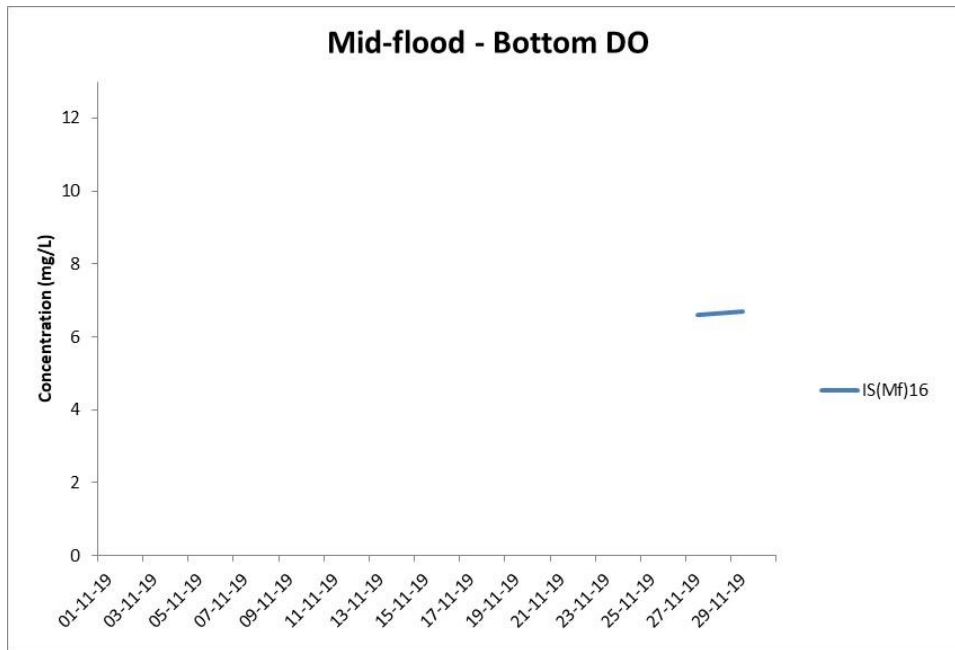
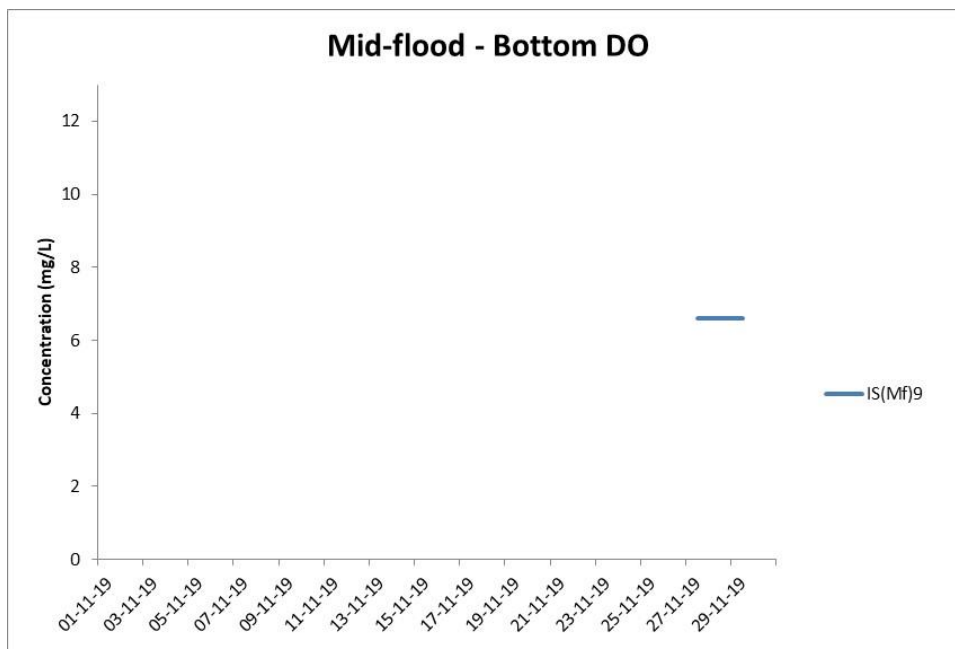
**Figure G16 Post-Construction Monitoring – Mean Level of Dissolved Oxygen (mg/L) in bottom waters during mid-flood tide between 1 November 2019 and 30 November 2019 at IS(Mf)16 and IS(Mf)9.**

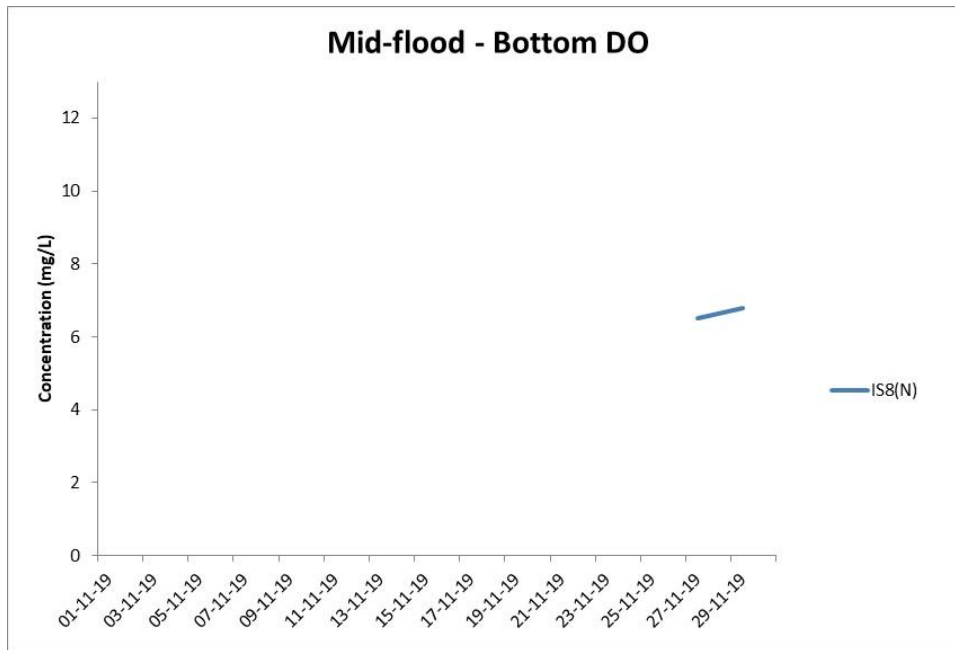
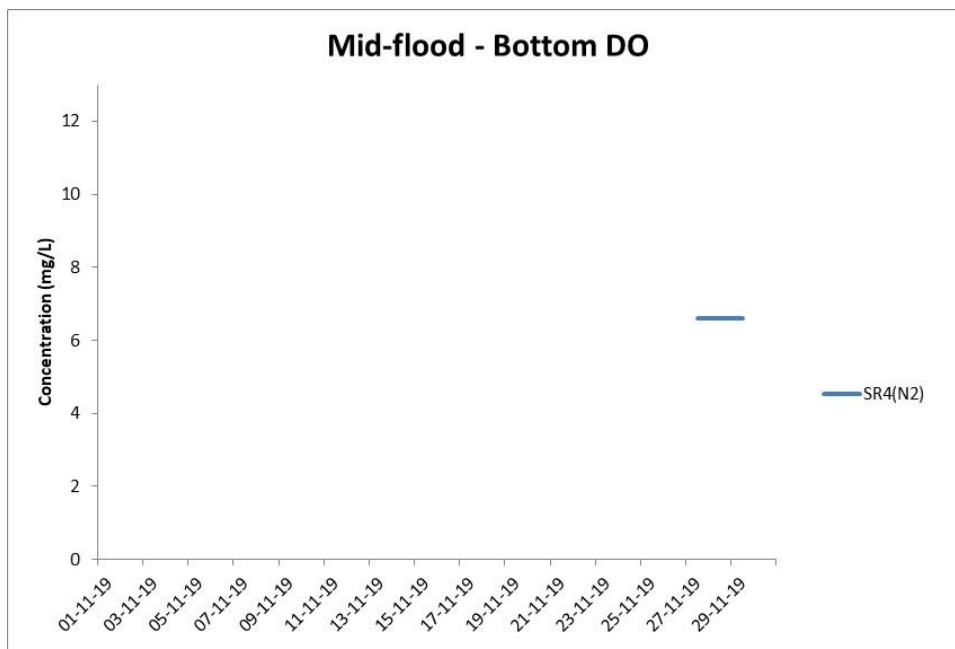
**Figure G17 Post-Construction Monitoring - Mean Level of Dissolved Oxygen (mg/L) in bottom waters during mid-flood tide between 1 November 2019 and 30 November 2019 at IS8(N) and SR4(N2).**

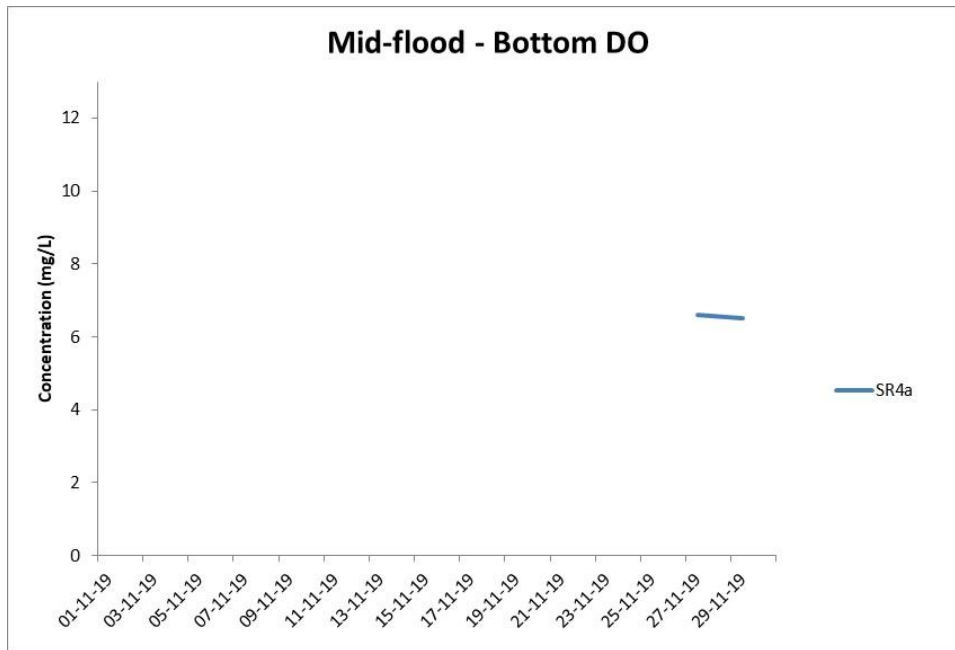
**Figure G18 Post-Construction Monitoring - Mean Level of Dissolved Oxygen (mg/L) in bottom waters during mid-flood tide between 1 November 2019 and 30 November 2019 at SR4a.**

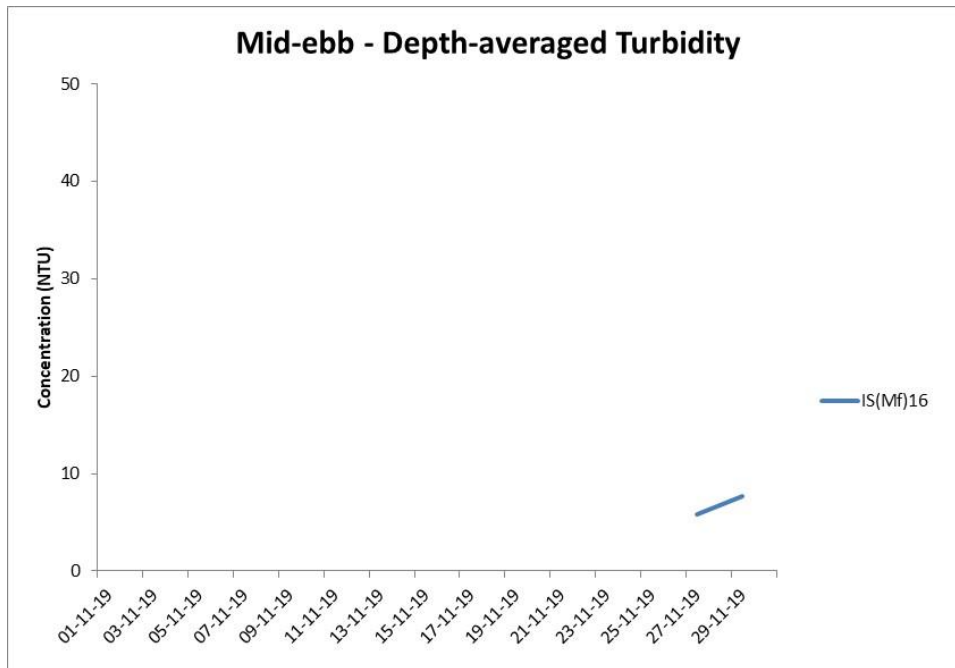
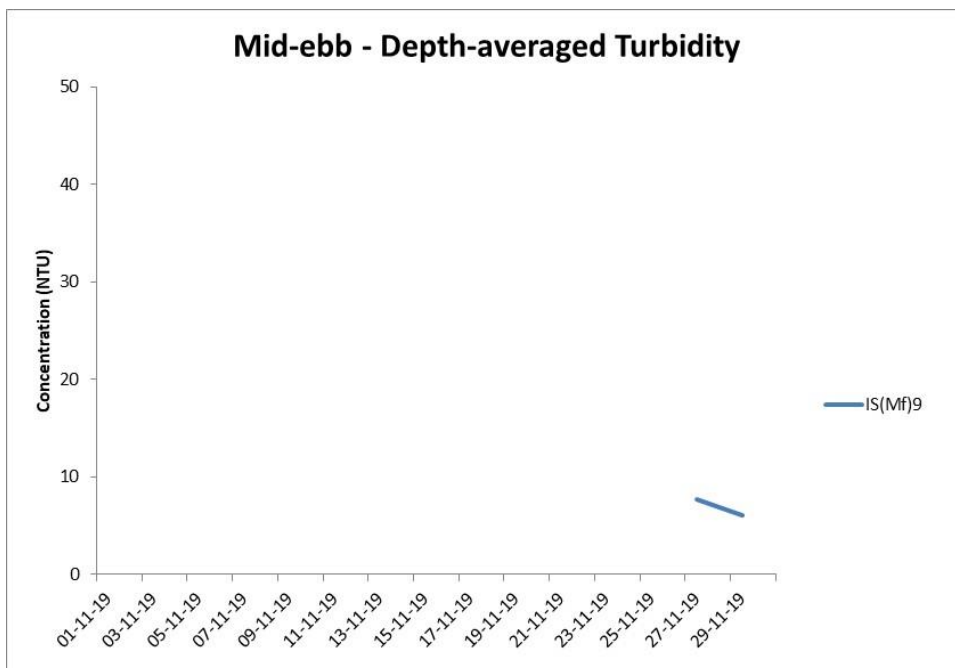
**Figure G20 Post-Construction Monitoring – Mean Level of depth-averaged Turbidity (NTU) during mid-ebb tide between 1 November 2019 and 30 November 2019 at IS(Mf)16 and IS(Mf)9.**

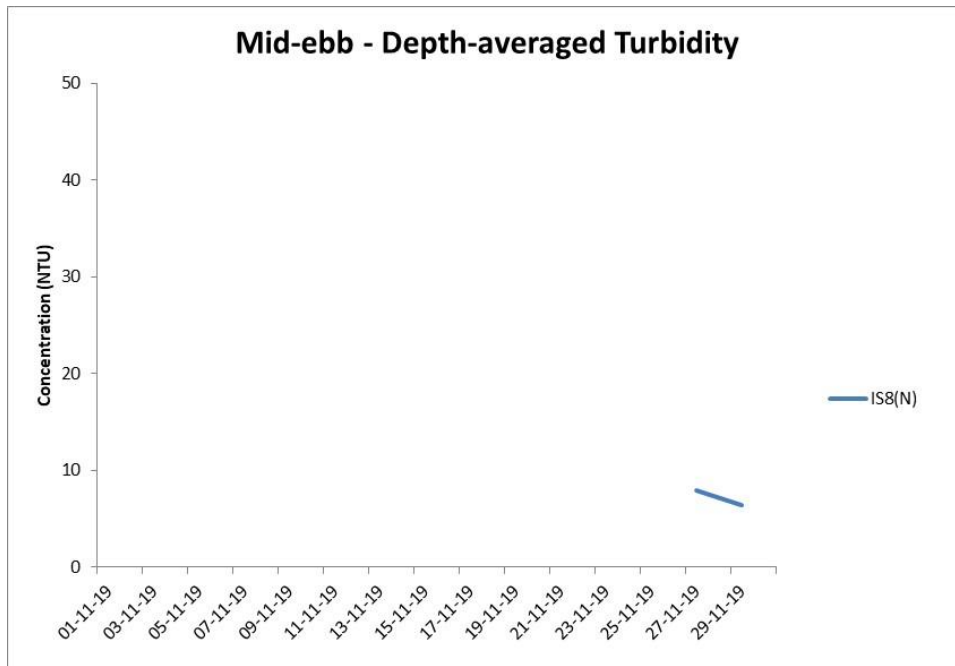
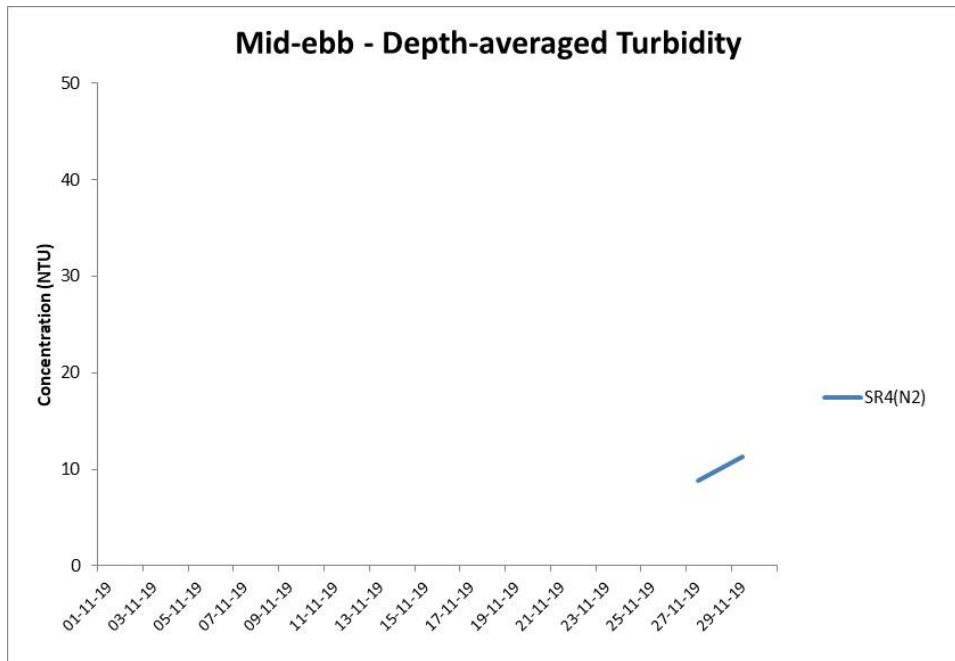
**Figure G21 Post-Construction Monitoring – Mean Level of depth-averaged Turbidity (NTU) during mid-ebb tide between 1 November 2019 and 30 November 2019 at IS8(N) and SR4(N2).**

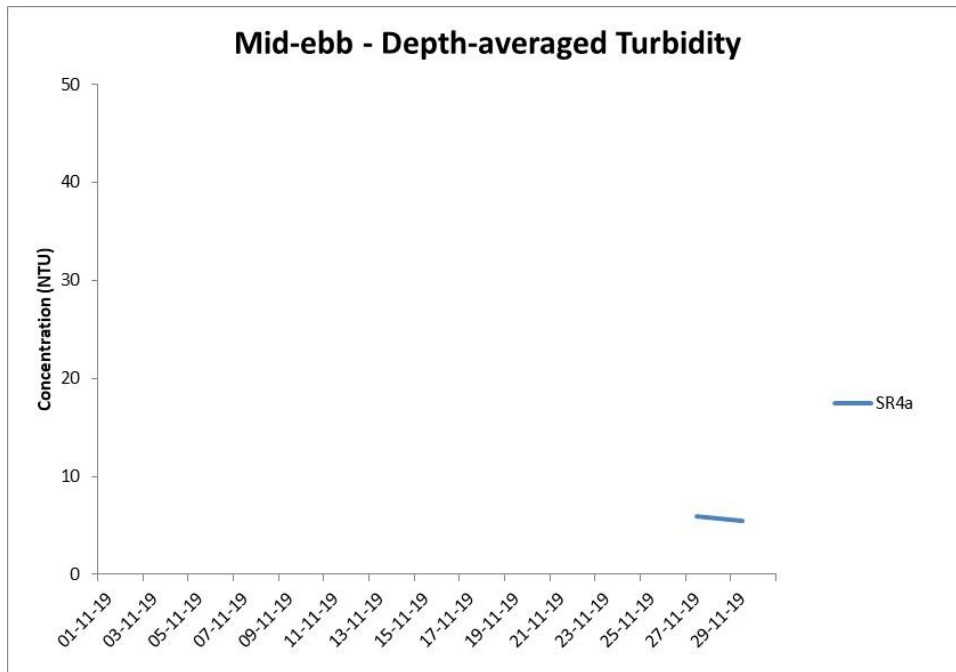
**Figure G22 Post-Construction Monitoring - Mean Level of depth-averaged Turbidity (NTU) during mid-ebb tide between 1 November 2019 and 30 November 2019 at SR4a.**

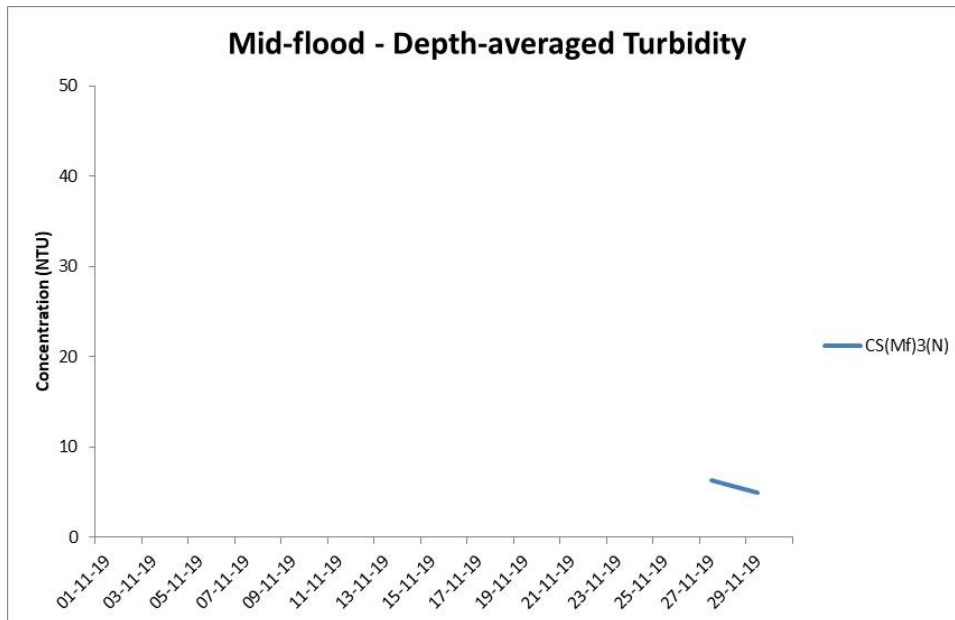
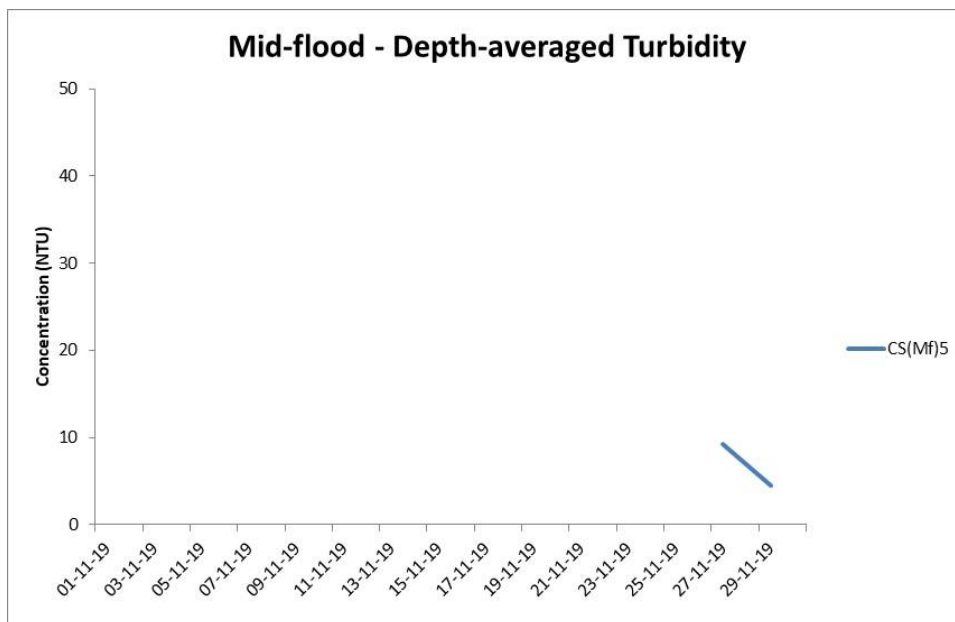
**Figure G23 Post-Construction Monitoring - Mean Level of depth-averaged Turbidity (NTU) during mid-flood tide between 1 November 2019 and 30 November 2019 at CS(Mf)3(N) and CS(MF)5.**

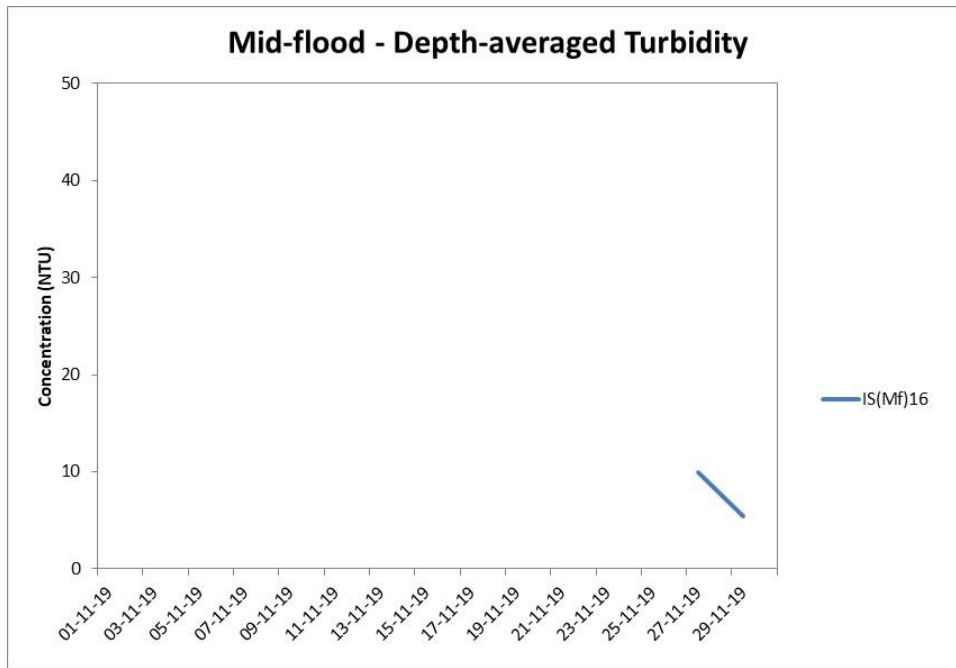
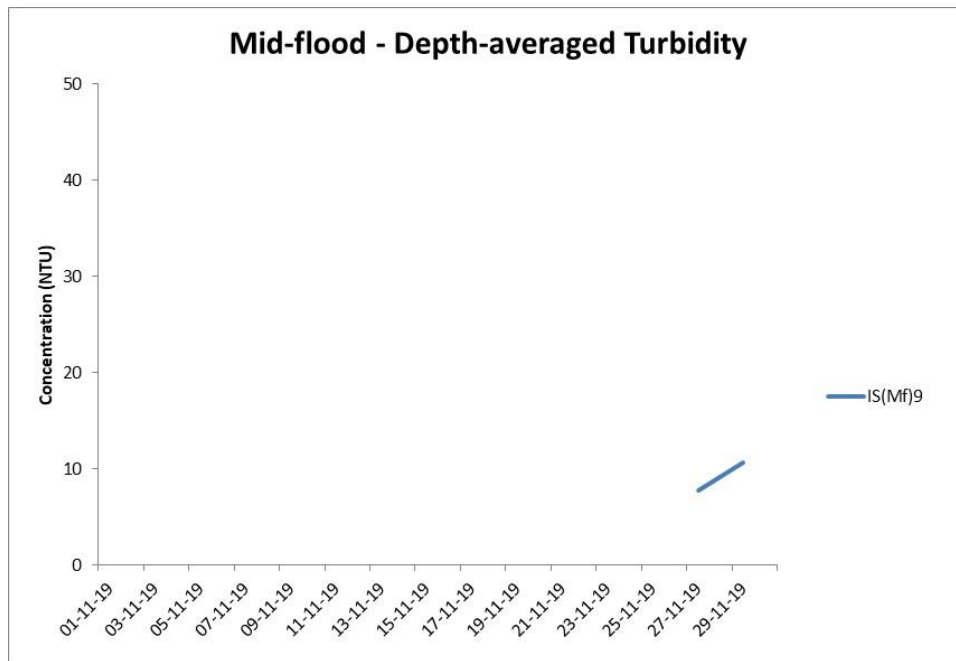
**Figure G24 Post-Construction Monitoring – Mean Level of depth-averaged Turbidity (NTU) during mid-flood tide between 1 November 2019 and 30 November 2019 at IS(Mf)16 and IS(Mf)9.**

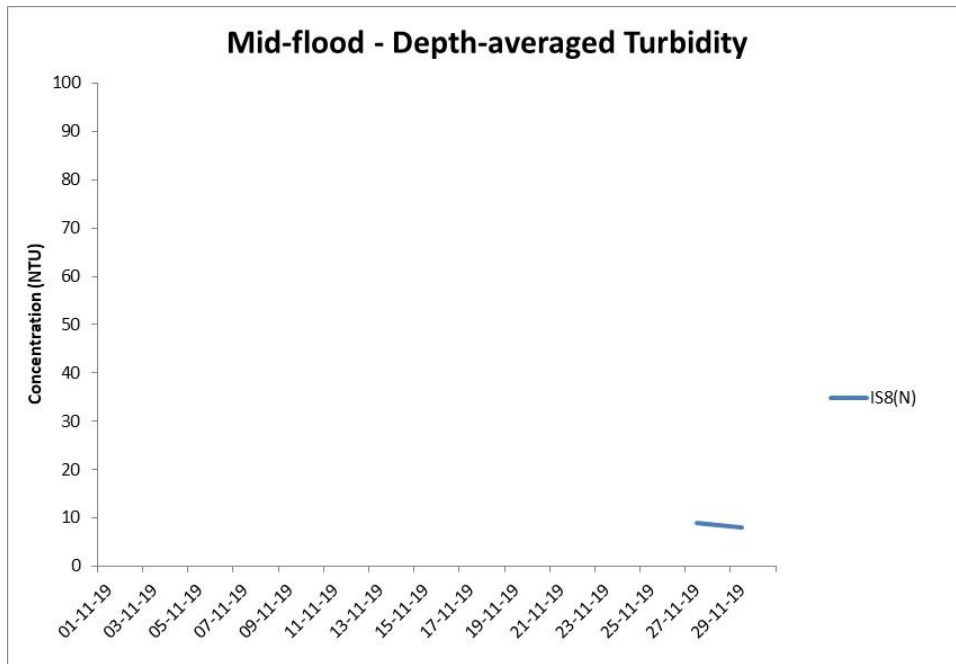
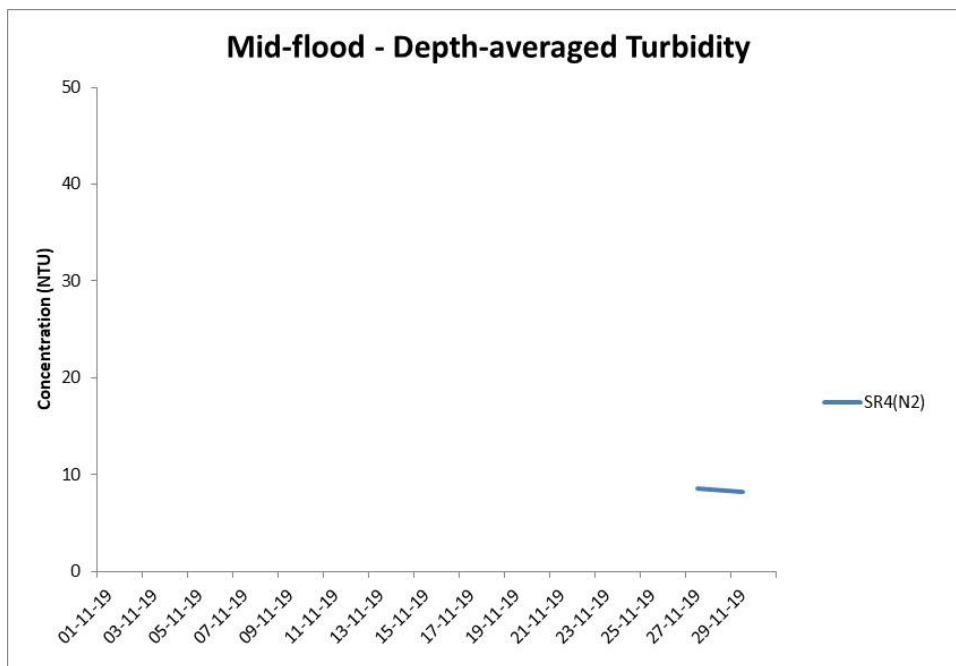
**Figure G25 Post-Construction Monitoring - Mean Level of depth-averaged Turbidity (NTU) during mid-flood tide between 1 November 2019 and 30 November 2019 at IS8(N) and SR4(N2).**

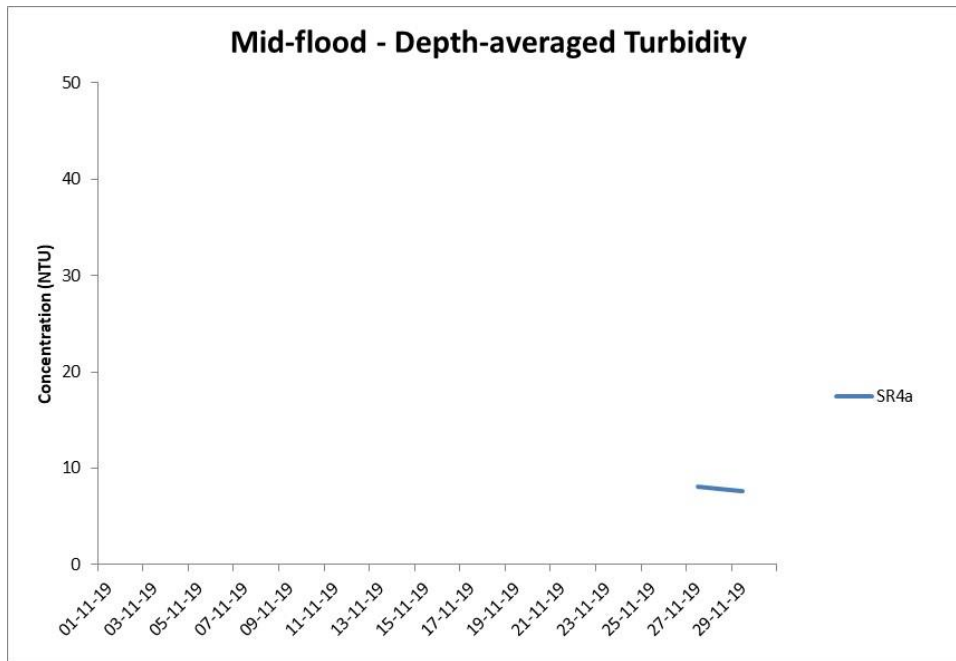
**Figure G26 Post-Construction Monitoring - Mean Level of depth-averaged Turbidity (NTU) during mid-flood tide between 1 November 2019 and 30 November 2019 at SR4a.**

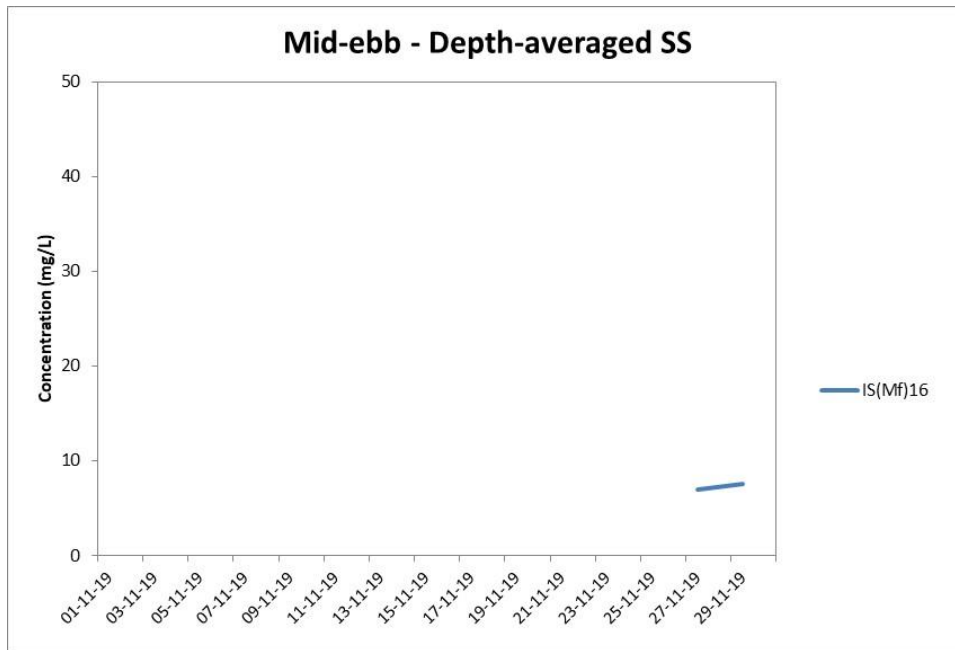
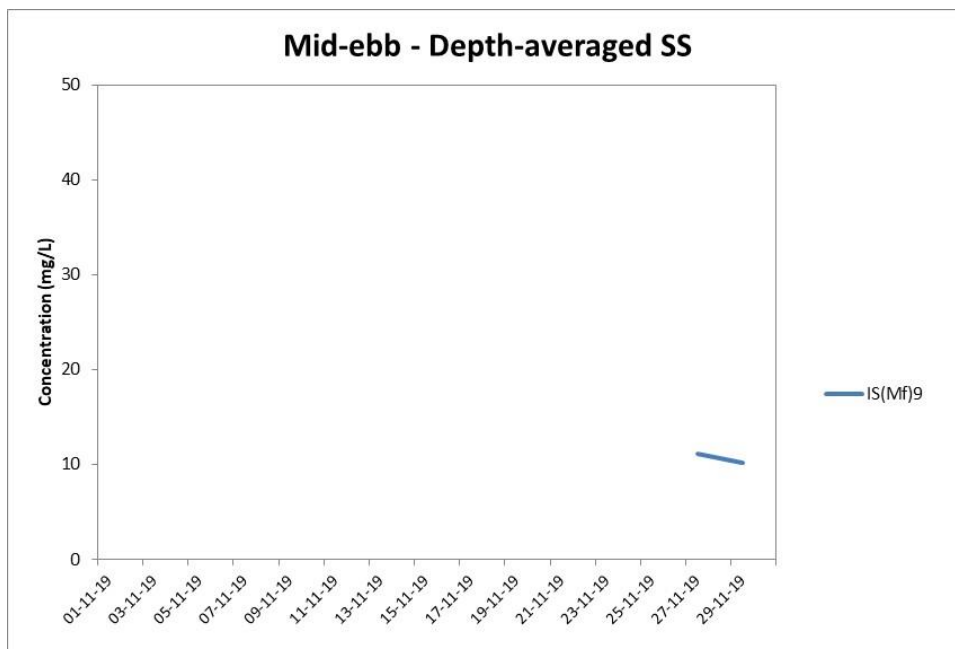
**Figure G28 Post-Construction Monitoring - Mean depth-averaged level of Suspended Solids (mg/L) during mid-ebb tide between 1 November 2019 and 30 November 2019 at IS(Mf)16 and IS(Mf)9.**

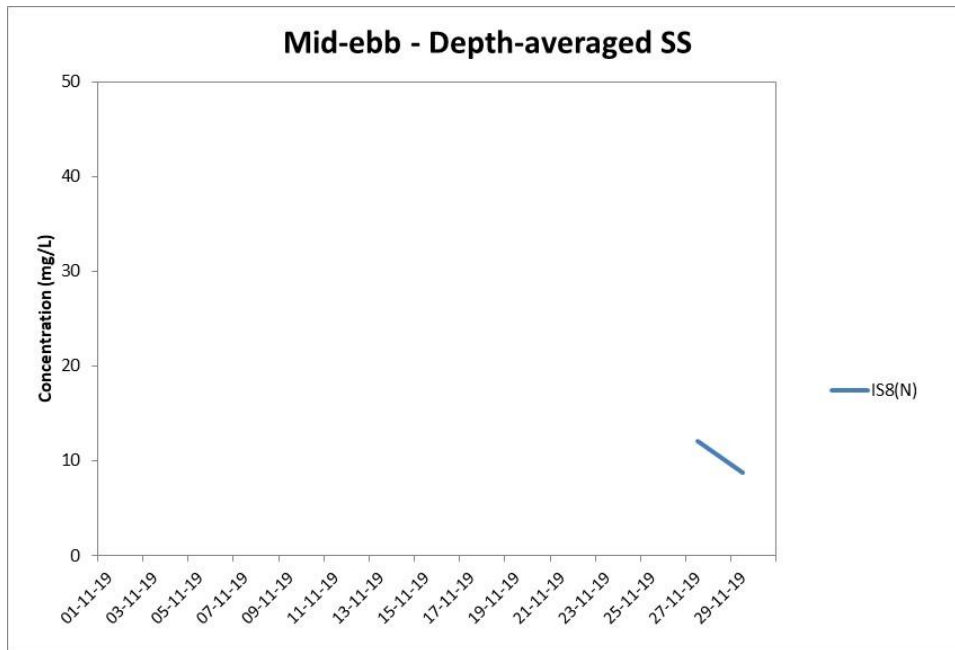
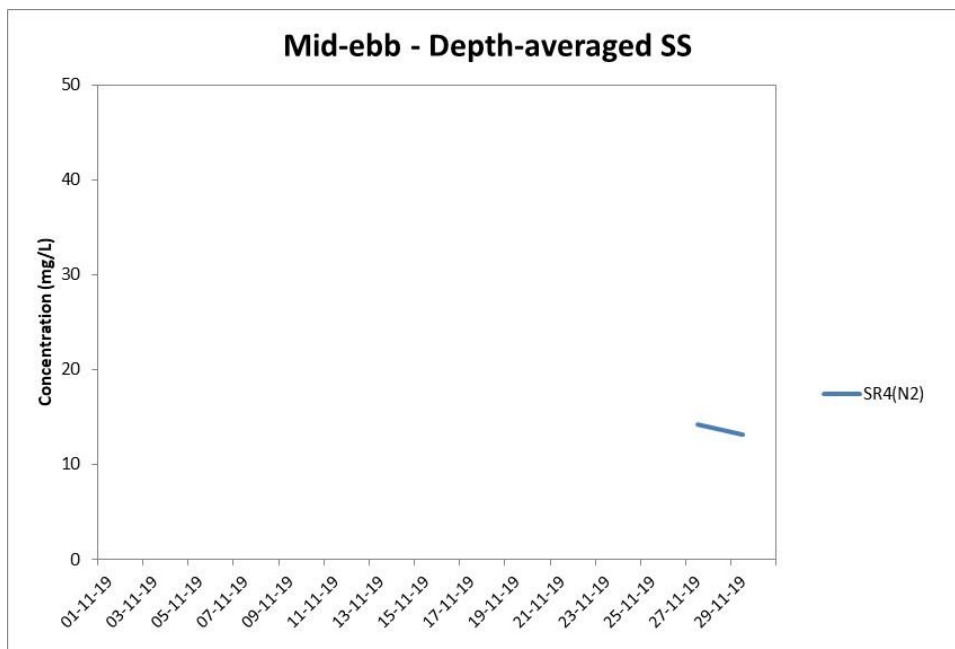
**Figure G29 Post-Construction Monitoring - Mean depth-averaged level of Suspended Solids (mg/L) during mid-ebb tide between 1 November 2019 and 30 November 2019 at IS8(N) and SR4(N2).**

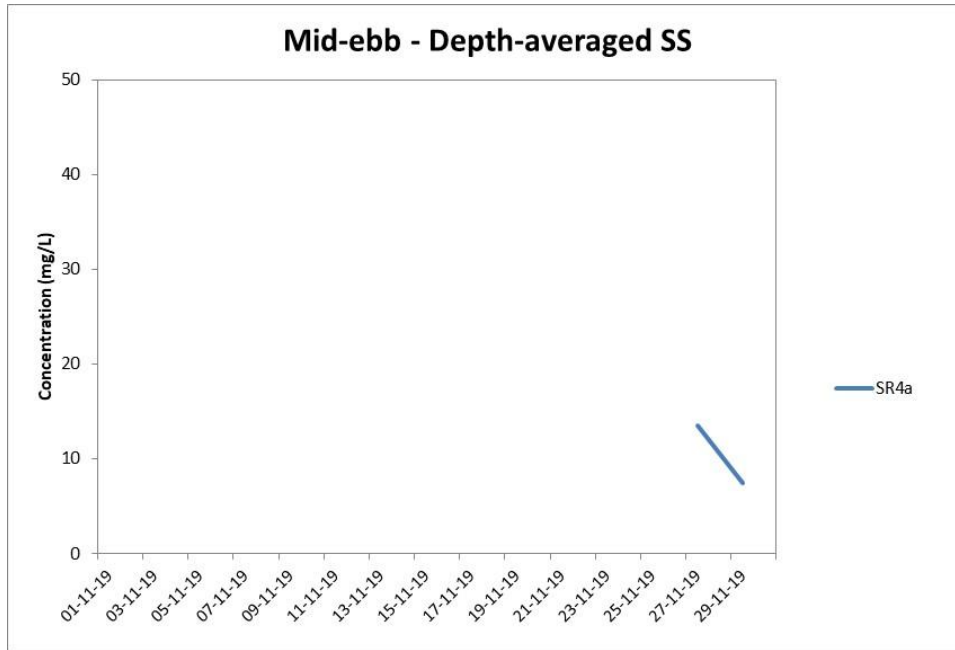
**Figure G30 Post-Construction Monitoring - Mean depth-averaged level of Suspended Solids (mg/L) during mid-ebb tide between 1 November 2019 and 30 November 2019 at SR4a.**

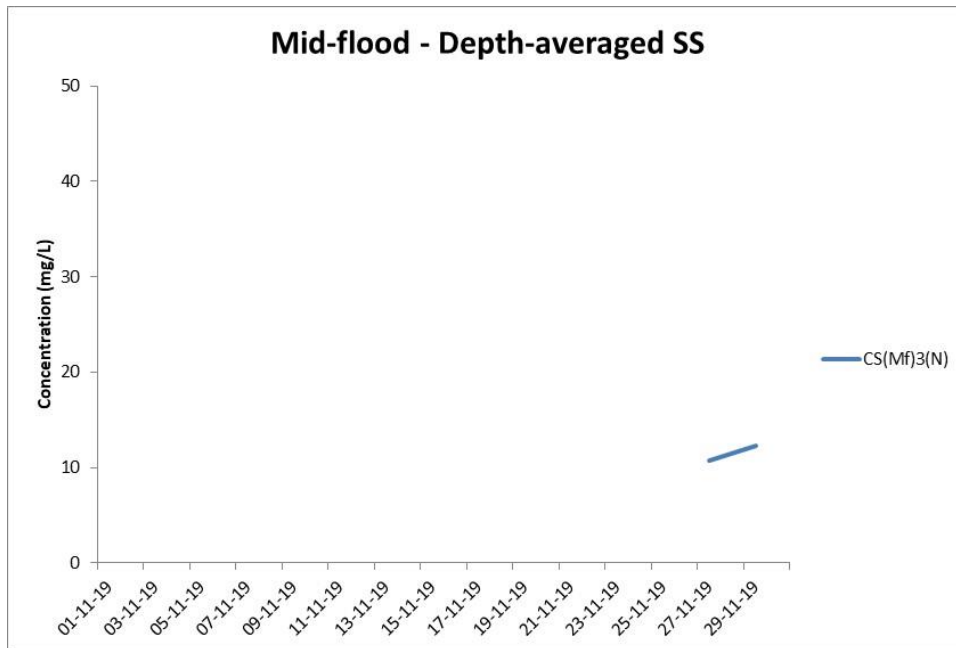
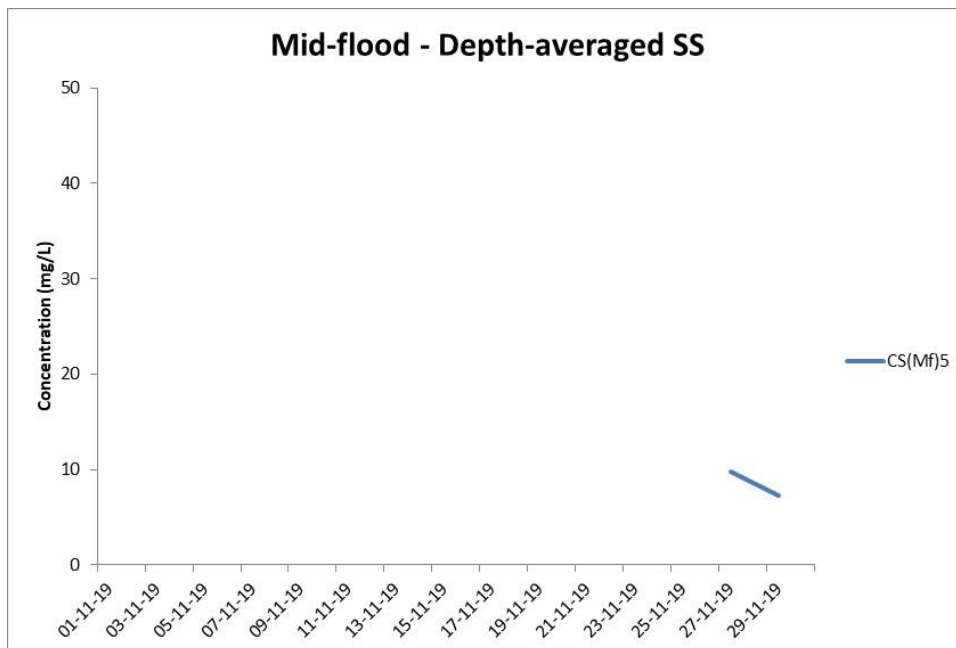
**Figure G31 Post-Construction Monitoring - Mean depth-averaged level of Suspended Solids (mg/L) during mid-flood tide between 1 November 2019 and 30 November 2019 at CS(Mf)3(N) and CS(Mf)5.**

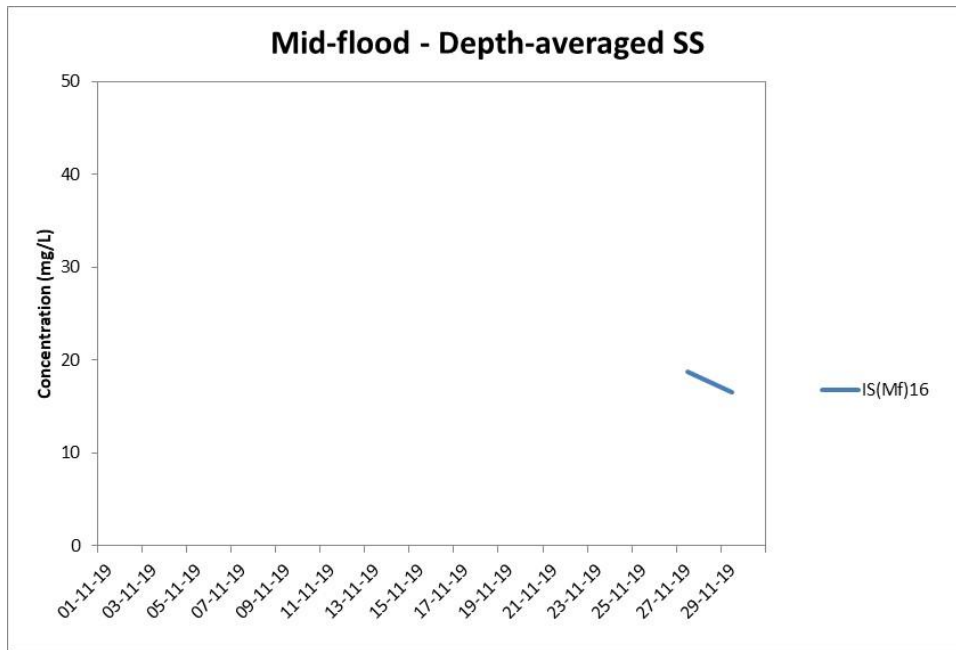
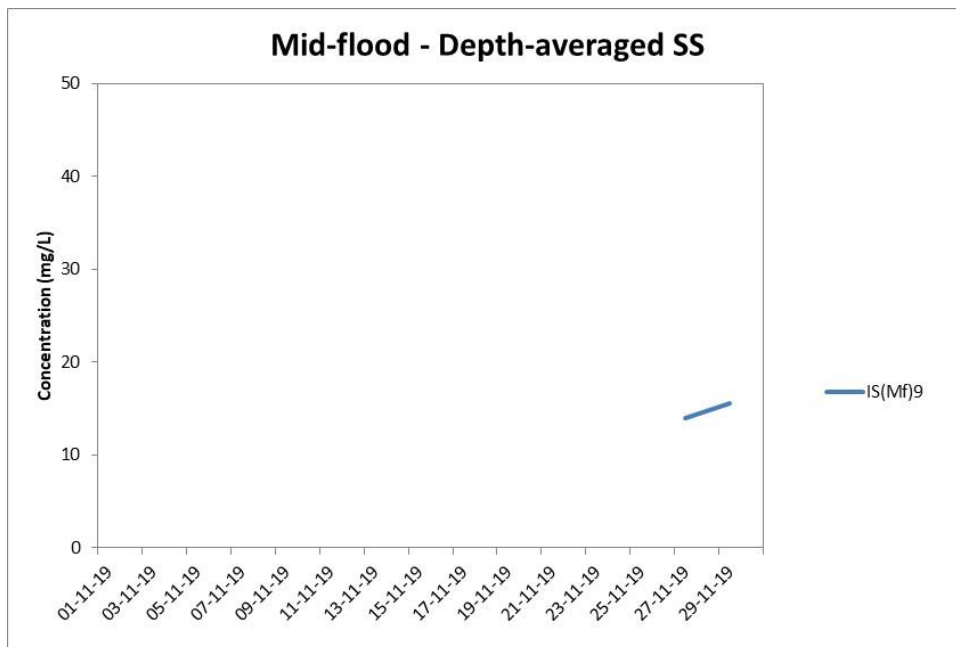
**Figure G32 Post-Construction Monitoring - Mean depth-averaged level of Suspended Solids (mg/L) during mid-flood tide between 1 November 2019 and 30 November 2019 at IS(Mf)16 and IS(Mf)9.**

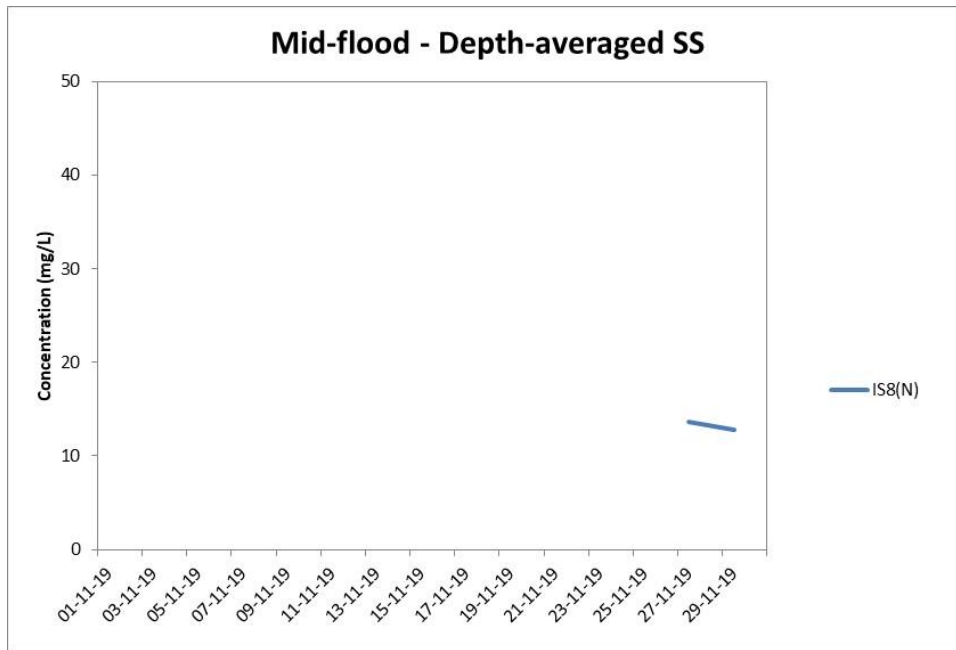
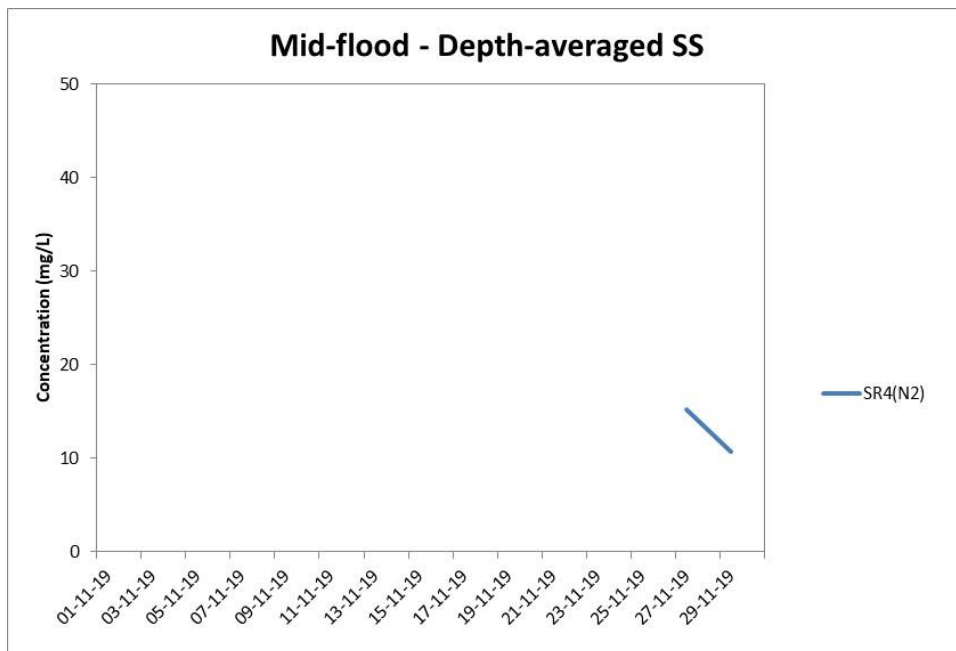
**Figure G33 Post-Construction Monitoring - Mean depth-averaged level of Suspended Solids (mg/L) during mid-flood tide between 1 November 2019 and 30 November 2019 at IS8(N) and SR4(N2).**

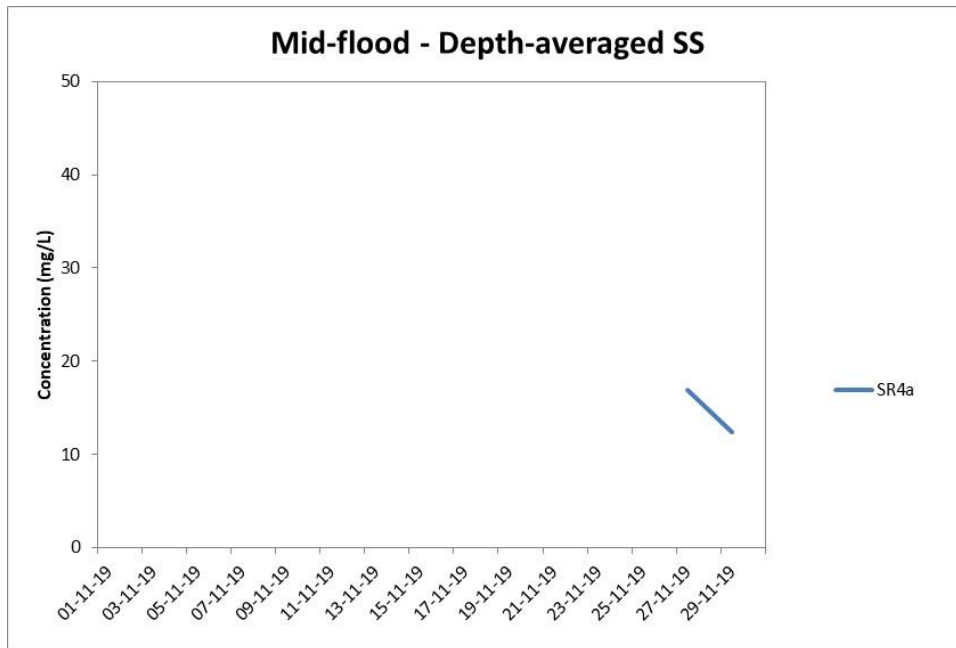
**Figure G34 Post-Construction Monitoring – Mean depth-averaged level of Suspended Solids (mg/L) during mid-flood tide between 1 November 2019 and 30 November 2019 at SR4a.**
