**Contract No. HY/2012/07
Tuen Mun – Chek Lap Kok Link –
Southern Connection Viaduct Section**

*Seventh Quarterly Environmental Monitoring &
Audit (EM&A) Report*

19 January 2016

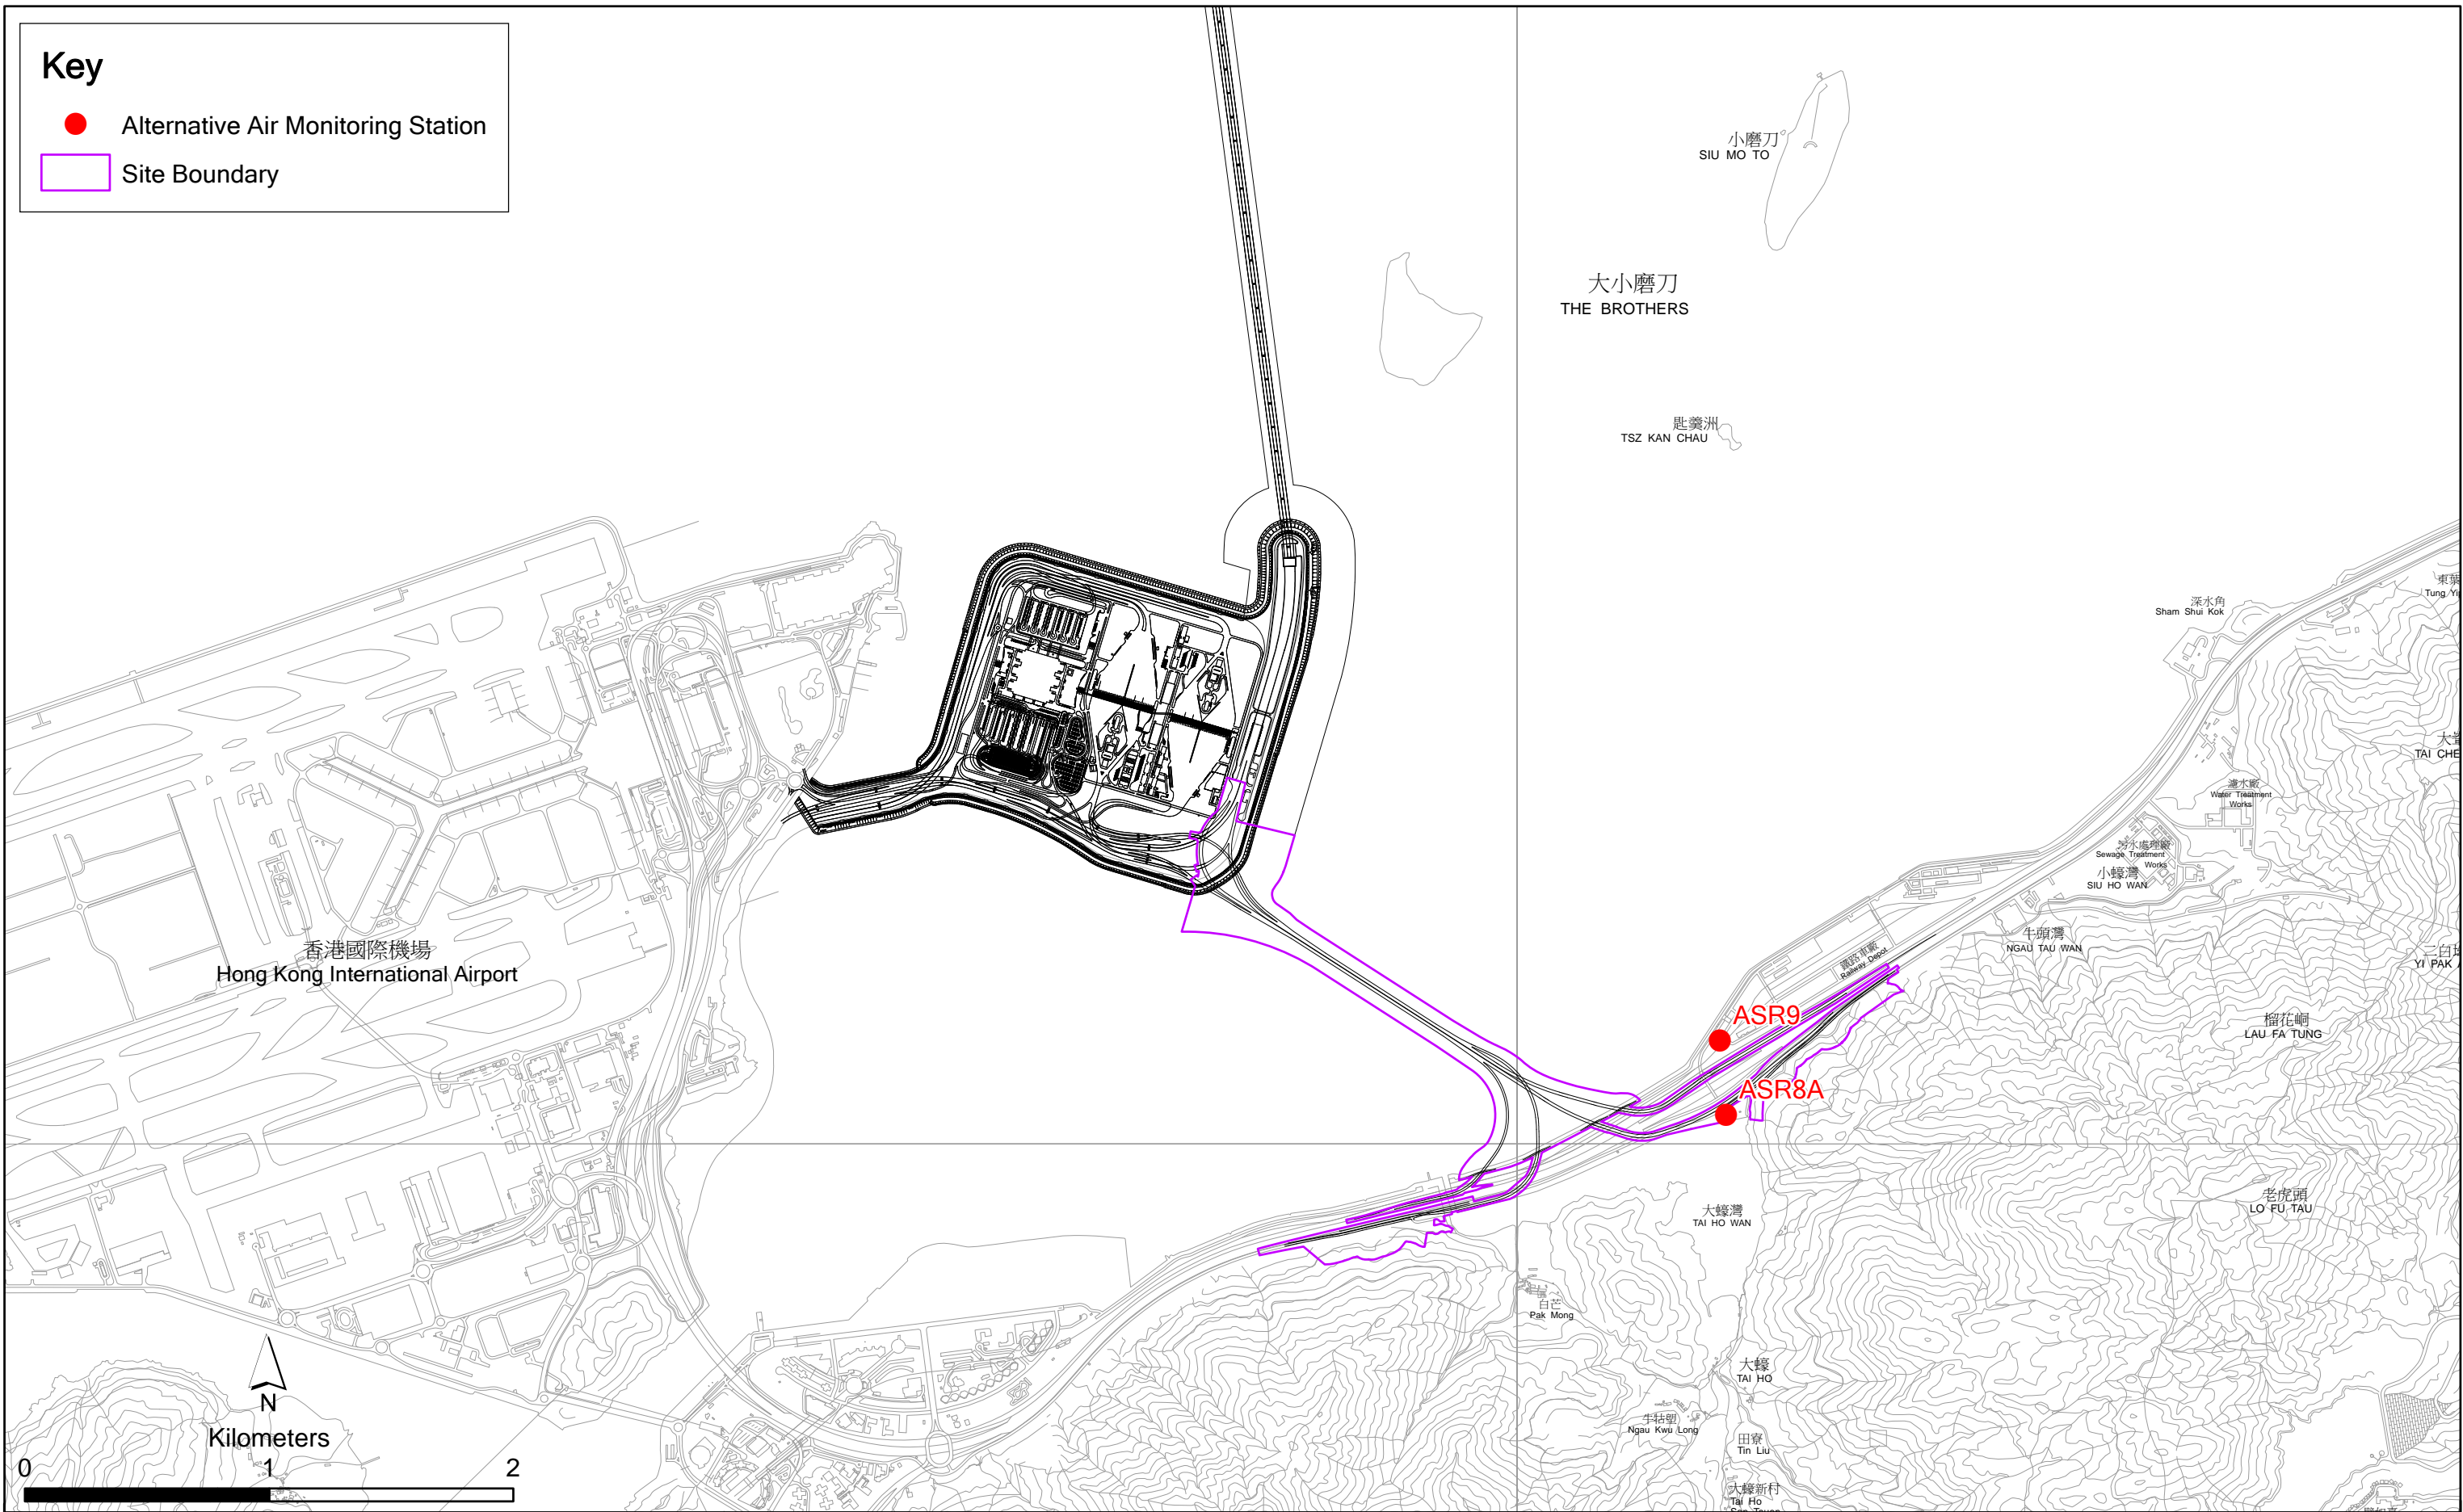
Figure 2.1

Locations of Air Quality Monitoring Stations

Wind data monitoring equipment was installed at Area 4 during the reporting period for logging wind speed and wind direction. The wind sensor was setup such that it was clear of obstructions or turbulence caused by building. The wind data monitoring equipment is recalibrated at least once every six months.

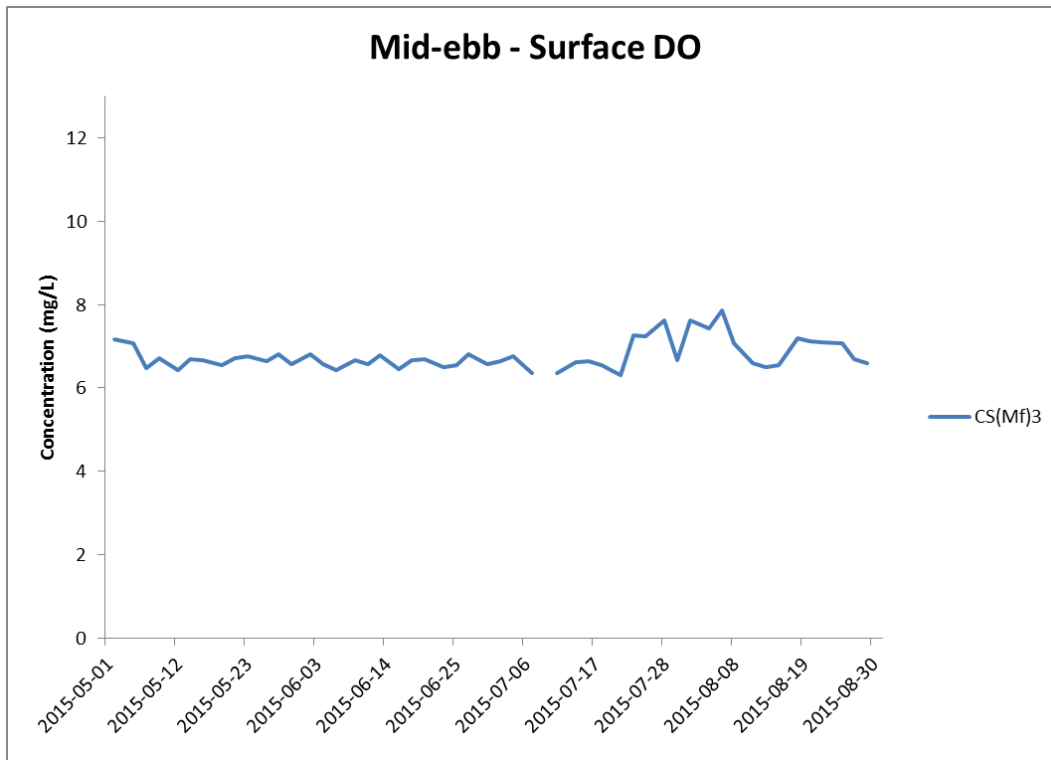
Figure H1 Impact Monitoring - Mean Level of Dissolved Oxygen (mg/L) in surface waters during mid-ebb tide between 1 May and 31 August 2015 at CS(Mf)3 and CS(Mf)5.

WQM was cancelled on 9 July 2015 due to adverse weather. (Weather condition varied between sunny to rainy within the reporting period.

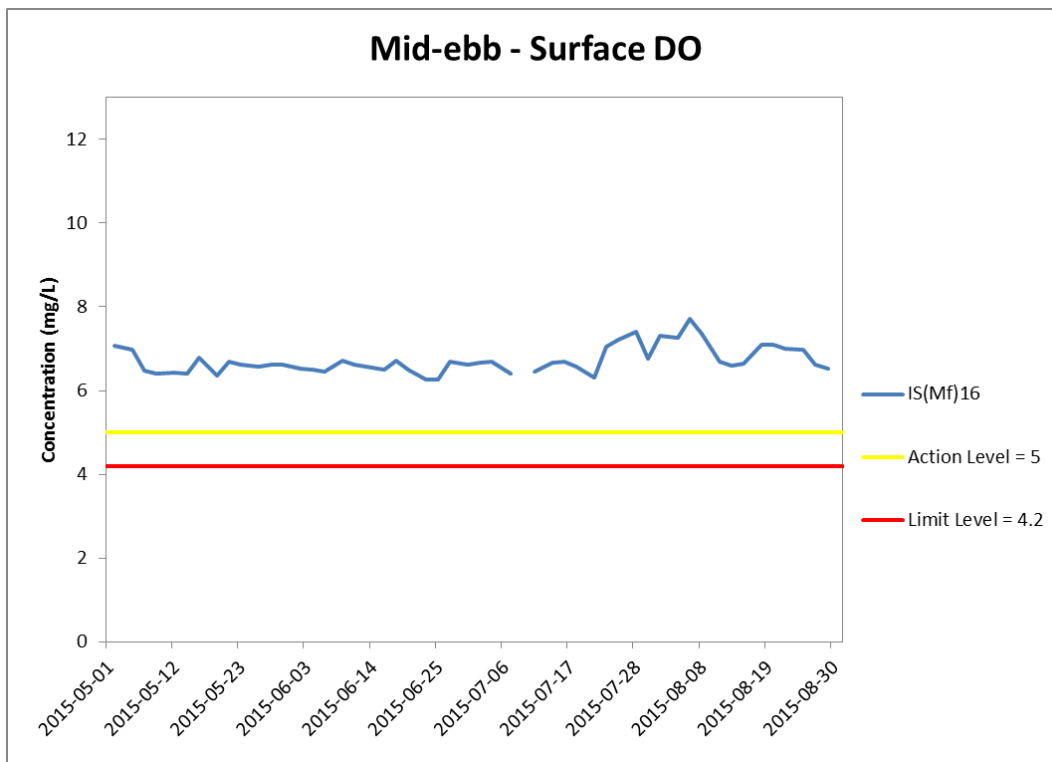
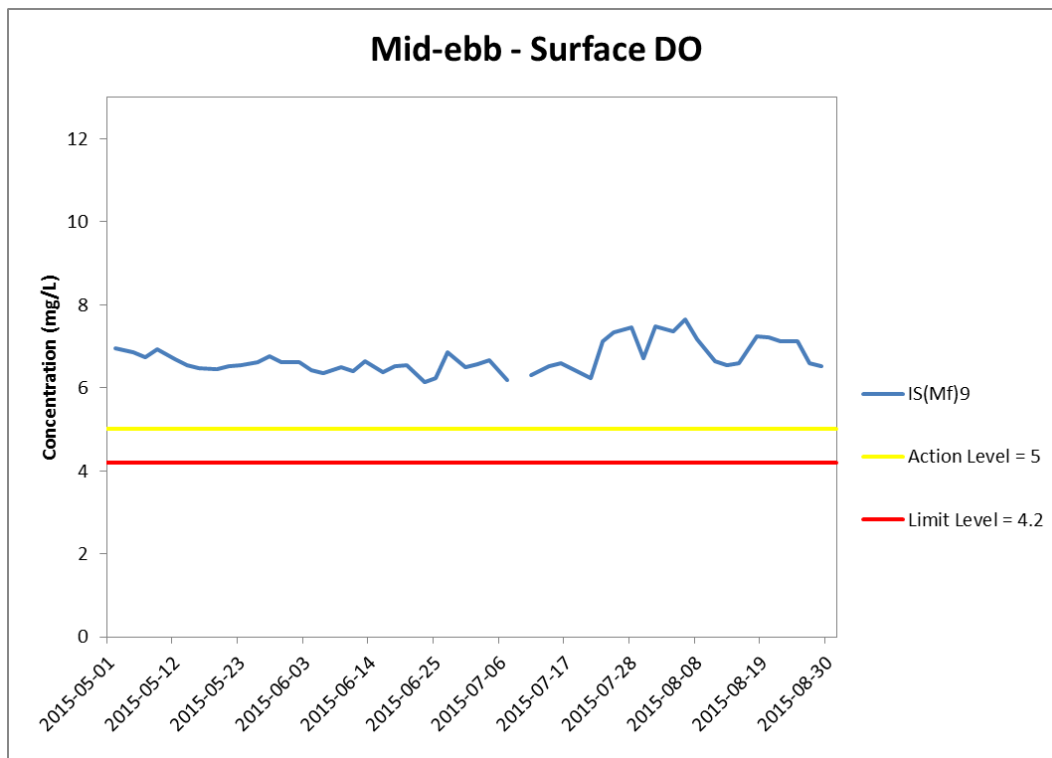
Figure H2 Impact Monitoring - Mean Level of Dissolved Oxygen (mg/L) in surface waters during mid-ebb tide between 1 May and 31 August 2015 at IS(Mf)16 and IS(Mf)9.

WQM was cancelled on 9 July 2015 due to adverse weather. (Weather condition varied between sunny to rainy within the reporting period.)

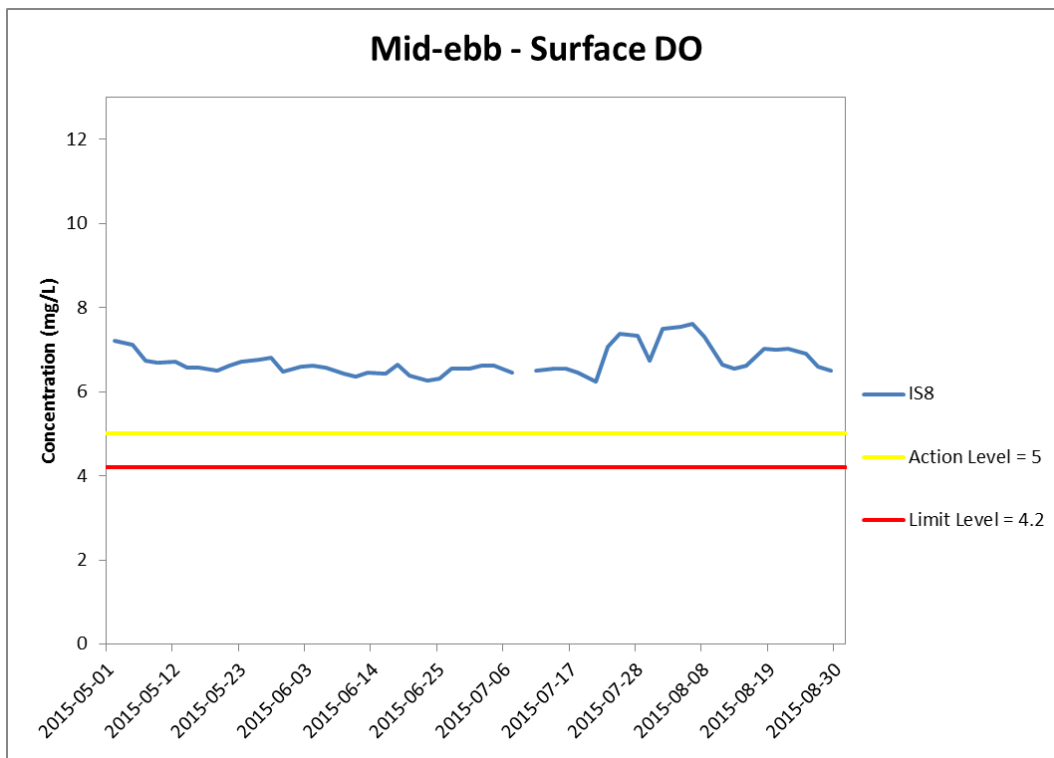
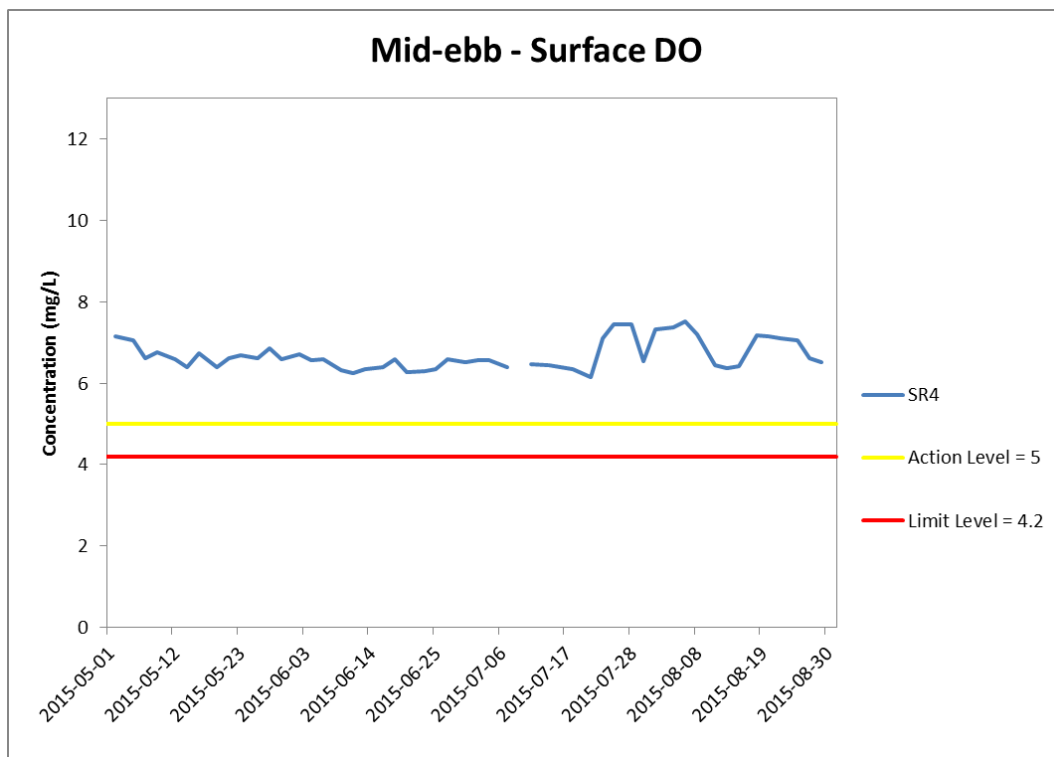
Figure H3 Impact Monitoring – Mean Level of Dissolved Oxygen (mg/L) in surface waters during mid-ebb tide between 1 May and 31 August 2015 at IS8 and SR4.

WQM was cancelled on 9 July 2015 due to adverse weather. (Weather condition varied between sunny to rainy within the reporting period.)
 Marine works within the reporting period include Construction and installation of pile caps; Uninstallation of marine piling platform; Pier head segment installation; Pile cap installation; Pier construction; Launching gantry assembly and marine

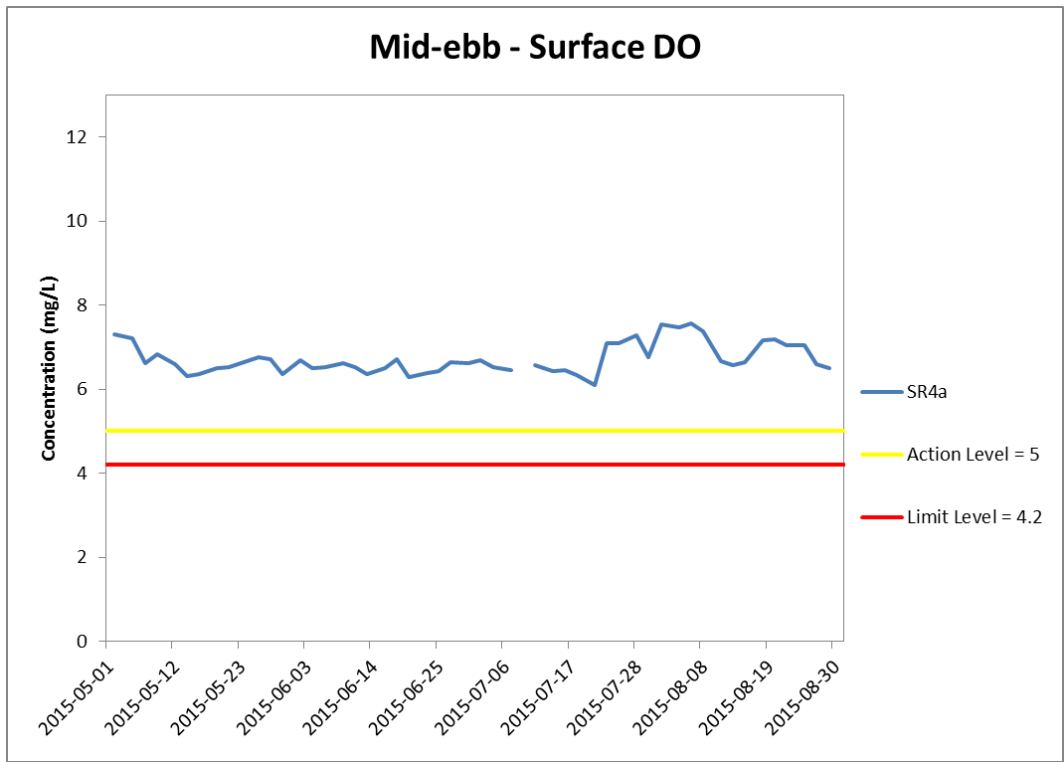
Figure H4 Impact Monitoring - Mean Level of Dissolved Oxygen (mg/L) in surface waters during mid-ebb tide between 1 May and 31 August 2015 at SR4a.

WQM was cancelled on 9 July 2015 due to adverse weather. (Weather condition varied between sunny to rainy within the reporting period.)

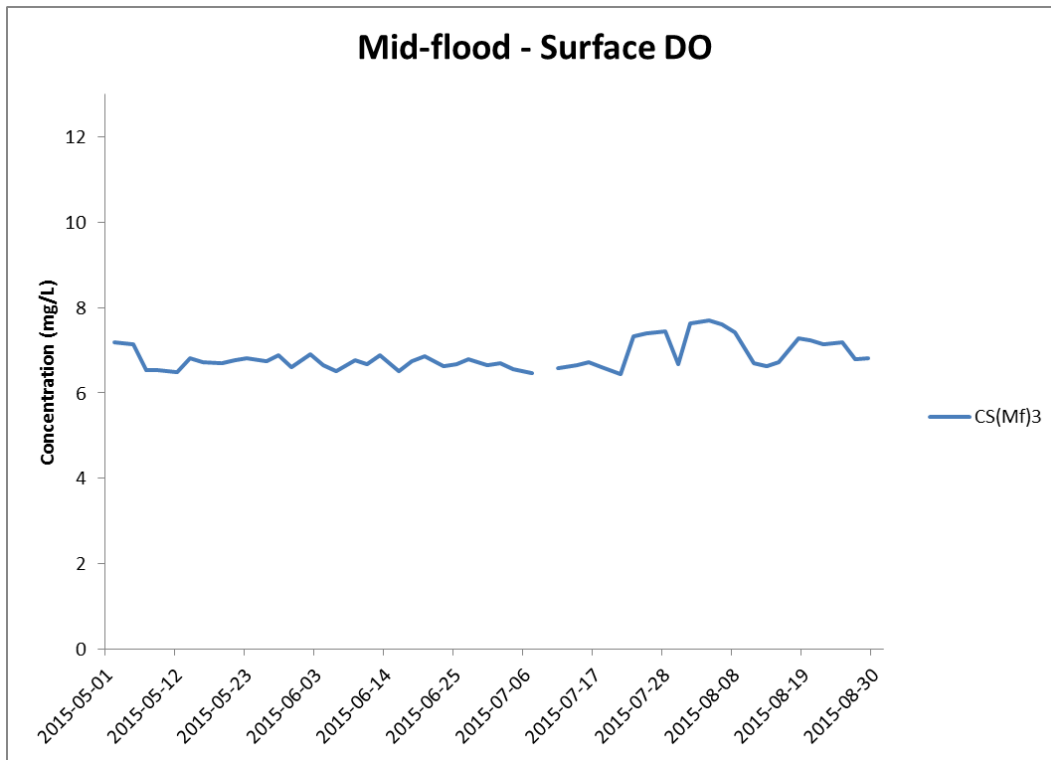
Figure H5 Impact Monitoring - Mean Level of Dissolved Oxygen (mg/L) in surface waters during mid-flood tide between 1 May and 31 August 2015 at CS(Mf)3 and CS(Mf)5.

WQM was cancelled on 9 July 2015 due to adverse weather. (Weather condition varied between sunny to rainy within the reporting period.)
 Marine works within the reporting period include Construction and installation of pile caps; Uninstallation of marine piling platform; Pier head segment installation; Pile cap installation; Pier construction; Launching gantry assembly and marine piling)

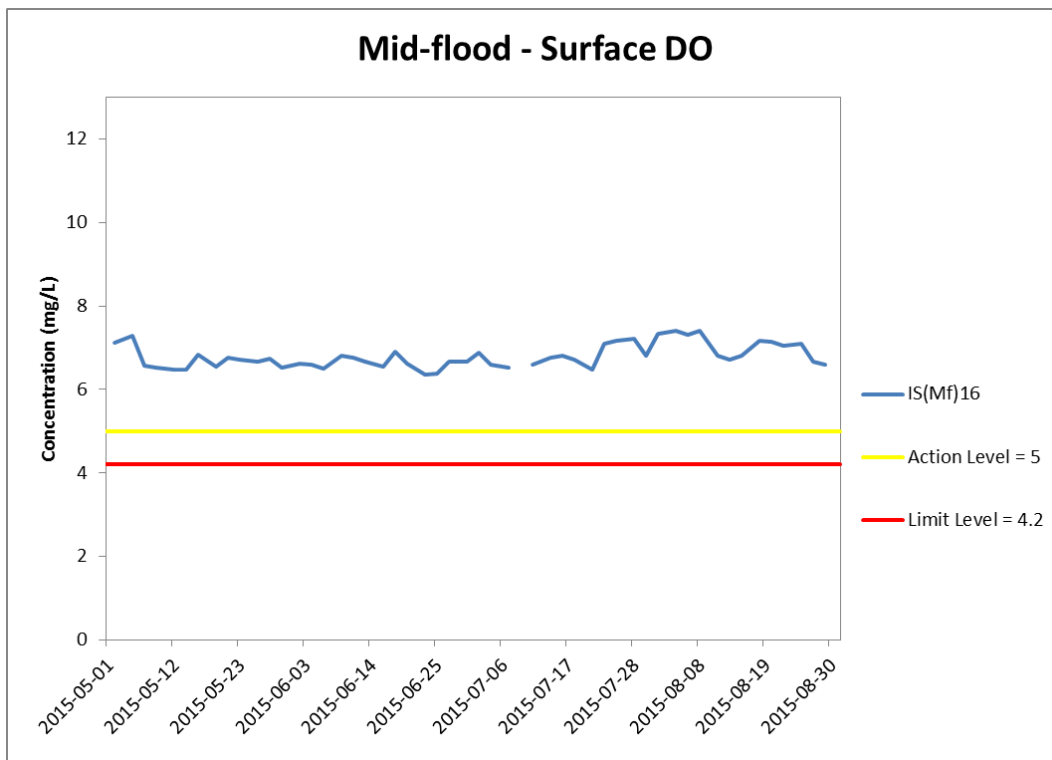
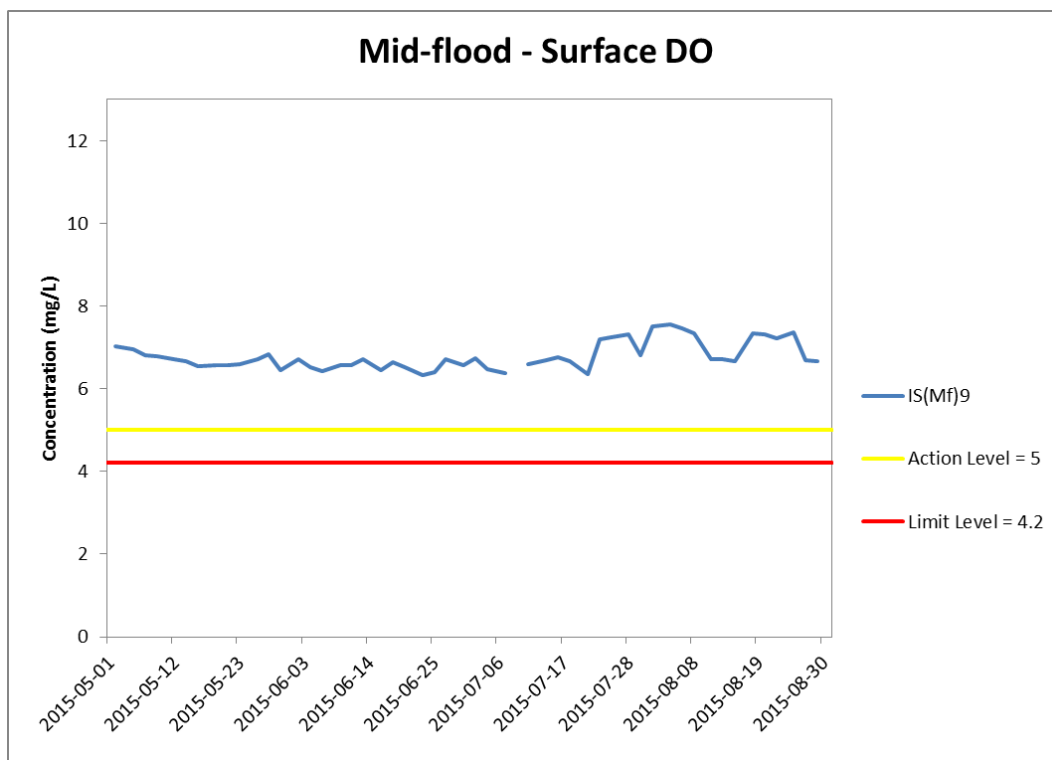
Figure H6 Impact Monitoring - Mean Level of Dissolved Oxygen (mg/L) in surface waters during mid-flood tide between 1 May and 31 August 2015 at IS(Mf)16 and IS(Mf)9.

WQM was cancelled on 9 July 2015 due to adverse weather. (Weather condition varied between sunny to rainy within the reporting period.)

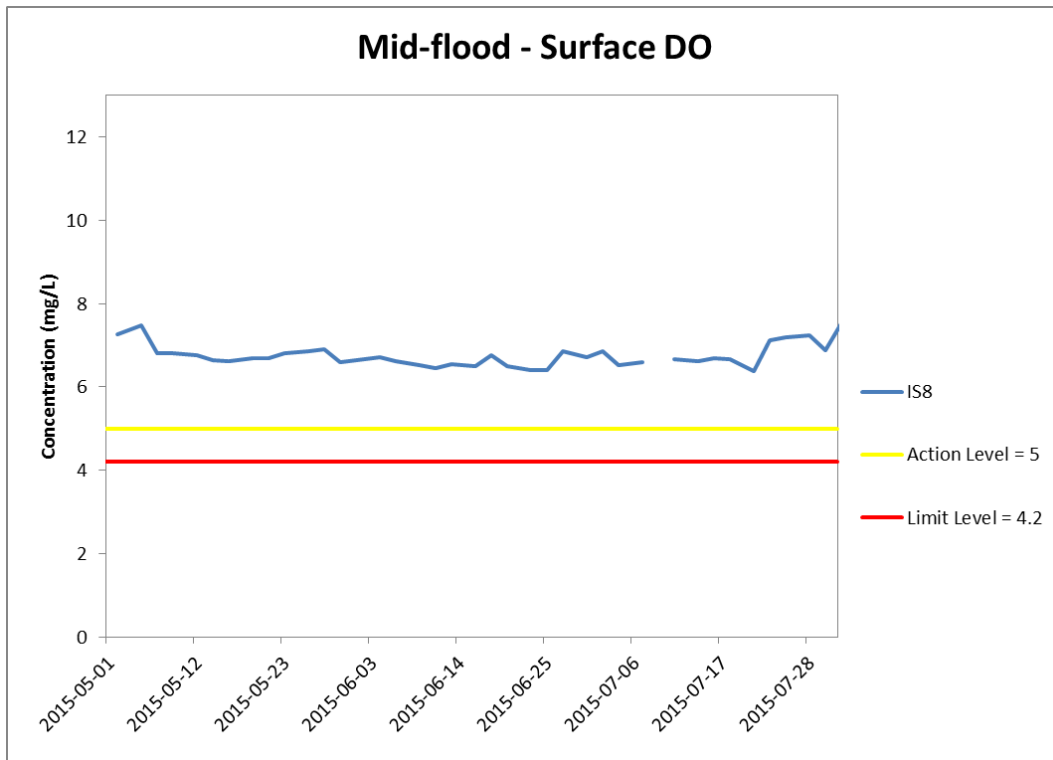
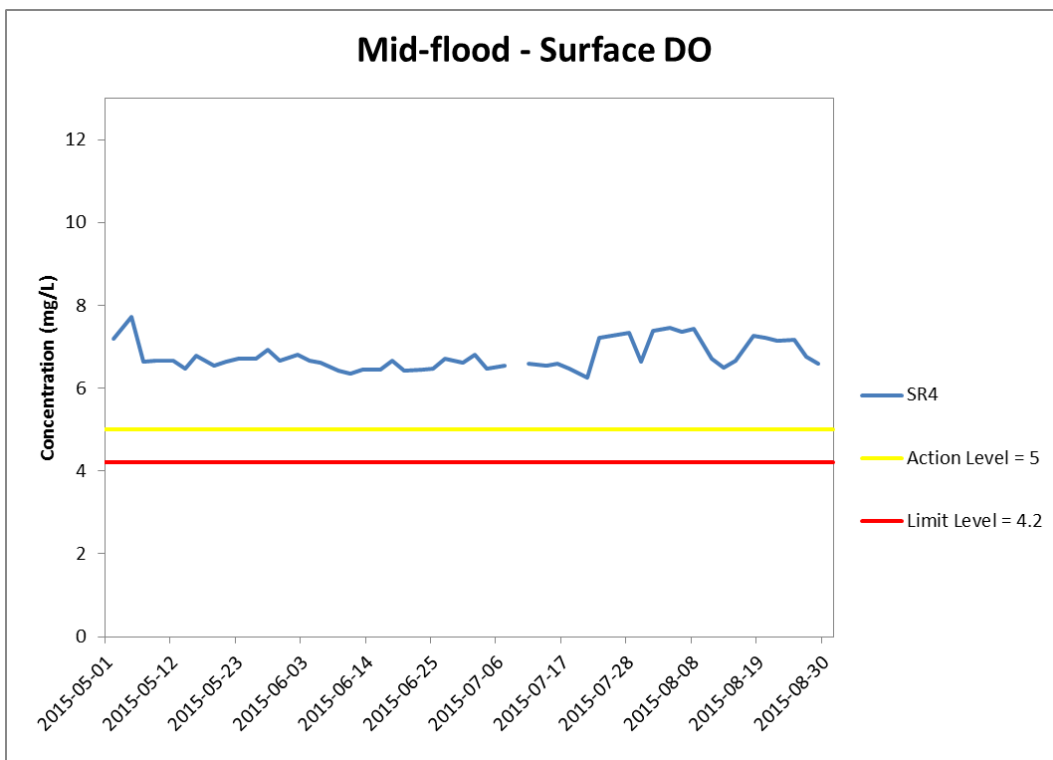
Figure H7 Impact Monitoring - Mean Level of Dissolved Oxygen (mg/L) in surface waters during mid-flood tide between 1 May and 31 August 2015 at IS8 and SR4.

WQM was cancelled on 9 July 2015 due to adverse weather. (Weather condition varied between sunny to rainy within the reporting period.)
Marine works within the reporting period include Construction and installation of pile caps; Uninstallation of marine piling platform; Pier head segment installation; Pile cap installation; Pier construction; Launching gantry assembly and marine piling)

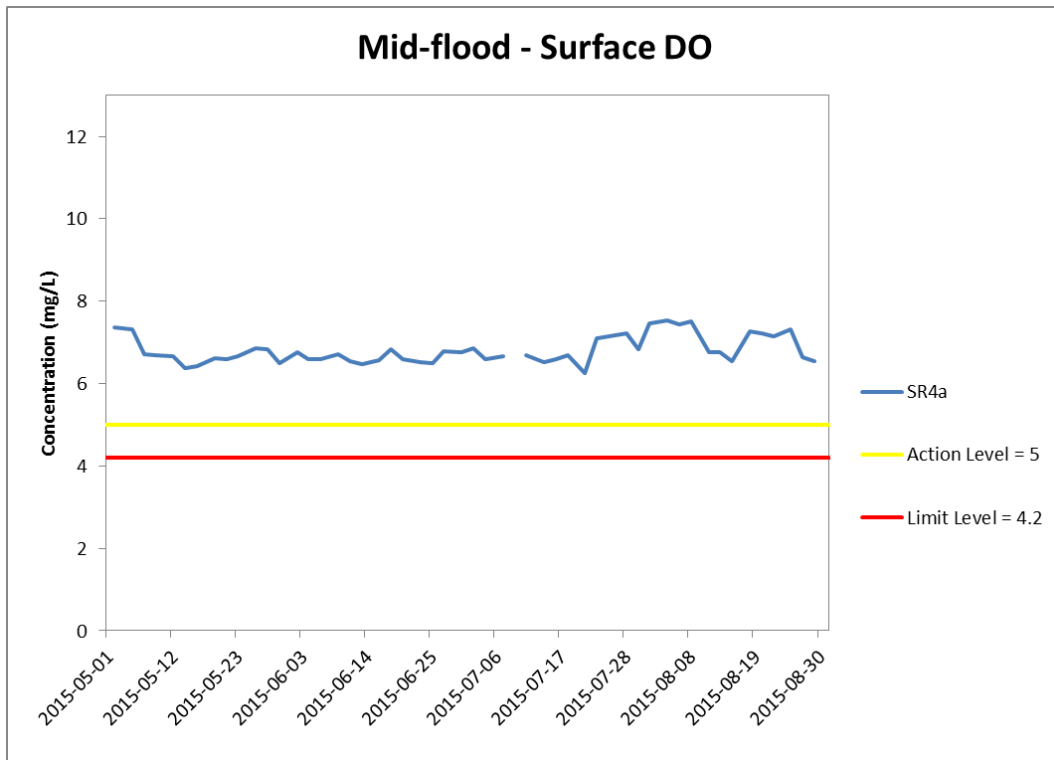
Figure H8 Impact Monitoring - Mean Level of Dissolved Oxygen (mg/L) in surface waters during mid-flood tide between 1 May and 31 August 2015 at SR4a.

WQM was cancelled on 9 July 2015 due to adverse weather. (Weather condition varied between sunny to rainy within the reporting period. Marine works within the reporting period include Construction and installation of pile caps; Uninstallation of marine piling platform; Pier head segment installation; Pile cap installation; Pier construction; Launching gantry assembly and marine piling)

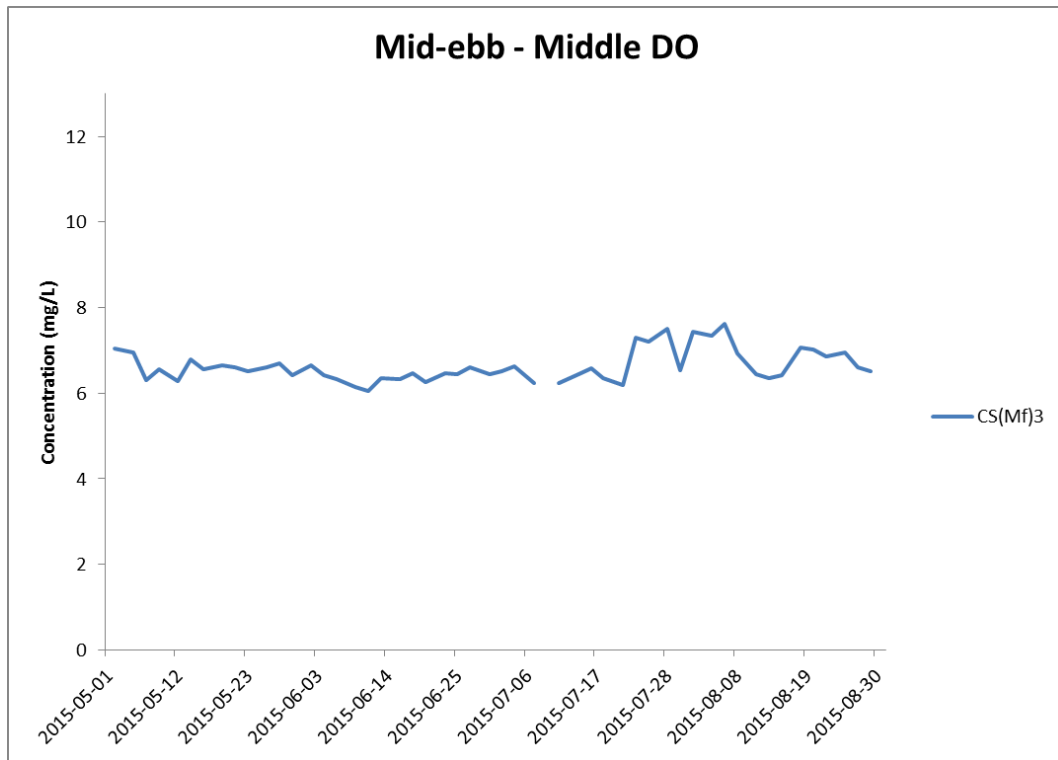
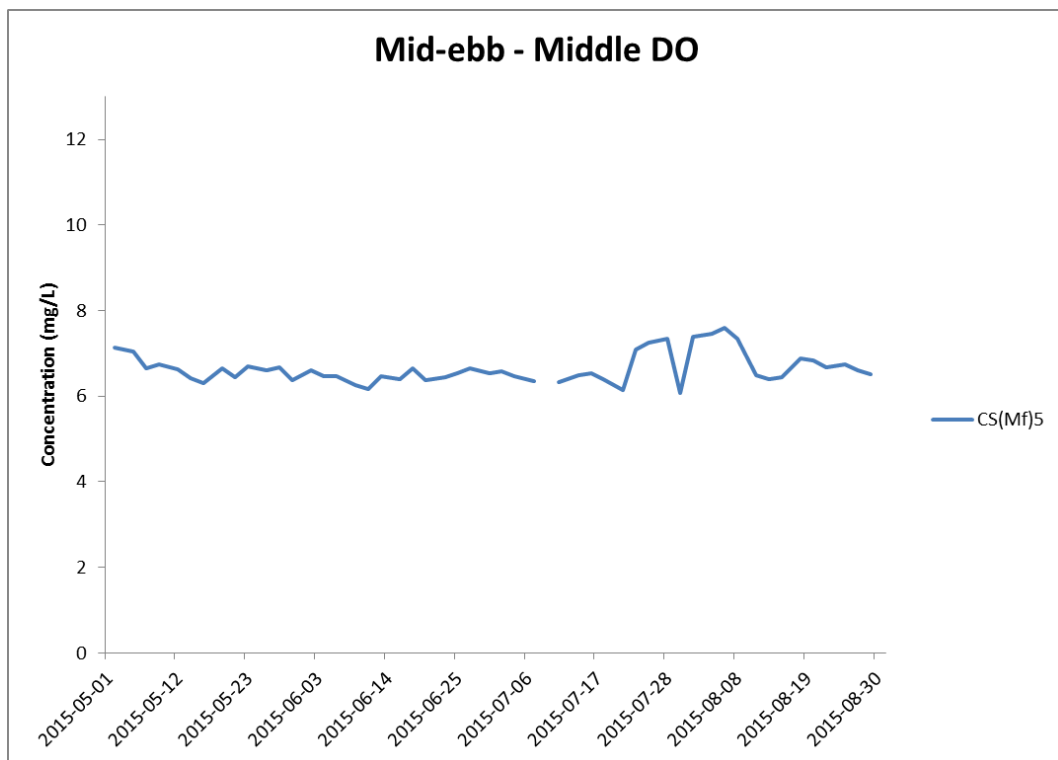
Figure H9 Impact Monitoring - Mean Level of Dissolved Oxygen (mg/L) in mid-depth waters during mid-ebb tide between 1 May and 31 August 2015 at CS(Mf)3 and CS(Mf)5.

WQM was cancelled on 9 July 2015 due to adverse weather. (Weather condition varied between sunny to rainy within the reporting period. Marine works within the reporting period include Construction and installation of pile caps; Uninstallation of marine piling platform; Pier head segment installation; Pile cap installation; Pier construction; Launching gantry assembly and marine piling)

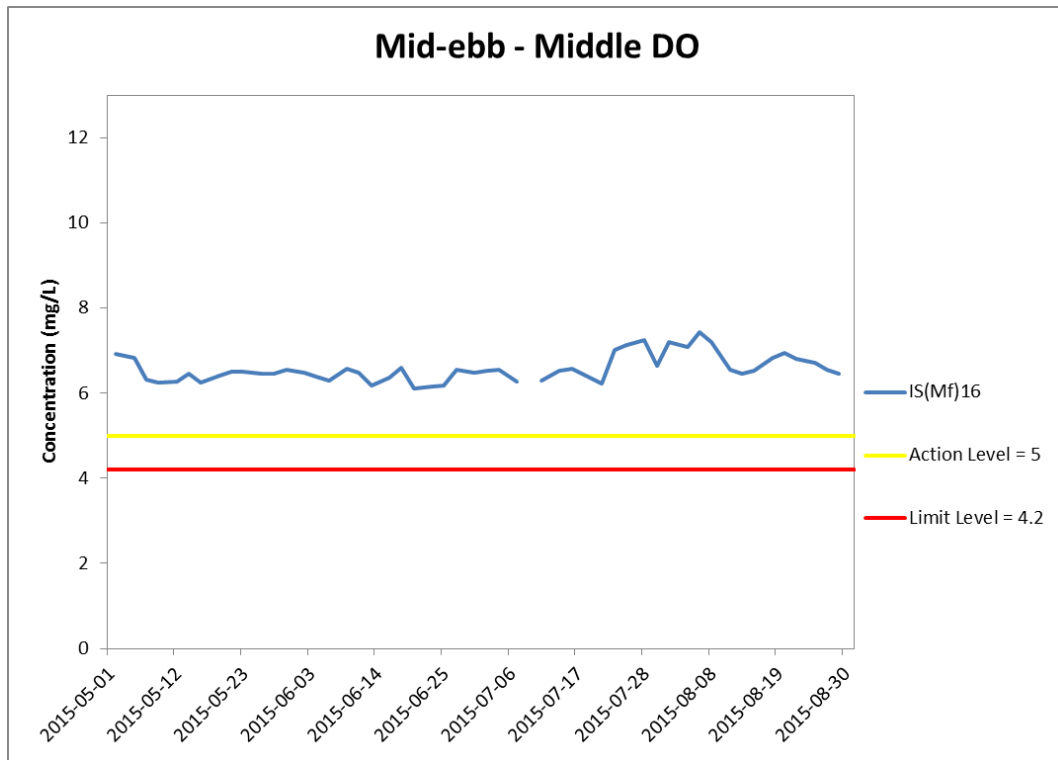
Figure H10 Impact Monitoring - Mean Level of Dissolved Oxygen (mg/L) in mid-depth waters during mid-ebb tide between 1 May and 31 August 2015 at IS(Mf)16.

WQM was cancelled on 9 July 2015 due to adverse weather. (Weather condition varied between sunny to rainy within the reporting period.)
Marine works within the reporting period include Construction and installation of pile caps; Uninstallation of marine piling platform; Pier head segment installation; Pile cap installation; Pier construction; Launching gantry assembly and marine piling)

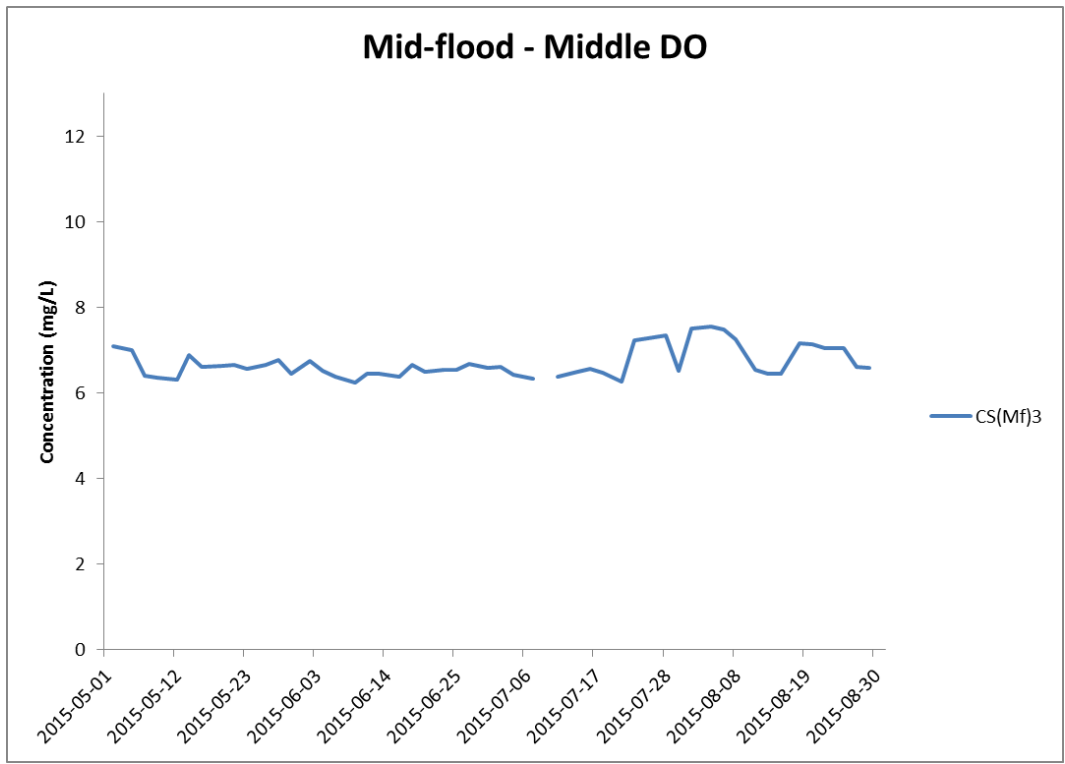
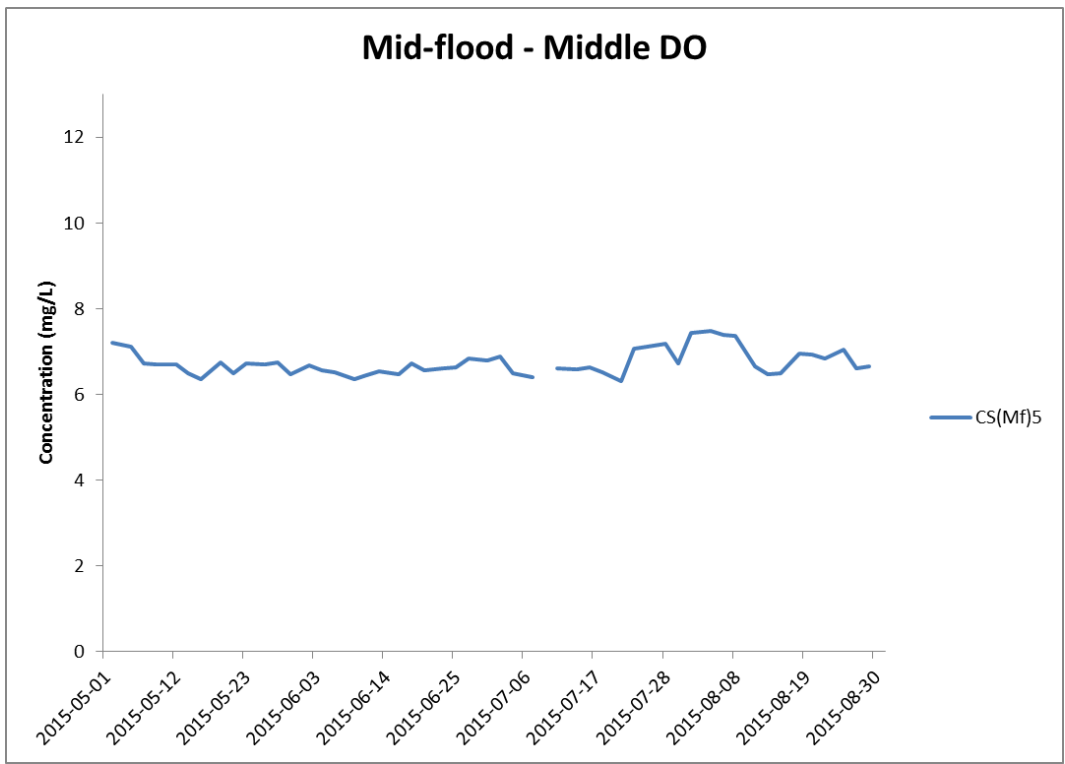
Figure H11 Impact Monitoring - Mean Level of Dissolved Oxygen (mg/L) in mid-depth waters during mid-flood tide between 1 May and 31 August 2015 at CS(Mf)3 and CS(Mf)5.

WQM was cancelled on 9 July 2015 due to adverse weather. (Weather condition varied between sunny to rainy within the reporting period.)
 Marine works within the reporting period include Construction and installation of pile caps; Uninstallation of marine piling platform; Pier head segment installation; Pile cap installation; Pier construction; Launching gantry assembly and marine piling)

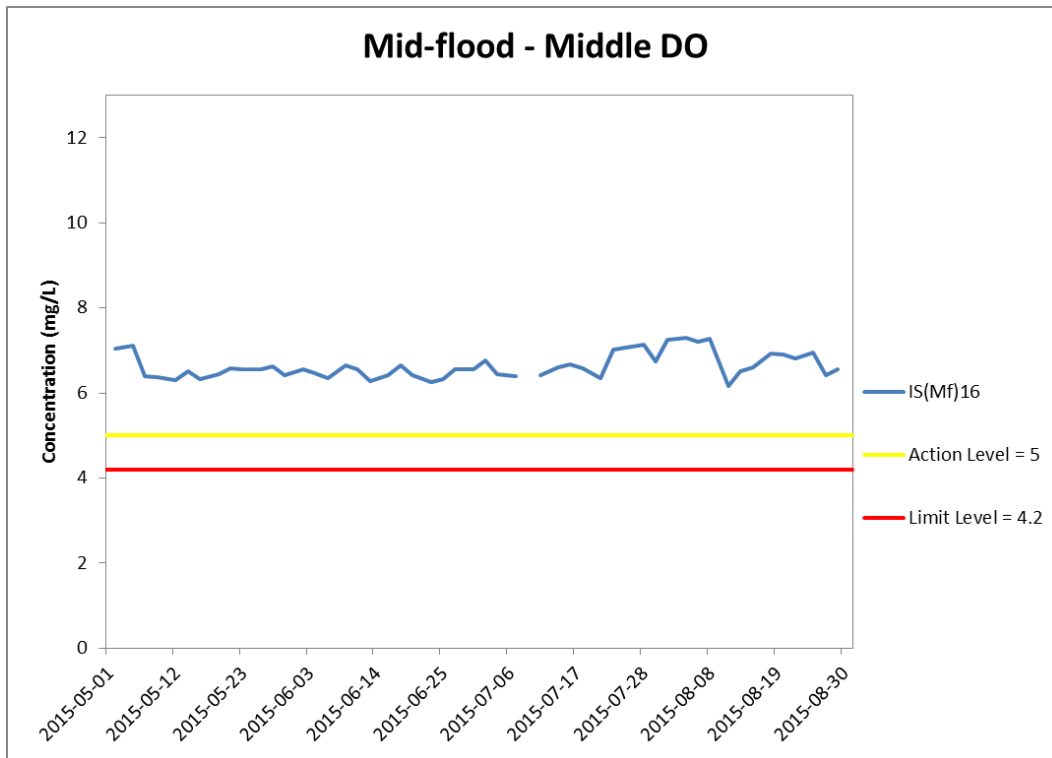
Figure H12 Impact Monitoring - Mean Level of Dissolved Oxygen (mg/L) in mid-depth waters during mid-flood tide between 1 May and 31 August 2015 at IS(Mf)16.

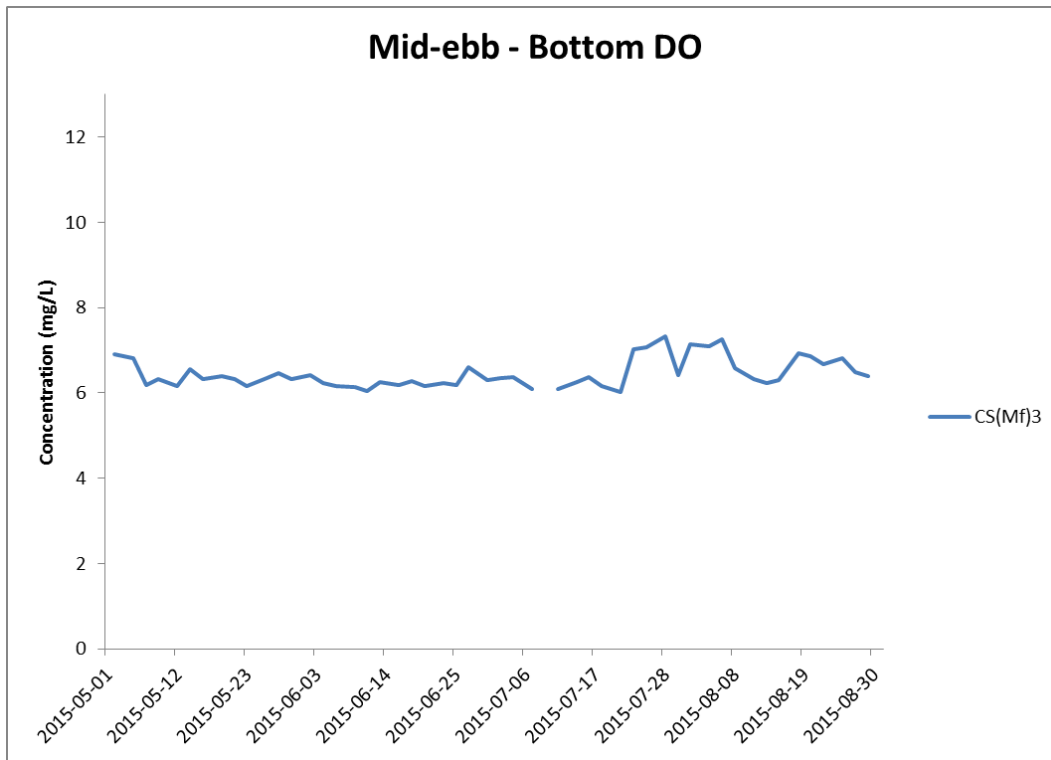
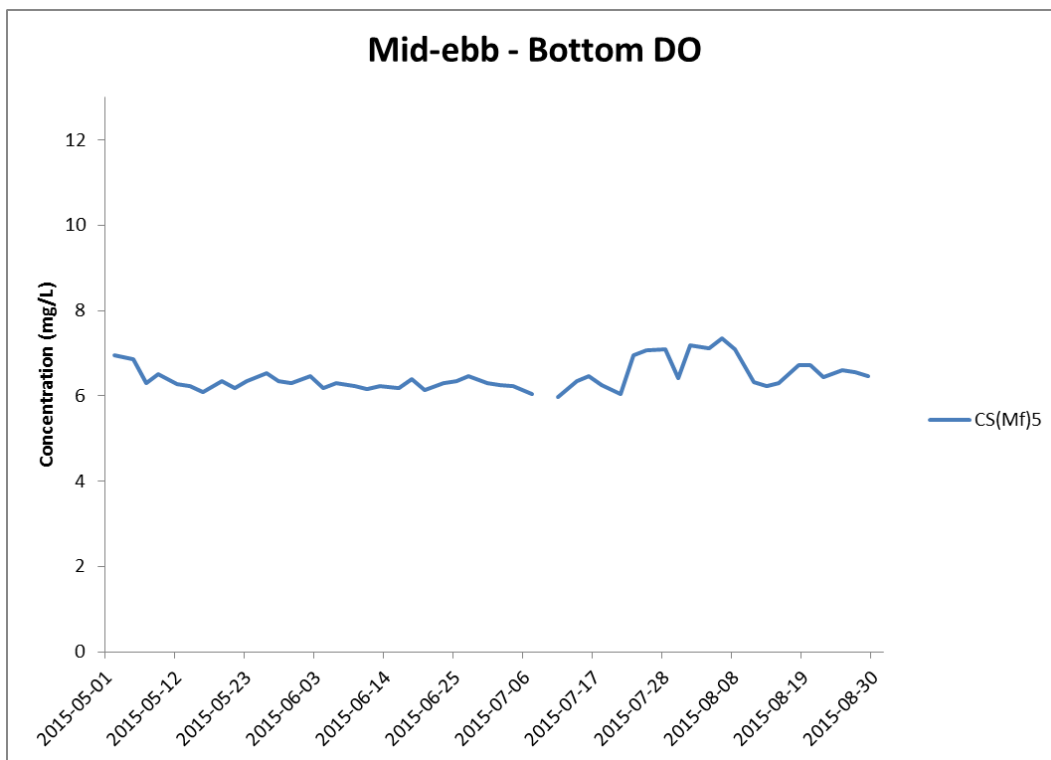
Figure H13 Impact Monitoring - Mean Level of Dissolved Oxygen (mg/L) in bottom waters during mid-ebb tide between 1 May and 31 August 2015 at CS(Mf)3 and CS(Mf)5.

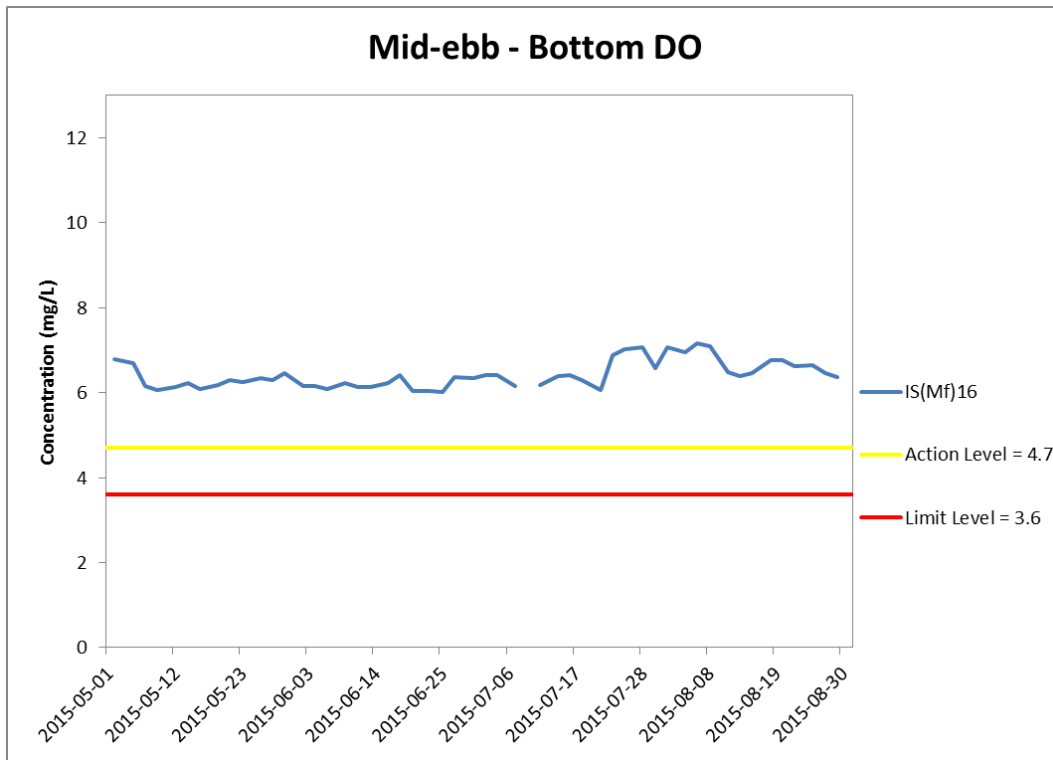
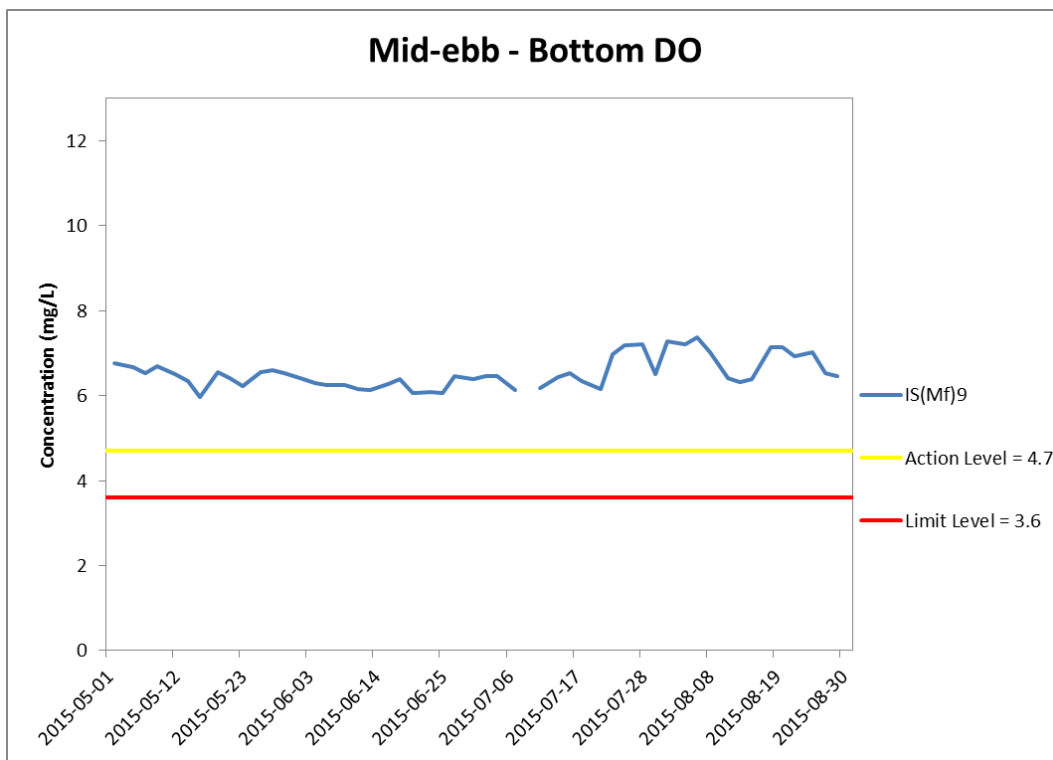
Figure H14 Impact Monitoring - Mean Level of Dissolved Oxygen (mg/L) in bottom waters during mid-ebb tide between 1 May and 31 August 2015 at IS(Mf)16 and IS(Mf)9.
