**Contract No. HY/2012/07
Tuen Mun – Chek Lap Kok Link –
Southern Connection Viaduct Section**

*Seventh Quarterly Environmental Monitoring &
Audit (EM&A) Report*

19 January 2016

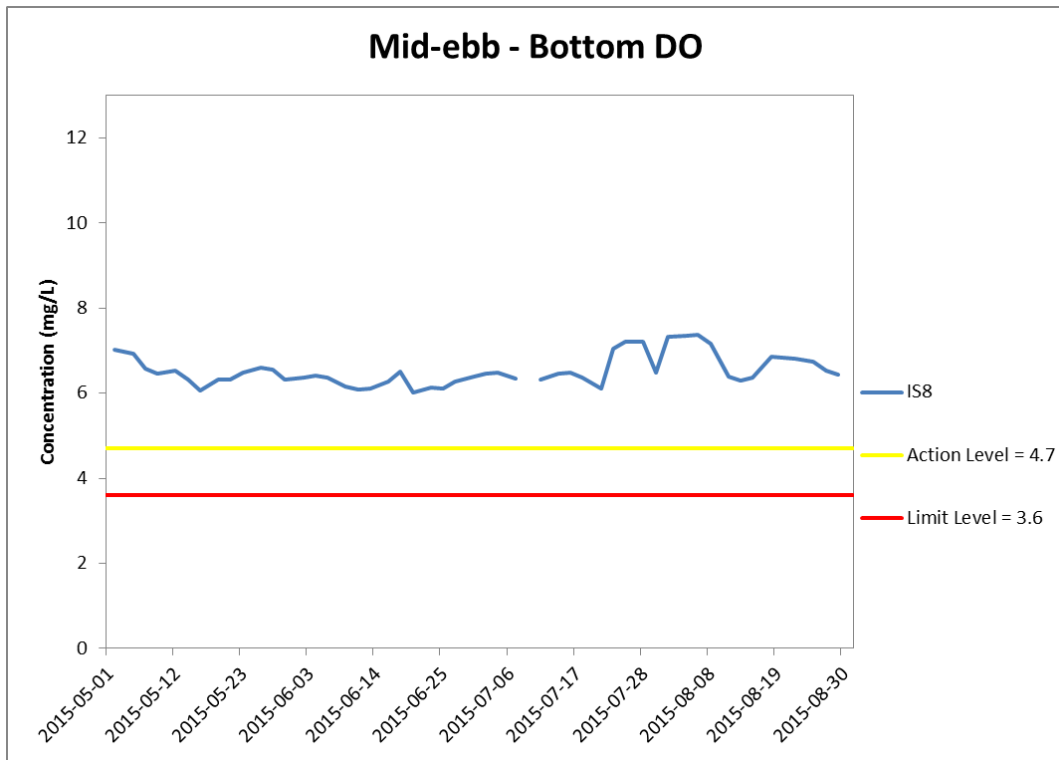
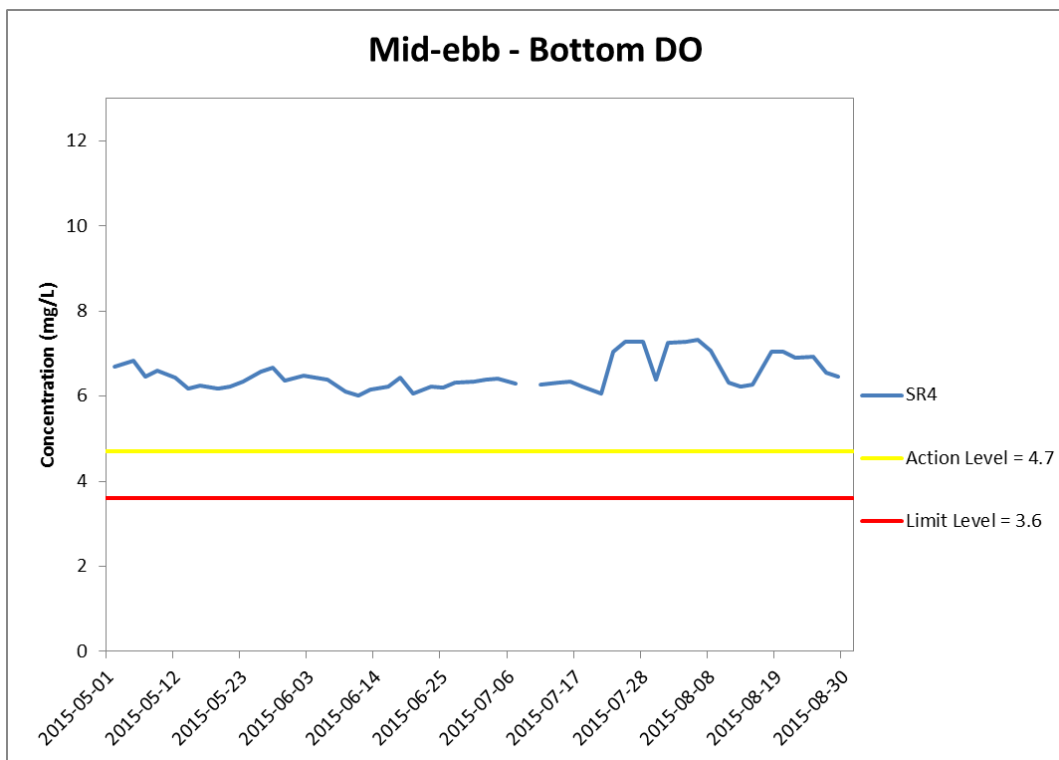
Figure H15 Impact Monitoring - Mean Level of Dissolved Oxygen (mg/L) in bottom waters during mid-ebb tide between 1 May and 31 August 2015 at IS8 and SR4.

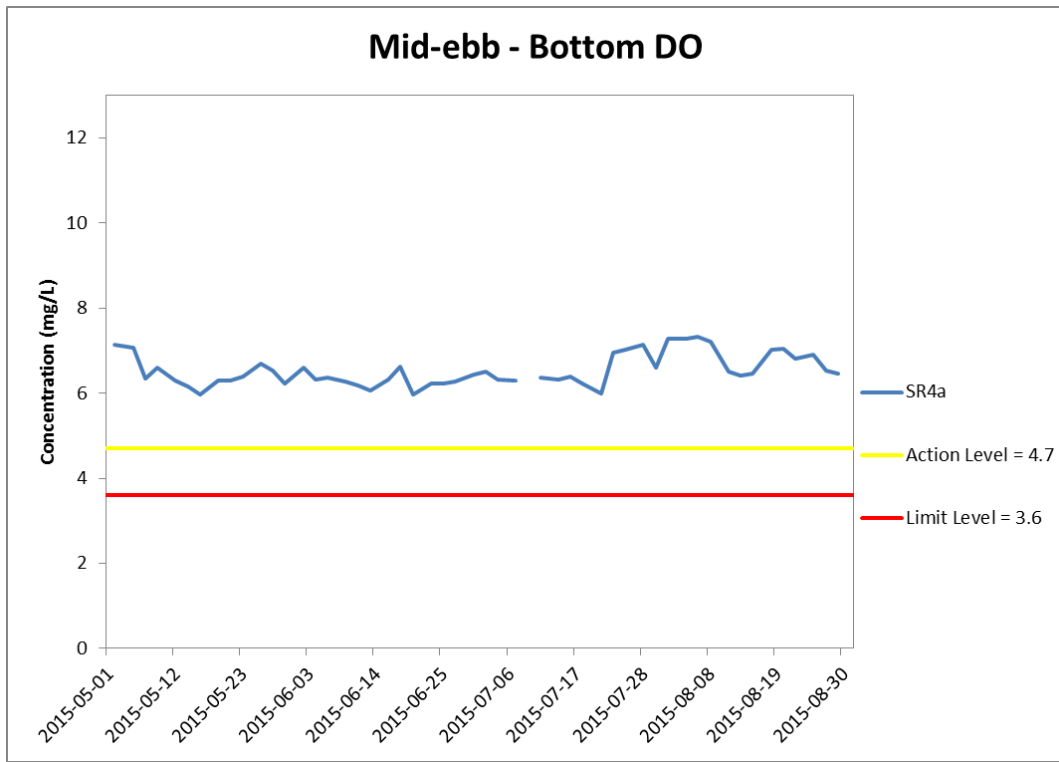
Figure H16 Impact Monitoring - Mean Level of Dissolved Oxygen (mg/L) in bottom waters during mid-ebb tide between 1 May and 31 August 2015 at SR4a.

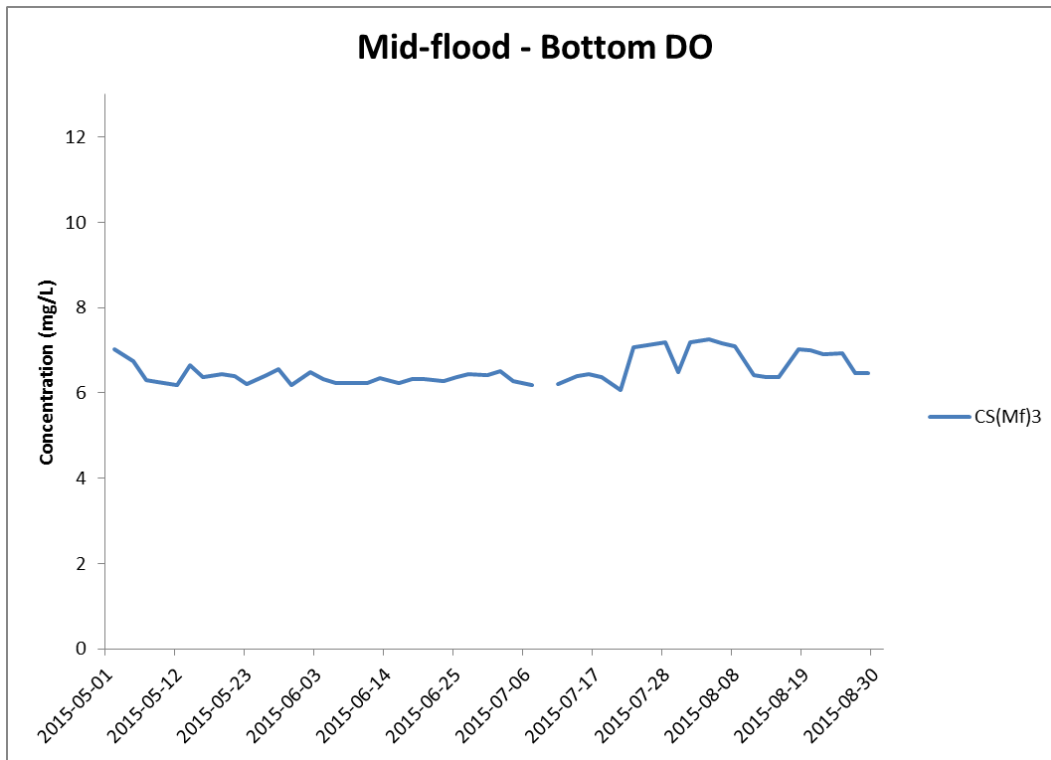
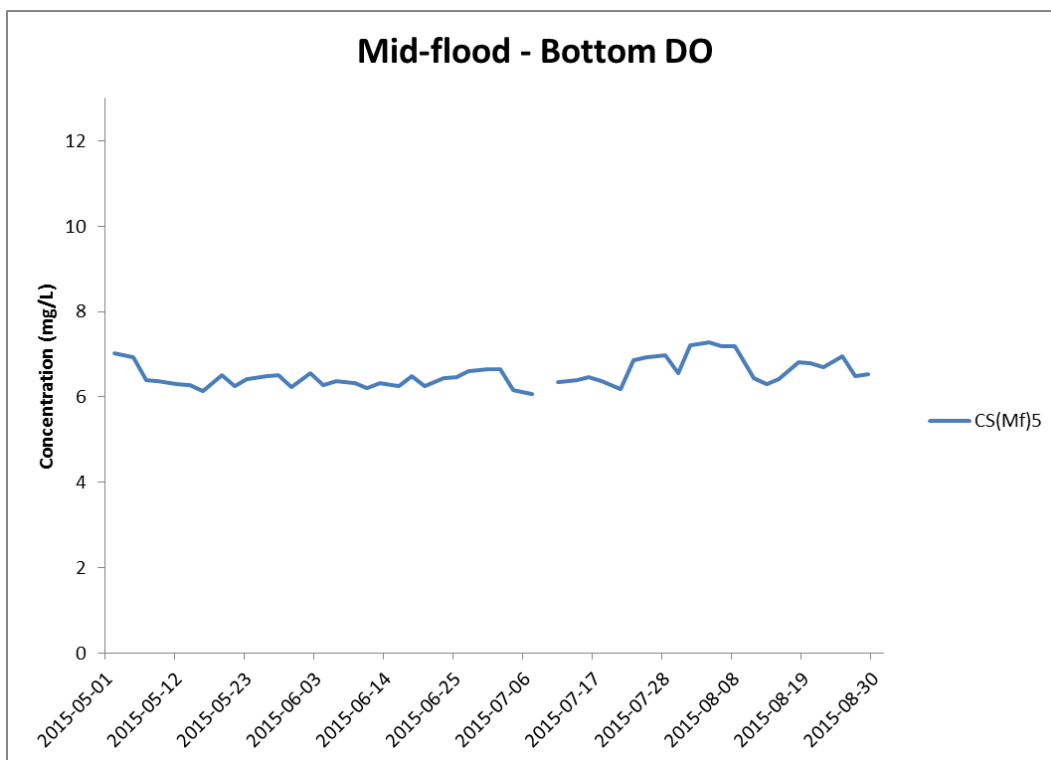
Figure H17 Impact Monitoring – Mean Level of Dissolved Oxygen (mg/L) in bottom waters during mid-flood tide between 1 May and 31 August 2015 at CS(Mf)3 and CS(Mf)5.

WQM was cancelled on 9 July 2015 due to adverse weather. (Weather condition varied between sunny to rainy within the reporting period.)

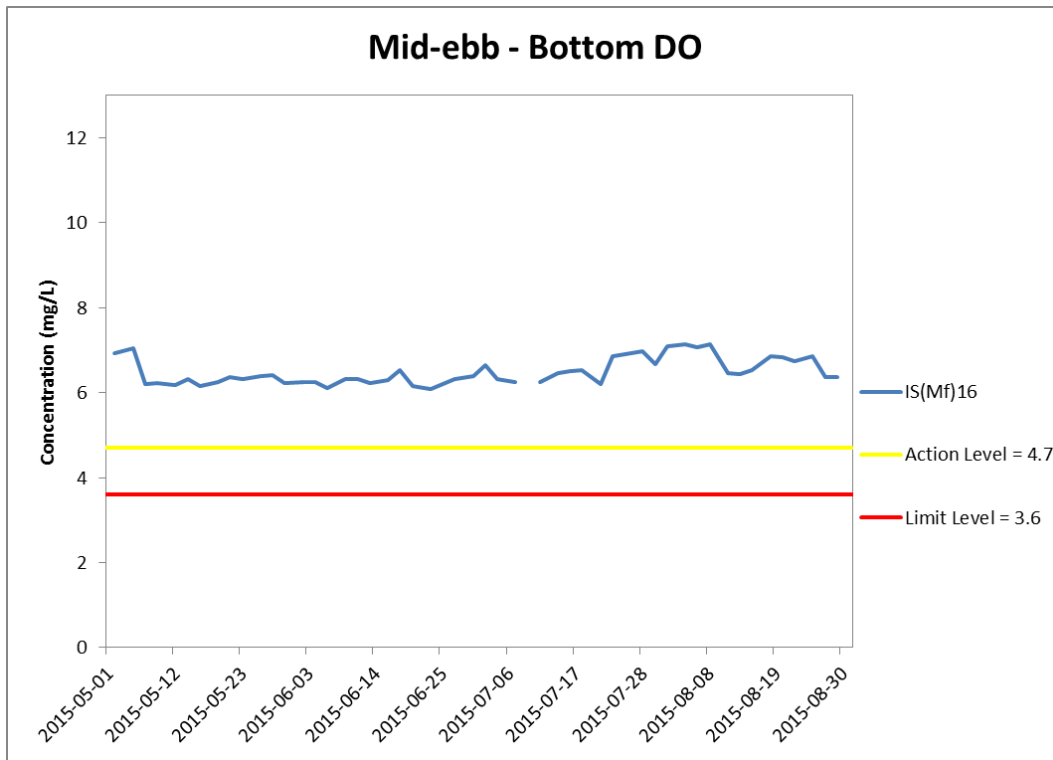
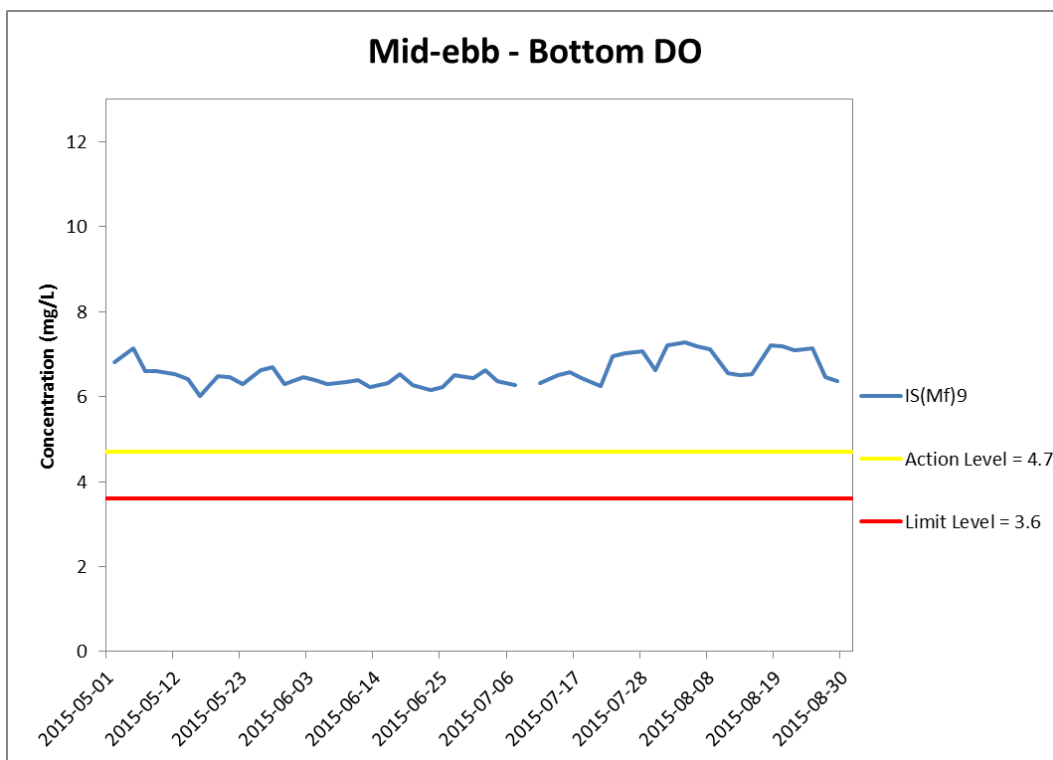
Figure H18 Impact Monitoring – Mean Level of Dissolved Oxygen (mg/L) in bottom waters during mid-flood tide between 1 May and 31 August 2015 at IS(Mf)16 and IS(Mf)9.

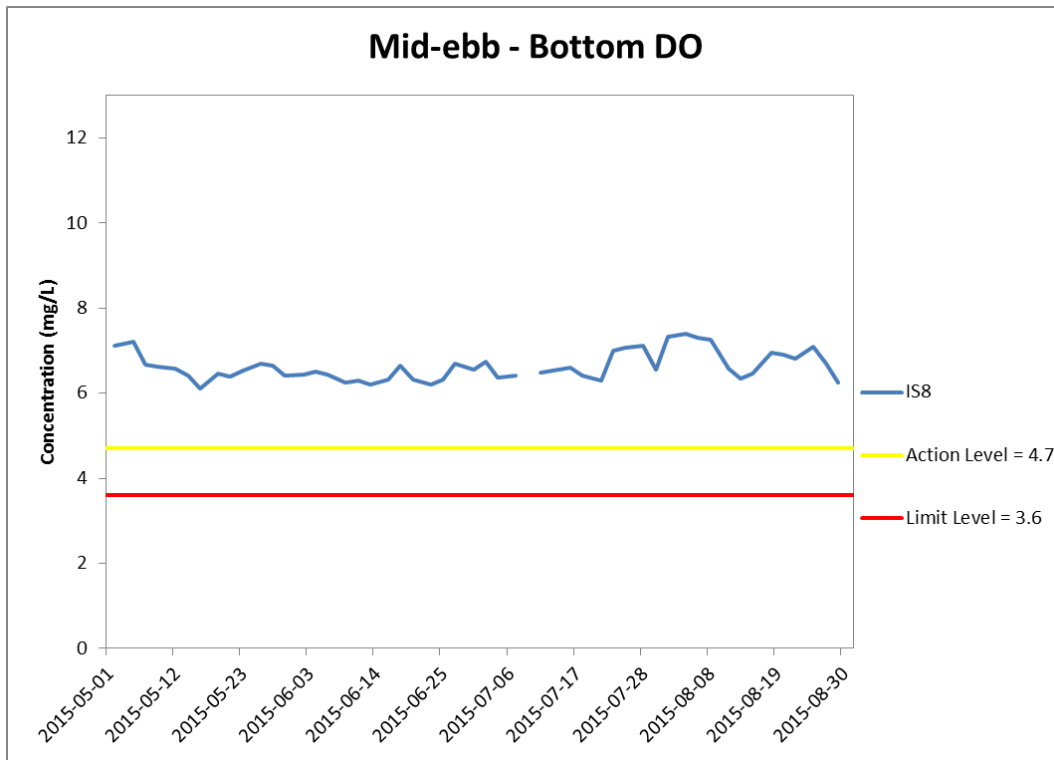
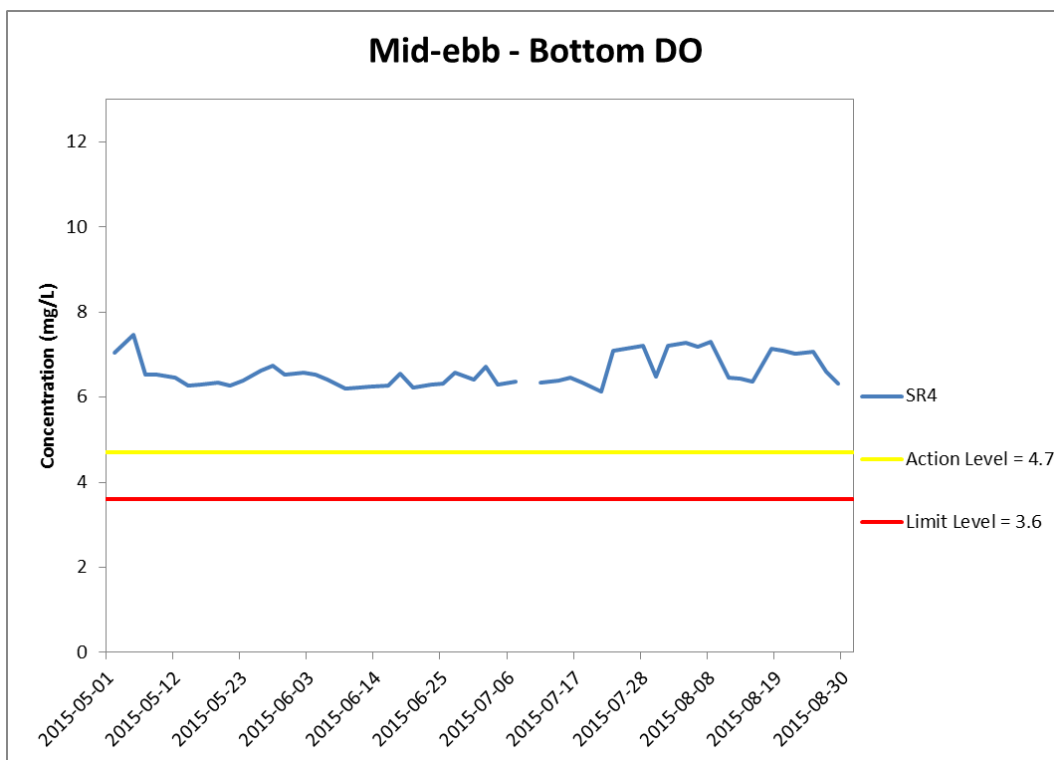
Figure H19 Impact Monitoring – Mean Level of Dissolved Oxygen (mg/L) in bottom waters during mid-flood tide between 1 May and 31 August 2015 at IS8 and SR4.

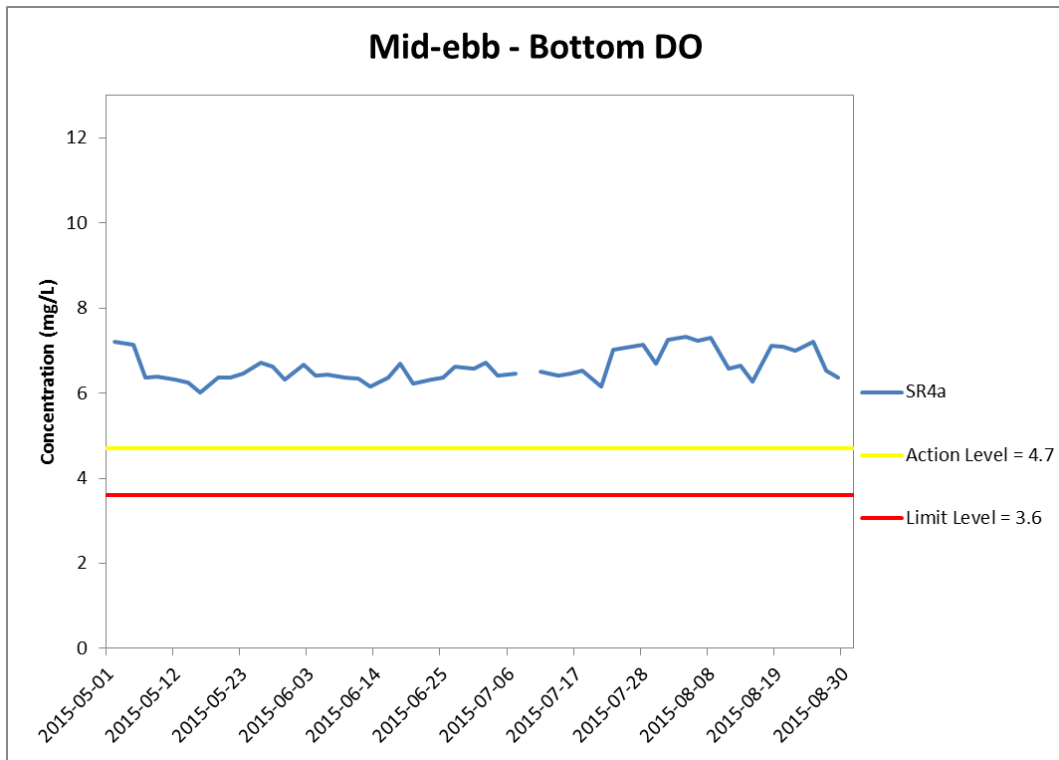
Figure H20 Impact Monitoring – Mean Level of Dissolved Oxygen (mg/L) in bottom waters during mid-flood tide between 1 May and 31 August 2015 at SR4a.

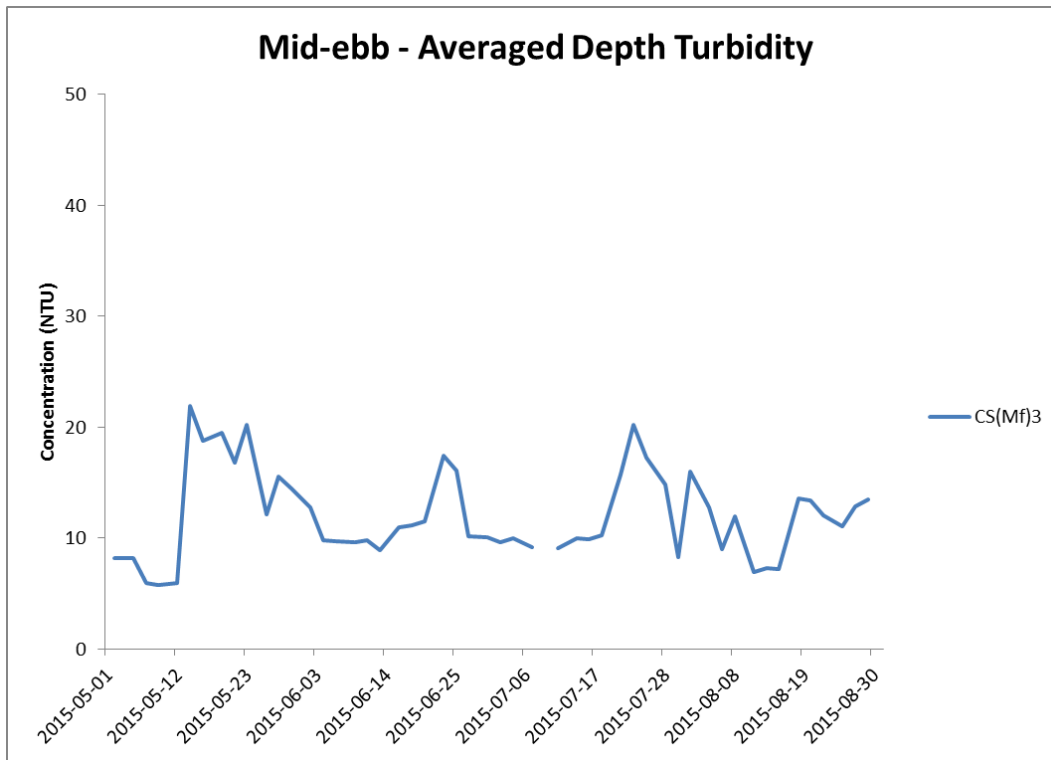
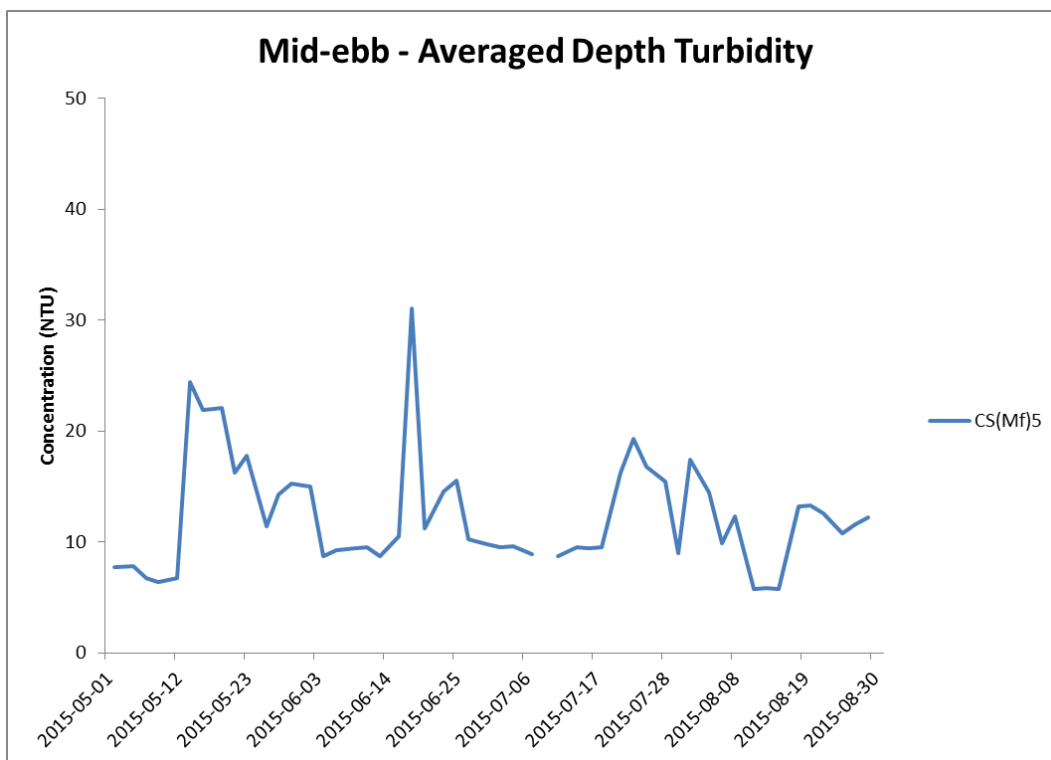
Figure H21 Impact Monitoring – Mean Level of depth-averaged Turbidity (NTU) during mid-ebb tide between 1 May and 31 August 2015 at CS(Mf)3 and CS(Mf)5.

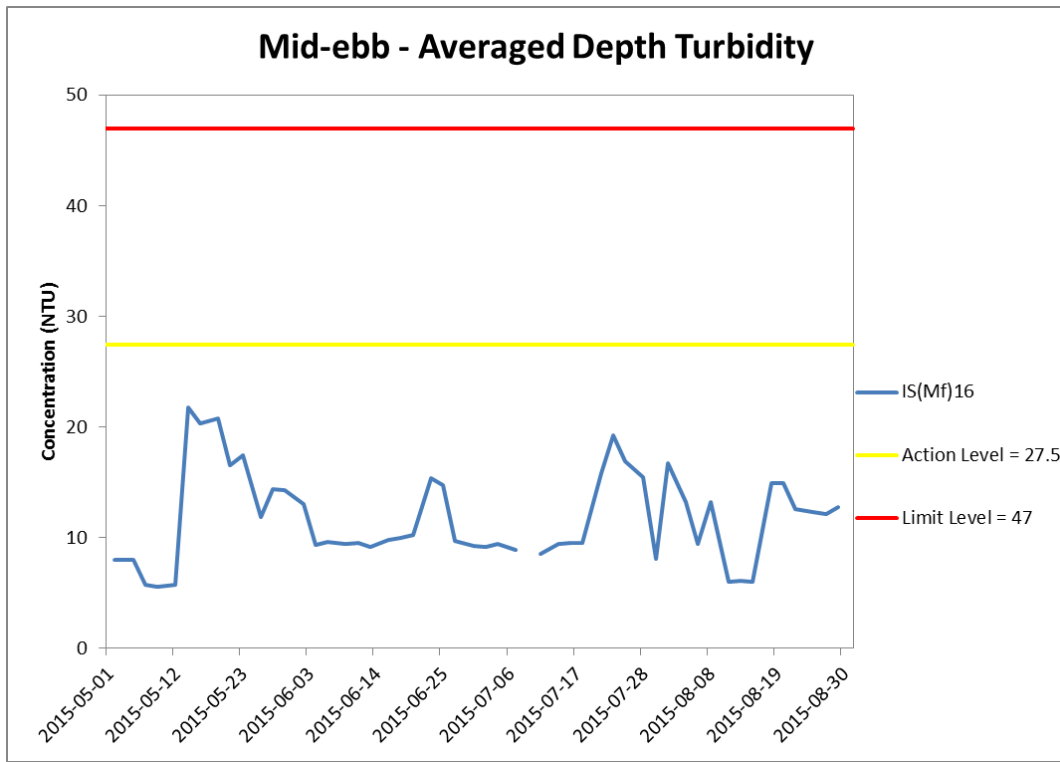
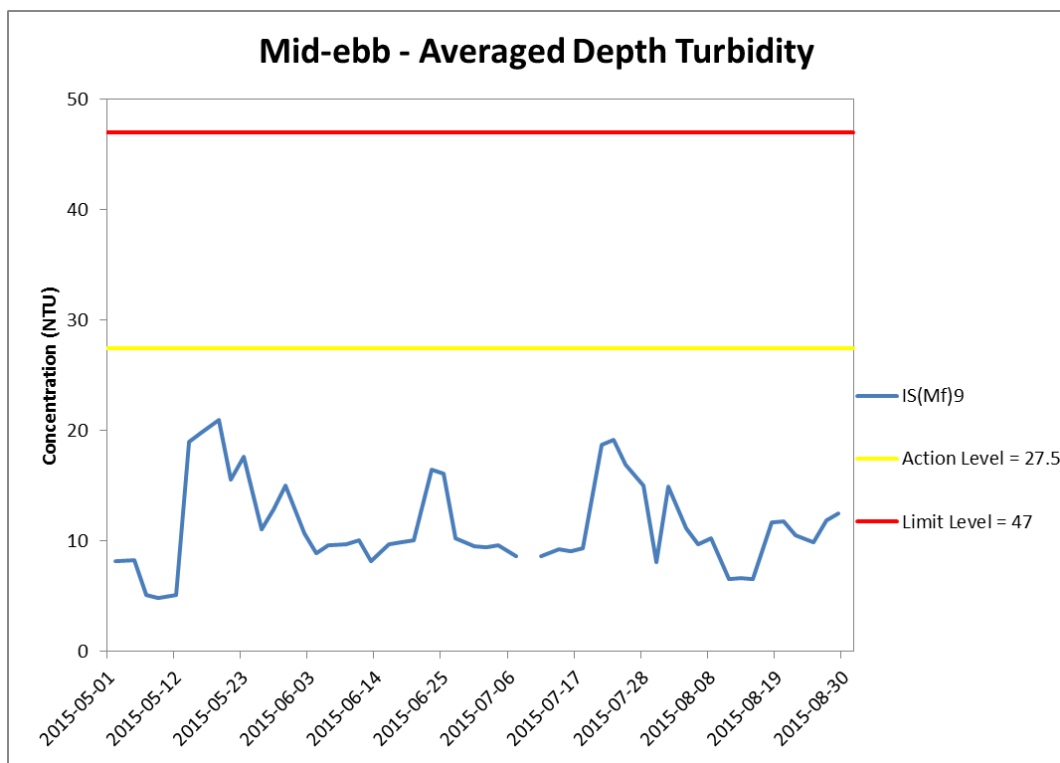
Figure H22 Impact Monitoring – Mean Level of depth-averaged Turbidity (NTU) during mid-ebb tide between 1 May and 31 August 2015 at IS(Mf)16 and IS(Mf)9.

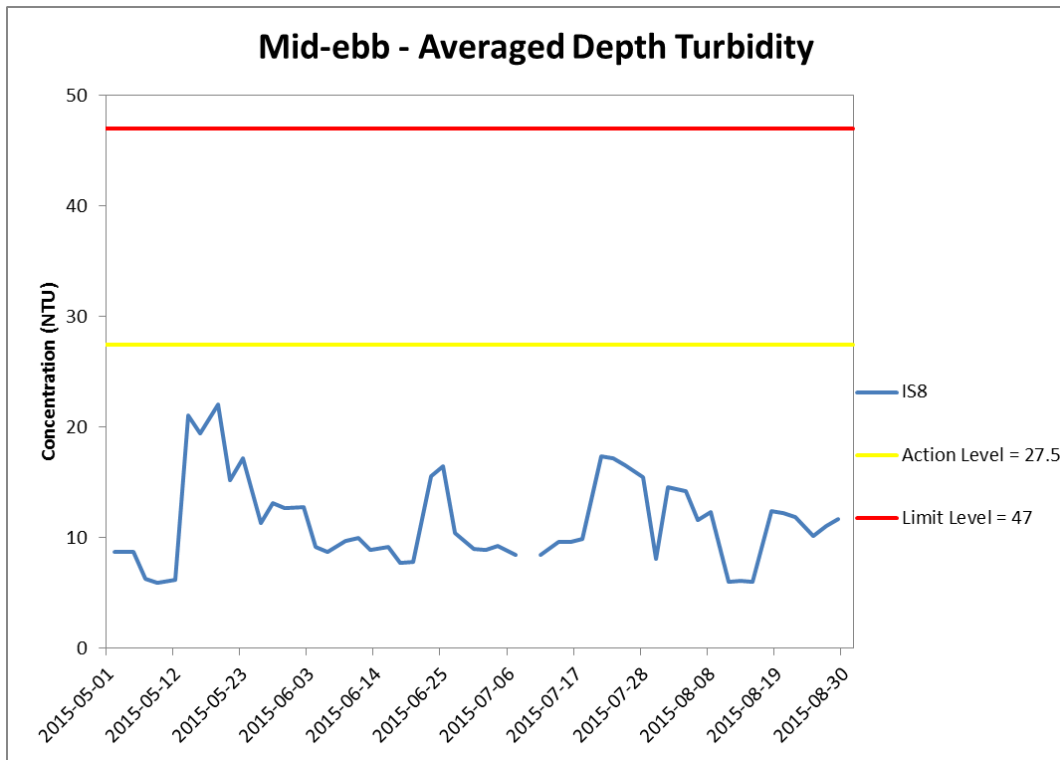
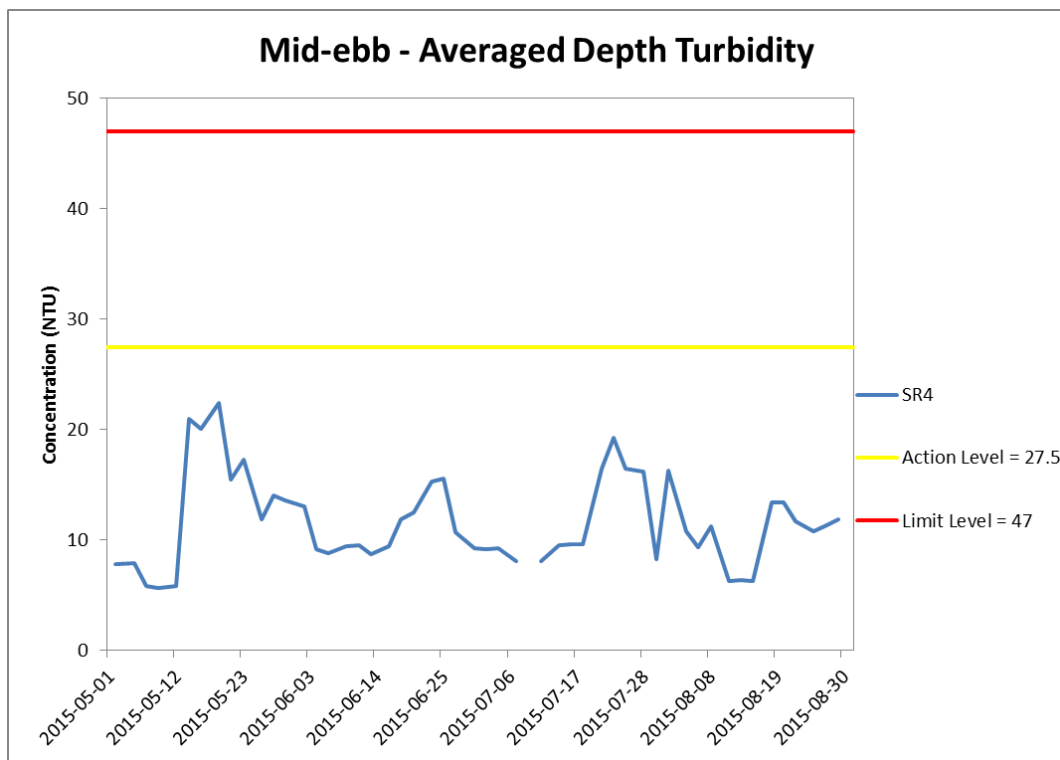
Figure H23 Impact Monitoring – Mean Level of depth-averaged Turbidity (NTU) during mid-ebb tide between 1 May and 31 August 2015 at IS8 and SR4.

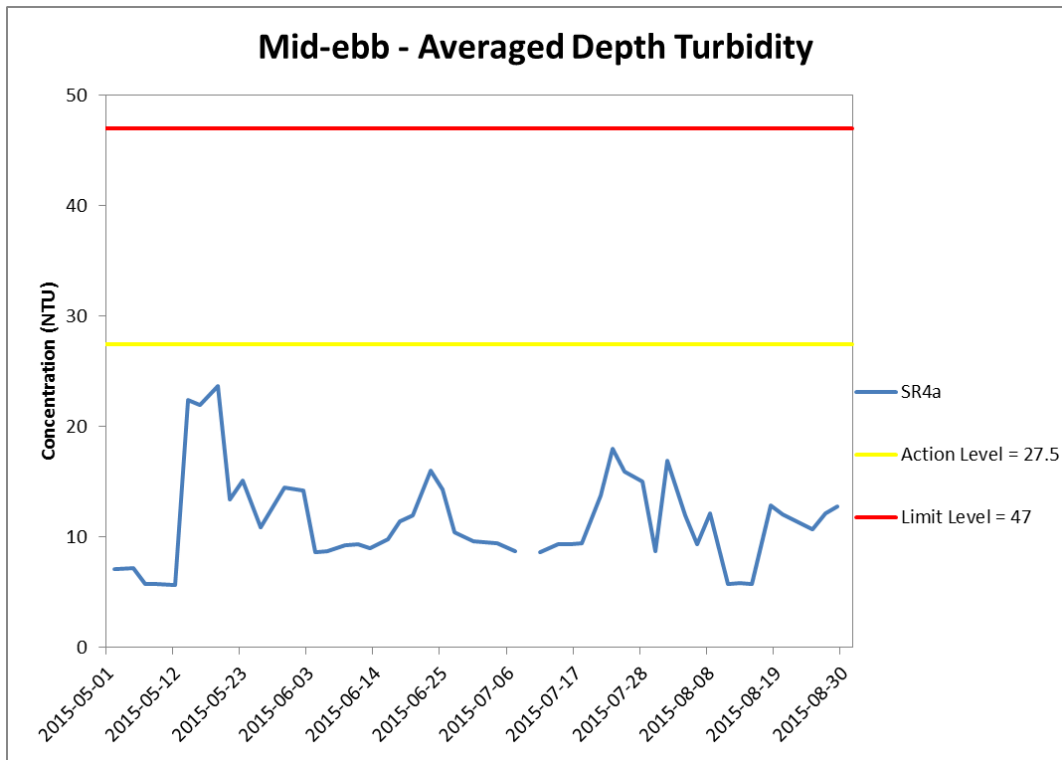
Figure H24 Impact Monitoring - Mean Level of depth-averaged Turbidity (NTU) during mid-ebb tide between 1 May and 31 August 2015 at SR4a.

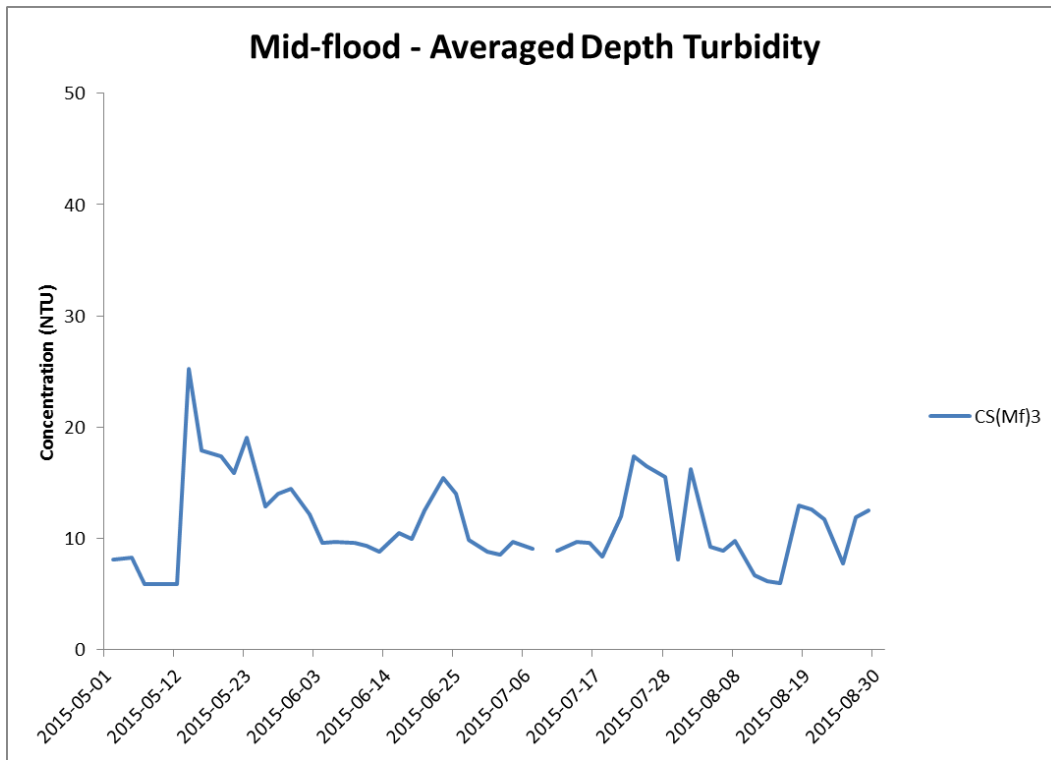
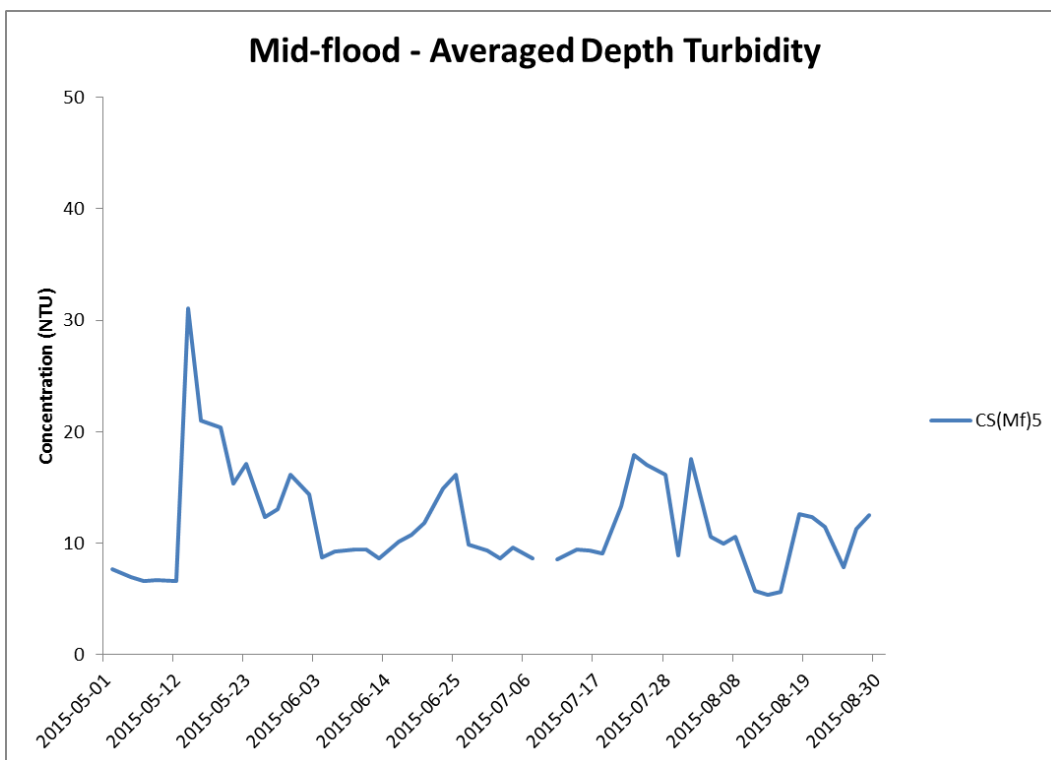
Figure H25 Impact Monitoring – Mean Level of depth-averaged Turbidity (NTU) during mid-flood tide between 1 May and 31 August 2015 at CS(Mf)3 and CS(MF)5.

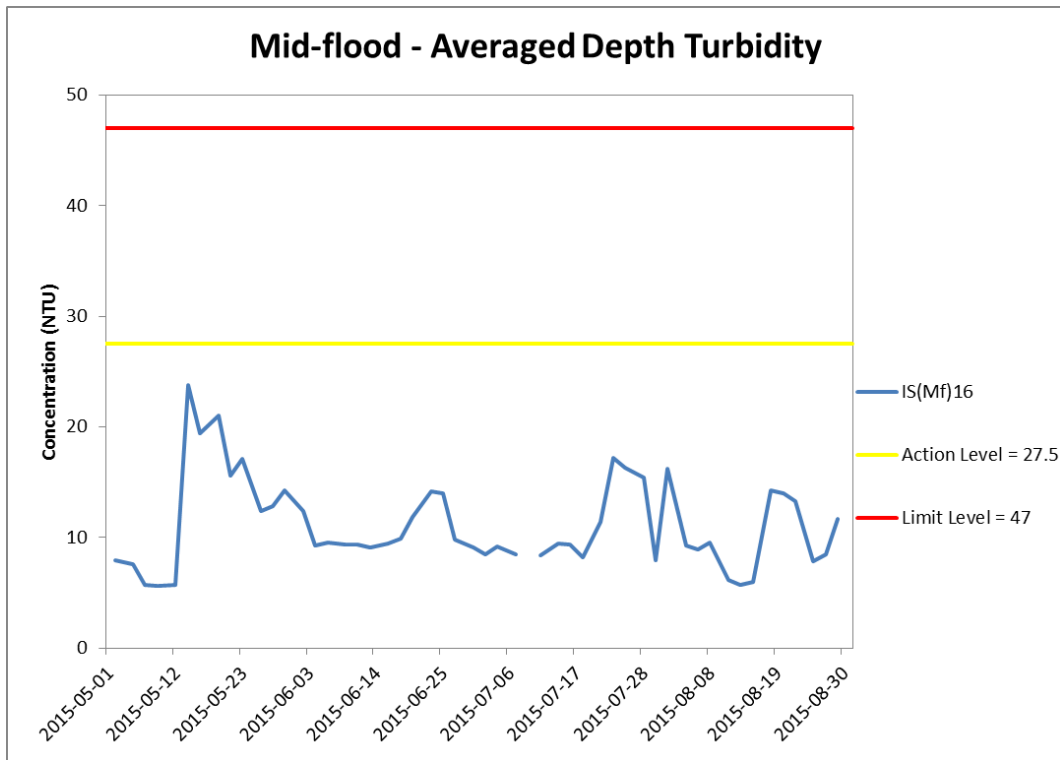
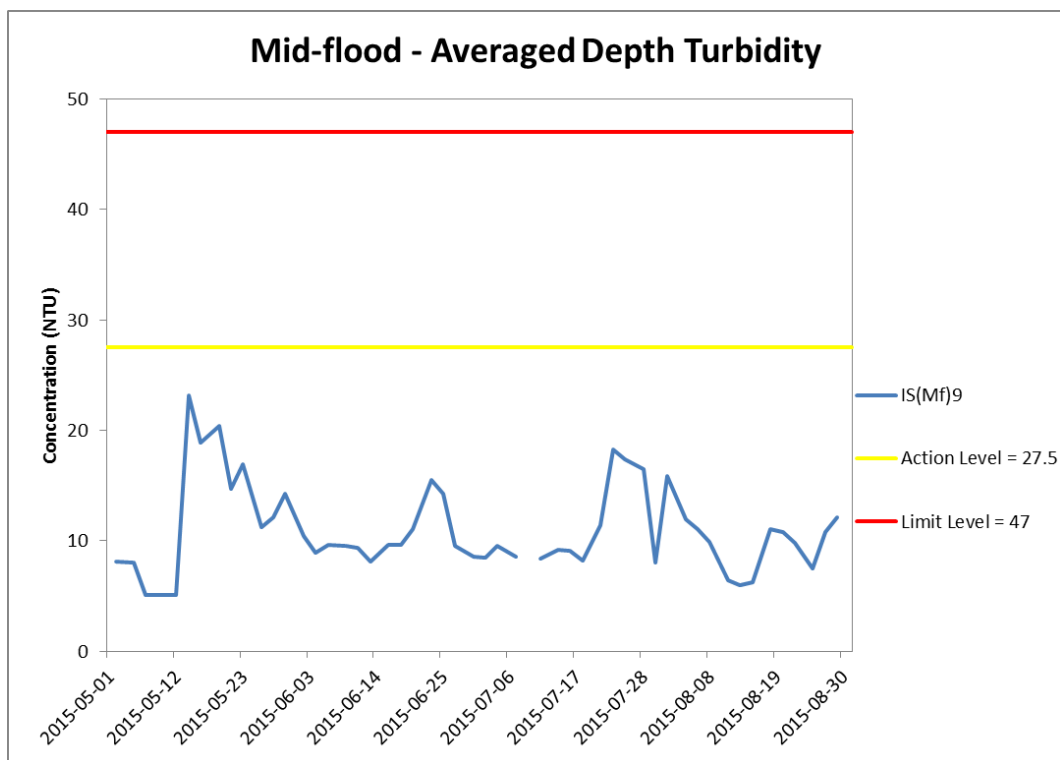
Figure H26 Impact Monitoring - Mean Level of depth-averaged Turbidity (NTU) during mid-flood tide between 1 May and 31 August 2015 at IS(Mf)16 and IS(Mf)9.

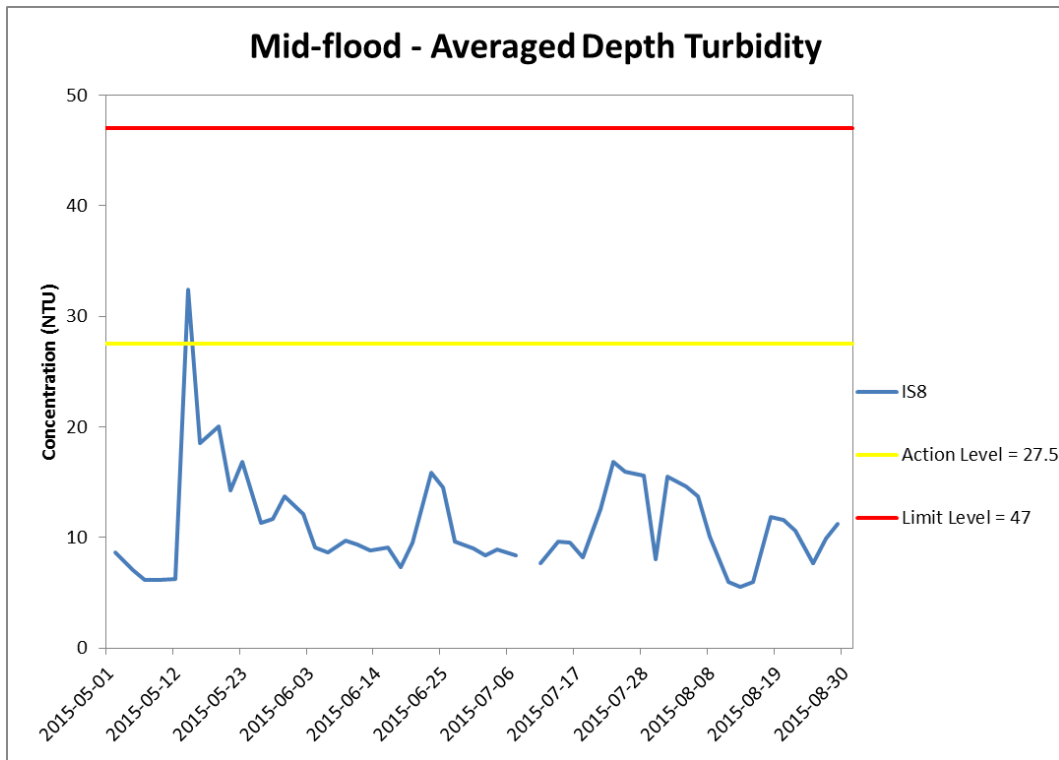
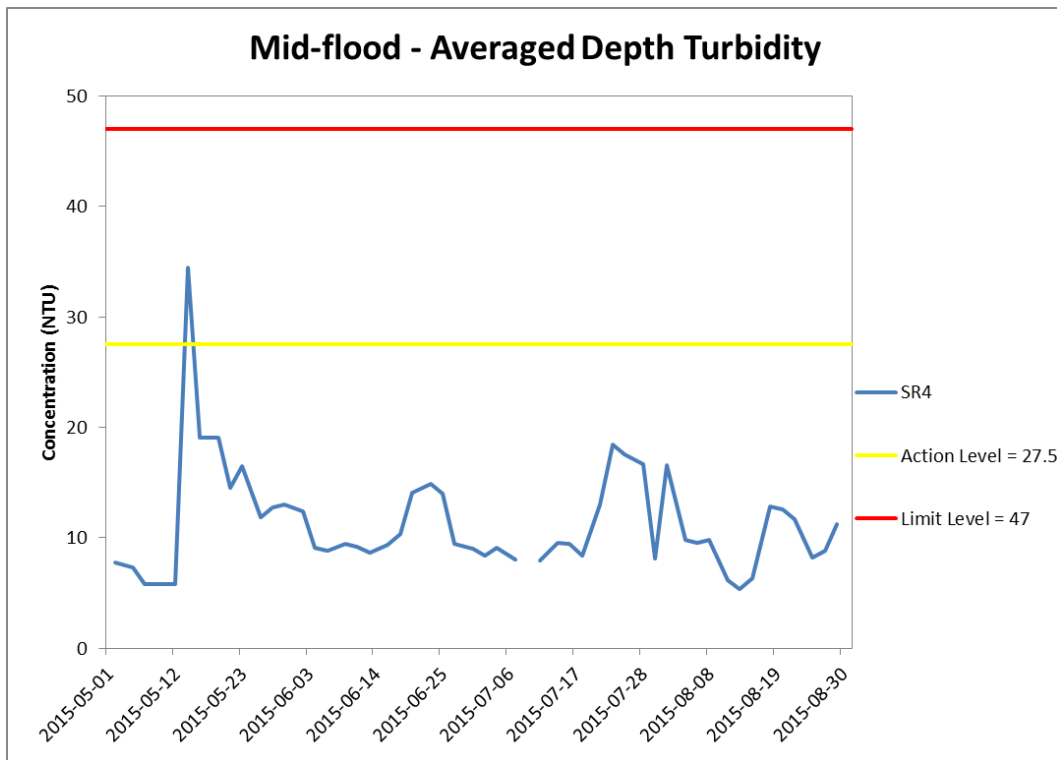
Figure H27 Impact Monitoring - Mean Level of depth-averaged Turbidity (NTU) during mid-flood tide between 1 May and 31 August 2015 at IS8 and SR4.

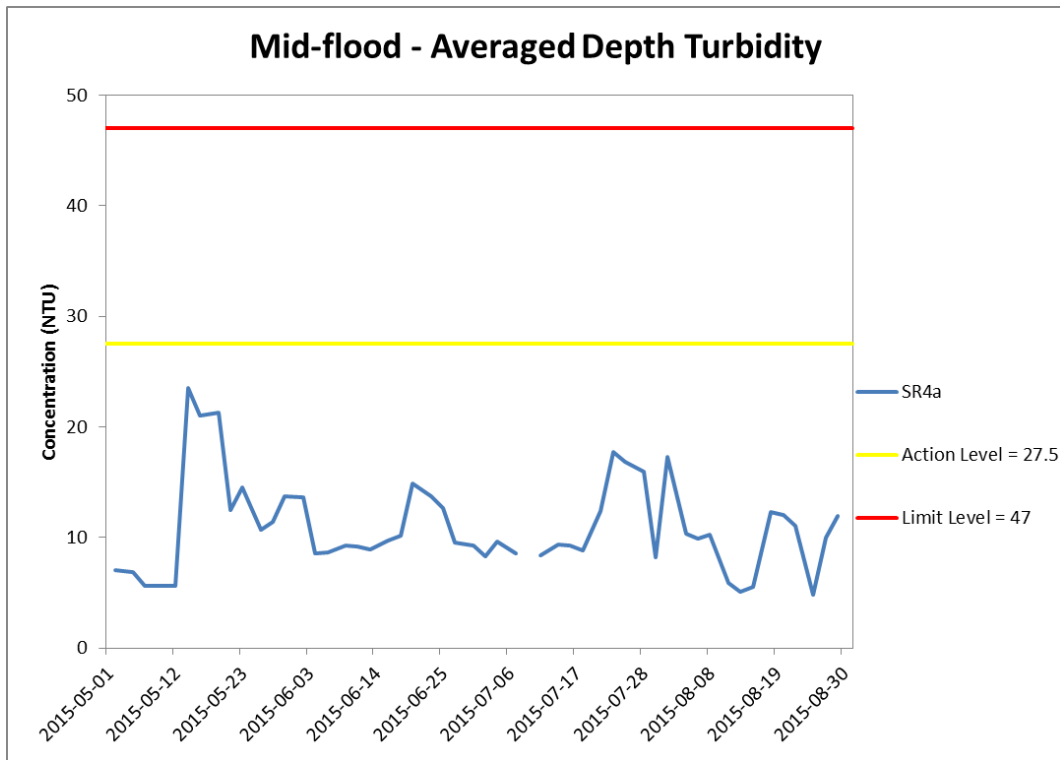
Figure H28 Impact Monitoring - Mean Level of depth-averaged Turbidity (NTU) during mid-flood tide between 1 May and 31 August 2015 at SR4a.

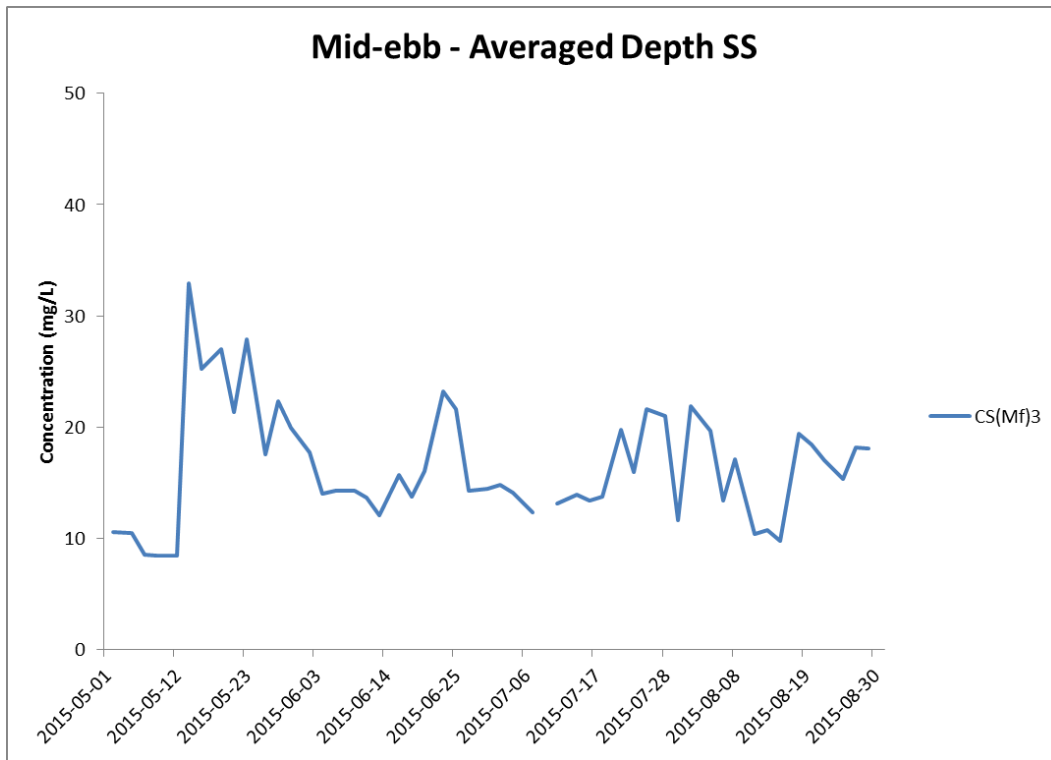
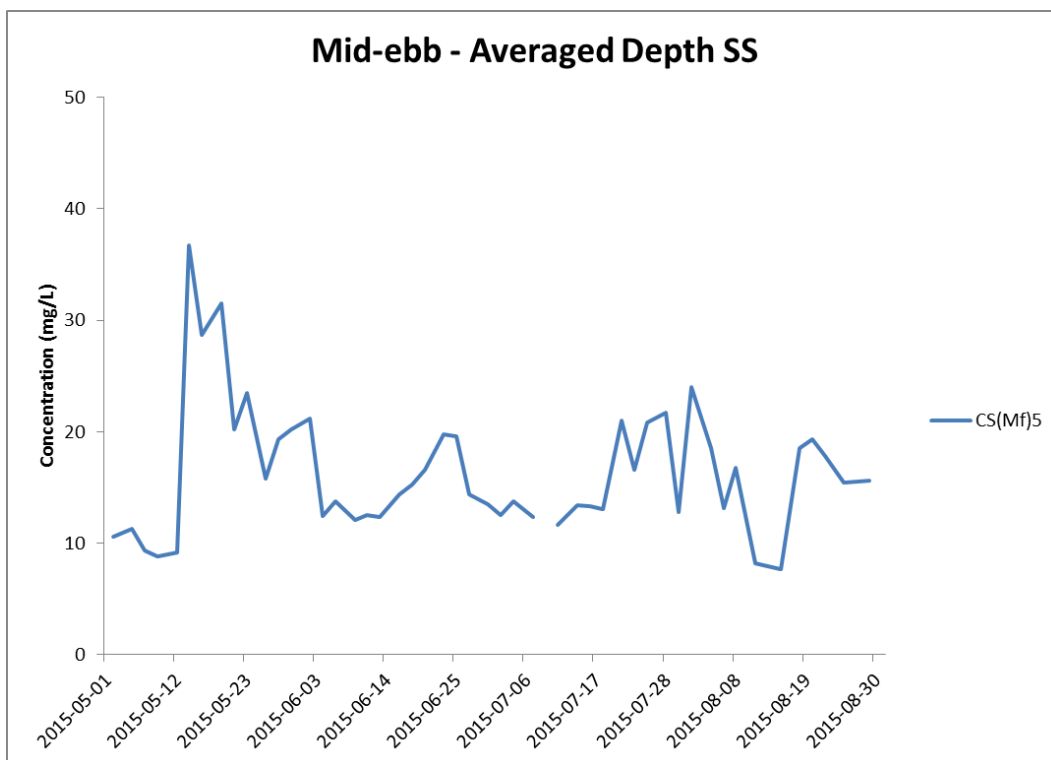
Figure H29 Impact Monitoring – Mean depth-averaged level of Suspended Solids (mg/L) during mid-ebb tide between 1 May and 31 August 2015 at CS(Mf)3 and CS(Mf)5.

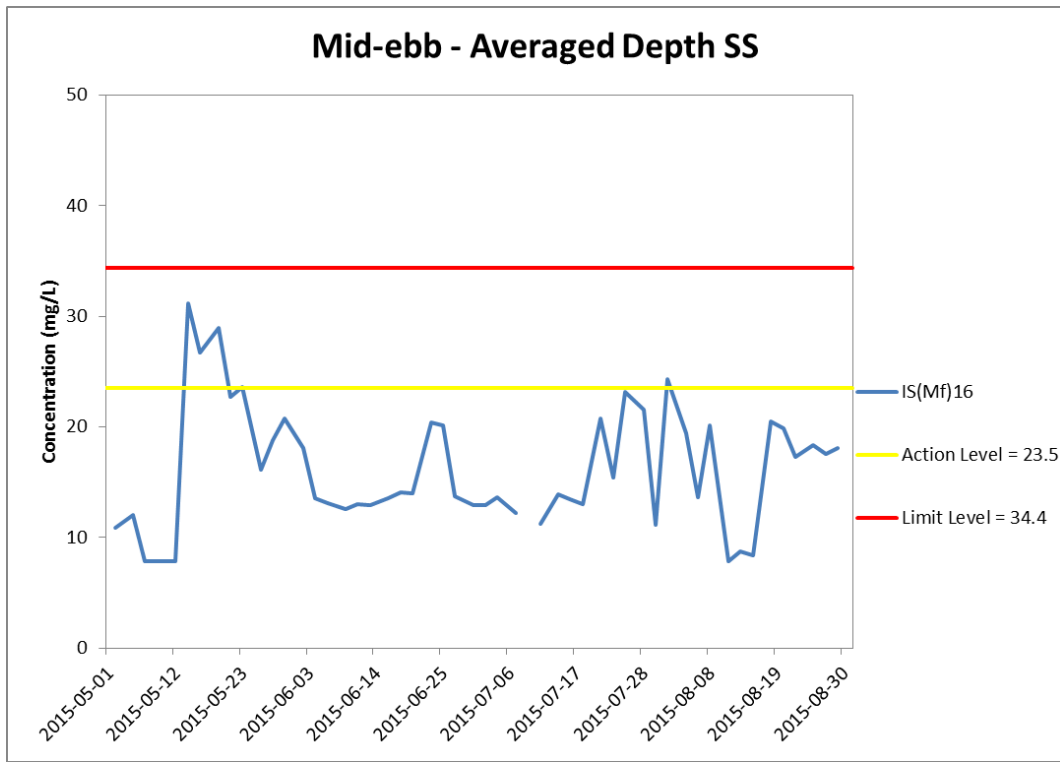
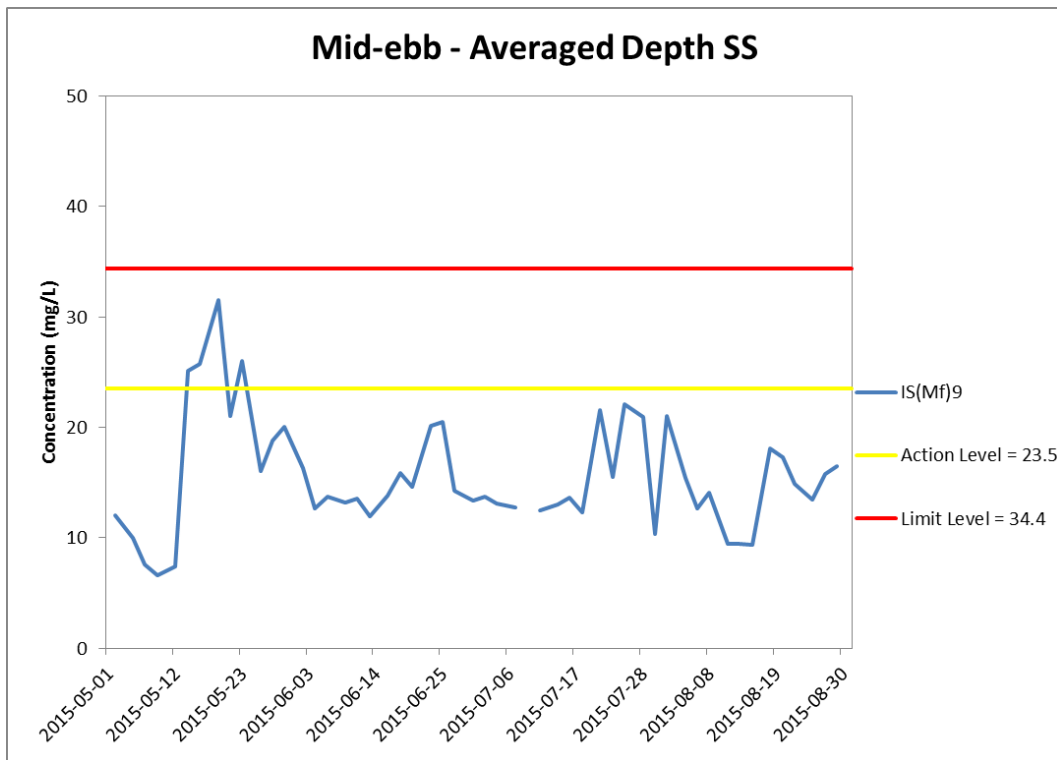
Figure H30 Impact Monitoring – Mean depth-averaged level of Suspended Solids (mg/L) during mid-ebb tide between 1 May and 31 August 2015 at IS(Mf)16 and IS(Mf)9.
