**Contract No. HY/2012/07
Tuen Mun – Chek Lap Kok Link –
Southern Connection Viaduct Section**

*Seventh Quarterly Environmental Monitoring &
Audit (EM&A) Report*

19 January 2016

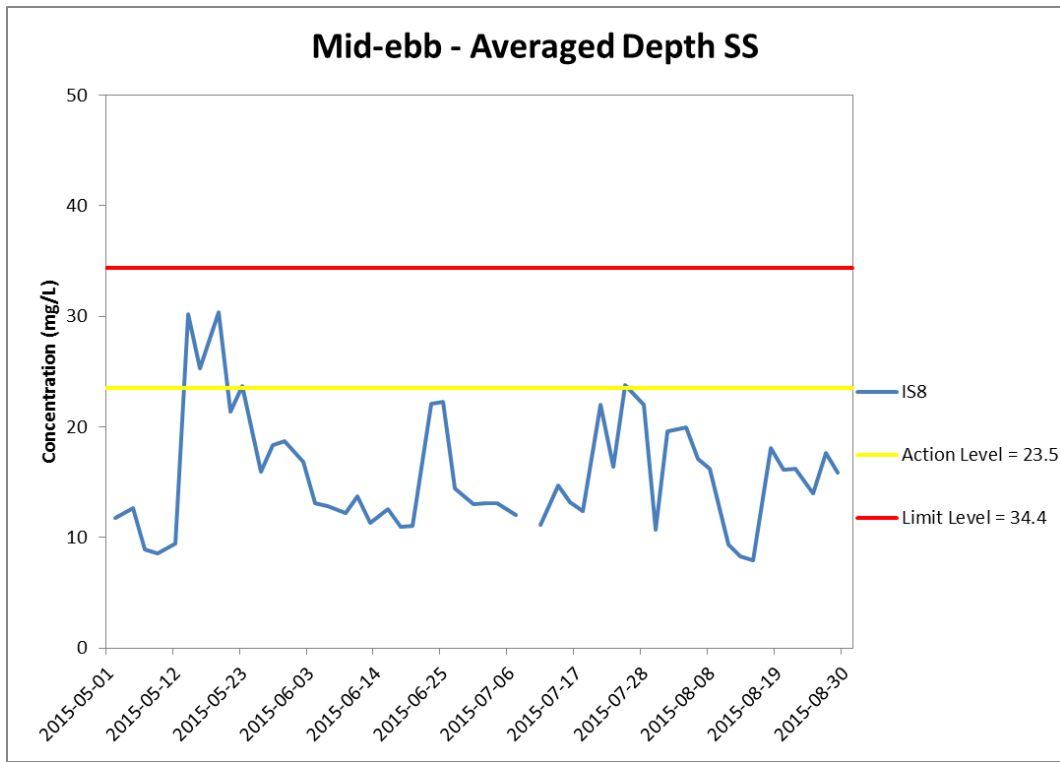
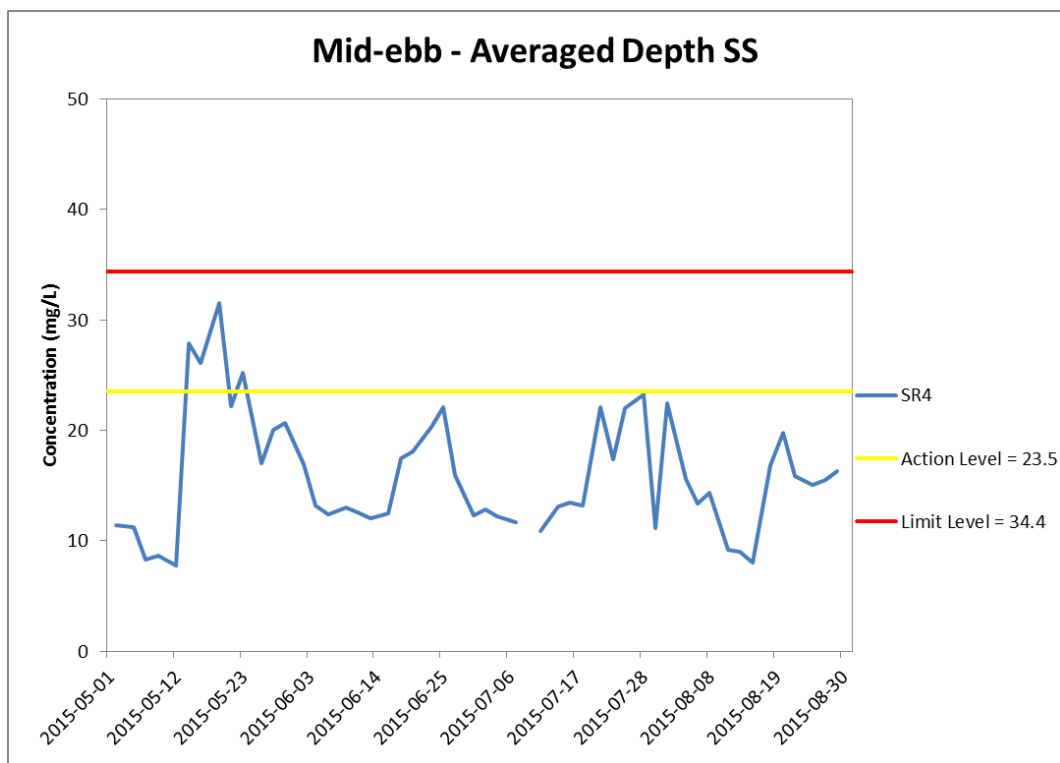
Figure H31 Impact Monitoring – Mean depth-averaged level of Suspended Solids (mg/L) during mid-ebb tide between 1 May and 31 August 2015 at IS8 and SR4.

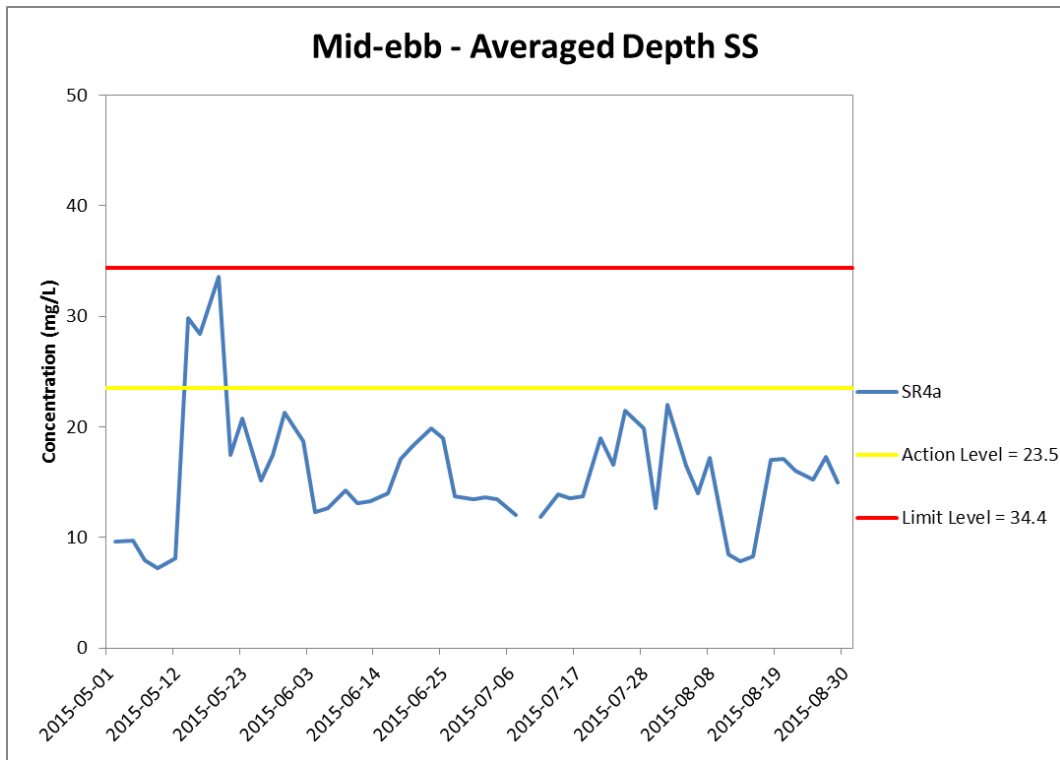
Figure H32 Impact Monitoring - Mean depth-averaged level of Suspended Solids (mg/L) during mid-ebb tide between 1 May and 31 August 2015 at SR4a.

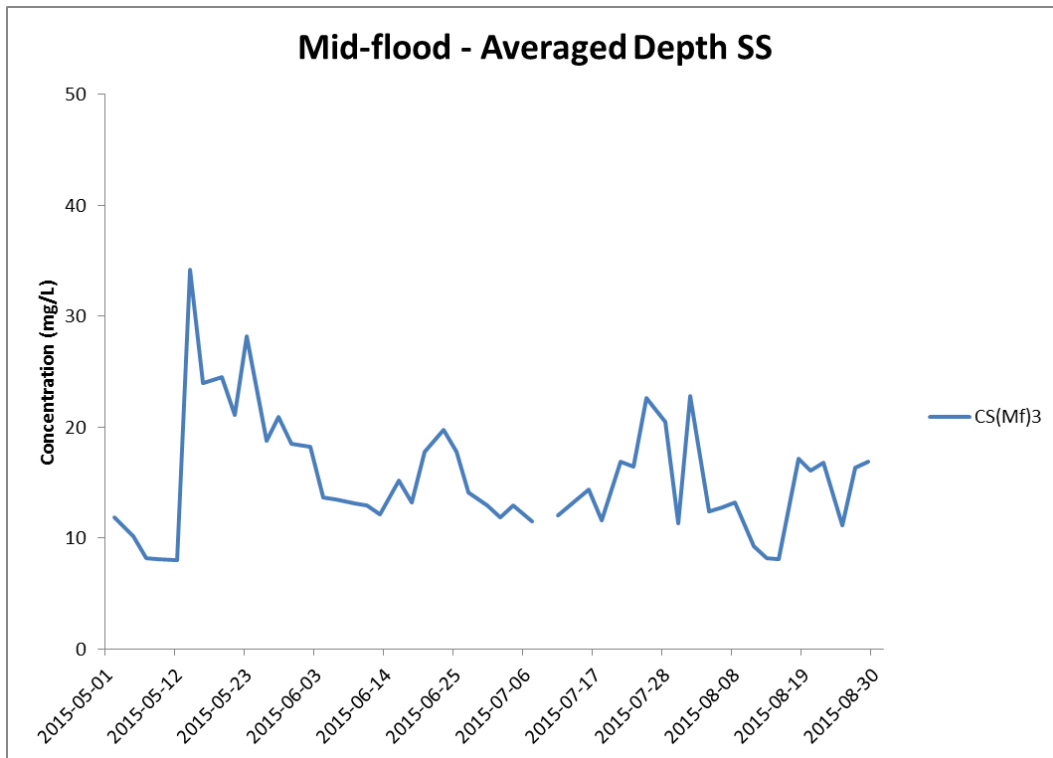
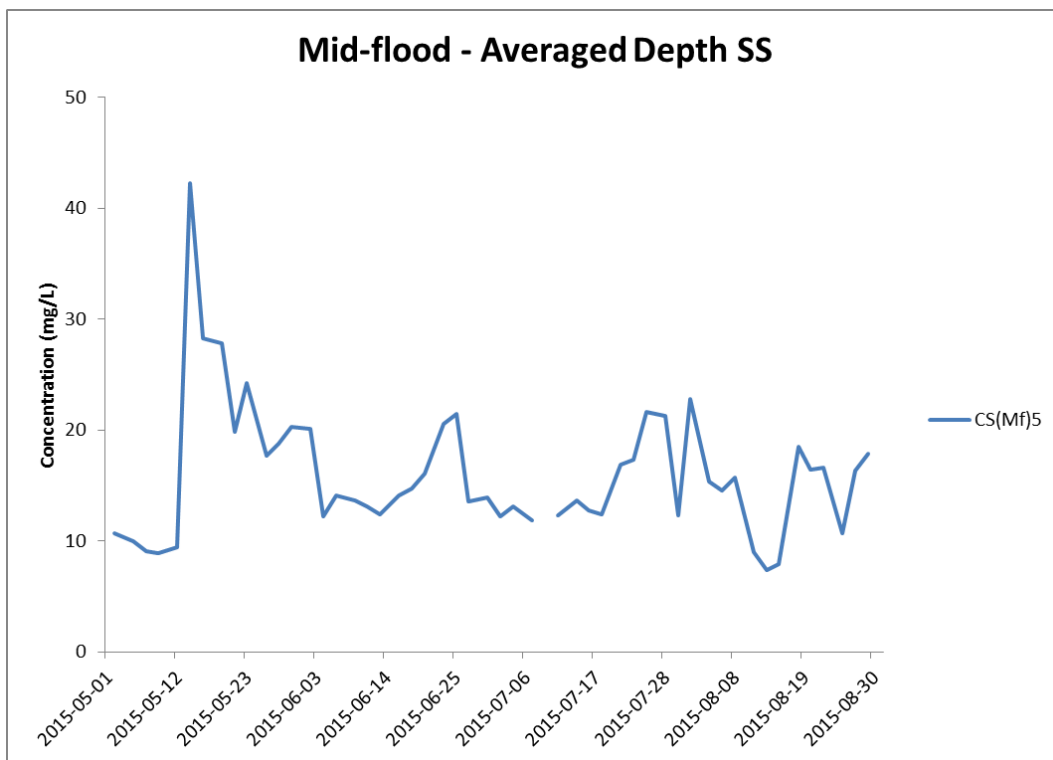
Figure H33 Impact Monitoring – Mean depth-averaged level of Suspended Solids (mg/L) during mid-flood tide between 1 May and 31 August 2015 at CS(Mf)3 and CS(Mf)5.

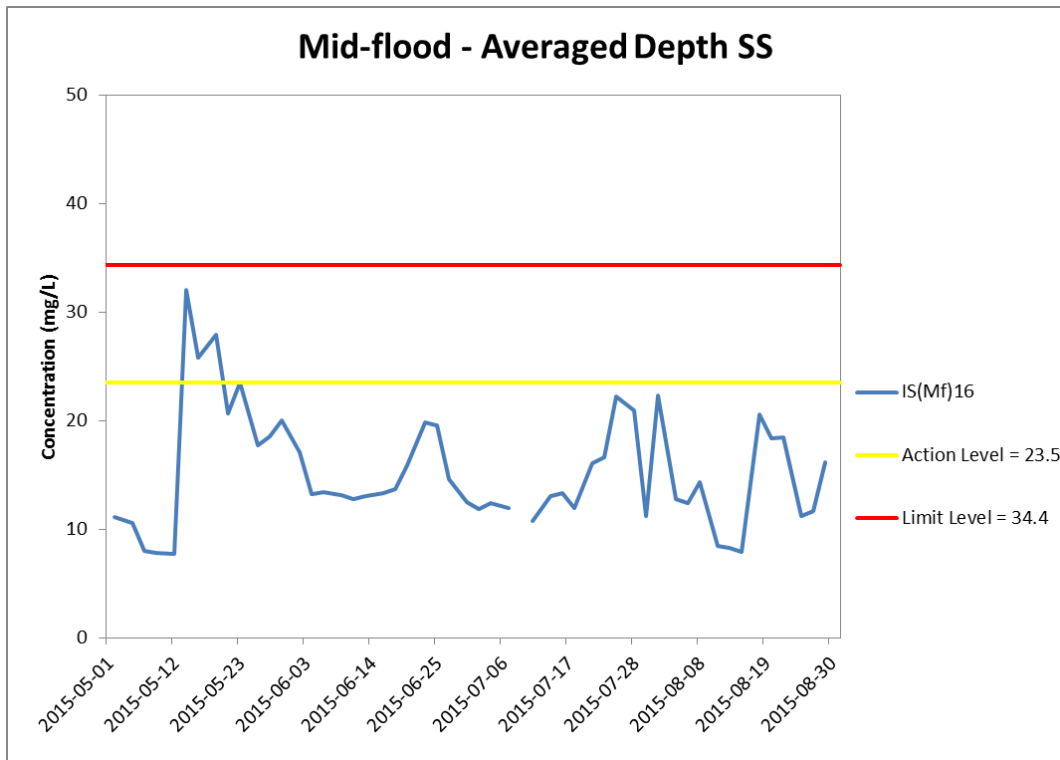
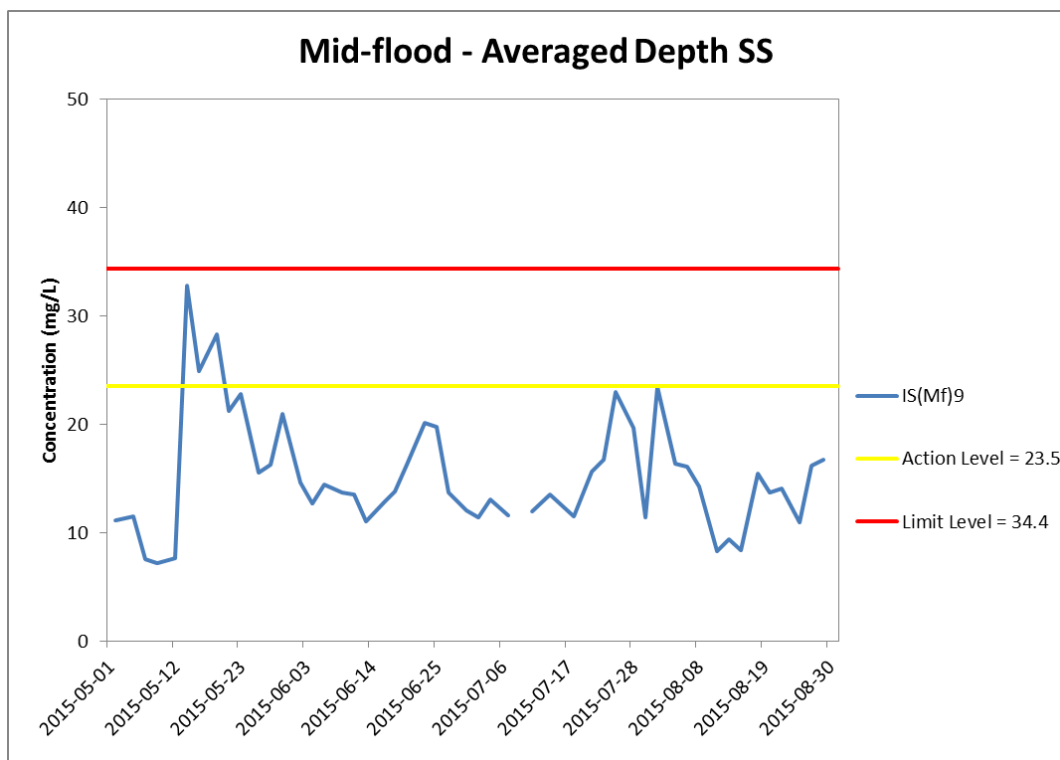
Figure H34 Impact Monitoring – Mean depth-averaged level of Suspended Solids (mg/L) during mid-flood tide between 1 May and 31 August 2015 at IS(Mf)16 and IS(Mf)9.

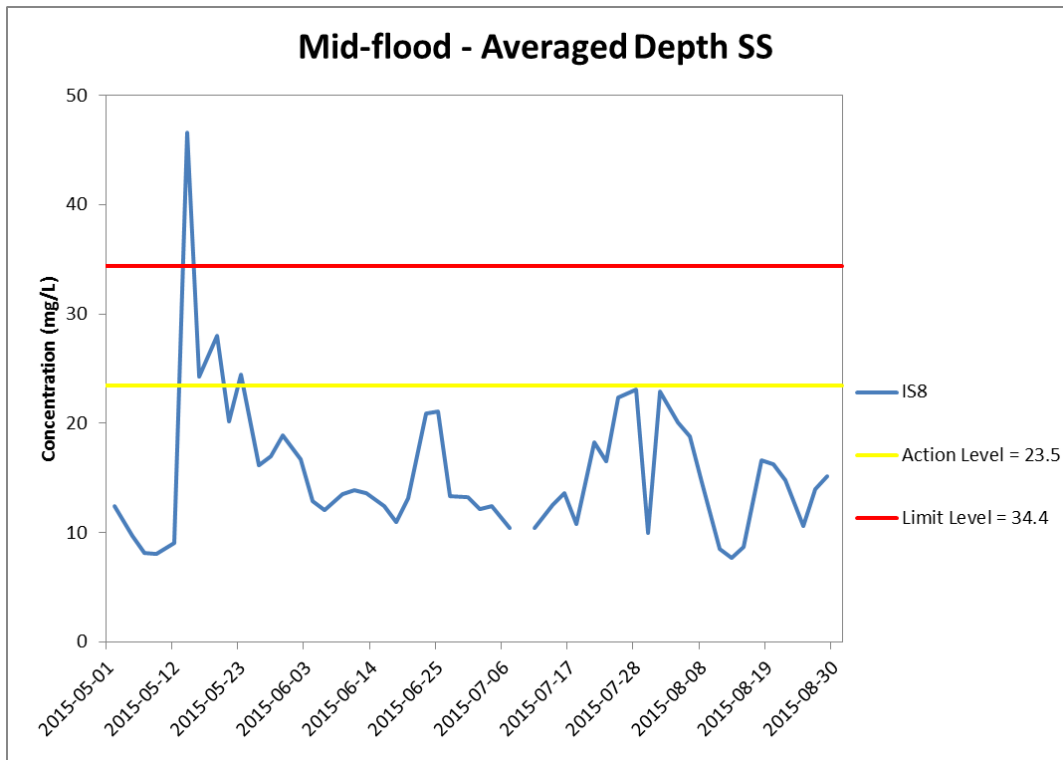
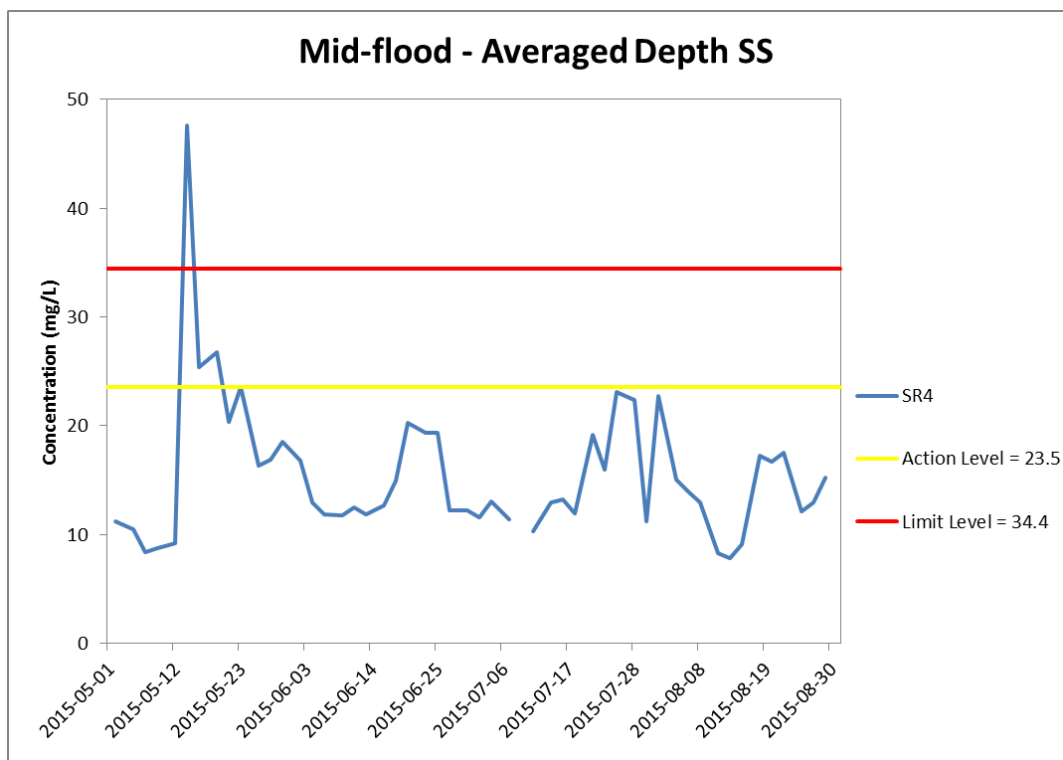
Figure H35 Impact Monitoring – Mean depth-averaged level of Suspended Solids (mg/L) during mid-flood tide between 1 May and 31 August 2015 at IS8 and SR4.

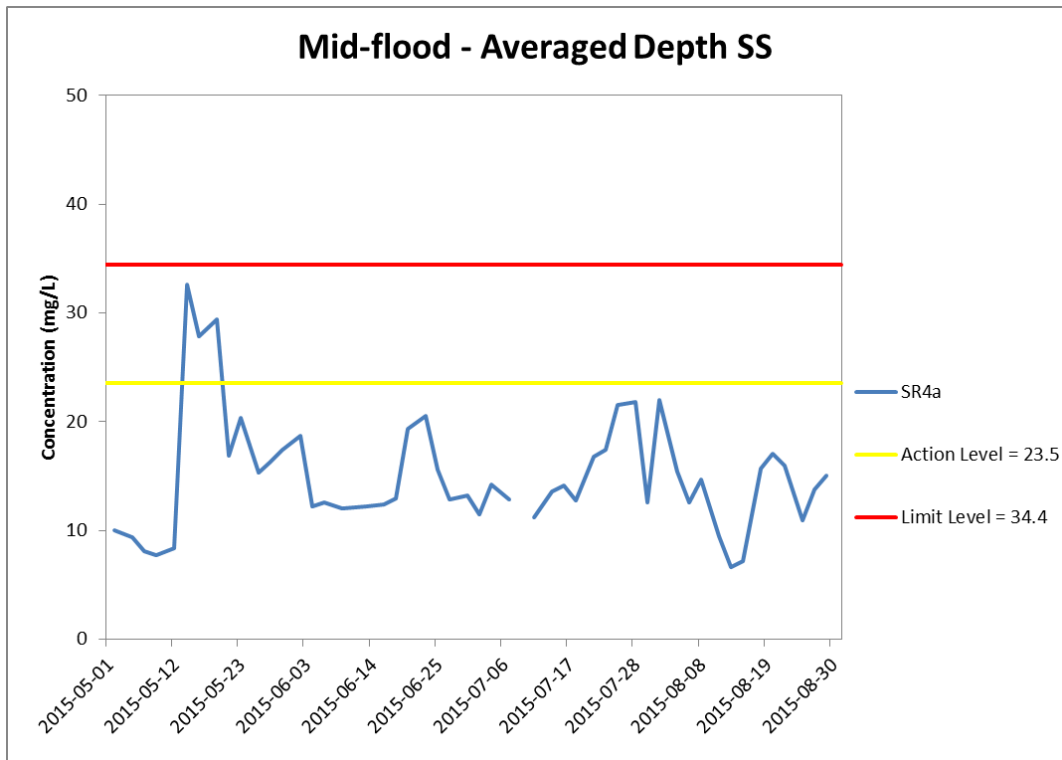
Figure H36 Impact Monitoring - Mean depth-averaged level of Suspended Solids (mg/L) during mid-flood tide between 1 May and 31 August 2015 at SR4a.
