**Contract No. HY/2012/07  
Tuen Mun – Chek Lap Kok Link –  
Southern Connection Viaduct Section**

*Second Annual Environmental Monitoring &  
Audit (EM&A) Report*

07 July 2016

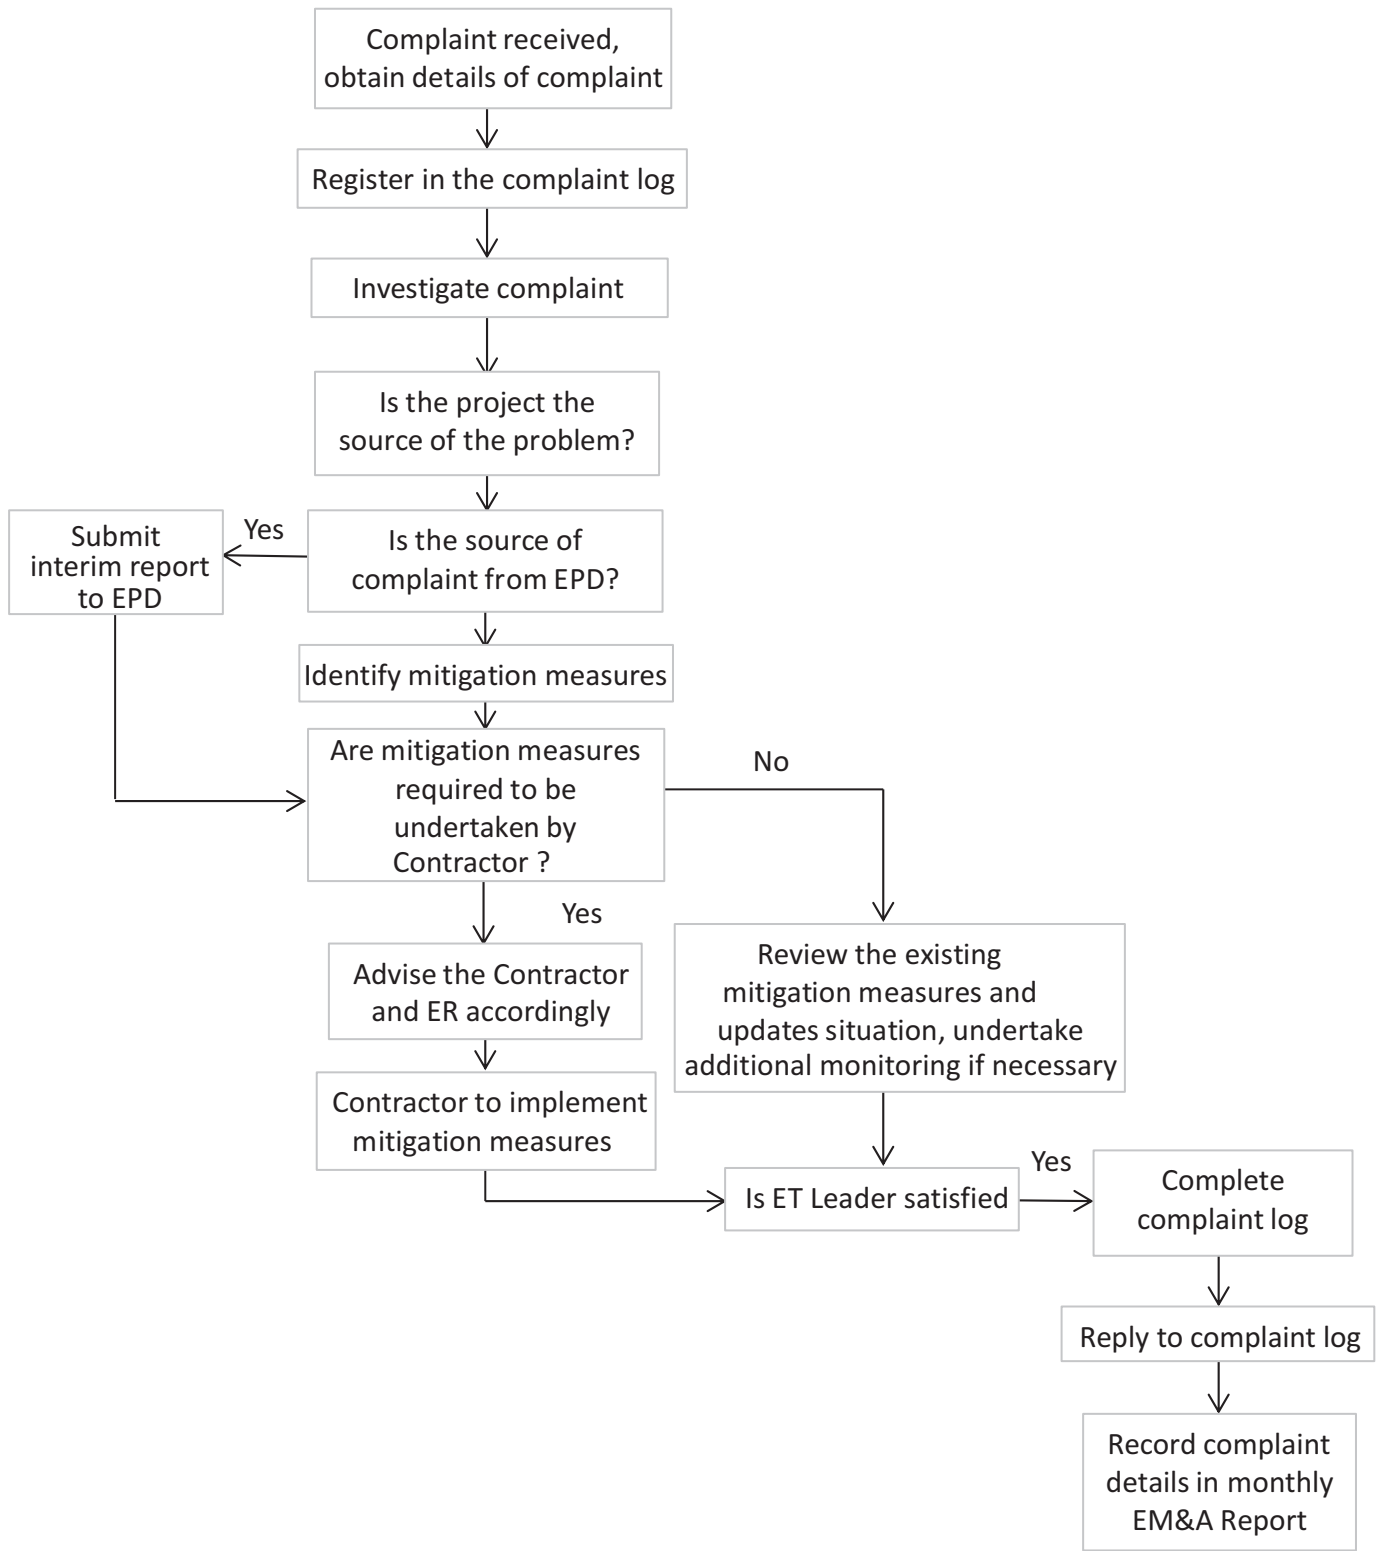
Figure 2.5 Environmental Complaint Handling Procedure

Two (2) complaints were received in the reporting period. The first complaint was referred by EPD to June 2015 regarding to the dust emission from dump trucks. Another complaint was referred by EPD in October 2015

regarding to potential noise from nighttime works. The complaints were followed up in accordance with the complaint handling procedure. Proper mitigation measures were recommended to the Contractor to minimize the corresponding impacts. The detailed investigation reports were presented in the *Appendix N* of the *Twentieth* and *Twenty-fourth Monthly EM&A Reports*.
