Contract No. HY/2010/02

Hong Kong – Zhuhai – Macao Bridge Hong Kong Boundary Crossing Facilities – Reclamation Works

Quarterly EM&A Report for
December 2014- February 2015

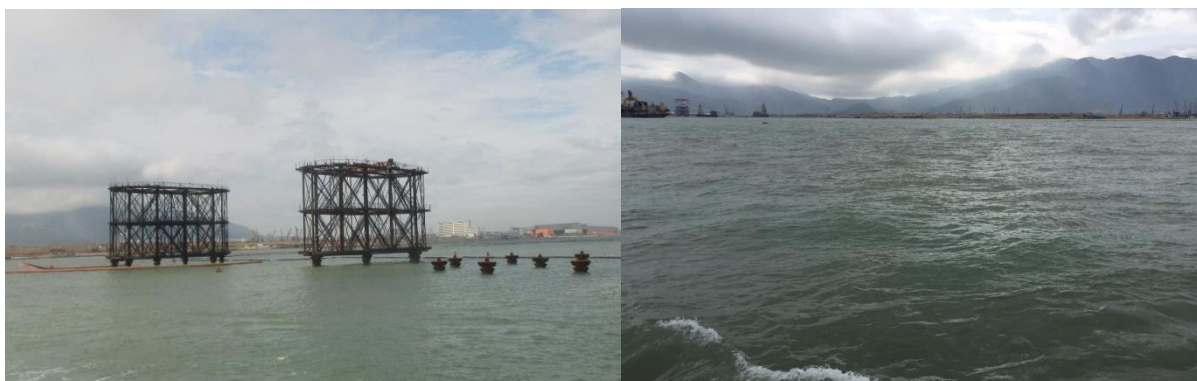
3.3.10.2 With reference to the silt curtain checking record, defects were observed at north and northwest part of the perimeter silt curtain which are close IS(Mf)11.

3.3.10.3 With referred to the layout map below, no marine based construction work was conducted on site on 23 February 2015 and no silt plume was observed to flow from the inside of the perimeter silt curtain to the outside of the perimeter silt curtain when monitoring was conducted during flood tide. (Also see below photo record for sea condition observed on 23 February 2015 during flood tide.

3.3.10.4 Photo record which shows the sea condition at north part of the HKBCF reclamation works during flood tide on 23 February 2015:

- 3.3.10.9 Nevertheless, the Contractor was reminded to ensure provision of ongoing maintenance to the silt curtains and to carry out maintenance work once defects were found.
