Contract No. HY/2010/02

**Hong Kong – Zhuhai – Macao Bridge  
Hong Kong Boundary Crossing  
Facilities –  
Reclamation Works**

**Quarterly EM&A Report for  
June 2015- August 2015**

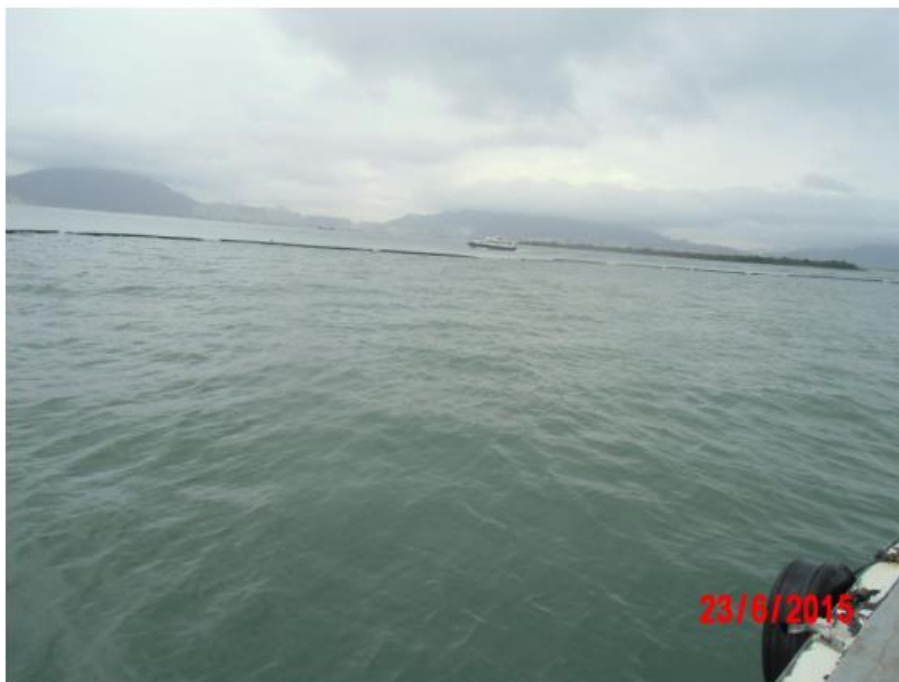
- 5.1.9.7 The oil stain observed was limited at nearby Northeastern sea area within the silt curtain.
- 5.1.9.8 Photo record shows that oil on sea was no longer on sea area near Cell No. 78. (Also refer to photo record below)

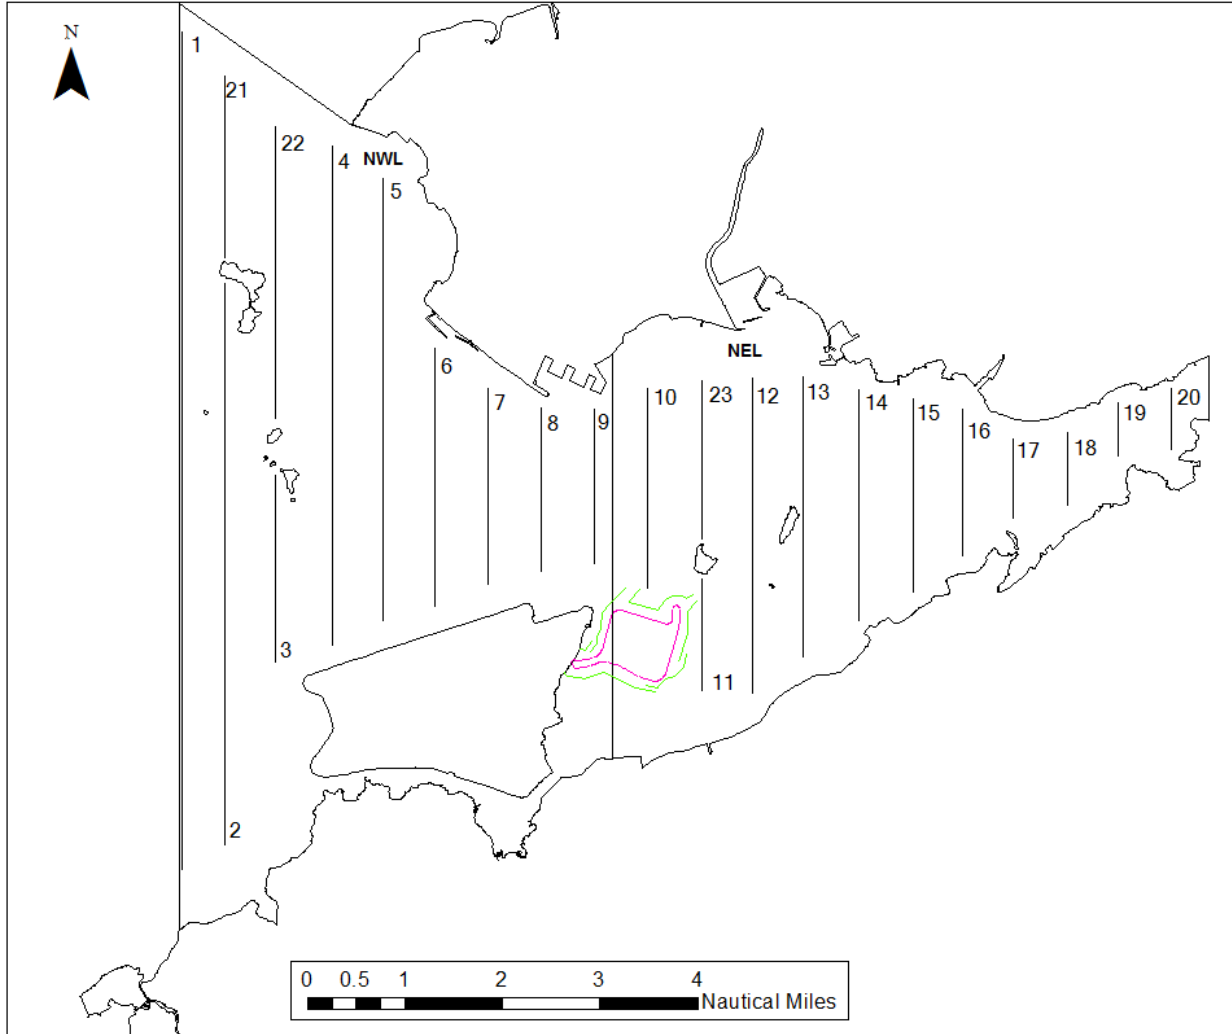
**Figure 2** Location of Transect Lines for Impact Monitoring during HKBCF (modification approved 19-08-2015)

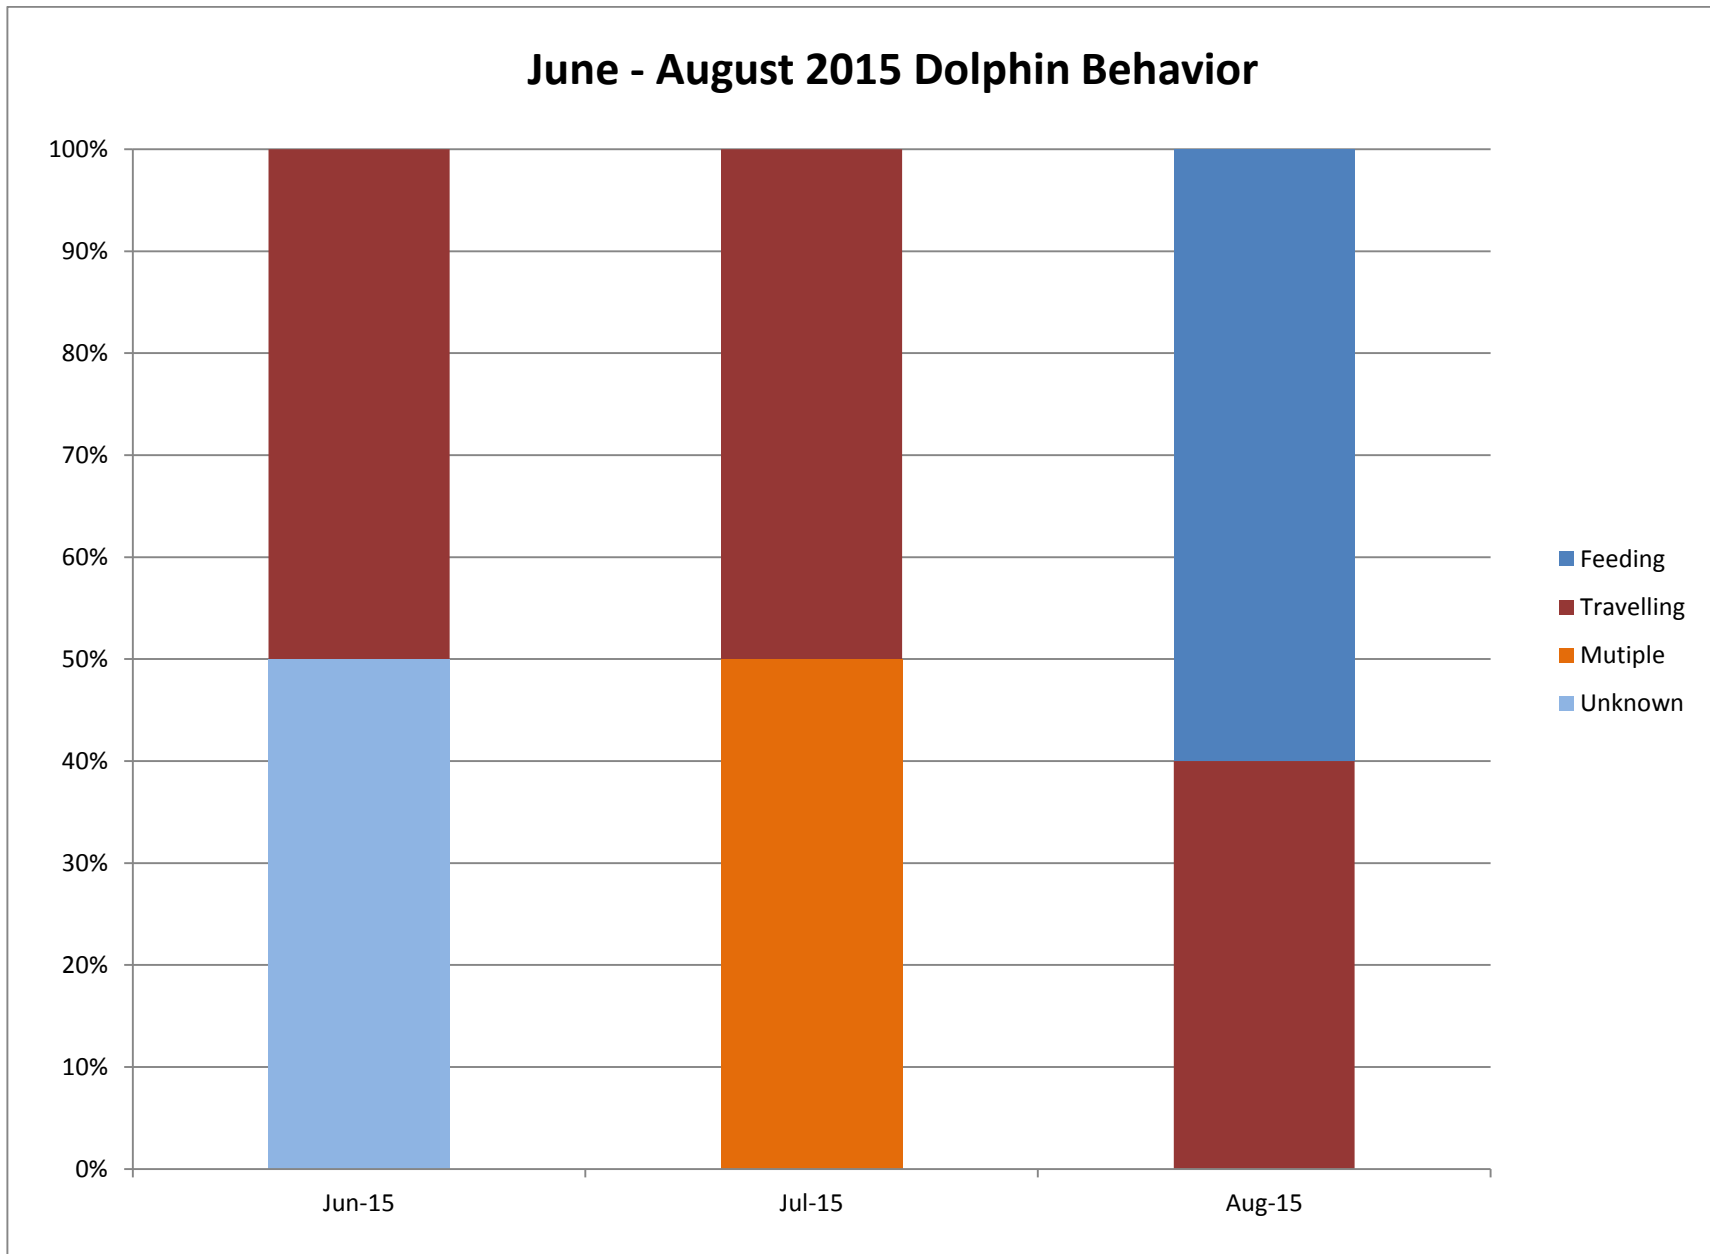
**Figure 11. Activity Budget for Dolphin Behaviour June to August 2015.**
