# Civil Engineering and Development Department

## Agreement No. CE 67/2015 (HY) Cycle Tracks from Tuen Mun to Sheung Shui – Remaining Works – Design and Construction

### Final EM&A Summary Report

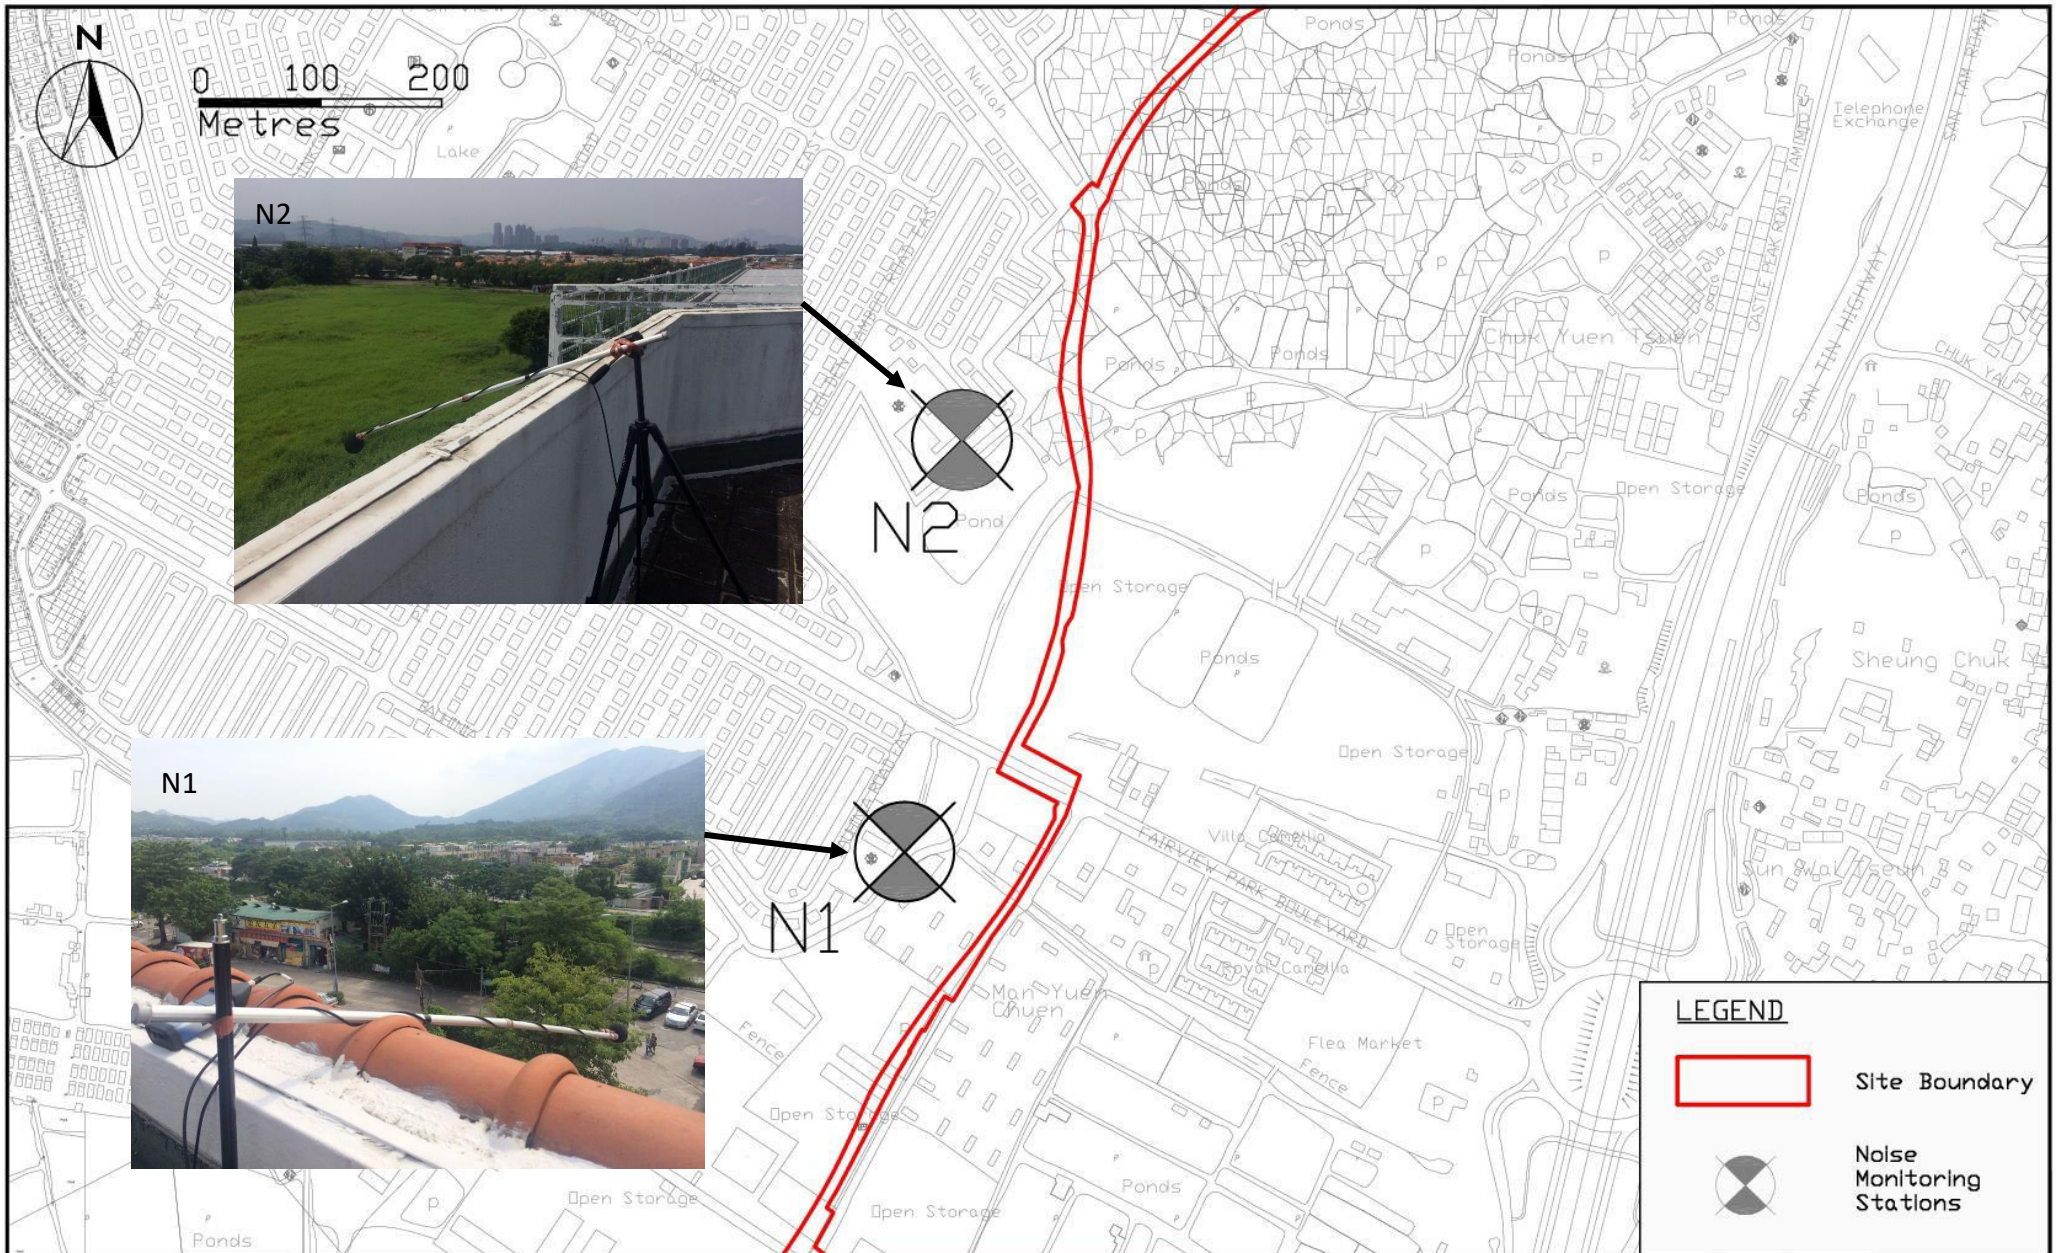
SCALE	A4 1:6m	DATE	Aug 2016
CHECK	JL	DRAWN	VW
JOB No.	MA16036	FIGURE NO.	2a
		REV	-

### Locations of the Noise Monitoring Stations (N1, N2)

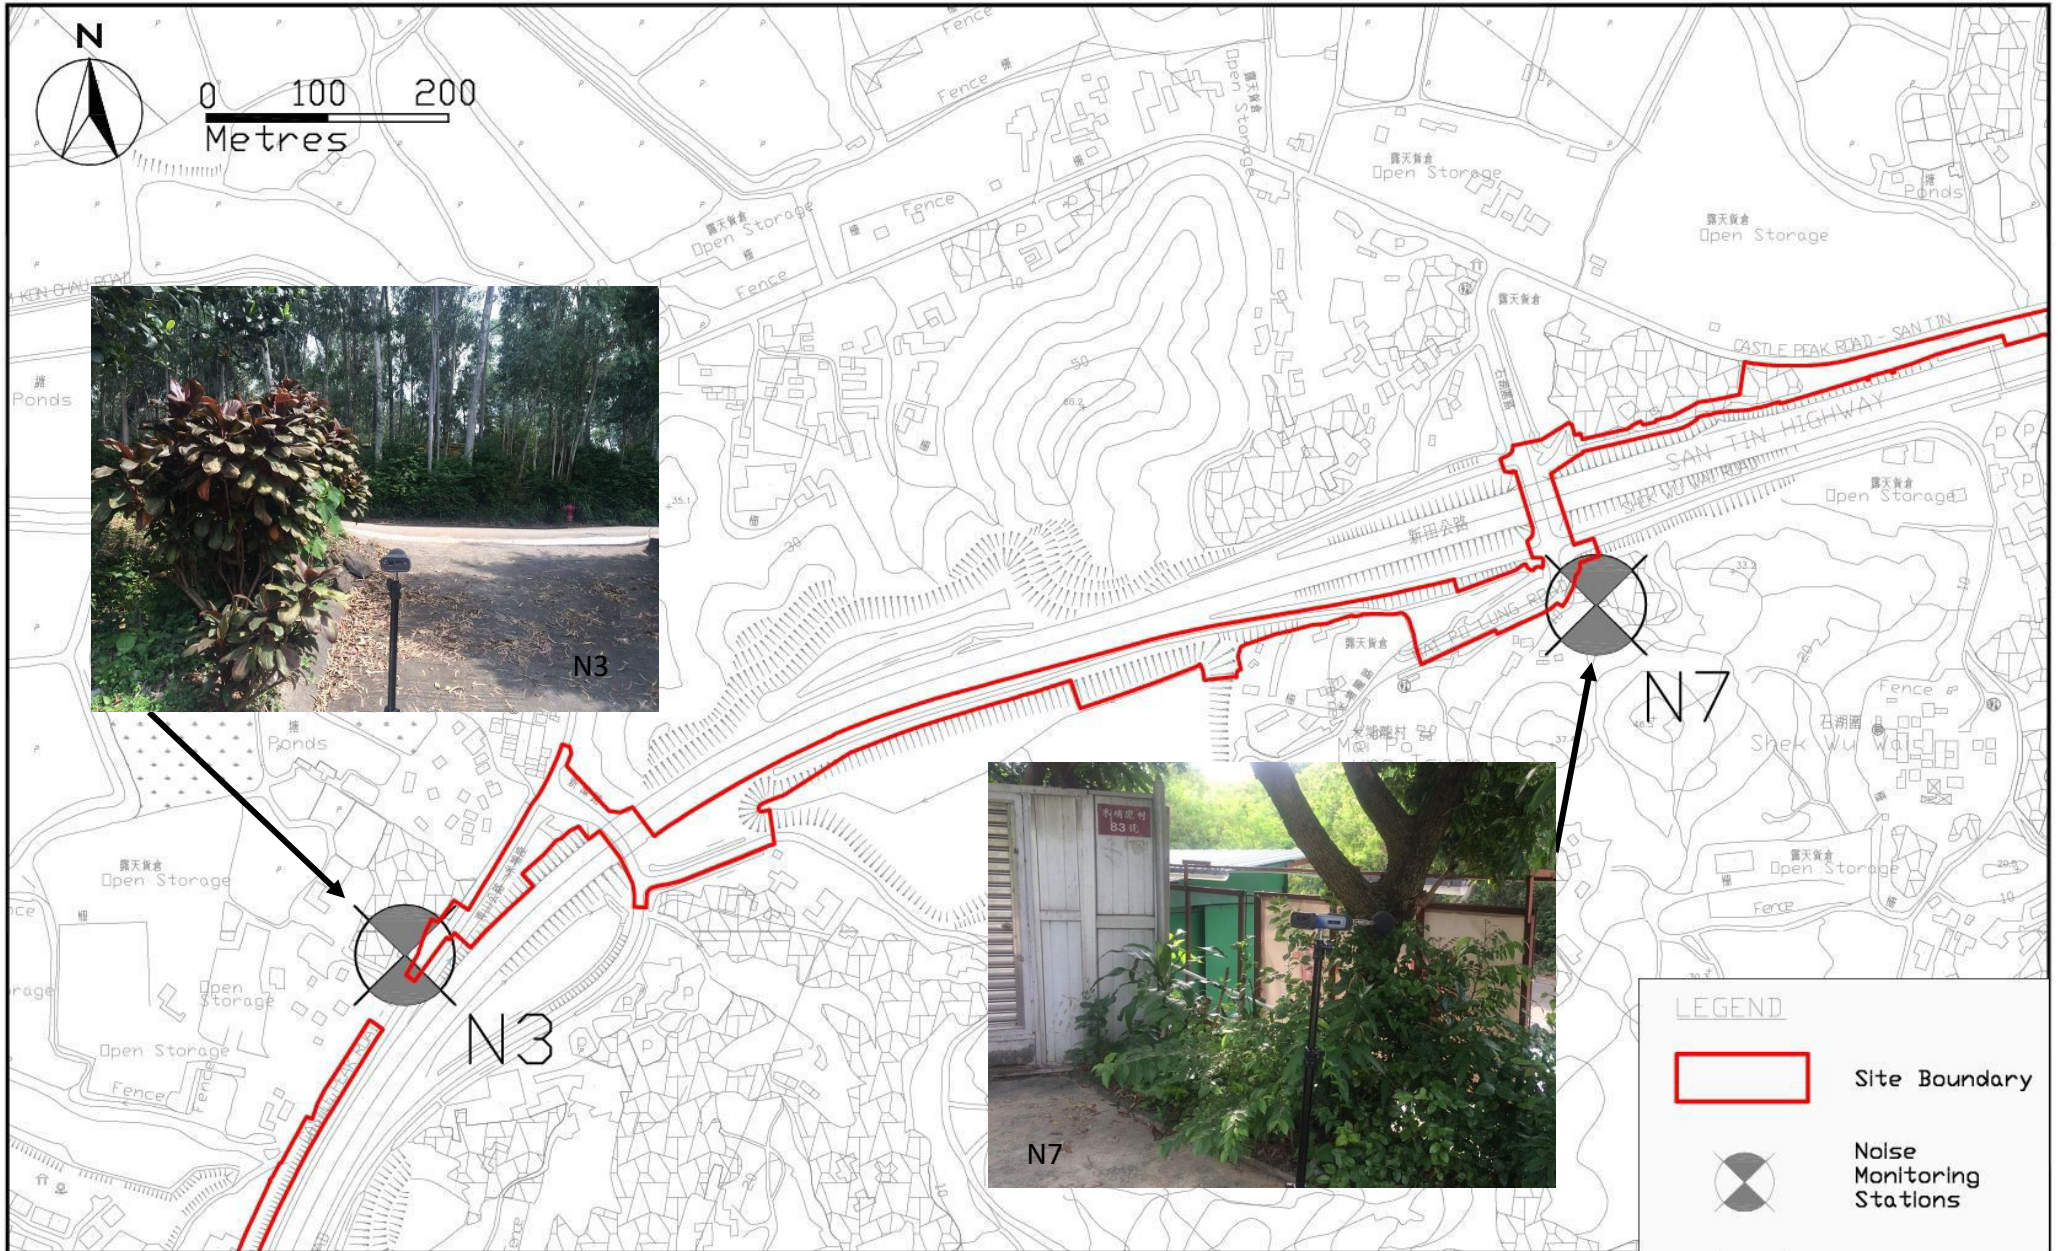
SCALE	A4 1:6m	DATE	Aug 2016
CHECK	JL	DRAWN	VW
JOB No.	MA16036	FIGURE NO.	2b
		REV	-

### Locations of the Noise Monitoring Stations (N3, N7)
