Contract No. HY/2010/02

## Hong Kong – Zhuhai – Macao Bridge Hong Kong Boundary Crossing Facilities – Reclamation Works

### Annual Review Report for March 2015 to February 2016

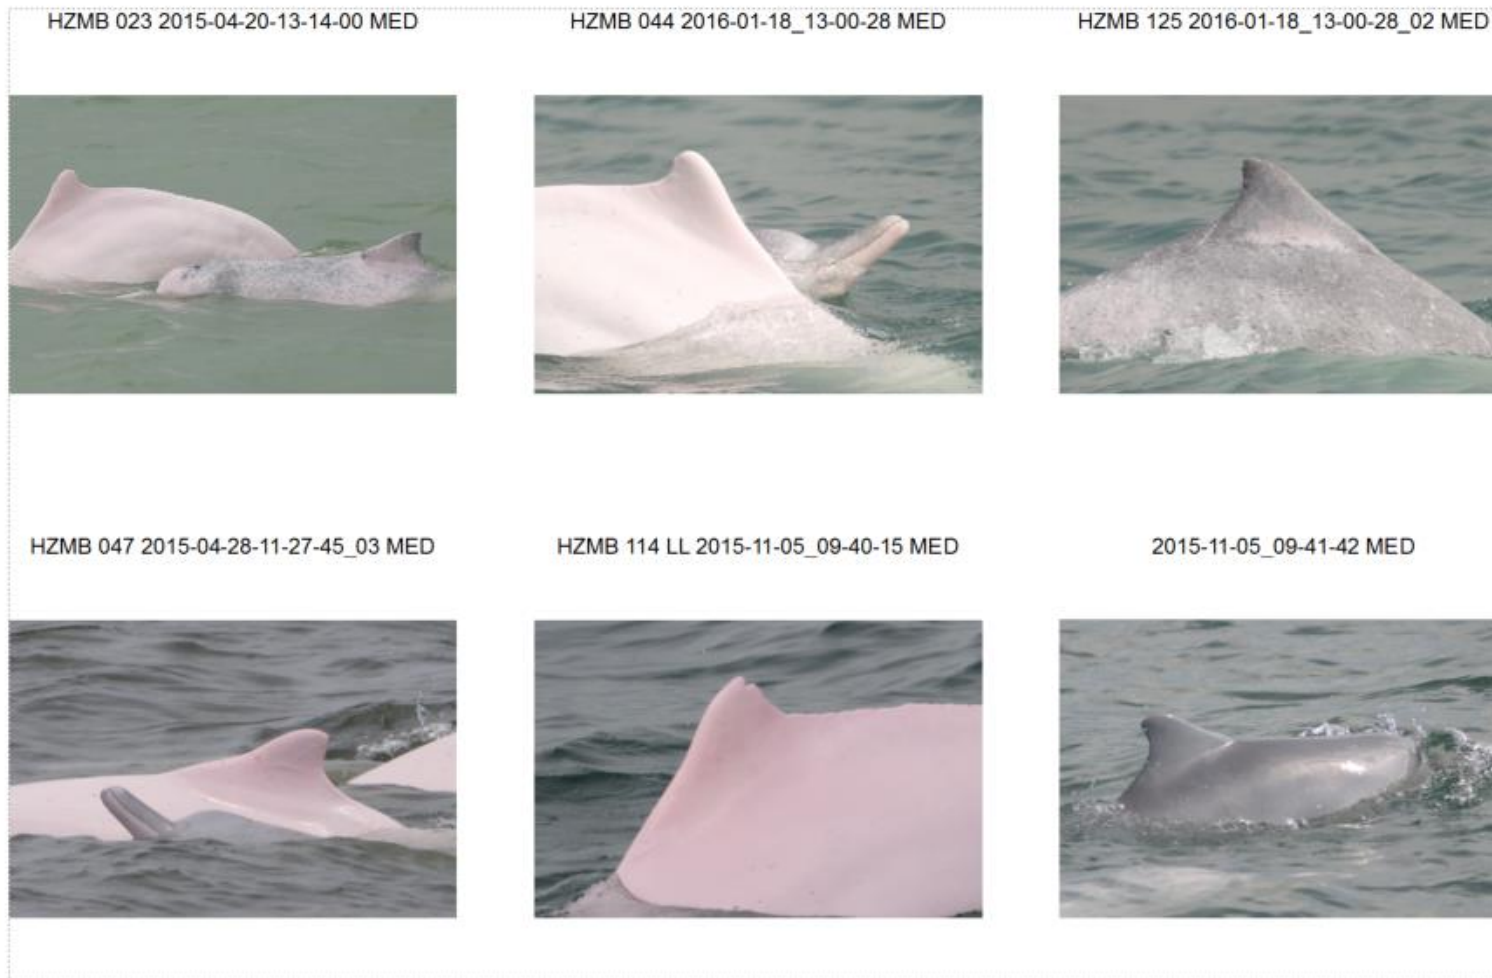
**Figure 9. Calves and Juveniles of Females Identified in the HZMB Catalogue seen during the year March 2015 - February 2015. HZMB 023 and HZMB 044 were sighted with offspring in 2012 and HZMB 047 and HZMB 114 were first sighted with calves in 2015-16.**
