Contract No. HY/2010/02

Hong Kong – Zhuhai – Macao Bridge Hong Kong Boundary Crossing Facilities – Reclamation Works

Quarterly EM&A Summary Report for December 2015 to February 2016

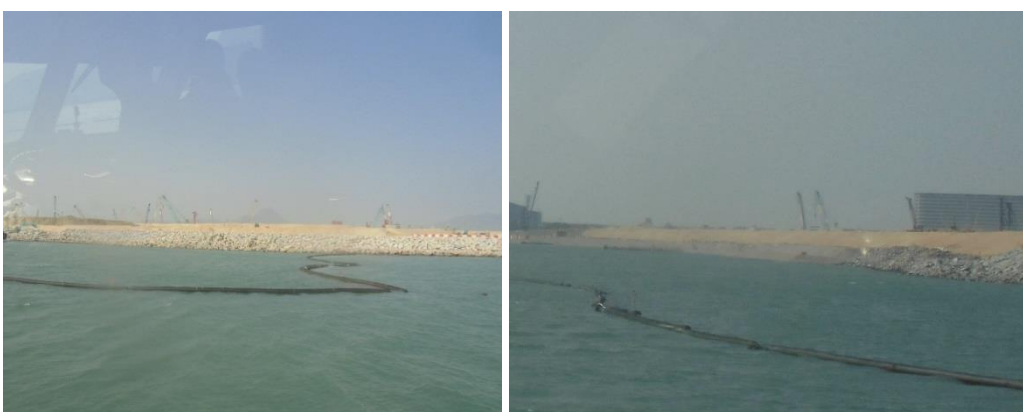
- 3.3.3.4 Photo record below which shows the sea condition at southern and southeastern part of the HKBCF reclamation works during flood tide on 5 February 2016.

- 3.3.3.5 Also, turbidity and suspended solids levels recorded at IS7, IS(Mf)9 and IS(Mf)16 were below the action and limit level. This indicates that the turbidity and suspended solids levels recorded at monitoring stations closer to the active works, were not adversely affected. As such, the exceedances recorded at SR4(N) and IS8 were unlikely attribute to the active works of this Contract.

- 3.3.3.12 Nevertheless, the Contractor was reminded to ensure provision of ongoing maintenance to the silt curtains and to carry out maintenance work once defects were found.
 - 3.3.3.13 Maintenance work of the silt curtain was carried out by the Contractor on a daily basis except Sunday and public holiday.
 - 3.3.3.14 The Contractor was reminded to adhere to the environmental permit requirement and undertake the necessary mitigation measures after the realignment of the perimeter silt curtain near southeastern corner of HKBCF Reclamation Works, as necessary.
- 3.3.4 The event action plan is annexed in Appendix K.

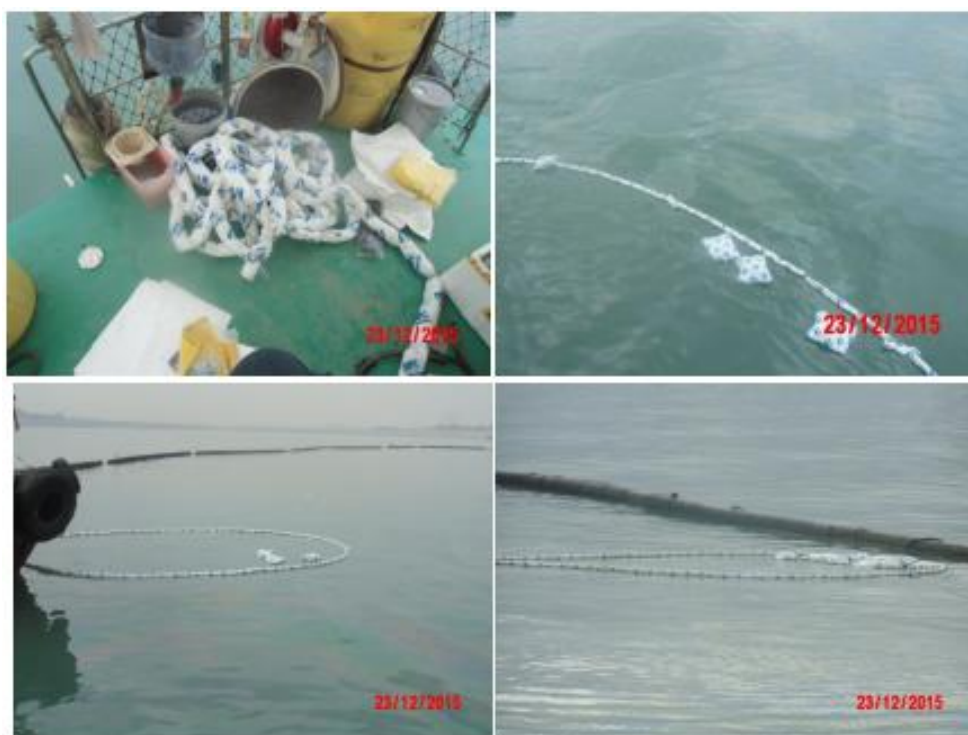
- The Contractor organized manpower to identify the spill source. During inspection, no construction vessel was observed around the concerned area and the source of oil spill was not identified.
- The oil spill was identified during inspection conducted by the Contractor and RSS on 23 December 2015 as discrete, non-continuous source with approximately 50m² spread. The below photo shows that the Contractor deployed absorption booms to remove the floating oil from water.

5.1.8.4 The following actions were taken by the Contractor:

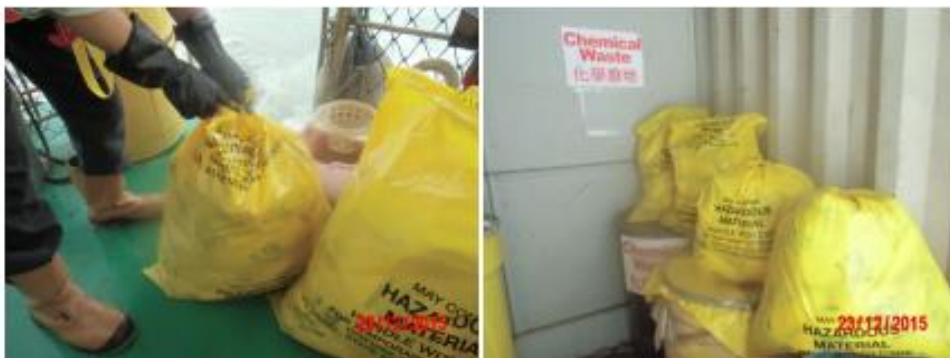
5.1.8.5 The below photos shows that the used absorption booms were collected using disposal bags as part of the spill kits item. The used absorption booms were disposed of as chemical waste by the Contractor.

5.1.8.6 The oil stain observed was limited at nearby southern sea area within the silt curtain.

5.1.8.10 The Contractor was reminded to continue to follow the spill response plan when oil is observed on sea.

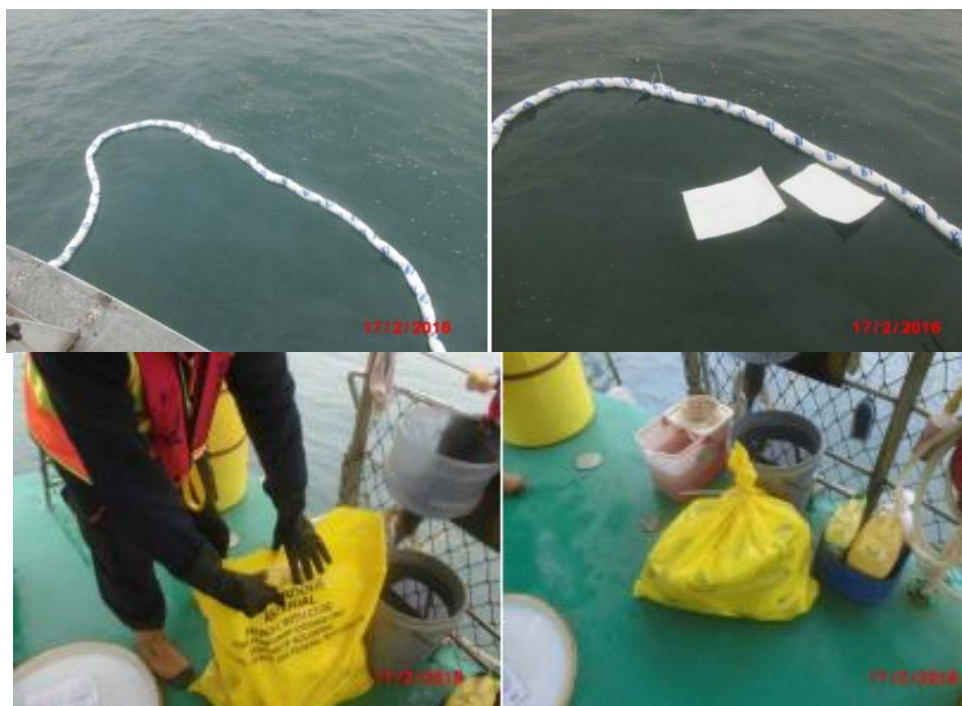
5.1.10.5 The oil spill was identified during join site inspection conducted by the Contractor and RSS on 17 Feb 2016 as discrete, non-continuous source with approximately 20m² spread. Also refer to photo below:

5.1.10.6 The Contractor deployed absorption booms to remove the floating oil from water and the used absorption booms were collected using disposal bags as part of the spill kits item. The used absorption booms were disposed of as chemical waste by the Contractor. (Also refer to photo record below).
