Contract No. HY/2010/02

Hong Kong – Zhuhai – Macao Bridge Hong Kong Boundary Crossing Facilities – Reclamation Works

Quarterly EM&A Summary Report for March 2016 – May 2016

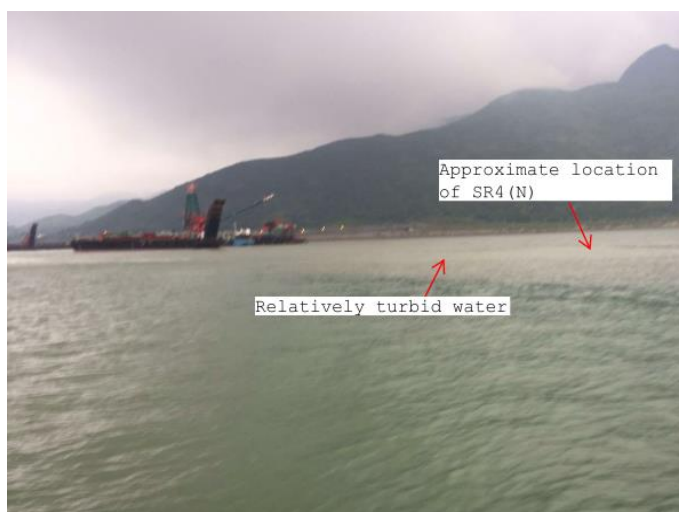
- 3.3.2.7 With referred to the photo record 2 taken at monitoring station SR4(N) on 20 May 2016 (also see attached photo record) turbid water was observed at this area. However, with referred to the photo record 1 taken at southern and southeastern part of the HKBCF reclamation works during flood tide on 20 May 2016, turbid water was not noted. Photo record 2 shows that vessel activities was observed when monitoring was conducted at monitoring location SR4(N), as confirmed with the Contractor of HY/2010/02, this Contract did not have any construction vessels working outside the site boundary of Contract HY/2010/02 on 20 May 2016 (also refer to the above layout map).

- 3.3.2.8 Photo record 2 which shows the sea condition taken on 20 May 2016 at near monitoring location SR4(N) and facing monitoring station SR4(N), turbid water was observed at this area.

- 3.3.2.9 The exceedances were likely due to local effects in the vicinity of SR4(N).
- 3.3.2.10 After investigation, there is no adequate information to conclude the recorded exceedances are related to this Contract.
- 3.3.2.11 Action taken under the action plan:
1. Not applicable as SS was not measured in situ;
 2. After considering the above mentioned investigation results, it appears that it was unlikely that the suspended solids exceedance was attributed to active construction activities of this Contract;
 3. IEC, Contractor, ER and EPD were informed via email;
 4. Monitoring data, all plant, equipment and Contractor's working methods were checked;
 5. Since it is considered that the suspended solids exceedance is unlikely to be contract related, as such, actions 5-7 under the EAP are not considered applicable.

- 3.3.2.12 Nevertheless, the Contractor was reminded to ensure provision of ongoing maintenance to the silt curtains and to carry out maintenance work once defects were found.
- 3.3.2.13 Maintenance work of the silt curtain was carried out by the Contractor on a daily basis except Sunday and public holiday.
- 3.3.2.14 The Contractor was reminded to adhere to the environmental permit requirement and undertake the necessary mitigation measures after the realignment of the perimeter silt curtain near southeastern corner of HKBCF Reclamation Works, as necessary.
- 3.3.2.15 No exceedance was recorded at all other monitoring stations in the reporting period.
- 3.3.3 The Impact Water Quality Monitoring originally scheduled on 27 May 2016 was cancelled due to Tropical Cyclone Warning Signal No.3 was hoisted.
- 3.3.4 The event action plan is annexed in Appendix K.
