Contract No. HY/2010/02

Hong Kong – Zhuhai – Macao Bridge Hong Kong Boundary Crossing Facilities – Reclamation Works

Quarterly EM&A Summary Report for June 2016 – August 2016

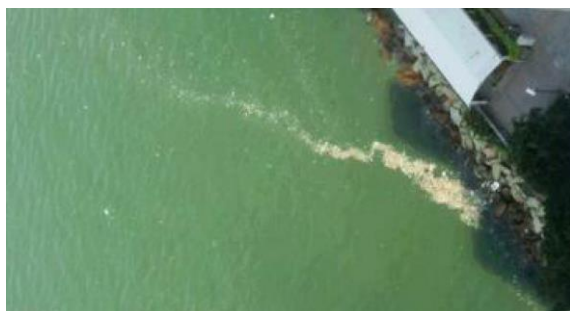
7.1.2 A complaint about marine litter near Tuen Mun Ferry Pier was received on 16 Jul 2016, 9:19am, also refer to below photo. The complainant complained that pollution was observed at Tuen Mun Ferry Pier and queried whether the pollutant came from the construction sites of the Lantau area or bridge construction.

- 1: Review of the information and provided by the complainant
- 2: Review the work activities conducted by Contract HY/2010/02 HKBCF Reclamation on 16 July 2016.
- 3: Review site condition
