Contract No. HY/2010/02

**Hong Kong – Zhuhai – Macao Bridge  
Hong Kong Boundary Crossing  
Facilities –  
Reclamation Works****Monthly EM&A Report for November 2017**

**Contract No. HY/2010/02 – HZMB HKBCF – Reclamation Works  
Monthly Environmental Monitoring & Audit Report for November 2017**

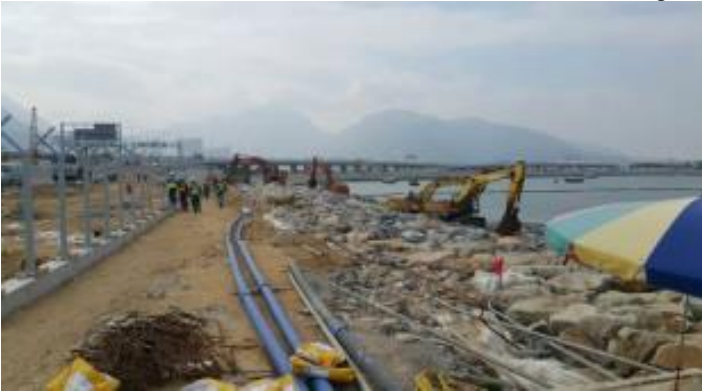
Photo record taken on 23 November 2017, shows no fugitive dust was generated at seawall construction area.

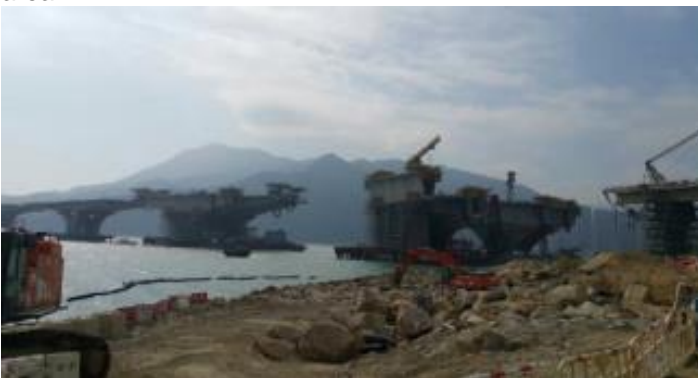
Photo record taken on 23 November 2017, shows no fugitive dust was generated at outfall pipeline installation area.

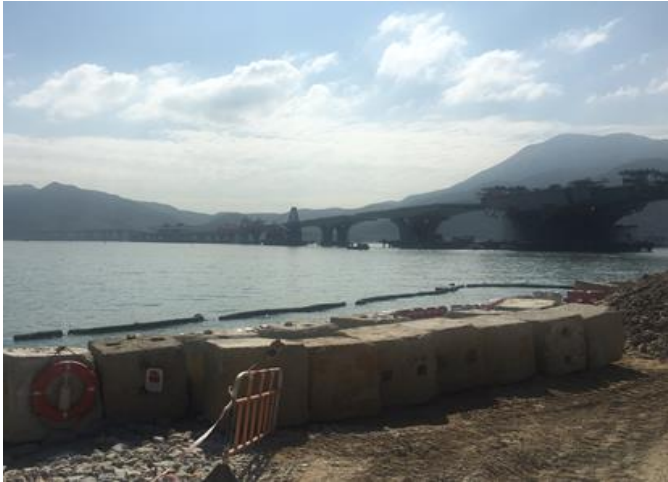
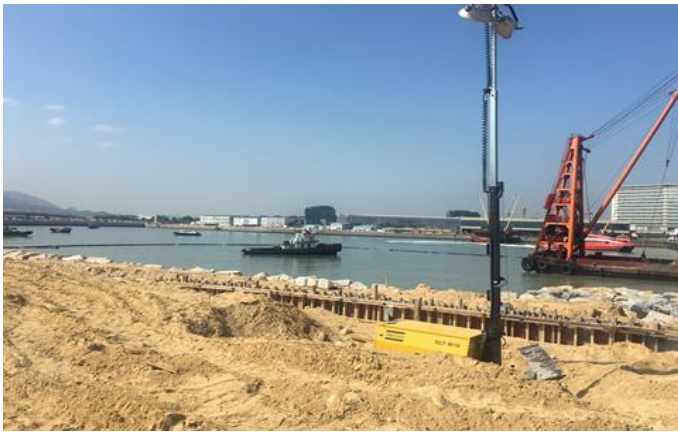
- out on 3 November 2017 which are unlikely to cause SS exceedances at the monitoring stations IS(Mf)11 and SR7 mentioned in Table 1.
- With referred to photo record taken on 9 November 2017 active works area was confined within silt curtain which was properly maintained during the period and no silt plume was observed at active works areas.
- In addition, there was no exceedances recorded at monitoring stations IS(Mf)16 and IS10(N) which are located closer to active works than it is of monitoring station mentioned in Table 1.
- Therefore, the recorded SS exceedances on 3 November 2017 during flood tide were unlikely to be related to construction works under Contract HY/2010/02.

Photo record show silt curtain condition and active seawall construction area on 9 Nov 2017.

The Contractor to properly implement all relevant water quality mitigation measures.

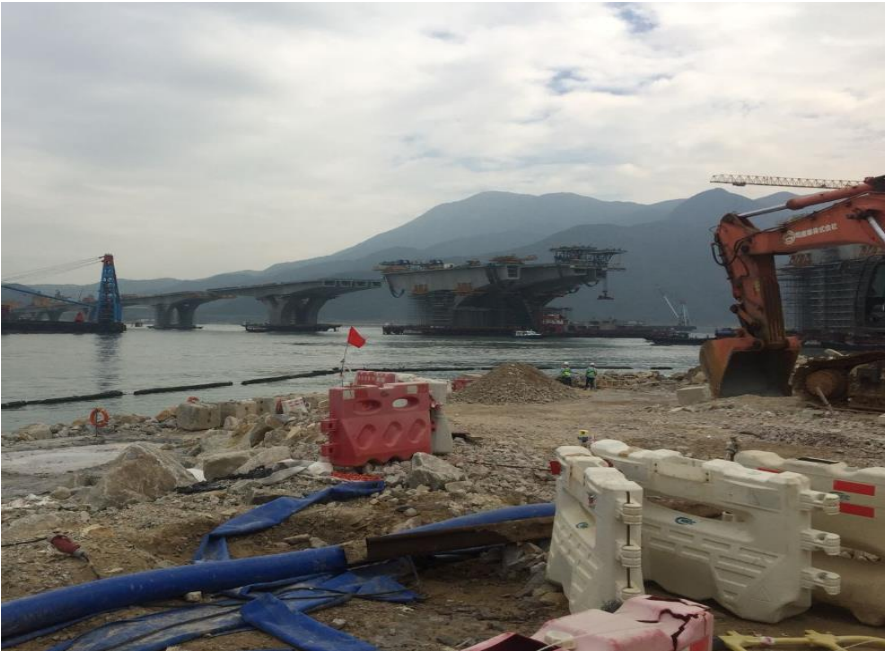
- carried out on 6 November 2017 which are unlikely to cause SS exceedances at the monitoring stations IS(Mf)16 and SR7 mentioned in Table 1.
- With referred to photo record taken on 6 November 2017 active works area were confined within silt curtain which were properly maintained during the period and no silt plume was observed at active works areas.

Photo record shows condition of silt curtain and active works area at outfall area on 6 Nov 2017.

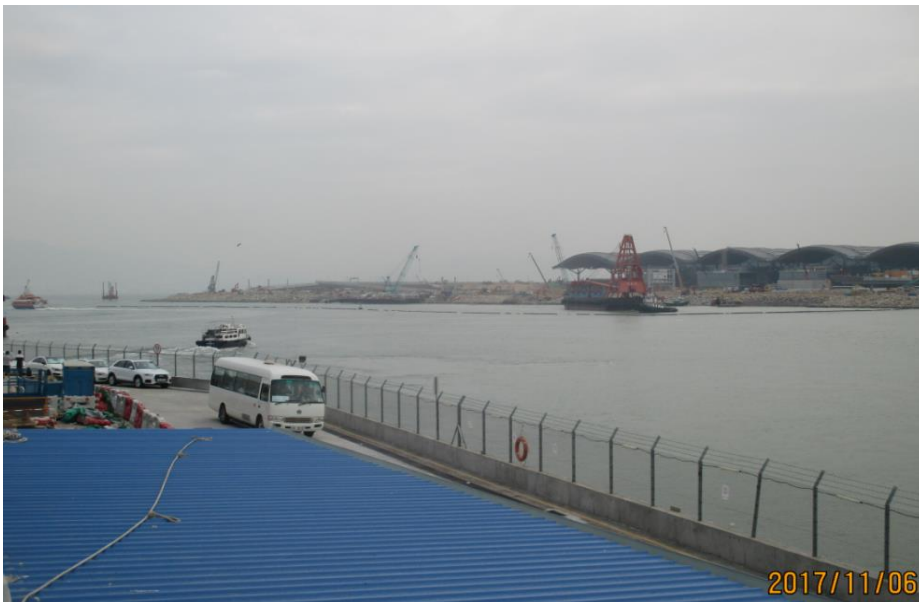
Photo record show silt curtain condition and active seawall construction area on 6 Nov 2017.

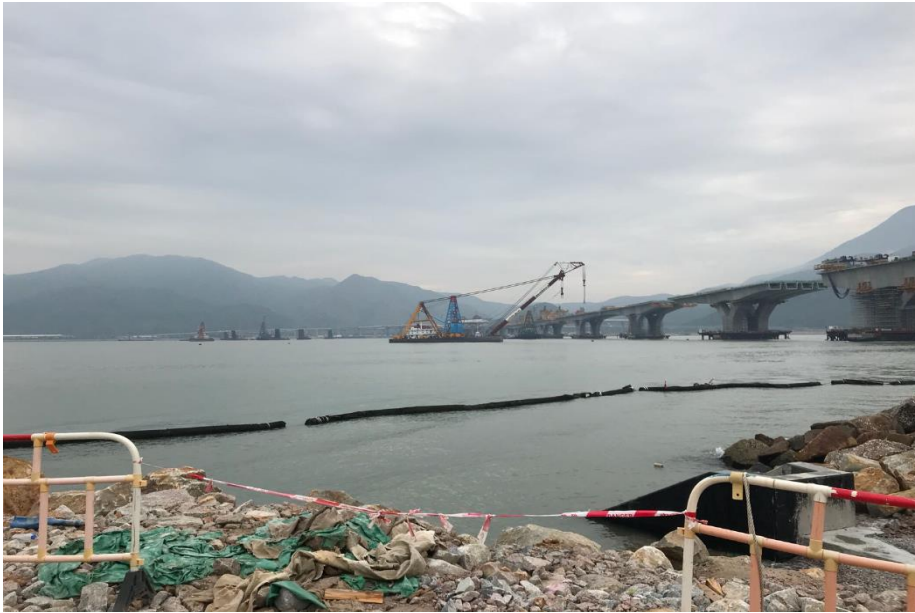
- With referred to photo record taken on 8 November 2017 active works area were confined within silt curtain which were properly maintained during the period and no silt plume was observed at active works areas.

Photo record shows condition of silt curtain and active works area at outfall area on 8 Nov 2017.

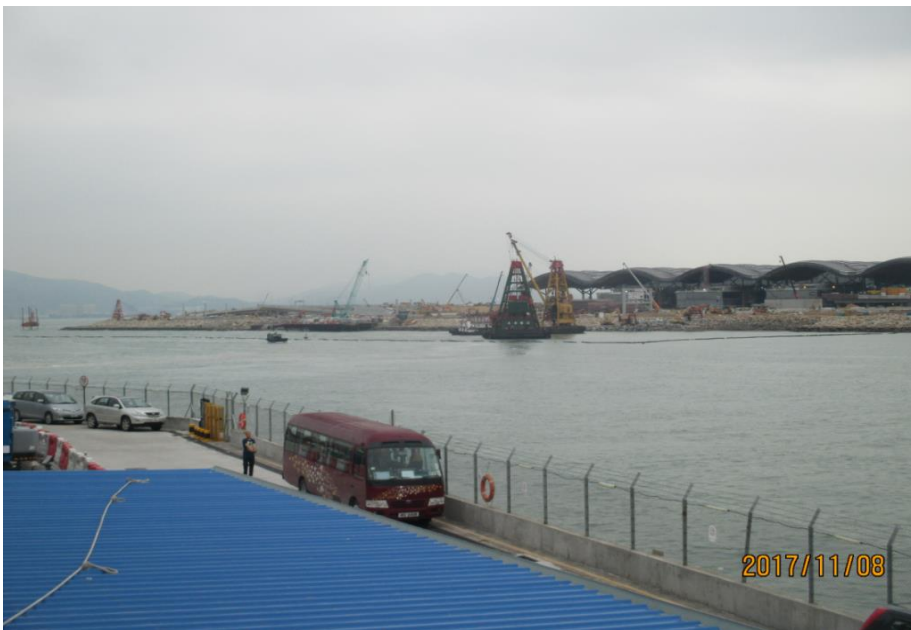
Photo record show silt curtain condition and active seawall construction area on 8 Nov 2017.

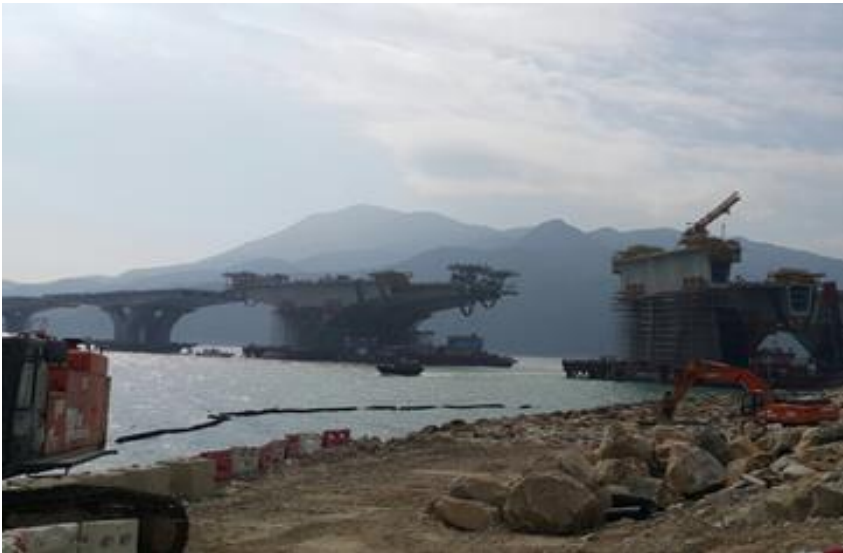
- With referred to photo record taken on 20 and 23 November 2017, active works area were confined within silt curtain which were properly maintained during the period and no silt plume was observed at active works areas.
- Exceedance recorded at monitoring station SR7 was located at the upstream of seawall reinstatement works area based on dominant tidal flow during flood tide, which was unlikely caused by construction works under this Contract.
- In addition, there was no exceedance recorded at monitoring station IS10(N), IS(Mf)9 and IS(Mf)16 which are located closer to active works area than it is of monitoring station mentioned in Table 1.
- Therefore, the recorded SS exceedances on 20 November 2017 during flood tide were unlikely to be related to construction works under Contract HY/2010/02.

Photo record shows condition of silt curtain and active works area at outfall area on 23 Nov 2017.

The Contractor to properly implement all relevant water quality mitigation measures.

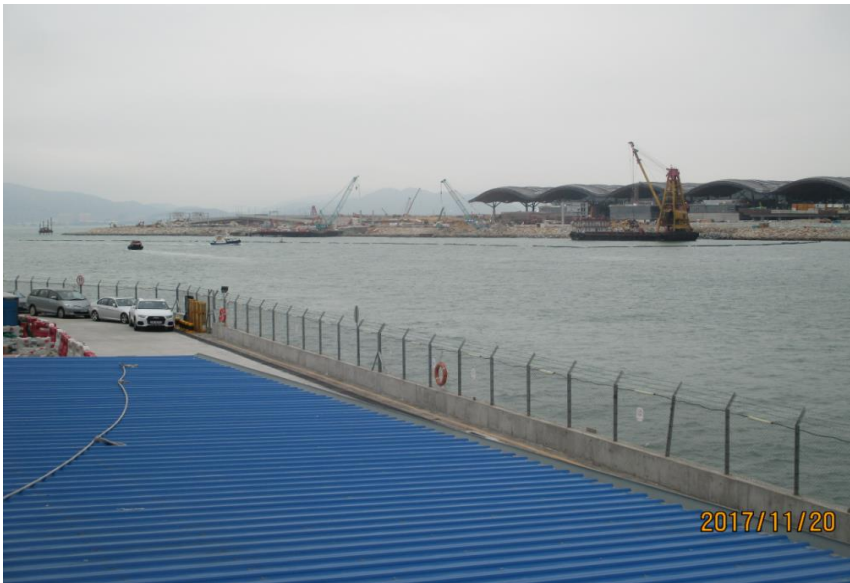
Photo record shows silt curtain condition and active seawall construction area on 20 Nov 2017.

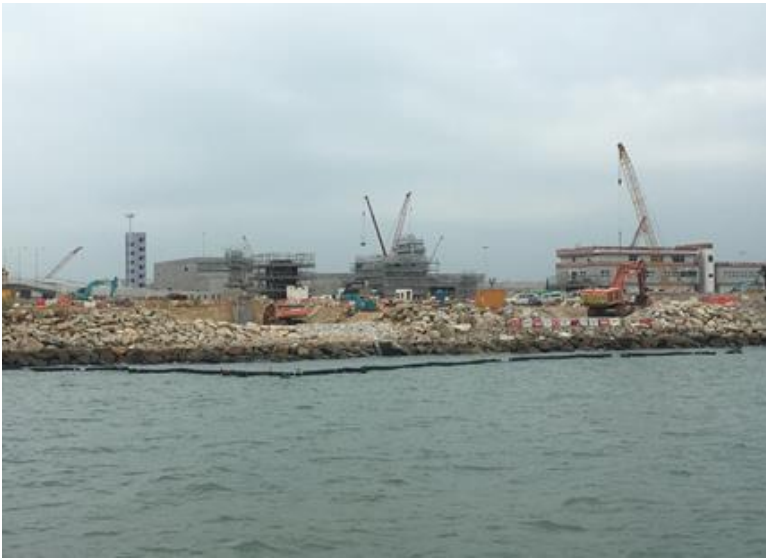
**Photo record taken on 30 November 2017 showed no fugitive dust was generated at outfall area.**

| <b>Actions taken / to be taken</b> | <p>The Contractor was recommended to continue implementing existing dust mitigation measures.</p> <p>Dust suppression should be provided to dusty materials for all works which might generate fugitive dust.</p> |

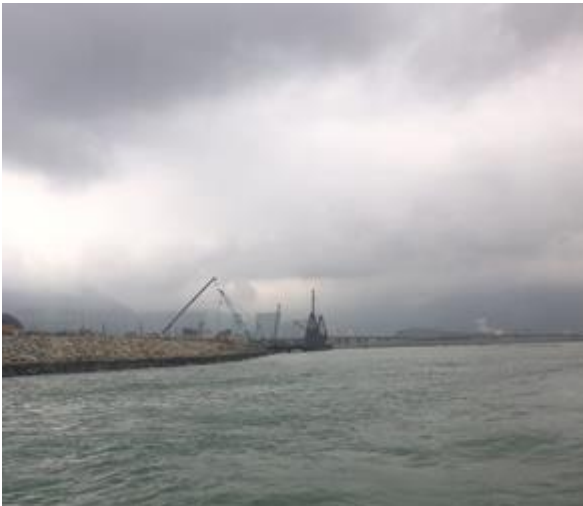
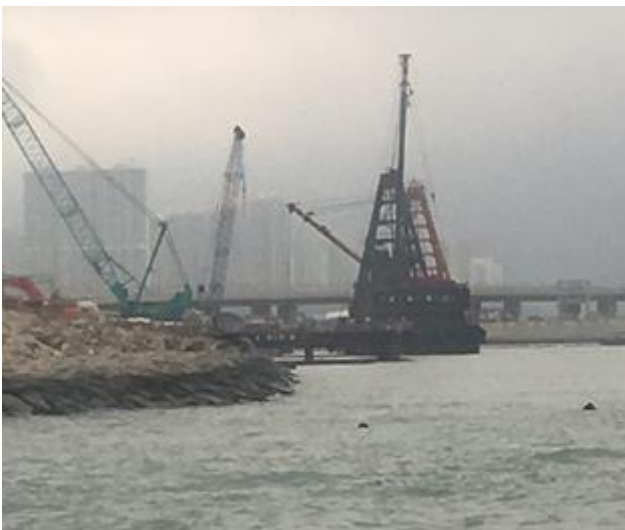
**Photo record taken on 30 November 2017 showed no fugitive dust was generated at active seawall construction area.**
