Contract No. HY/2010/02

## Hong Kong – Zhuhai – Macao Bridge Hong Kong Boundary Crossing Facilities – Reclamation Works

Monthly EM&A Report for December 2017

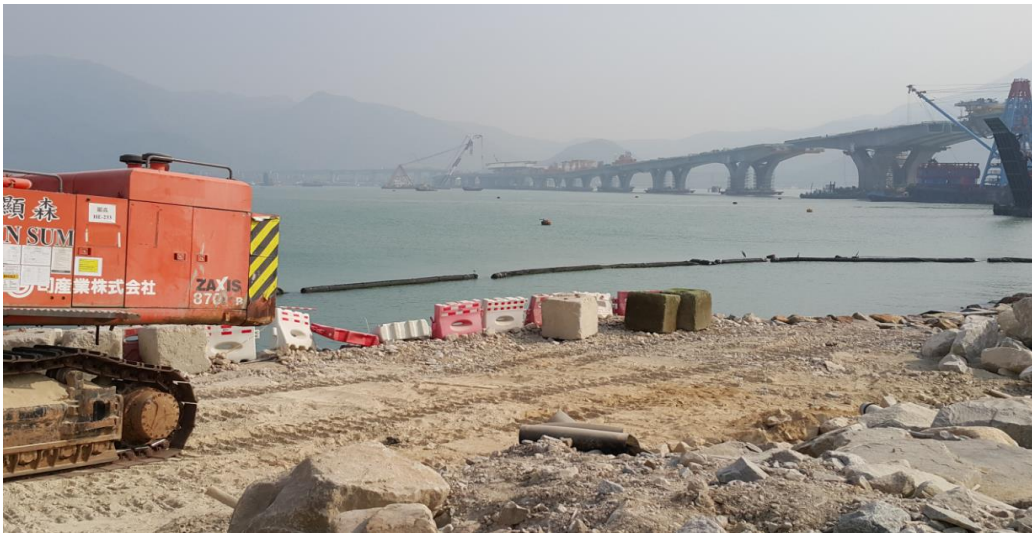
With referred to the information provided by the Contractor, seawall reinstatement work and outfall installation were carried out on 6 December 2017 which are unlikely to cause SS exceedance at the monitoring station IS(Mf)9 mentioned in Table 1.

- Photo record taken on 6 and 7 December 2017 showed active works area were confined within silt curtain which were properly maintained during the period and no silt plume was observed at active works areas.
- In addition, there was no exceedance recorded at monitoring station IS(Mf)16 which is located closer to active works area than it is of monitoring station mentioned in Table 1.
- No exceedance was recorded at other downstream impact monitoring station (i.e. IS7) during the same tide, the case appeared to be an isolated case with no spatial trend to indicate any effect due to project activities.
- Therefore, the recorded SS exceedances on 6 December 2017 during flood tide were unlikely to be related to construction works under Contract HY/2010/02.

Photo record shows condition of silt curtain and active works area at outfall area on 7 Dec 2017.

The Contractor to properly implement all relevant water quality mitigation measures.

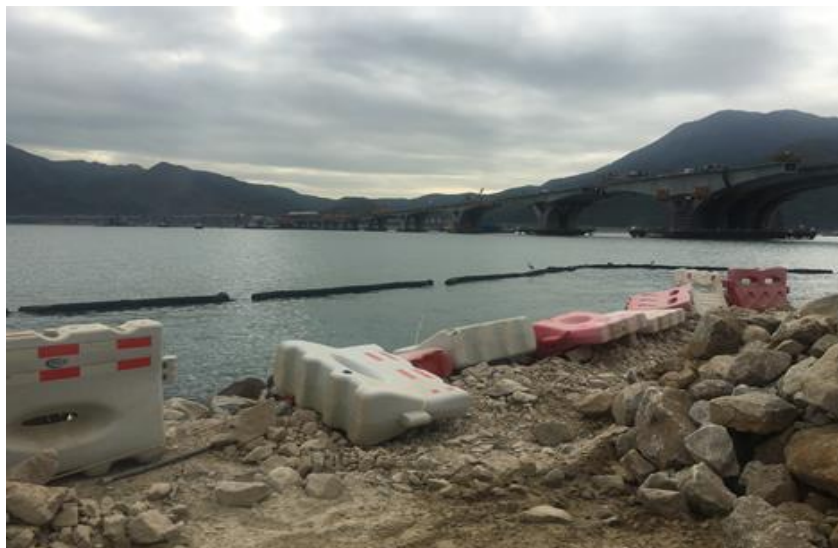
- were carried out on 11 December 2017 which are unlikely to cause SS exceedance at the monitoring station IS(Mf)9 mentioned in Table 1.
- With referred to photo record taken on 14 December 2017, active work area was confined within silt curtain which was properly maintained during the period and no silt plume was observed at active work area.
- Exceedance recorded at monitoring station IS(Mf)9 was located at the upstream of outfall works area based on dominant tidal flow during ebb tide, which was unlikely caused by construction works under this Contract.
- In addition, there was no exceedance recorded at monitoring station IS(Mf)16 which are located closer to active work area than it is of monitoring station mentioned in Table 1.
- Therefore, the recorded SS exceedances on 11 December 2017 during flood tide were unlikely to be related to construction works under Contract HY/2010/02.

Photo record shows condition of silt curtain and active works area at outfall area on 14 Dec 2017.

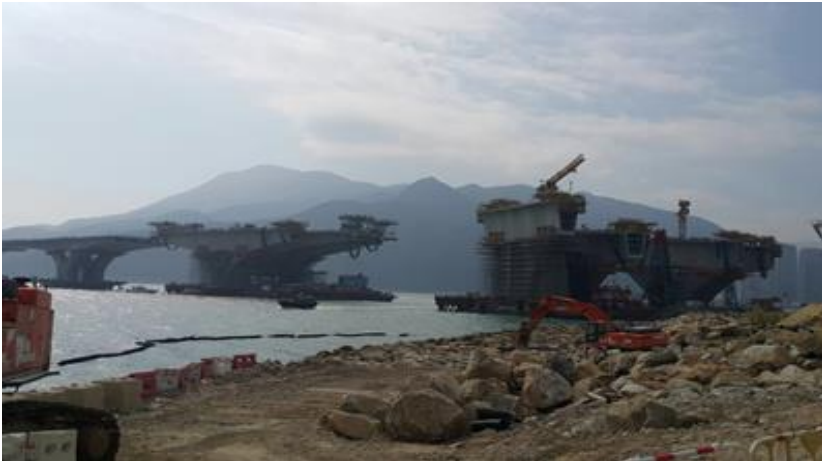
With referred to the information provided by the Contractor, seawall reinstatement work and outfall pipeline installation were carried out on 4 December 2017 which are unlikely to cause SS exceedance at the monitoring station SR7 mentioned in Table 1.

- With referred to photo record taken on 6 and 7 December 2017, active work area were confined within silt curtain which were properly maintained during the period and no silt plume was observed at active work area.
- Exceedance recorded at monitoring station SR7 was located at the upstream of seawall construction area based on dominant tidal flow during flood tide, which was unlikely caused by construction works under this Contract.
- In addition, there was no exceedance recorded at monitoring station IS10(N), IS(Mf)16 and IS(Mf)9 which are located closer to active work area than it is of monitoring station mentioned in Table 1.
- Therefore, the recorded SS exceedances on 4 December 2017 during flood tide were unlikely to be related to construction works under Contract HY/2010/02.

Photo record shows condition of silt curtain and active works area at outfall area on 7 Dec 2017.

The Contractor to properly implement all relevant water quality mitigation measures.

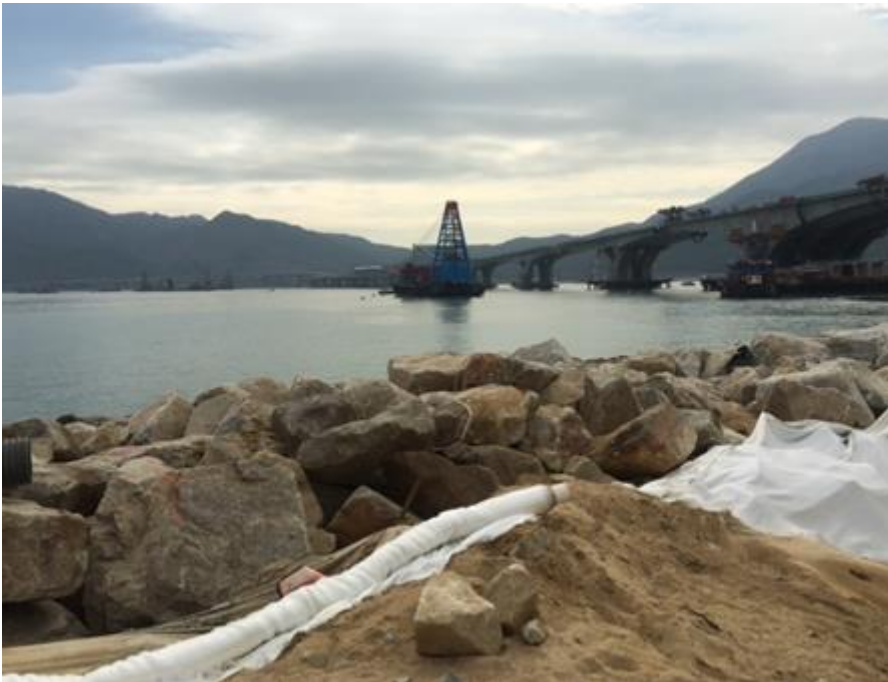
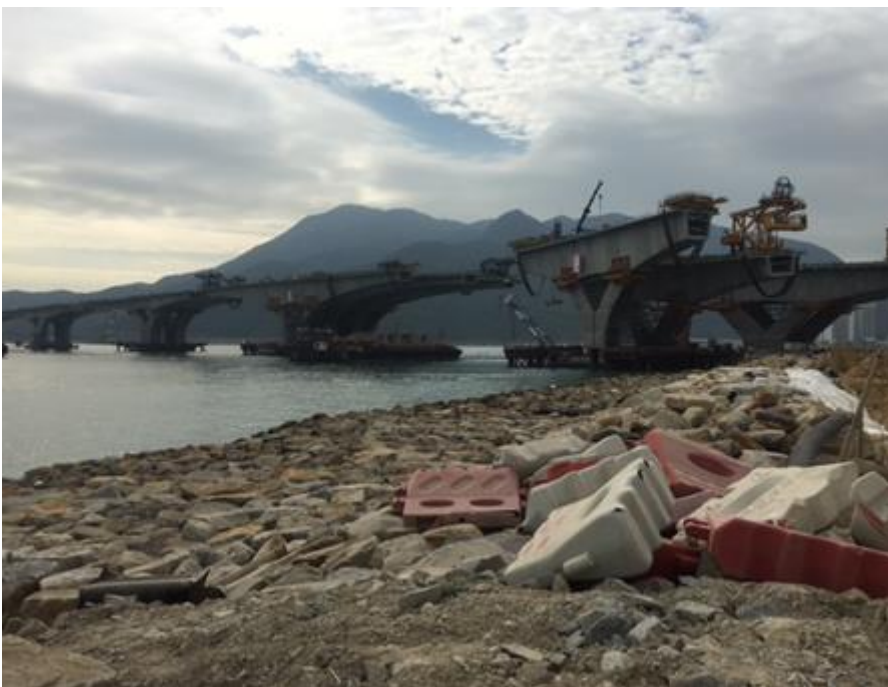
**Photo record taken on 28 December 2017 showed no fugitive dust was generated at outfall area.**

<b>Actions taken / to be taken</b>	<p>The Contractor was recommended to continue implementing existing dust mitigation measures.</p> <p>Dust suppression should be provided to dusty materials for all works which might generate fugitive dust.</p>
<b>Remarks</b>	--
