Contract No. HY/2011/03

**Hong Kong-Zhuhai-Macao Bridge Hong Kong Link Road
Section between Scenic Hill and Hong Kong Boundary Crossing
Facilities**

Monthly EM&A Report No.93 (June 2020)

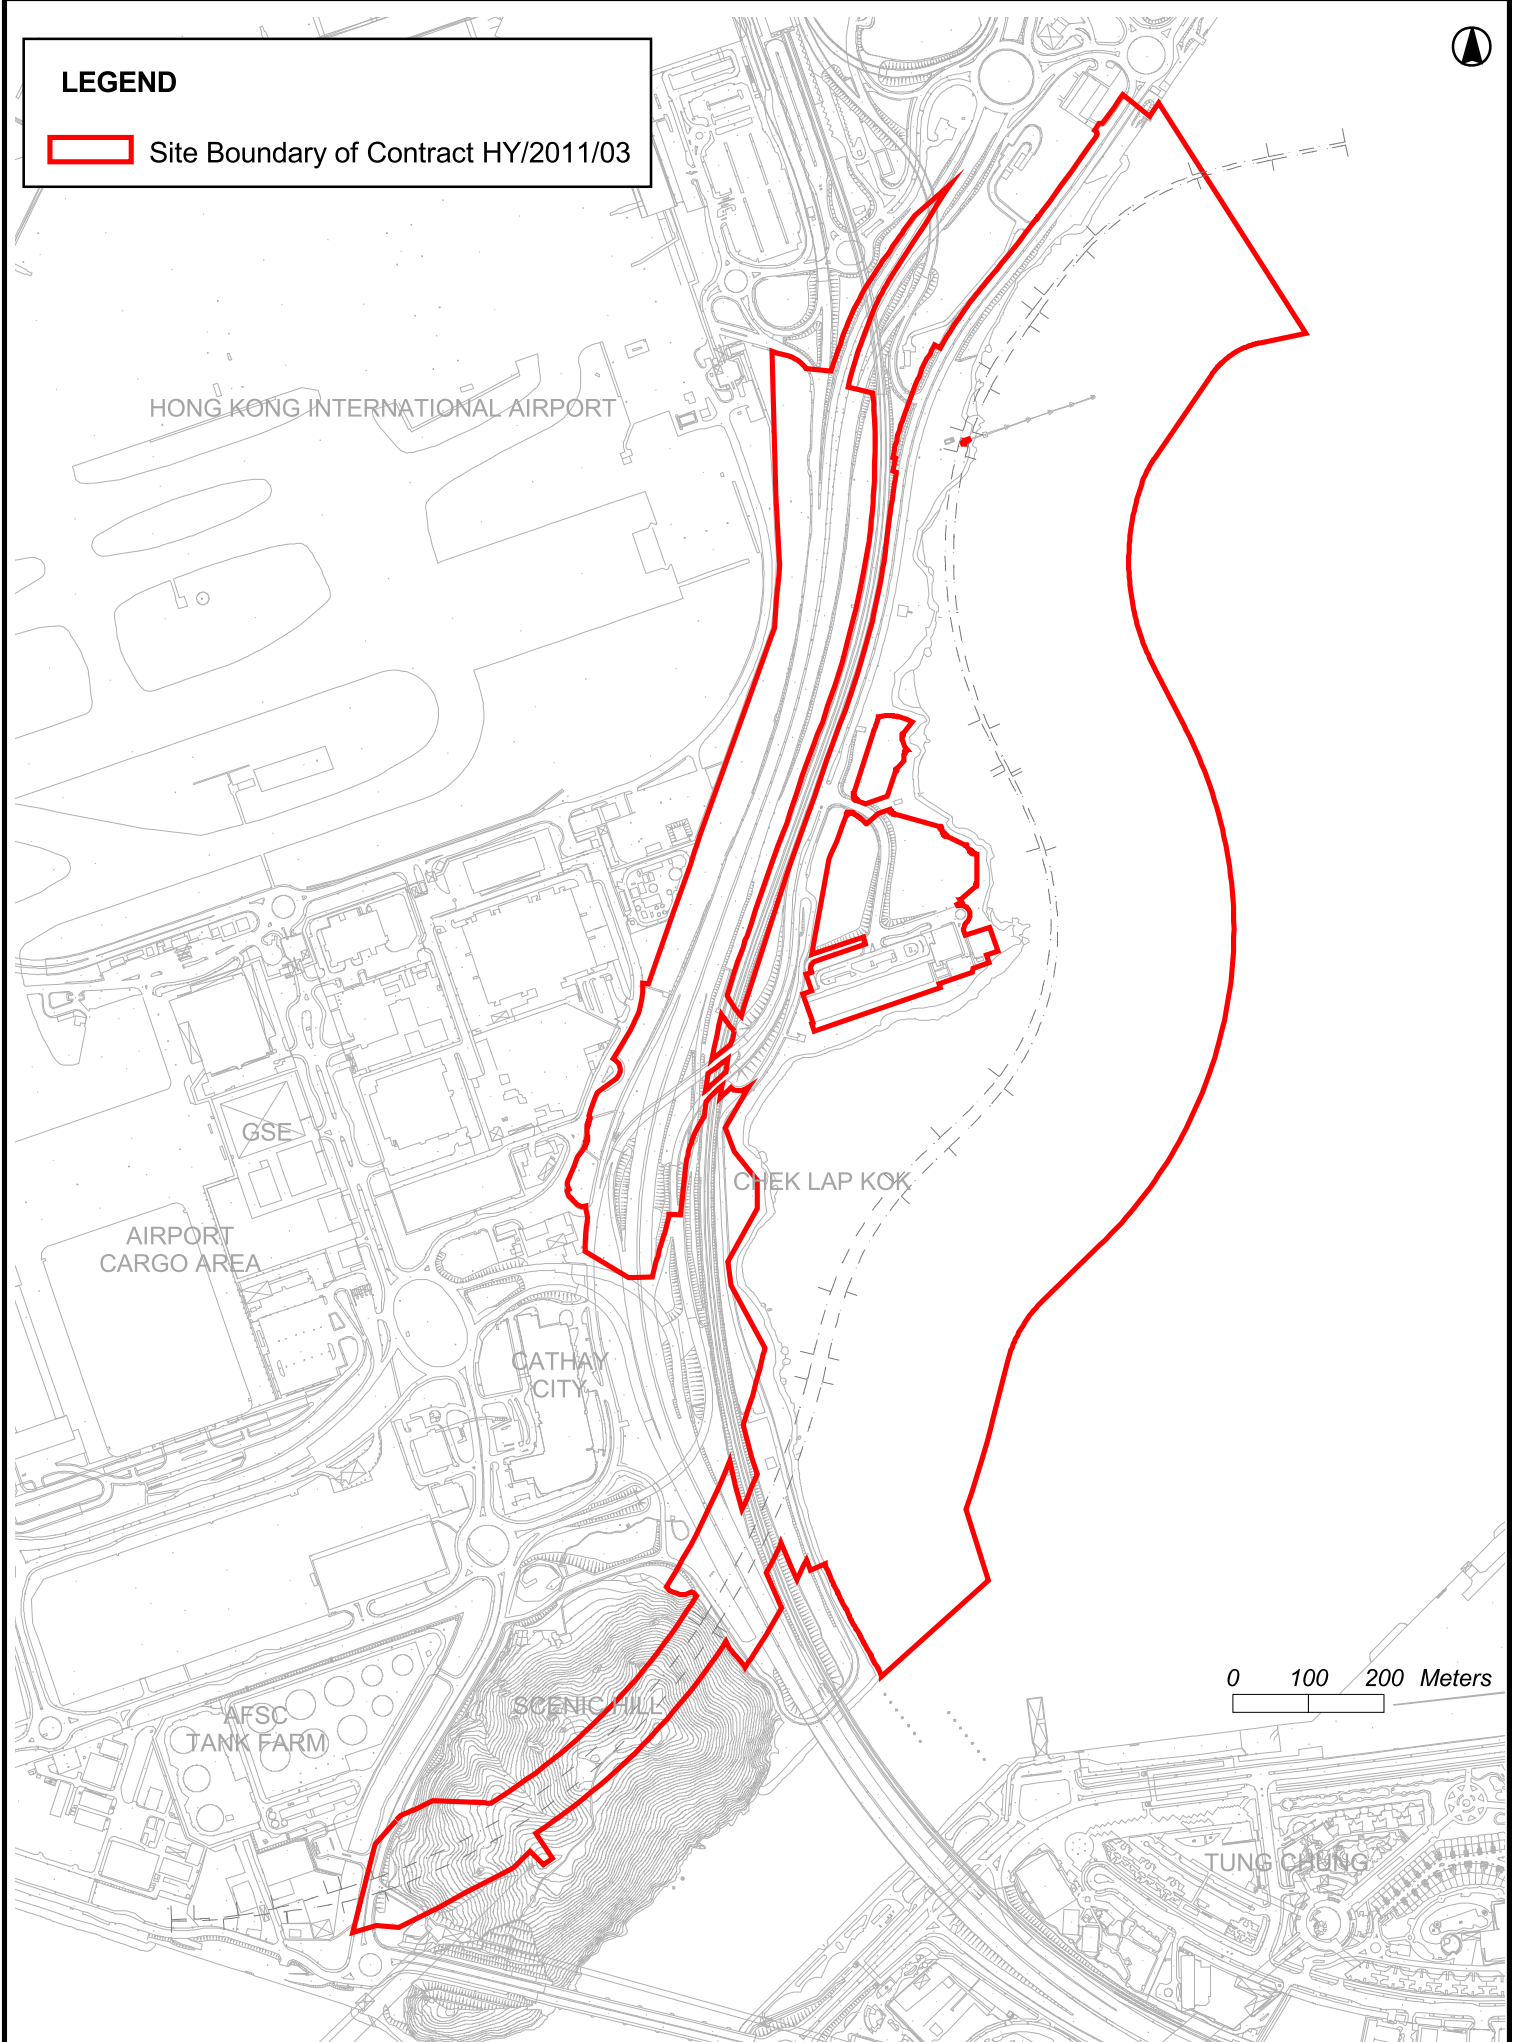
Figure 1.1 Location of the Site

Site Boundary of Contract HY/2011/03

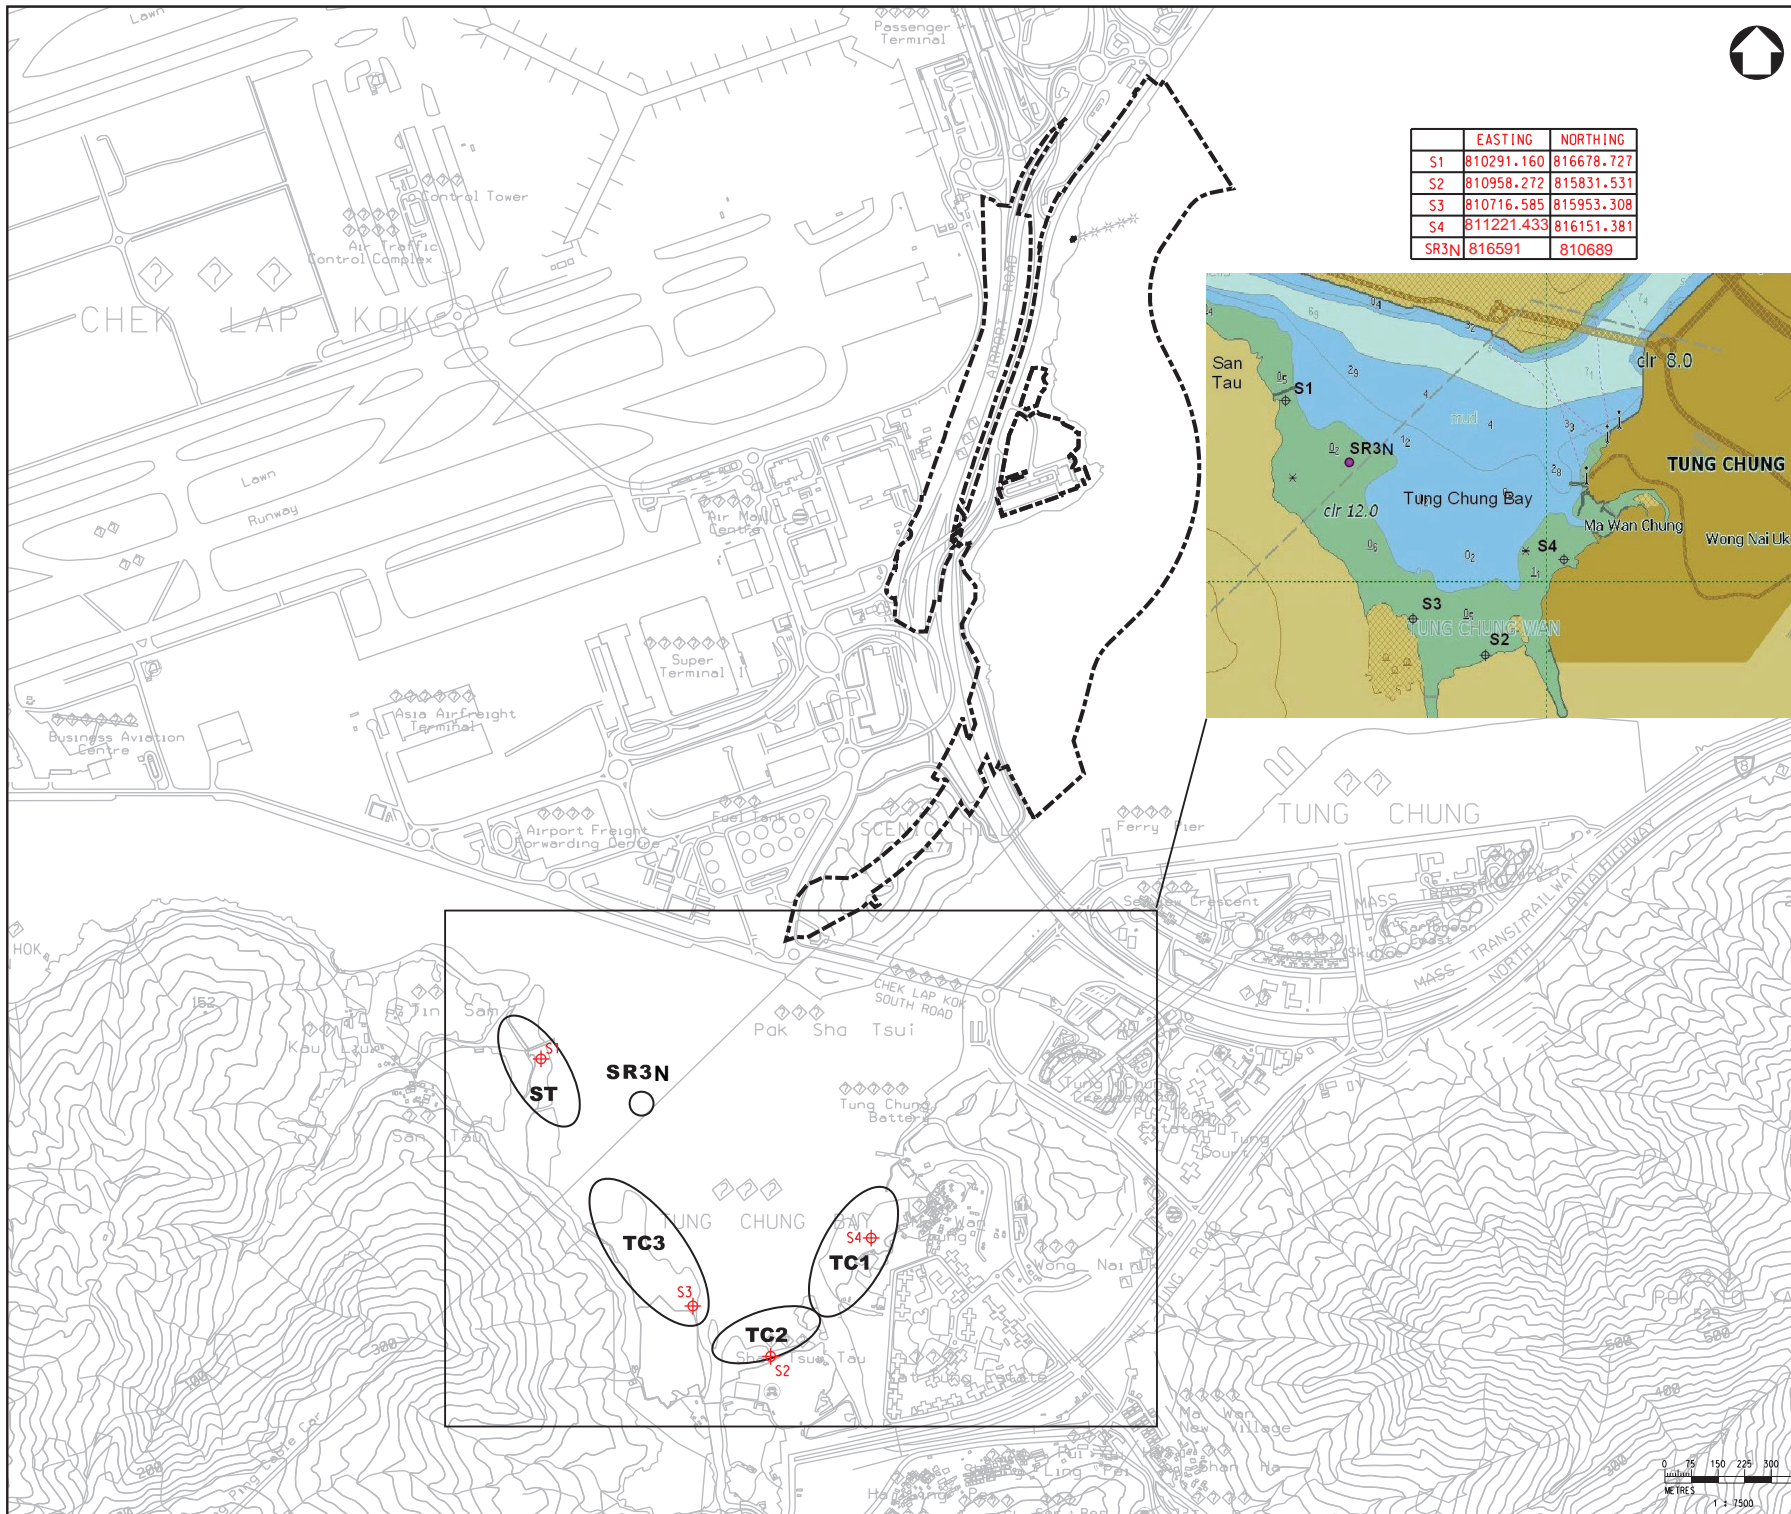
- 6.1.4 Four monitoring stations were established based on the site conditions for the sedimentation monitoring and are shown in **Figure 6.1**.

EASTING	NORTHING
S1	810291.160	816678.727
S2	810958.272	815831.531
S3	810716.585	815953.308
S4	811221.433	816151.381
SR3N	816591	810689

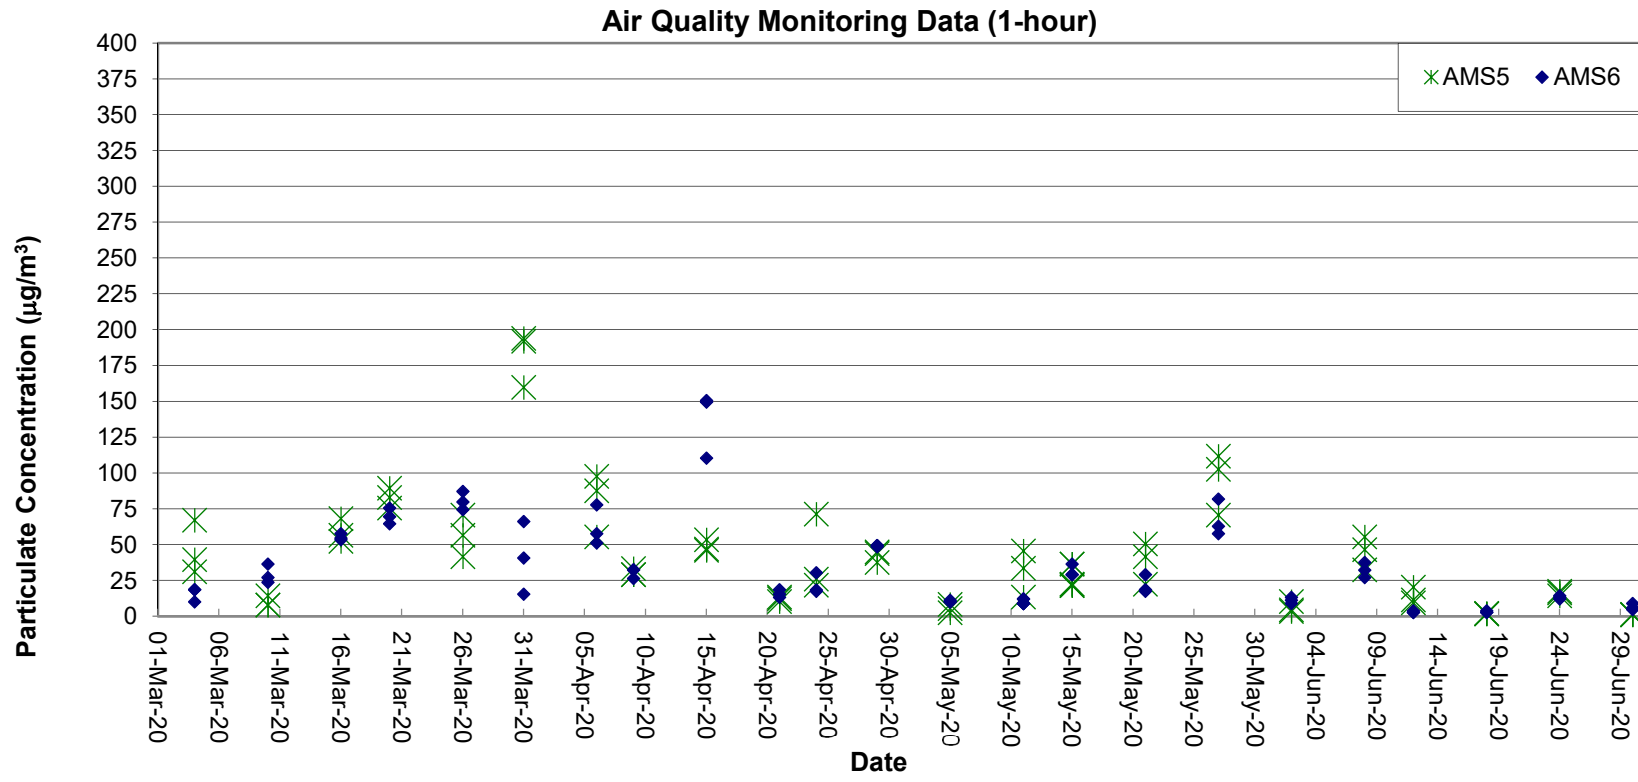
Graphical Plot of 1-hour TSP at AMS5 and AMS6

- 1) Due to power failure, 24-hr TSP monitoring on 17 June 2020 at AMS5 was rescheduled to 18 June 2020.
- 2) Due to malfunction of high volume sampler (HVS) at AMS5, the 24-hr TSP monitoring on 23 June 2020 was cancelled. Competent person repaired the HVS on 30 June 2020. The 24-hr TSP monitoring on 29 June 2020 at AMS5 was rescheduled to 30 June 2020.

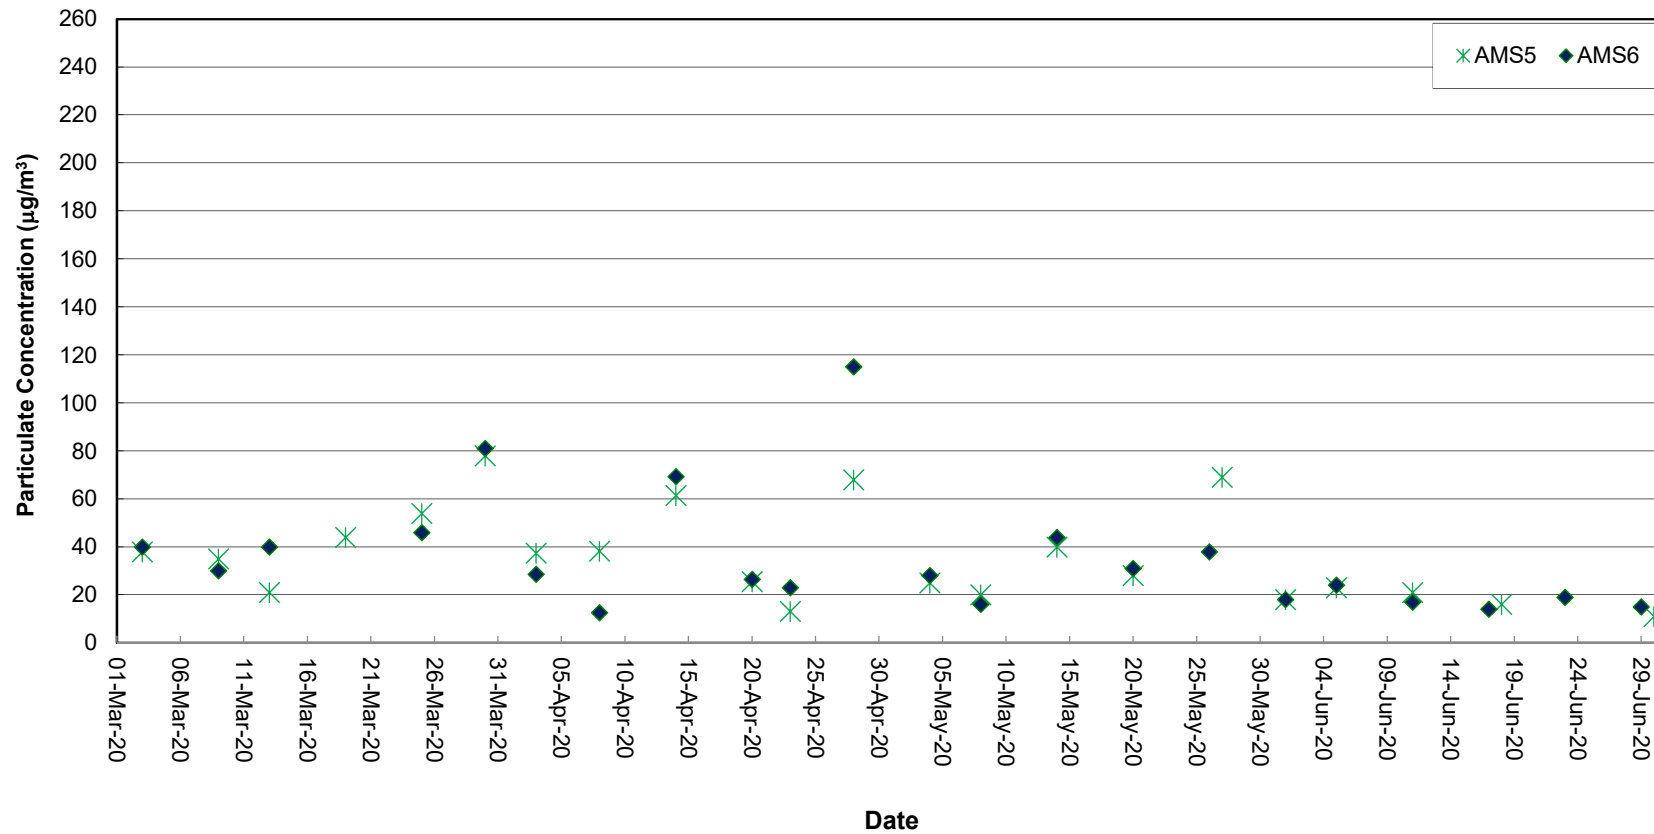
Graphical Plot of 24-hour TSP at AMS5 and AMS6

- 1) Due to power failure and malfunction of High Volume Sampler (HVS) at AMS6 - Dragonair / CNAC (Group) Building (HKIA), 24-hr TSP monitoring on 19 March 2020 at AMS6 was cancelled. The HVS was repaired on 25 March 2020. The 24-hr TSP monitoring at AMS6 was resumed on 25 March 2020.
- 2) Due to power failure, 24-hr TSP monitoring on 26 May 2020 at AMS5 (Ma Wan Chung Village) was rescheduled to 27 May 2020.
- 3) Due to power failure, 24-hr TSP monitoring on 17 June 2020 at AMS5 was rescheduled to 18 June 2020.
- 4) Due to malfunction of HVS at AMS5, the 24-hr TSP monitoring on 23 June 2020 was cancelled. Competent person repaired the HVS on 30 June 2020. The 24-hr TSP monitoring on 29 June 2020 at AMS5 was rescheduled to 30 June 2020.

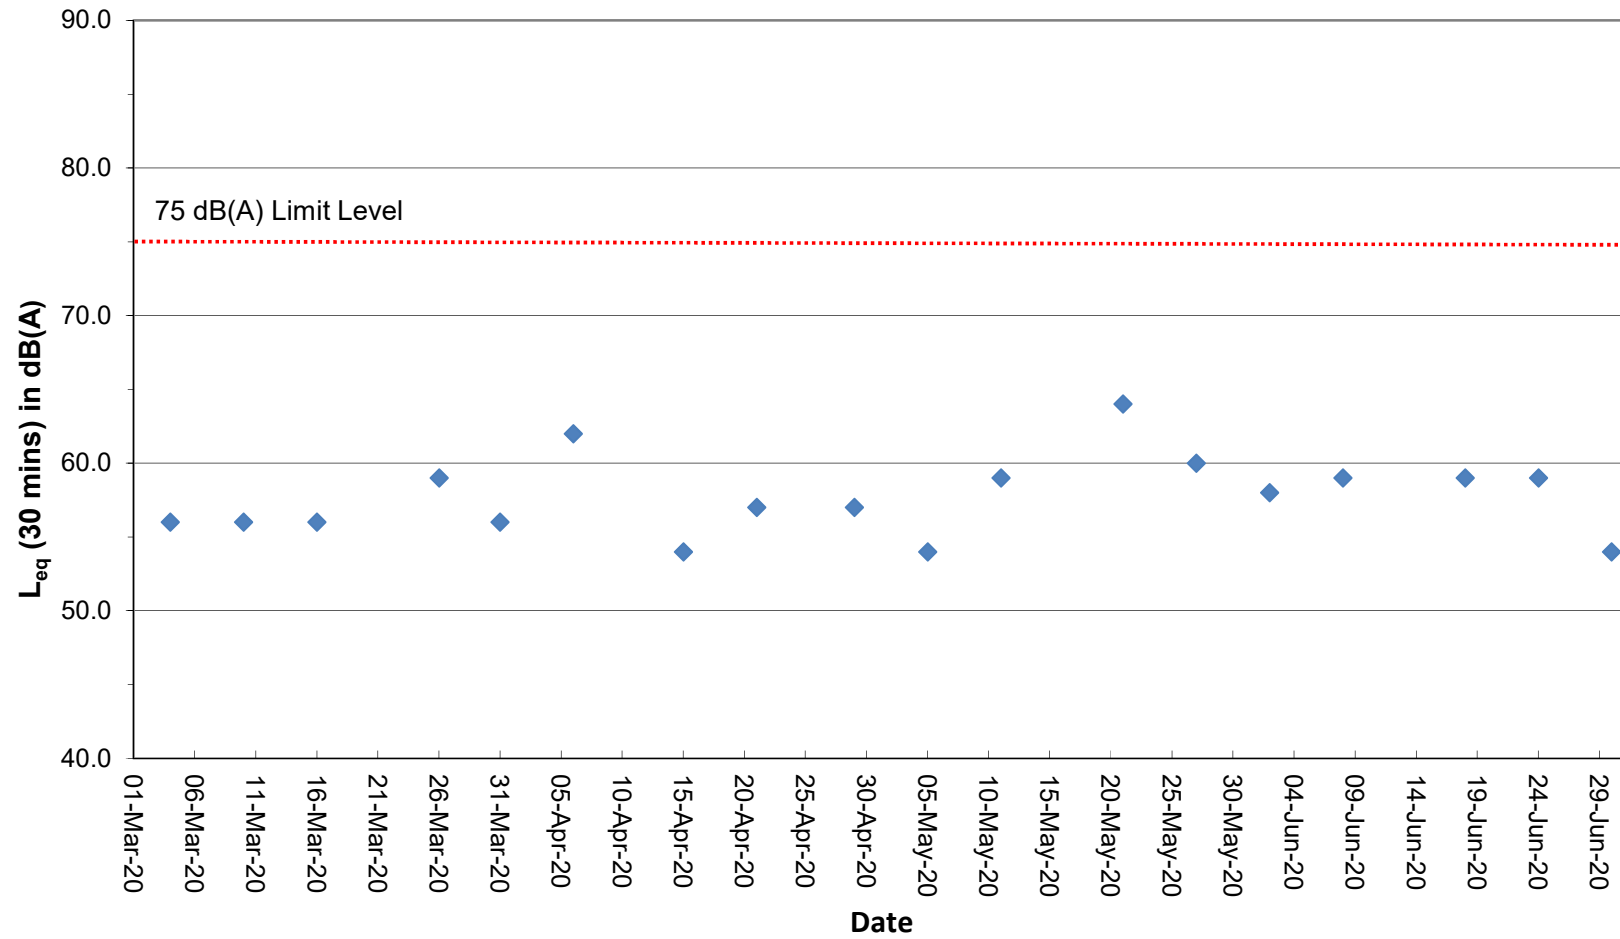
Graphical Plot of Noise Levels at NMS5

(1) A facade correction of +3 dB(A) was applied to the measured noise level.

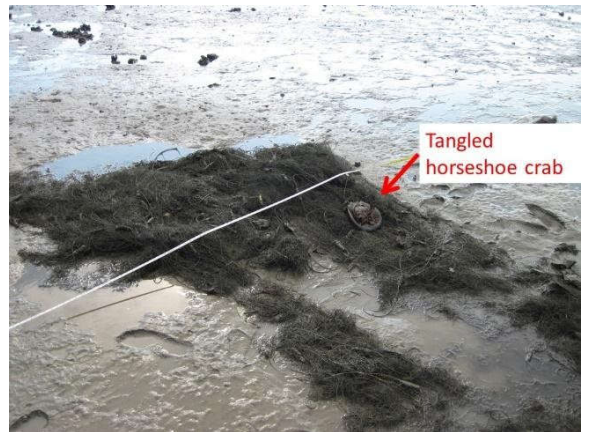
Figure 2.3 *Examples of photographic record of the big trashes found on the mudflat.*

Trash gill net and hand trolley

A tangled horseshoe crab on a trash net
(record in June 2017)

- 6.3.2 Since the field survey of June 2016, increasing number of trashes and even big trashes (**Figure 2.3 of Appendix I**) were found in every sampling zone. It raised a concern about the solid waste dumping and current-driven waste issues in Tung Chung Wan. Respective measures (e.g. manual clean-up) should be implemented by responsible governmental agency units.

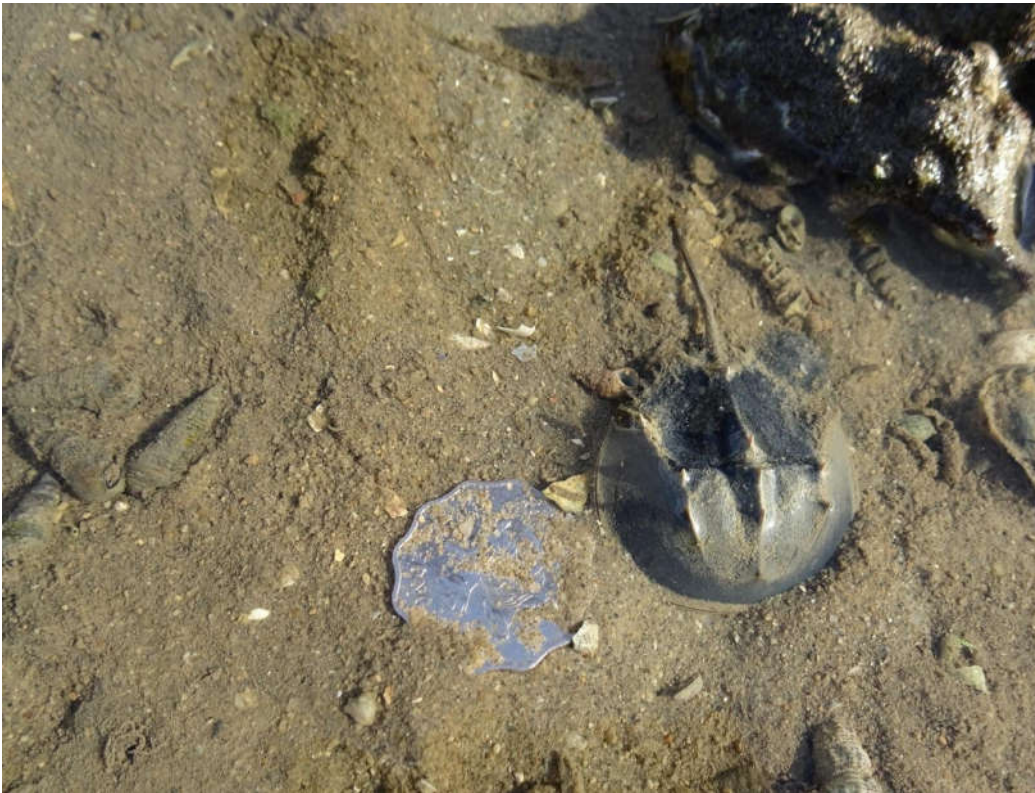
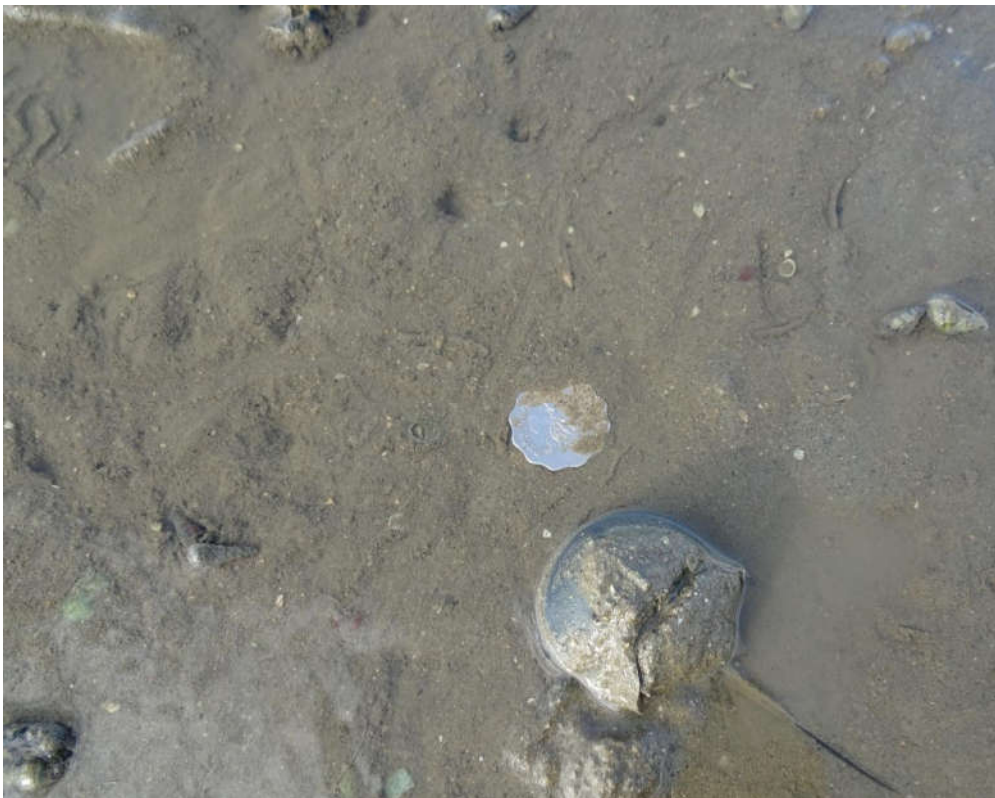
Figure 3.1 Examples of photographic records of horseshoe crab (June 2020)

ST *Carcinoscorpius rotundicauda*

ST *Tachypleus tridentatus*

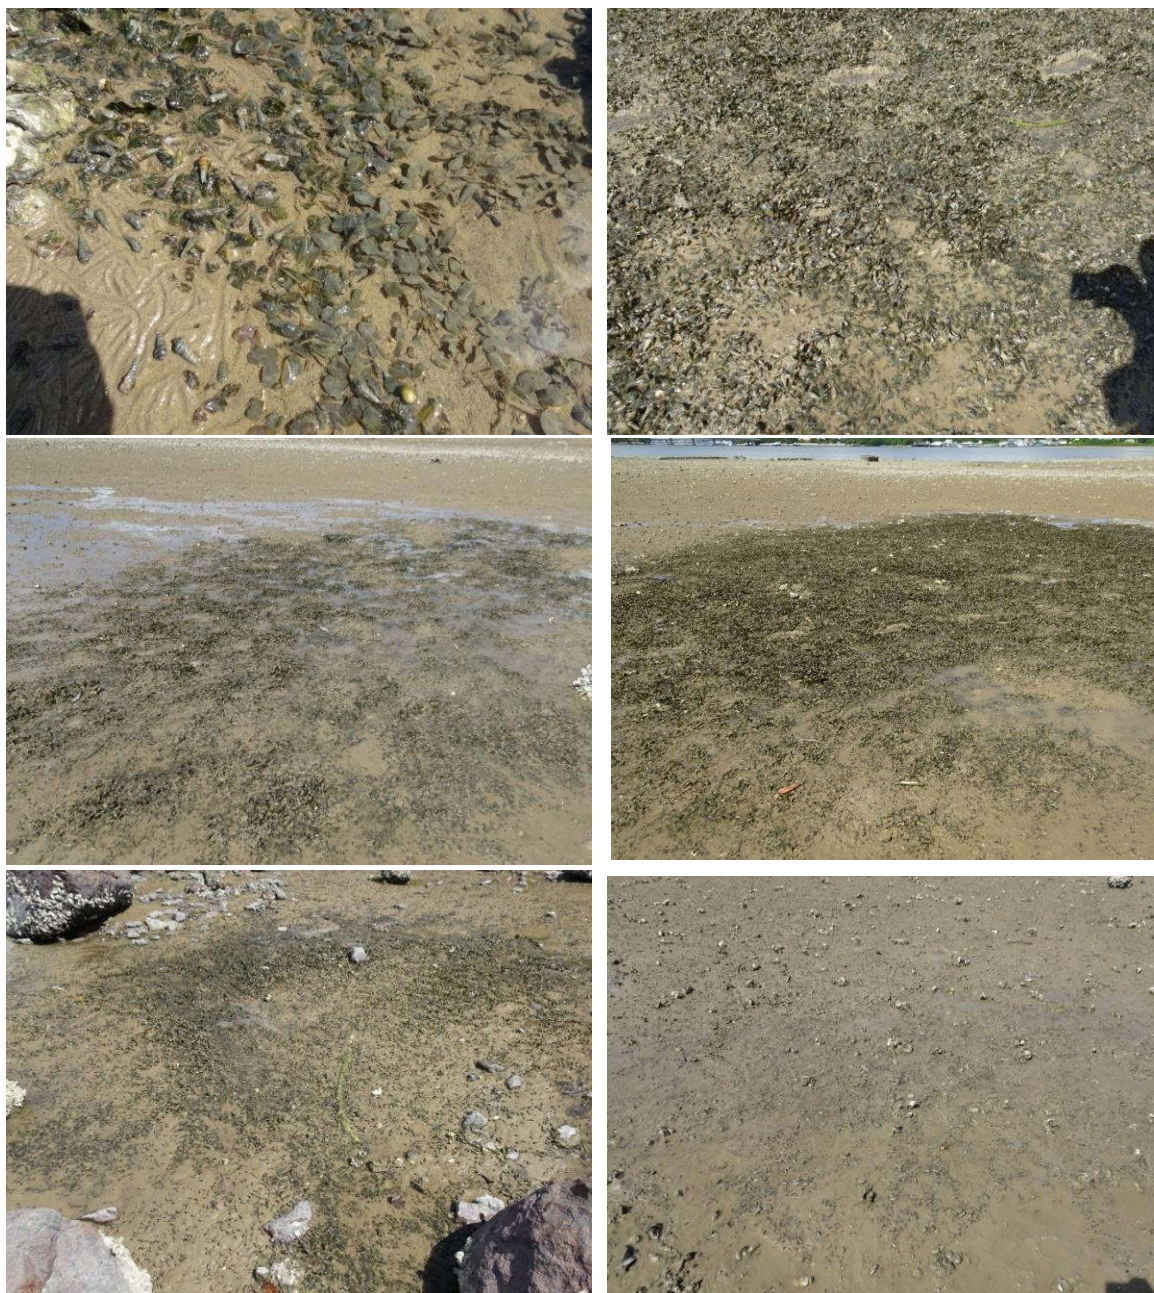
Figure 3.9 *Photographic record of seagrass beds in present survey.*

***Halophila ovalis* in TC3**

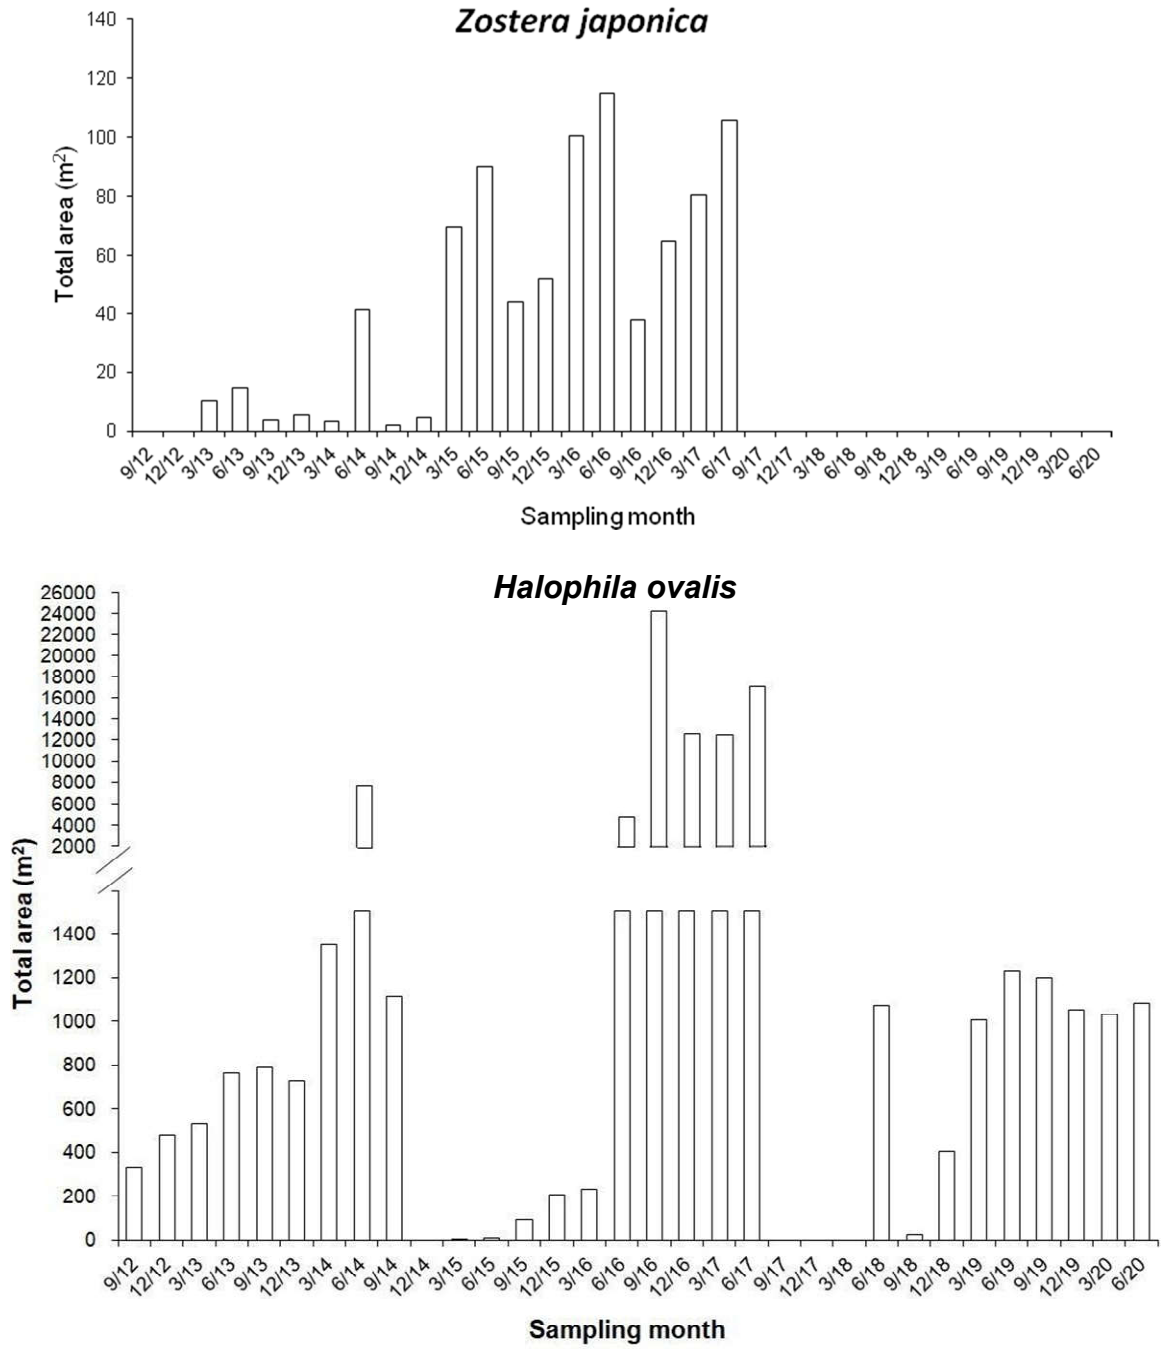
Figure 3.11 Temporal changes of estimated total area of seagrass beds in ST

Sampling zone	TC3 <i>Halophila ovalis</i>	ST <i>Halophila ovalis</i>
Number of patches	6	3
Total area (m²)	92.5	1079
Average area (m²)	15.4	360
