**Contract No. HY/2012/07
Tuen Mun - Chek Lap Kok Link -
Southern Connection Viaduct Section**

***Final Environmental Monitoring & Audit (EM&A)
Report***

22 December 2020

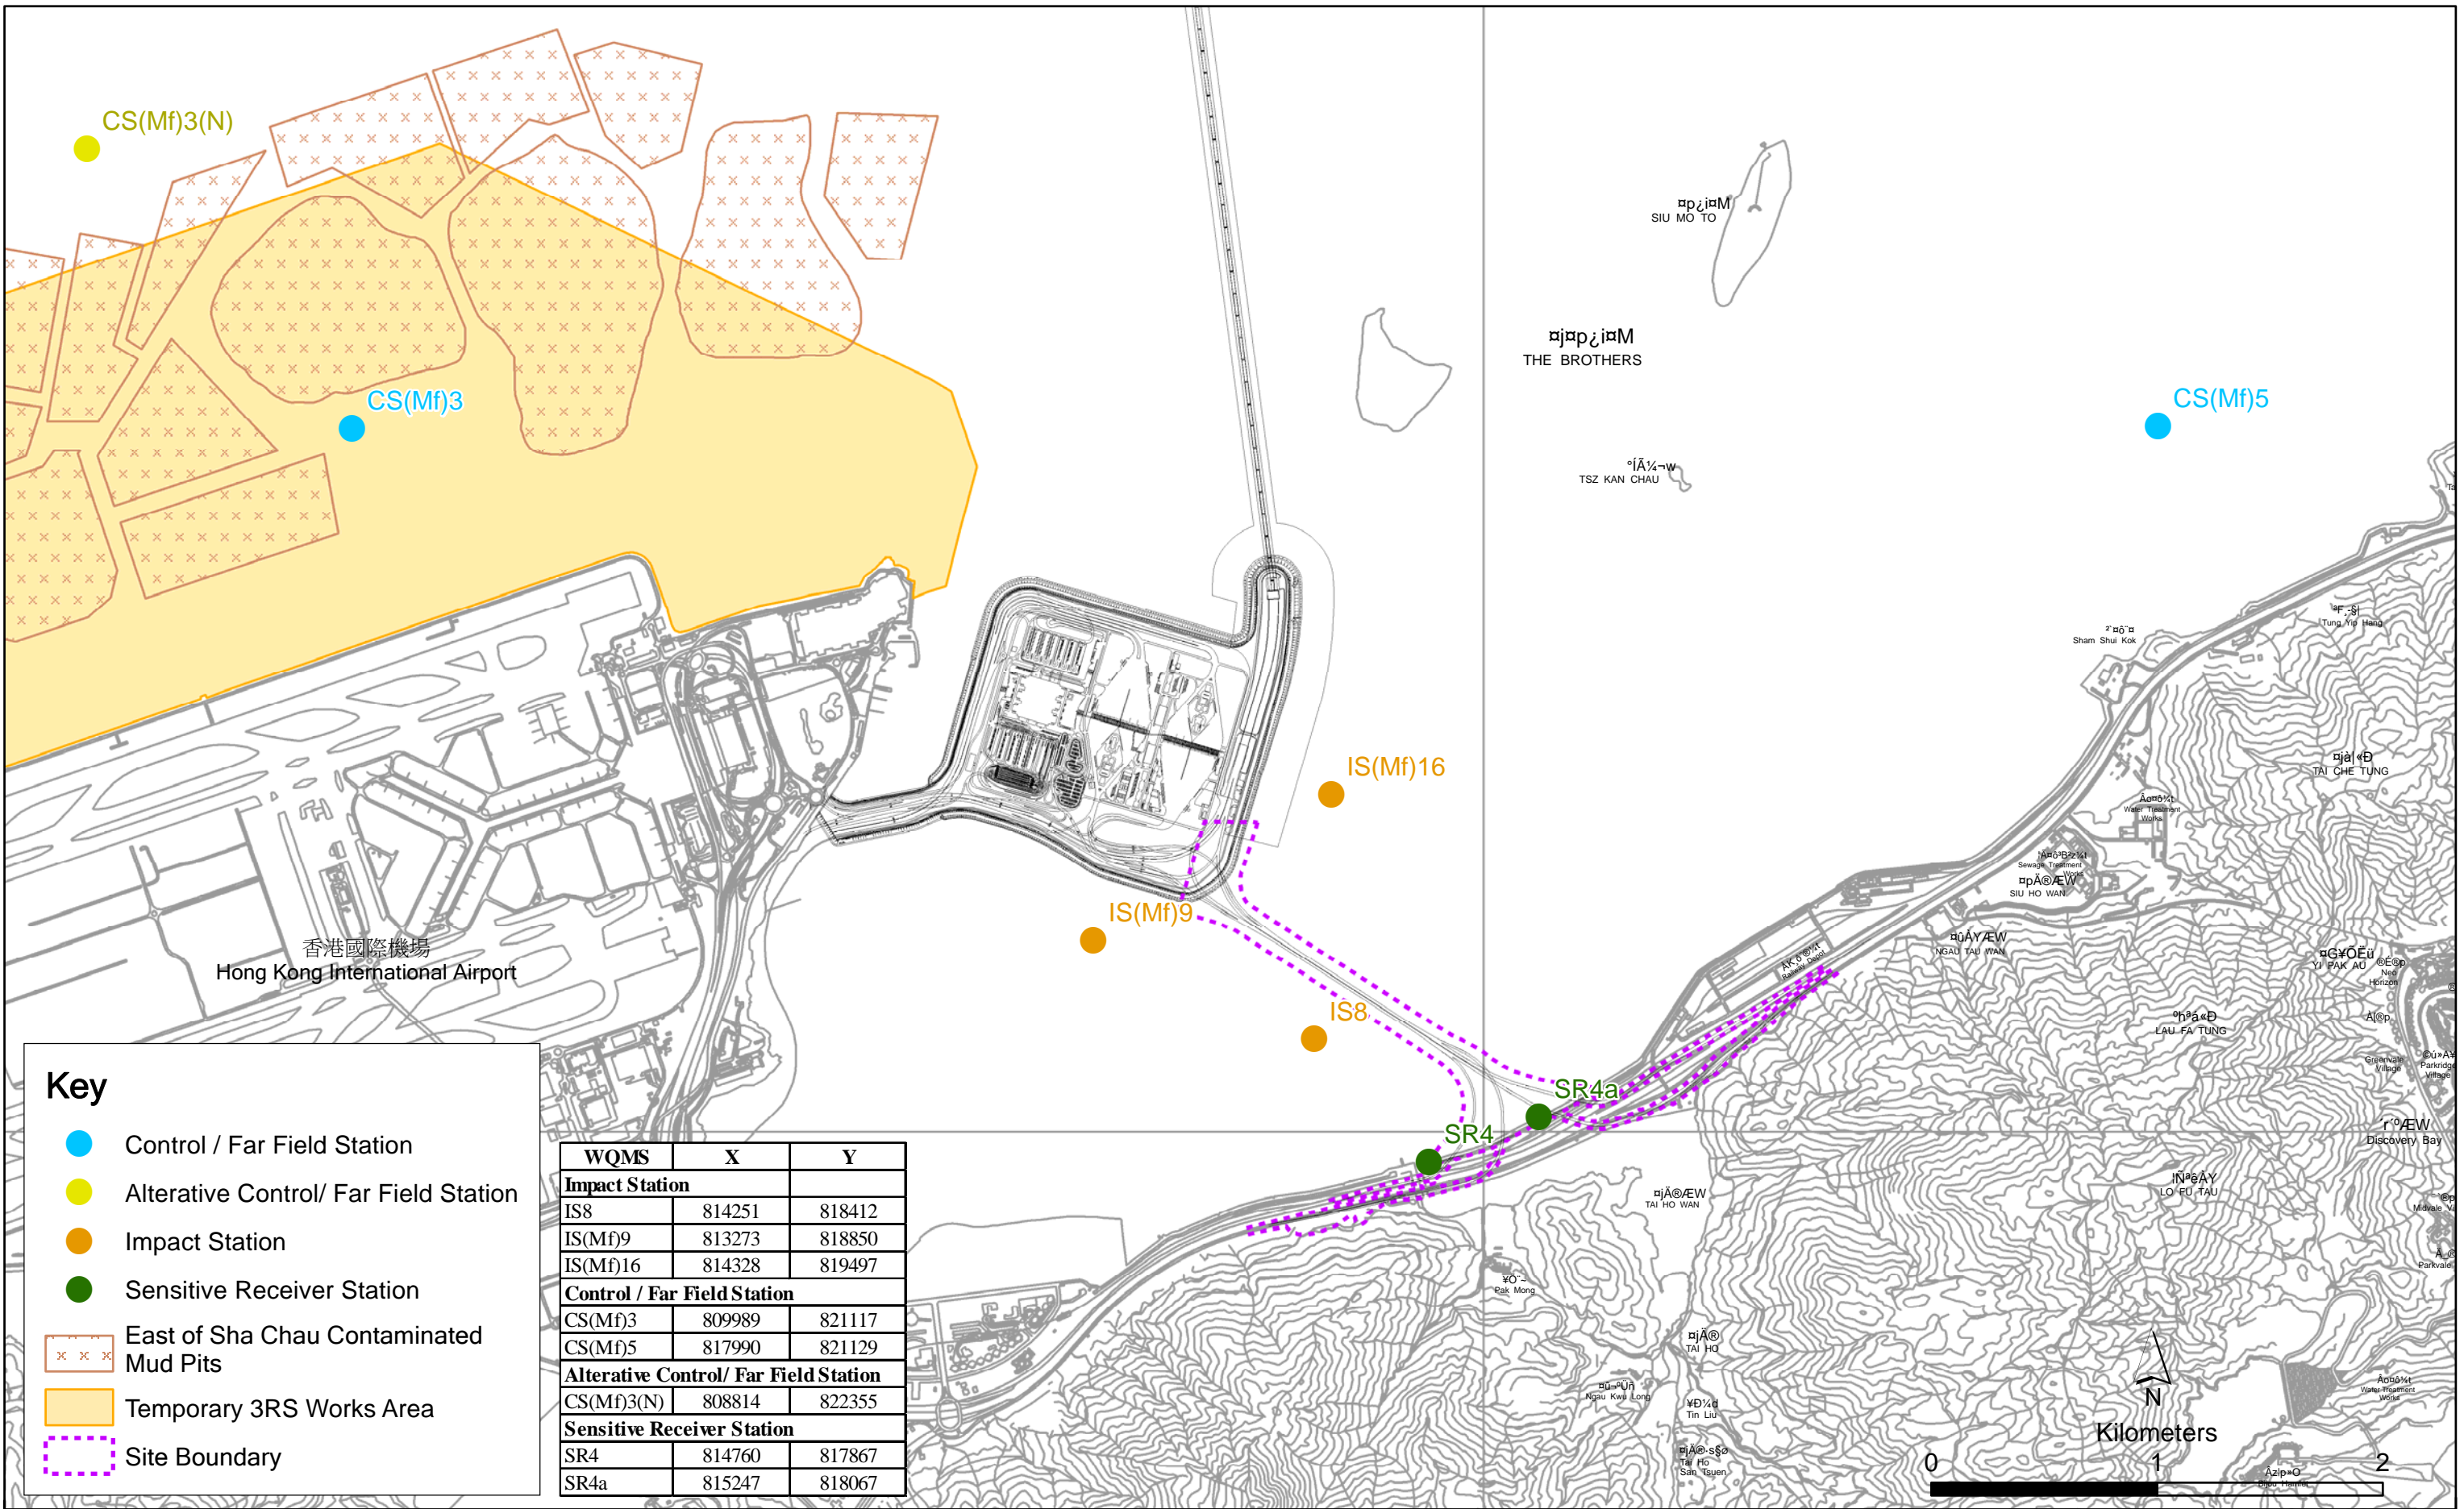
Figure 2.3b

Locations of Water Quality Monitoring Stations

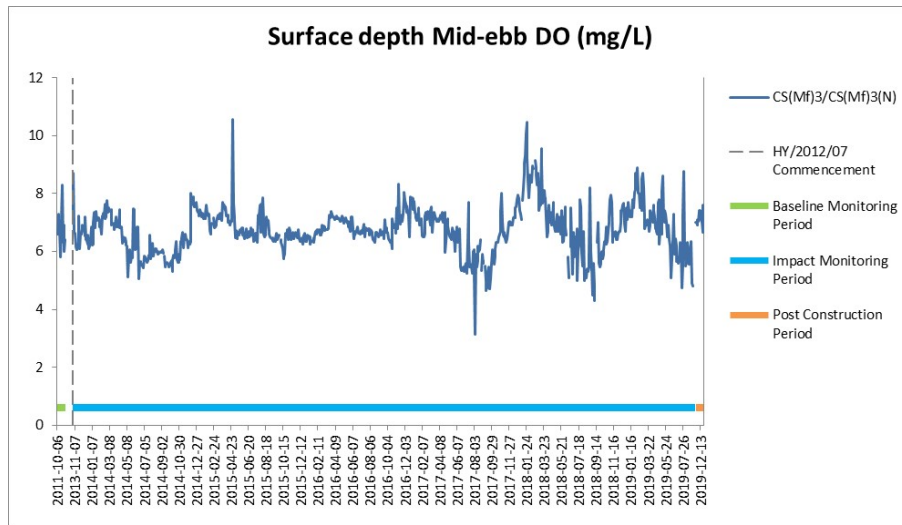
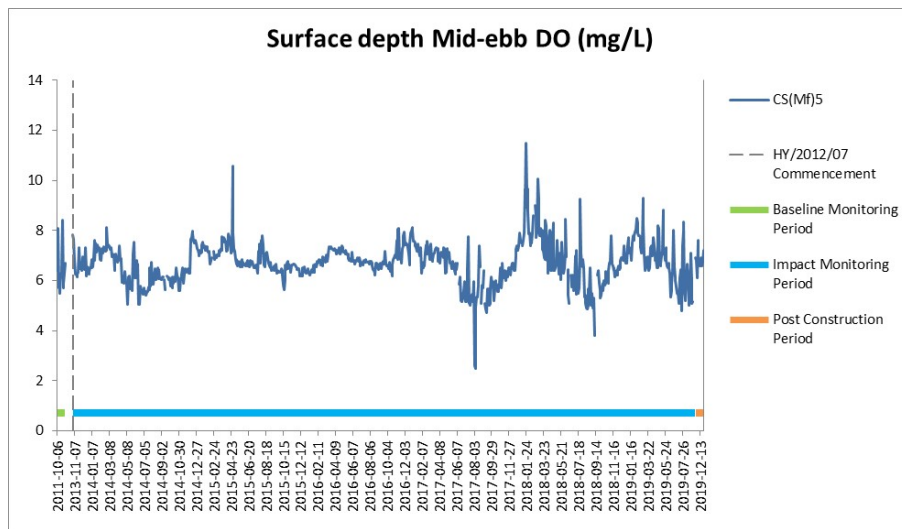
Figure F1 Impact Monitoring – Mean Level of Dissolved Oxygen (mg/L) in surface waters during mid-ebb tide between 6 October 2011 and 23 December 2019 at CS(Mf)3/CS(Mf)3(N) and CS(Mf)5.

(Weather condition varied between sunny to rainy during the course of the Project.) Overall monitoring results were not affected by weather conditions. In-situ monitoring is taken according to the requirement specified in the EM&A Manual, i.e. 3 water depth namely 1m below sea surface, mid-depth and 1m above sea bed. If the water depth is less than 3m, mid-depth sampling only. If water depth less than 6m, mid-depth may be omitted.

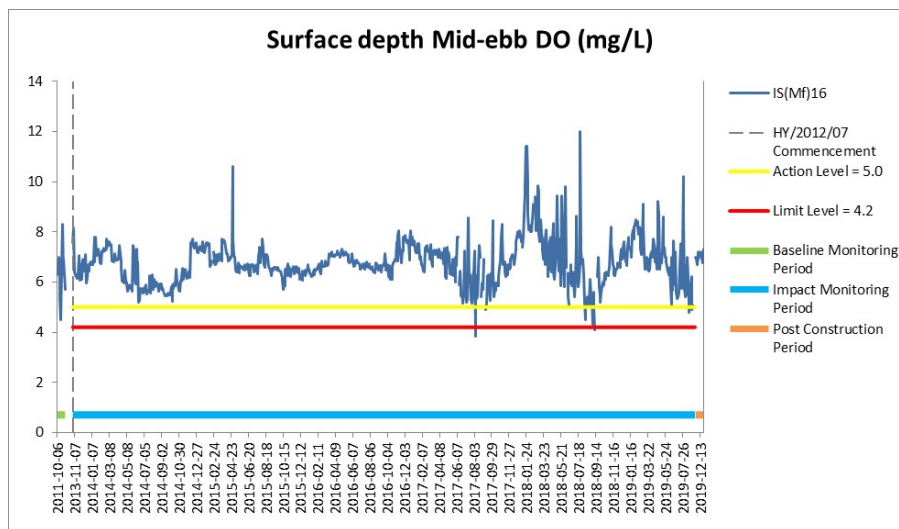
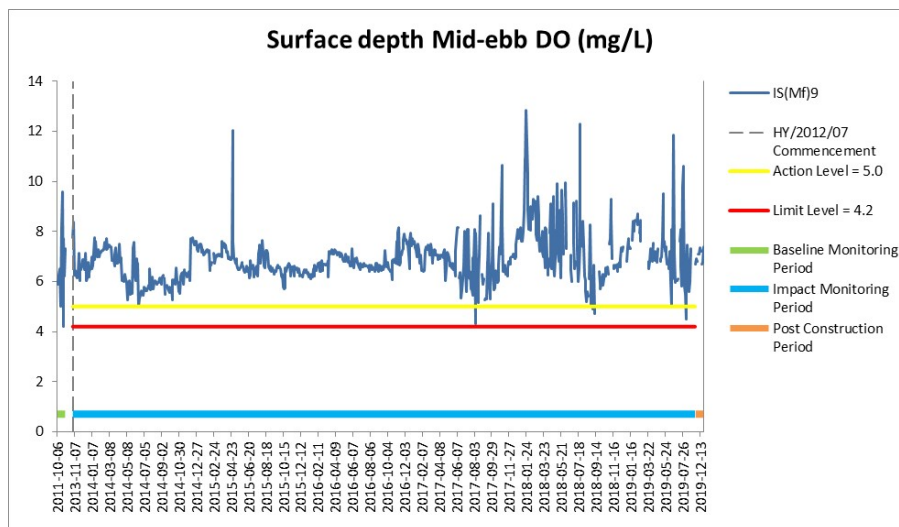
Figure F2 Impact Monitoring – Mean Level of Dissolved Oxygen (mg/L) in surface waters during mid-ebb tide between 6 October 2011 and 23 December 2019 at IS(Mf)16 and IS(Mf)9.

(Weather condition varied between sunny to rainy during the course of the Project.)
 Overall monitoring results were not affected by weather conditions. In-situ monitoring is taken according to the requirement specified in the EM&A Manual, i.e. 3 water depth namely 1m below sea surface, mid-depth and 1m above sea bed. If the water depth is less than 3m, mid-depth sampling only. If water depth less than 6m, mid-depth may be omitted.

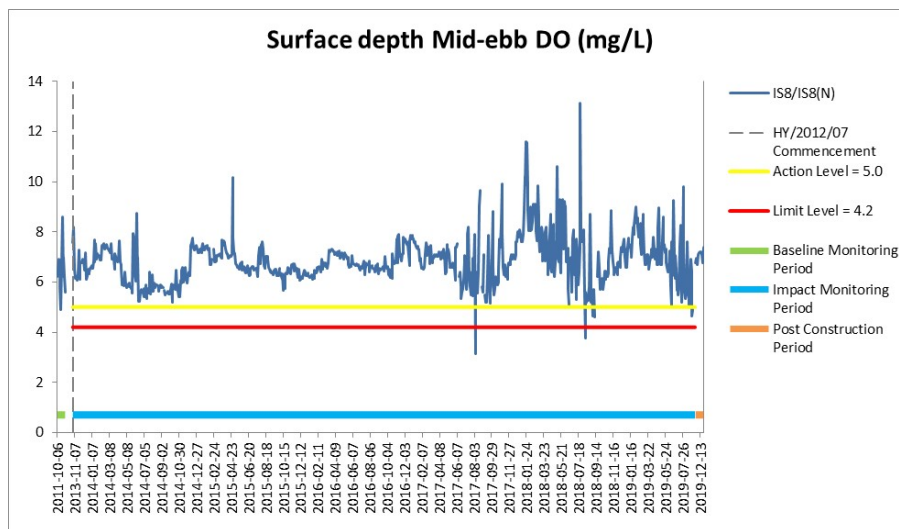
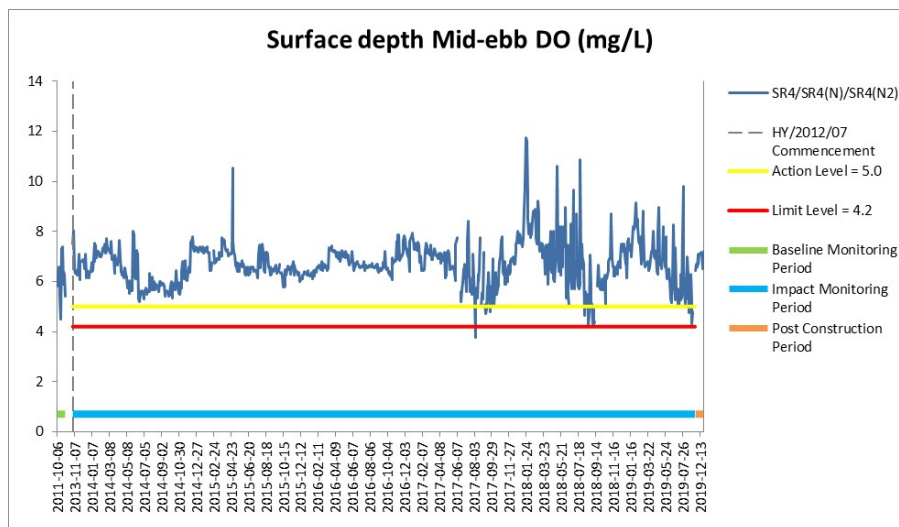
Figure F3 Impact Monitoring – Mean Level of Dissolved Oxygen (mg/L) in surface waters during mid-ebb tide between 6 October 2011 and 23 December 2019 at IS8/IS8(N) and SR4/SR4(N)/SR4(N2). *(Weather condition varied between sunny to rainy during the course of the Project.) Overall monitoring results were not affected by weather conditions. In-situ monitoring is taken according to the requirement specified in the EM&A Manual, i.e. 3 water depth namely 1m below sea surface, mid-depth and 1m above sea bed. If the water depth is less than 3m, mid-depth sampling only. If water depth less than 6m, mid-depth may be omitted.*

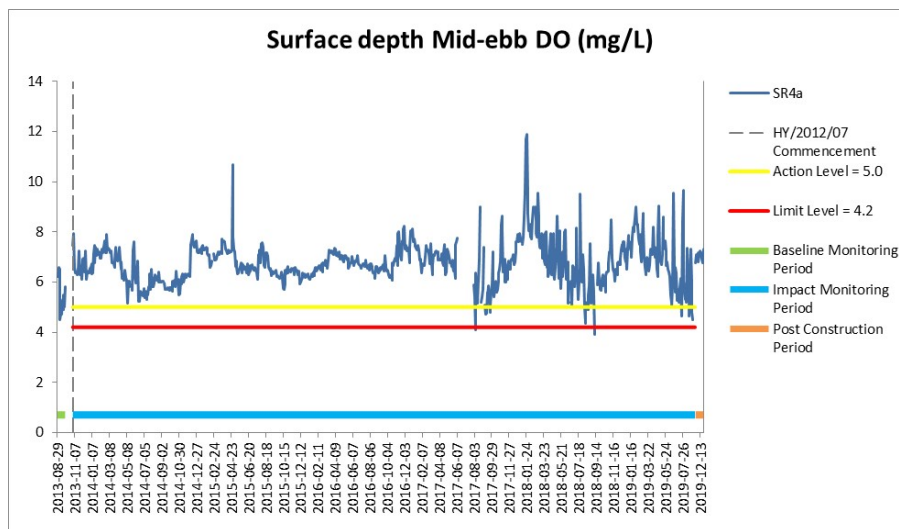
Figure F4 Impact Monitoring – Mean Level of Dissolved Oxygen (mg/L) in surface waters during mid-ebb tide between 29 August 2013 and 23 December 2019 at SR4a.

(Weather condition varied between sunny to rainy during the course of the Project.) Overall monitoring results were not affected by weather conditions. In-situ monitoring is taken according to the requirement specified in the EM&A Manual, i.e. 3 water depth namely 1m below sea surface, mid-depth and 1m above sea bed. If the water depth is less than 3m, mid-depth sampling only. If water depth less than 6m, mid-depth may be omitted.

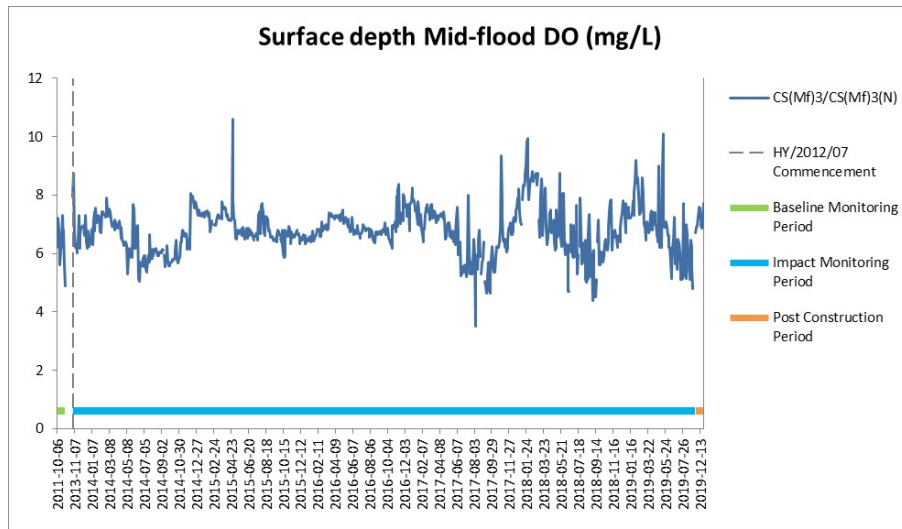
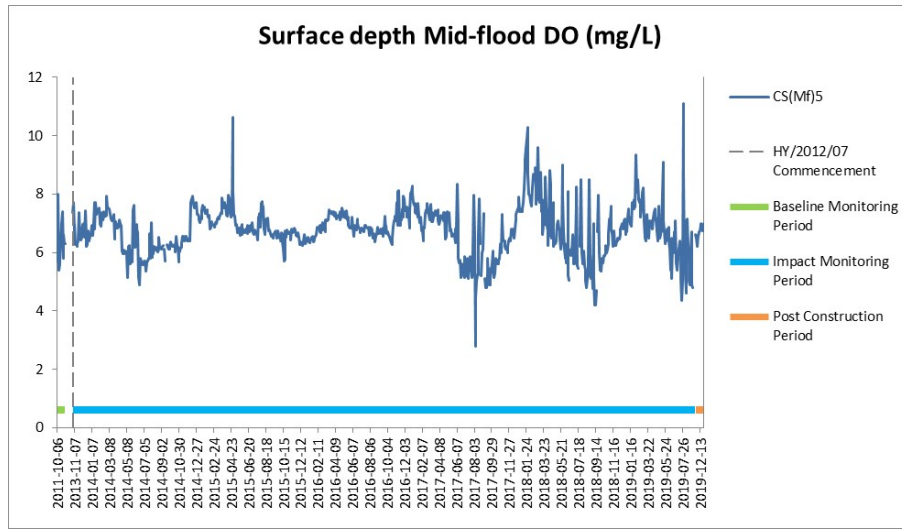
Figure F5 Impact Monitoring – Mean Level of Dissolved Oxygen (mg/L) in surface waters during mid-flood tide between 6 October 2011 and 23 December 2019 at CS(Mf)3/CS(Mf)3(N) and CS(Mf)5.

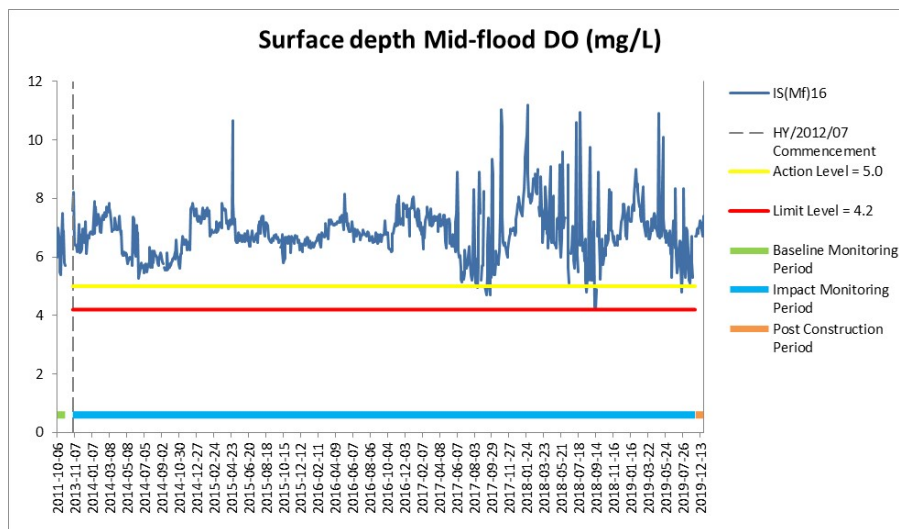
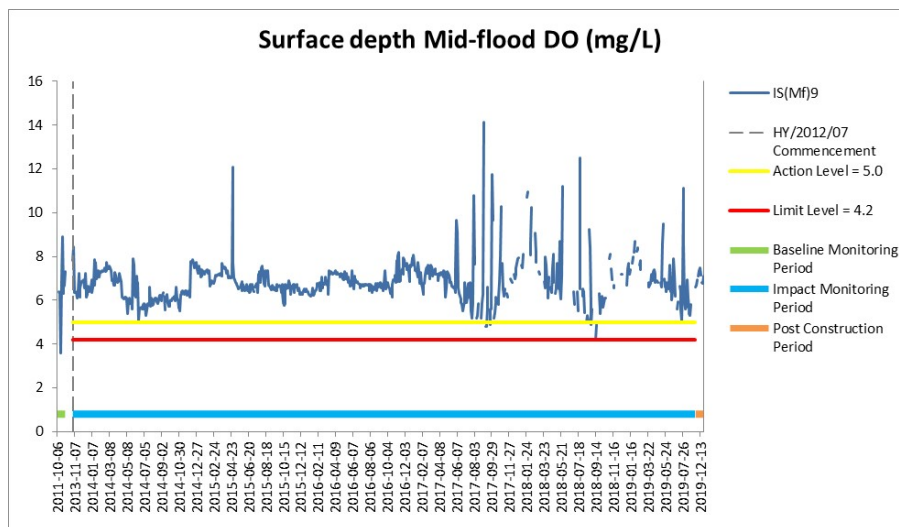
Figure F6 Impact Monitoring – Mean Level of Dissolved Oxygen (mg/L) in surface waters during mid-flood tide between 6 October 2011 and 23 December 2019 at IS(Mf)16 and IS(Mf)9.

(Weather condition varied between sunny to rainy during the course of the Project.) Overall monitoring results were not affected by weather conditions. In-situ monitoring is taken according to the requirement specified in the EM&A Manual, i.e. 3 water depth namely 1m below sea surface, mid-depth and 1m above sea bed. If the water depth is less than 3m, mid-depth sampling only. If water depth less than 6m, mid-depth may be omitted.

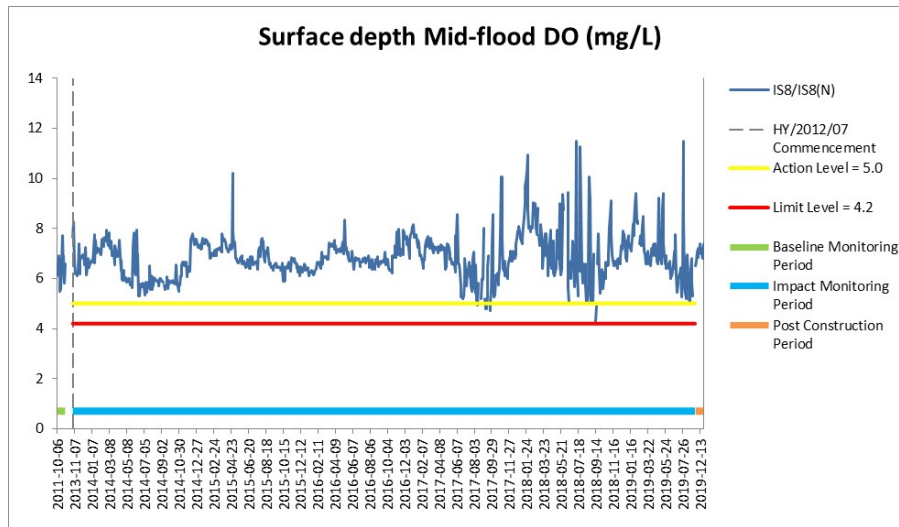
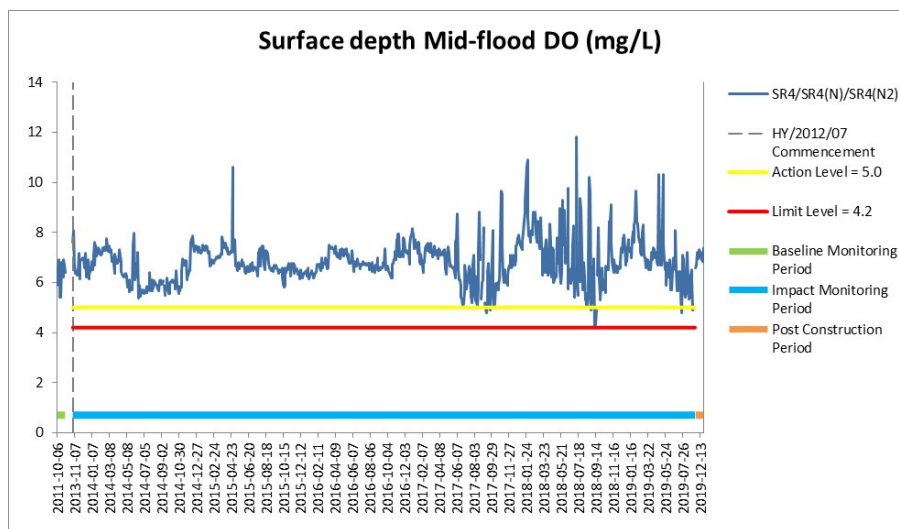
Figure F7 Impact Monitoring – Mean Level of Dissolved Oxygen (mg/L) in surface waters during mid-flood tide between 6 October 2011 and 23 December 2019 at IS8/IS8(N) and SR4/SR4(N)/SR4(N2).

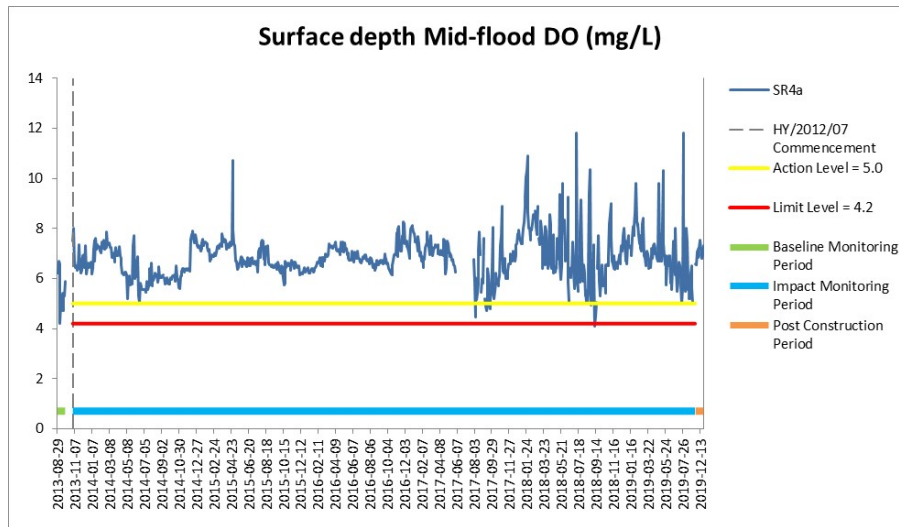
Figure F8 Impact Monitoring – Mean Level of Dissolved Oxygen (mg/L) in surface waters during mid-flood tide between 29 August 2013 and 23 December 2019 at SR4a.

(Weather condition varied between sunny to rainy during the course of the Project.)
Overall monitoring results were not affected by weather conditions. In-situ monitoring is taken according to the requirement specified in the EM&A Manual, i.e. 3 water depth namely 1m below sea surface, mid-depth and 1m above sea bed. If the water depth is less than 3m, mid-depth sampling only. If water depth less than 6m, mid-depth may be omitted.

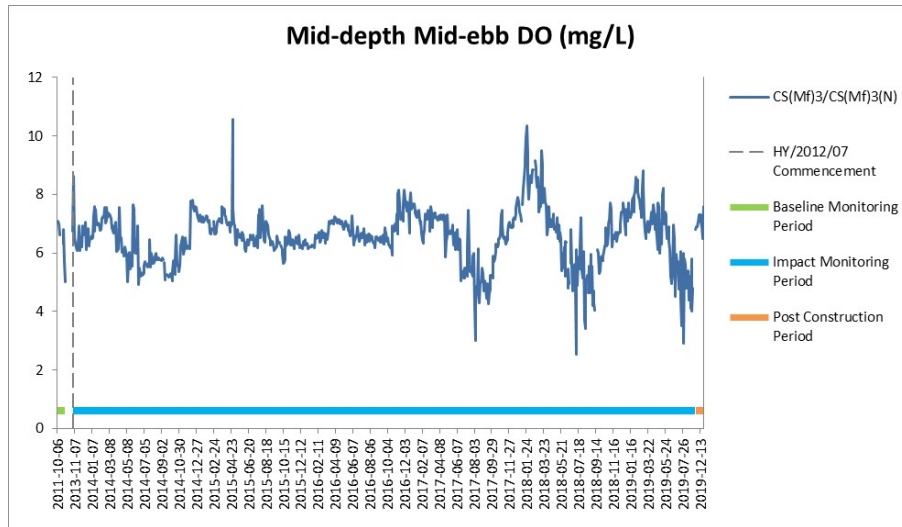
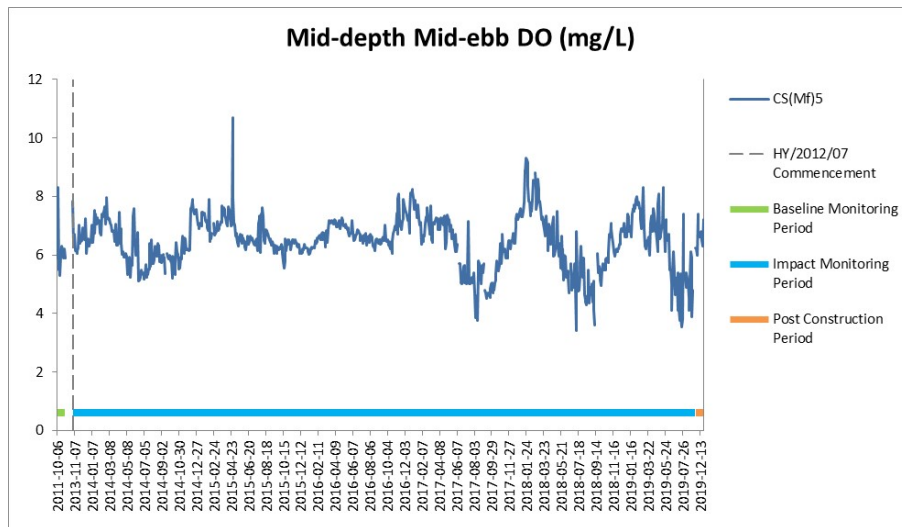
Figure F9 Impact Monitoring – Mean Level of Dissolved Oxygen (mg/L) in mid-depth waters during mid-ebb tide between 6 October 2011 and 23 December 2019 at CS(Mf)3(N) and CS(Mf)5.

(Weather condition varied between sunny to rainy during the course of the Project.) Overall monitoring results were not affected by weather conditions. In-situ monitoring is taken according to the requirement specified in the EM&A Manual, i.e. 3 water depth namely 1m below sea surface, mid-depth and 1m above sea bed. If the water depth is less than 3m, mid-depth sampling only. If water depth less than 6m, mid-depth may be omitted.

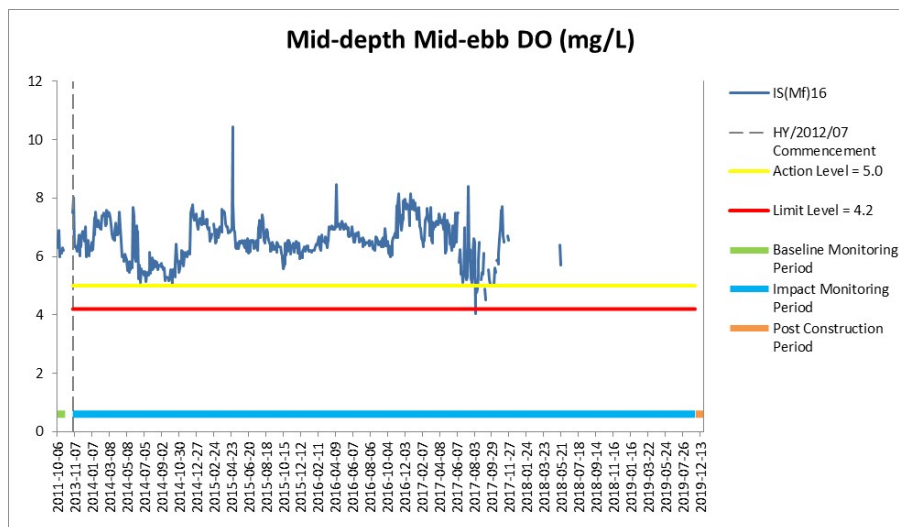
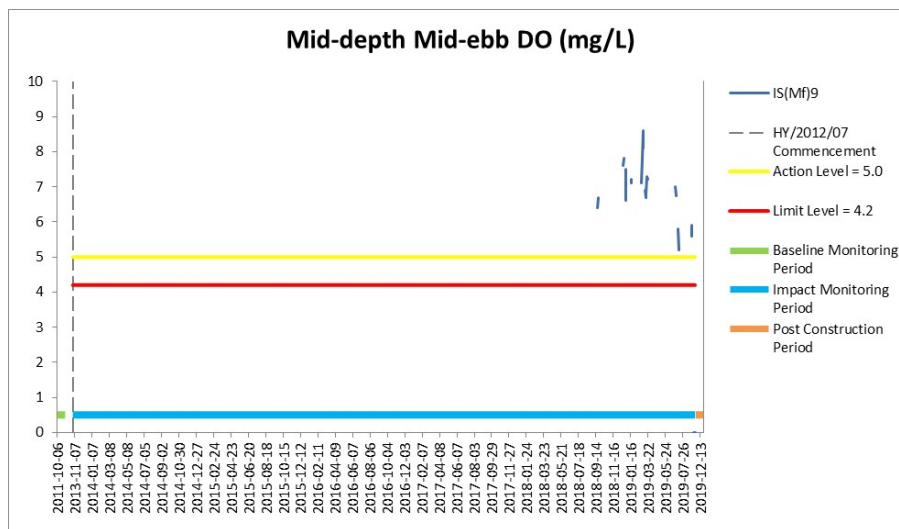
Figure F10 Impact Monitoring – Mean Level of Dissolved Oxygen (mg/L) in mid-depth waters during mid-ebb tide between 6 October 2011 and 23 December 2019 at IS(Mf)16 and IS(Mf)9.

(Weather condition varied between sunny to rainy during the course of the Project.) Overall monitoring results were not affected by weather conditions. In-situ monitoring is taken according to the requirement specified in the EM&A Manual, i.e. 3 water depth namely 1m below sea surface, mid-depth and 1m above sea bed. If the water depth is less than 3m, mid-depth sampling only. If water depth less than 6m, mid-depth may be omitted.

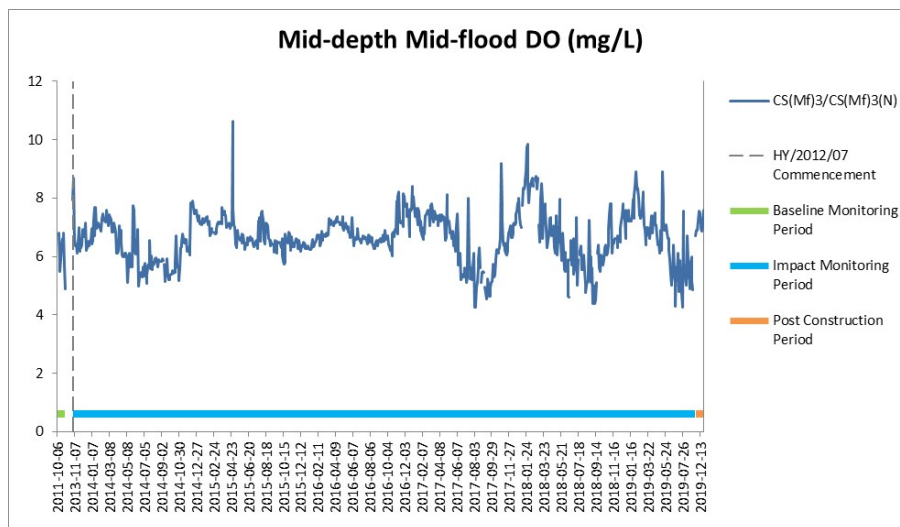
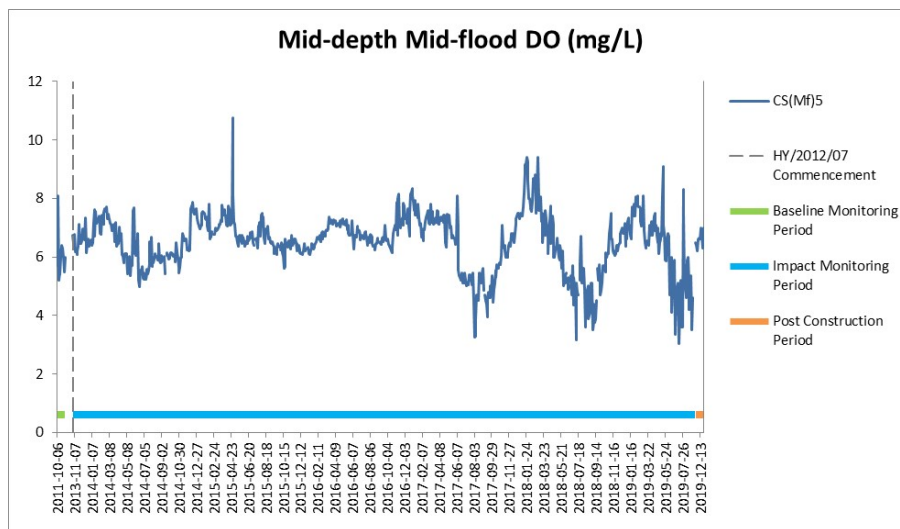
Figure F11 Impact Monitoring – Mean Level of Dissolved Oxygen (mg/L) in mid-depth waters during mid-flood tide between 6 October 2011 and 23 December 2019 at CS(Mf)3(N) and CS(Mf)5.

(Weather condition varied between sunny to rainy during the course of the Project.) Overall monitoring results were not affected by weather conditions. In-situ monitoring is taken according to the requirement specified in the EM&A Manual, i.e. 3 water depth namely 1m below sea surface, mid-depth and 1m above sea bed. If the water depth is less than 3m, mid-depth sampling only. If water depth less than 6m, mid-depth may be omitted.

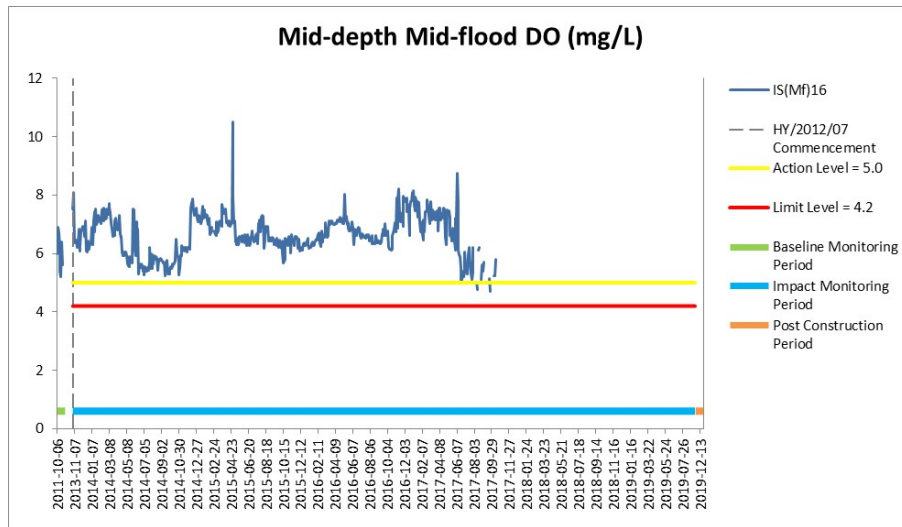
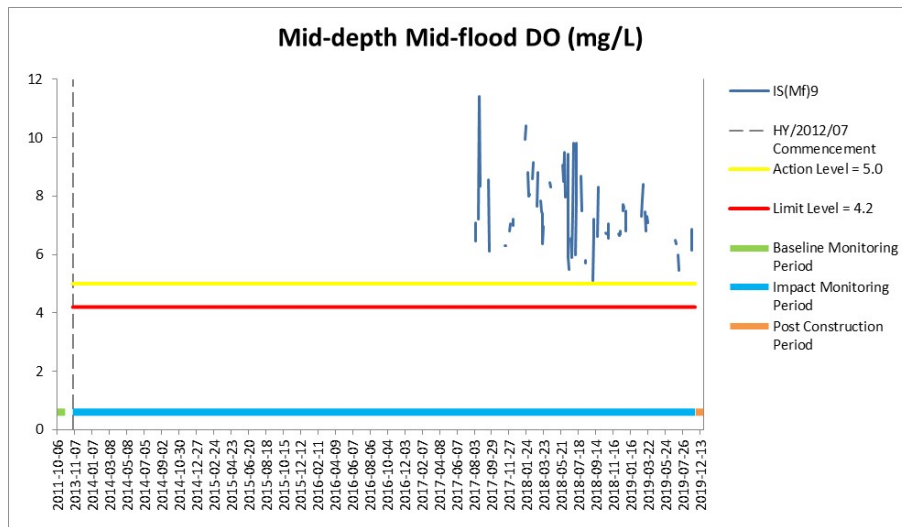
Figure F12 Impact Monitoring – Mean Level of Dissolved Oxygen (mg/L) in mid-depth waters during mid-flood tide between 6 October 2011 and 23 December 2019 at IS(Mf)16 and IS(Mf)9.

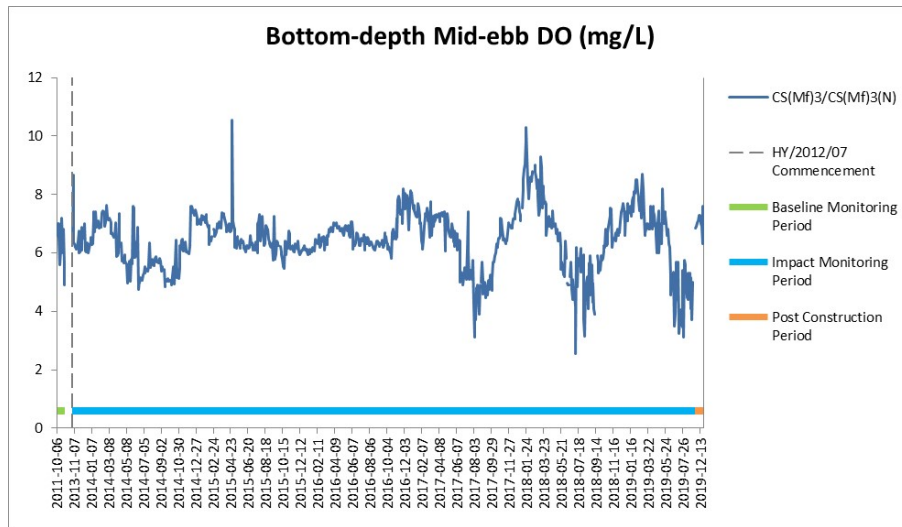
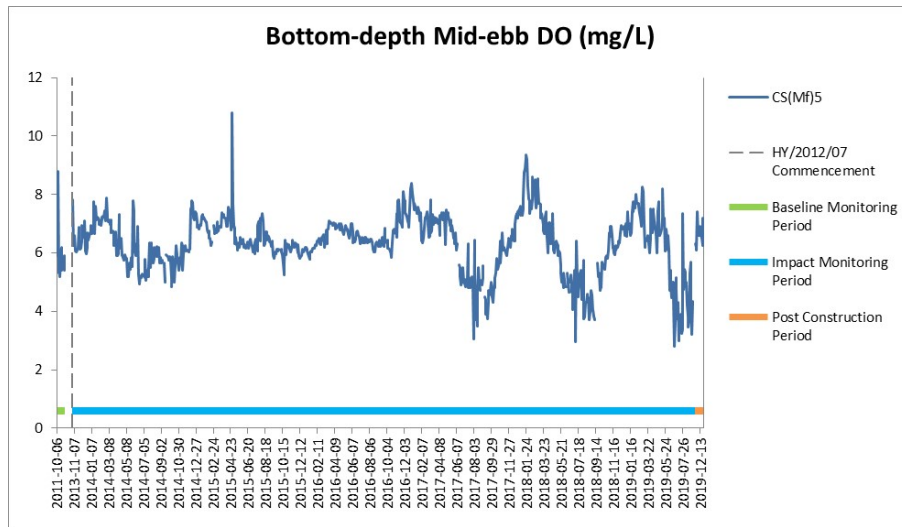
Figure F13 Impact Monitoring – Mean Level of Dissolved Oxygen (mg/L) in bottom waters during mid-ebb tide between 6 October 2011 and 23 December 2019 at CS(Mf)3/CS(Mf)3(N) and CS(Mf)5.

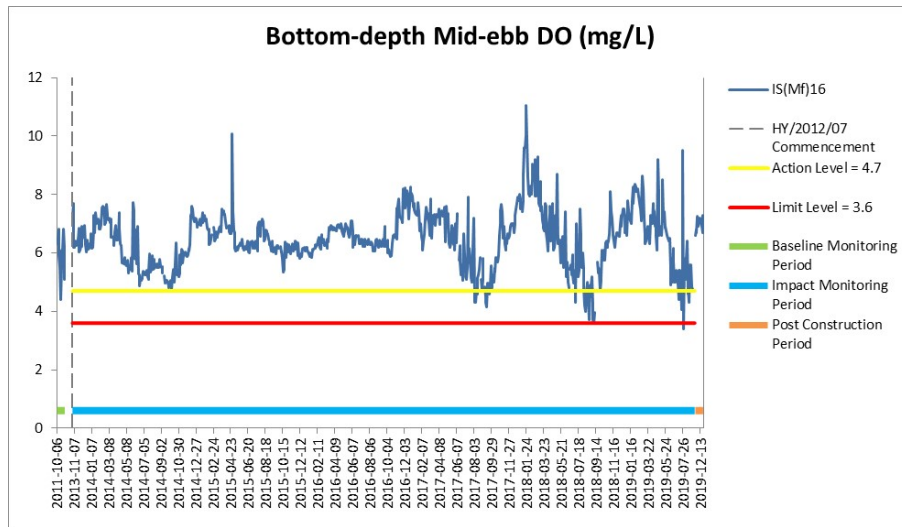
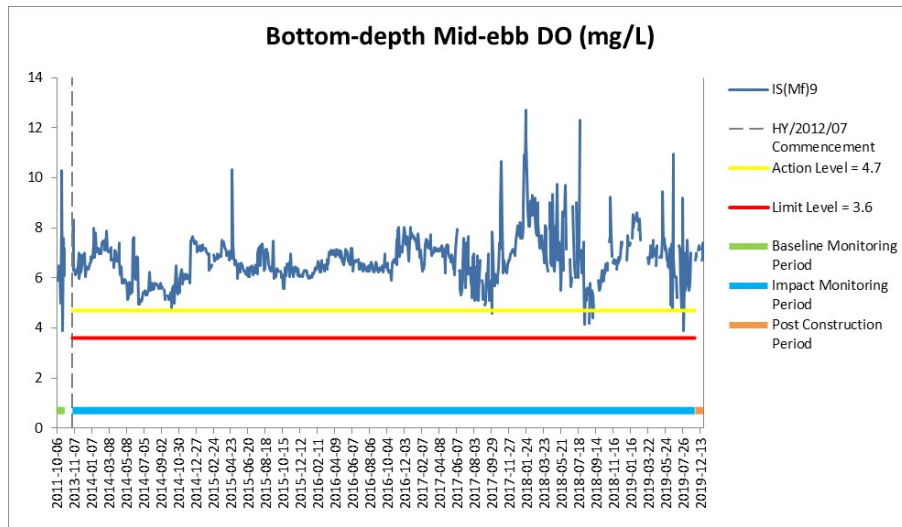
Figure F14 Impact Monitoring – Mean Level of Dissolved Oxygen (mg/L) in bottom waters during mid-ebb tide between 6 October 2011 and 23 December 2019 at IS(Mf)16 and IS(Mf)9.

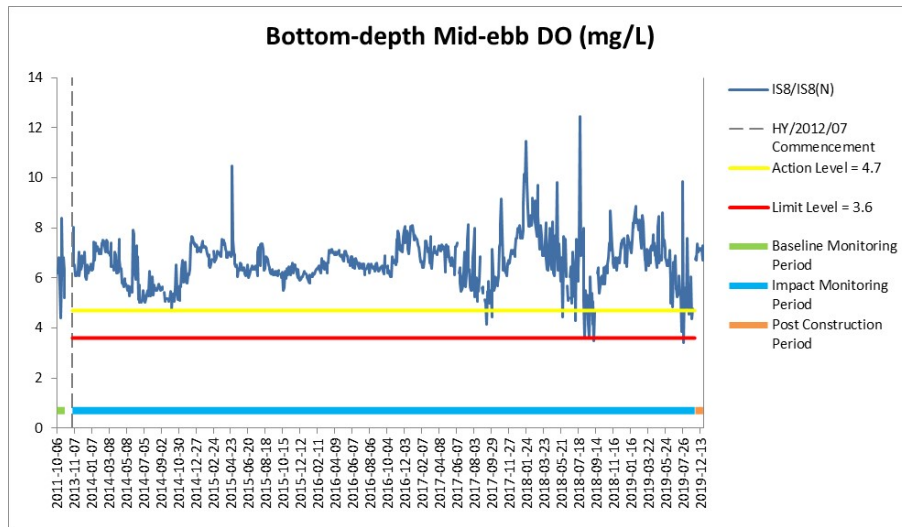
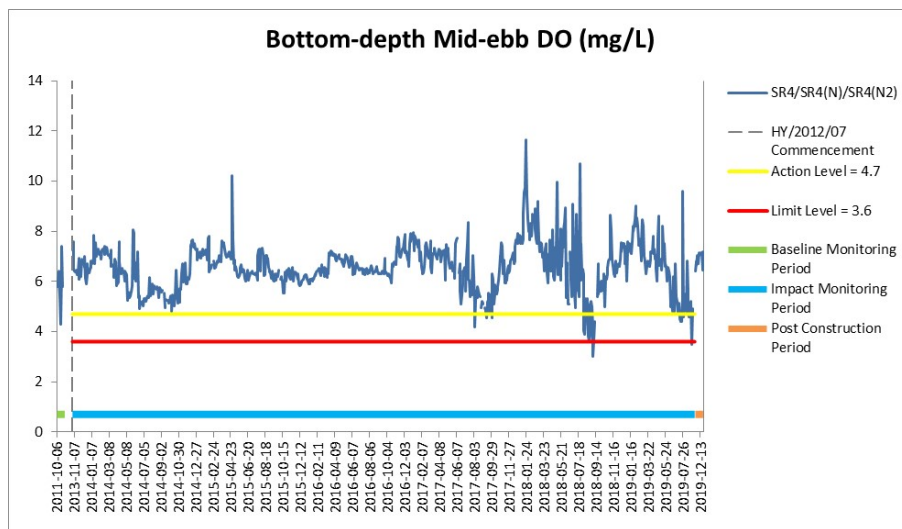
Figure F15 Impact Monitoring - Mean Level of Dissolved Oxygen (mg/L) in bottom waters during mid-ebb tide between 6 October 2011 and 23 December 2019 at IS8/IS8(N) and SR4/SR4(N)/SR4(N2).

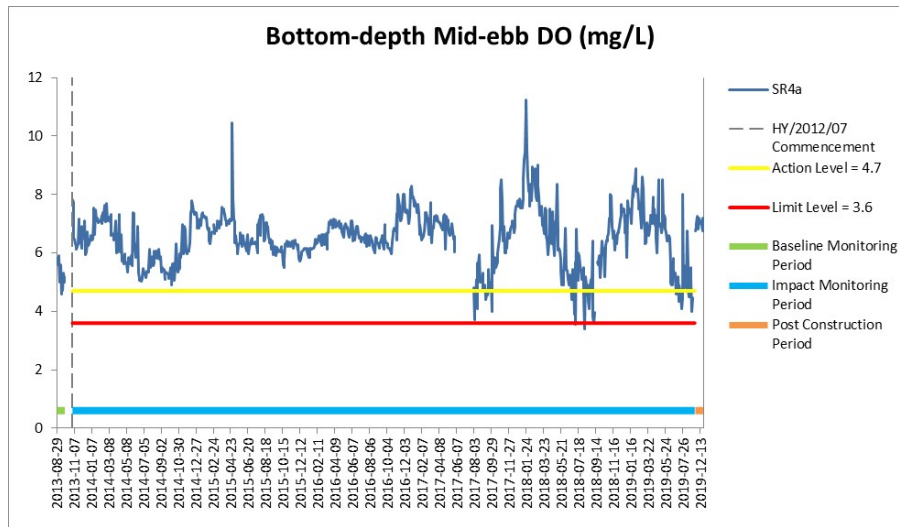
Figure F16 Impact Monitoring – Mean Level of Dissolved Oxygen (mg/L) in bottom waters during mid-ebb tide between 29 August 2013 and 23 December 2019 at SR4a.

(Weather condition varied between sunny to rainy during the course of the Project.)
 Overall monitoring results were not affected by weather conditions. In-situ monitoring is taken according to the requirement specified in the EM&A Manual, i.e. 3 water depth namely 1m below sea surface, mid-depth and 1m above sea bed. If the water depth is less than 3m, mid-depth sampling only. If water depth less than 6m, mid-depth may be omitted.

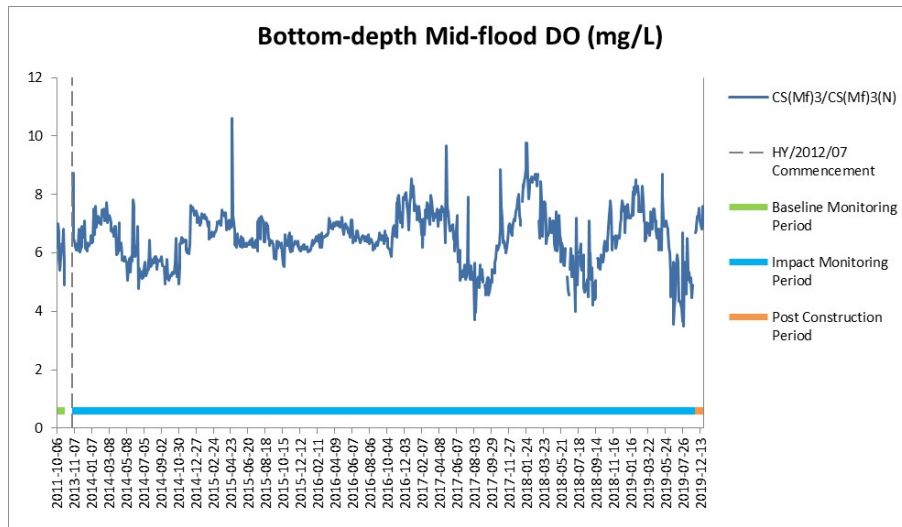
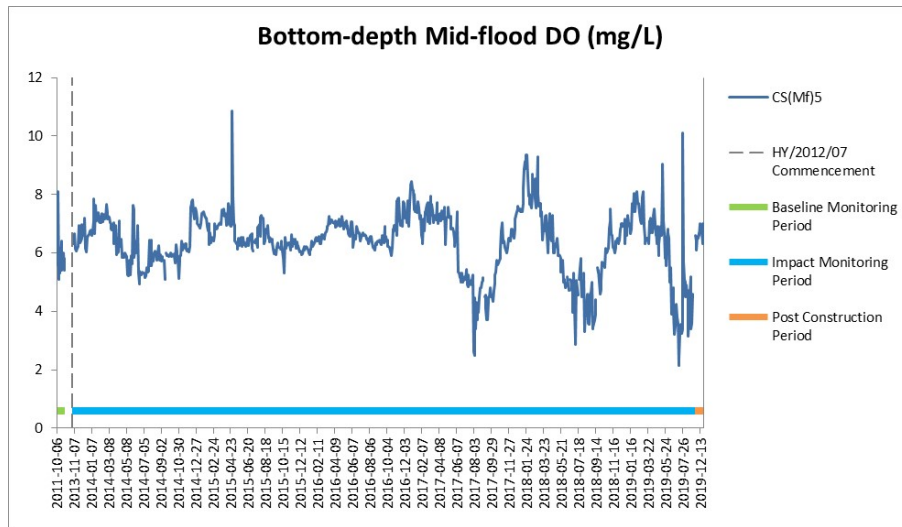
Figure F17 Impact Monitoring – Mean Level of Dissolved Oxygen (mg/L) in bottom waters during mid-flood tide between 6 October 2011 and 23 December 2019 at CS(Mf)3/CS(Mf)3(N) and CS(Mf)5.

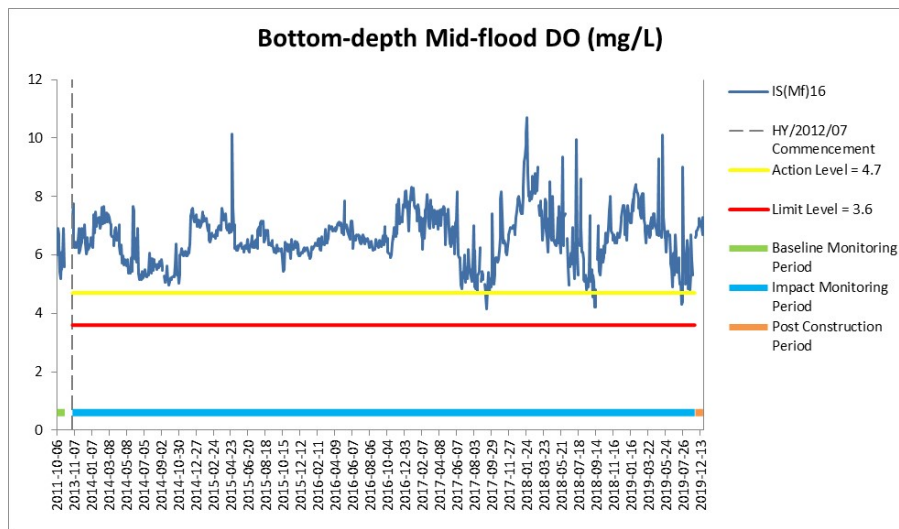
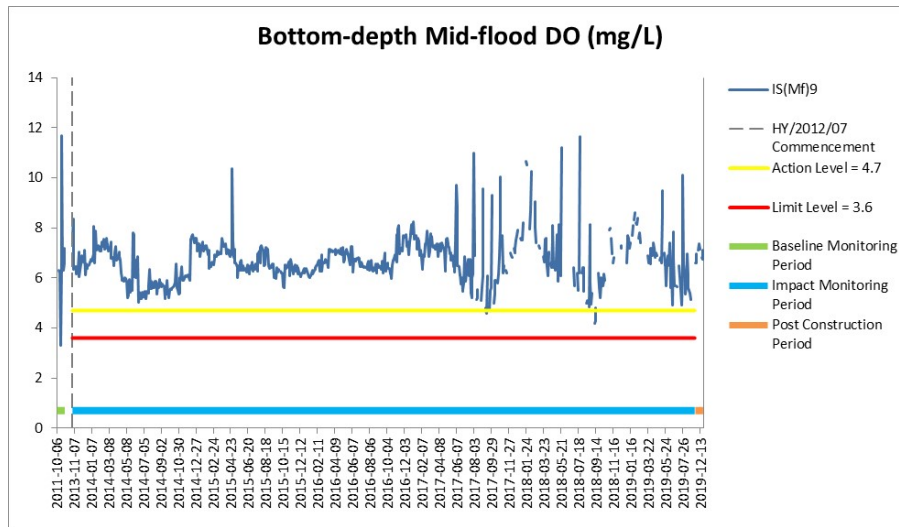
Figure F18 Impact Monitoring – Mean Level of Dissolved Oxygen (mg/L) in bottom waters during mid-flood tide between 6 October 2011 and 23 December 2019 at IS(Mf)16 and IS(Mf)9.

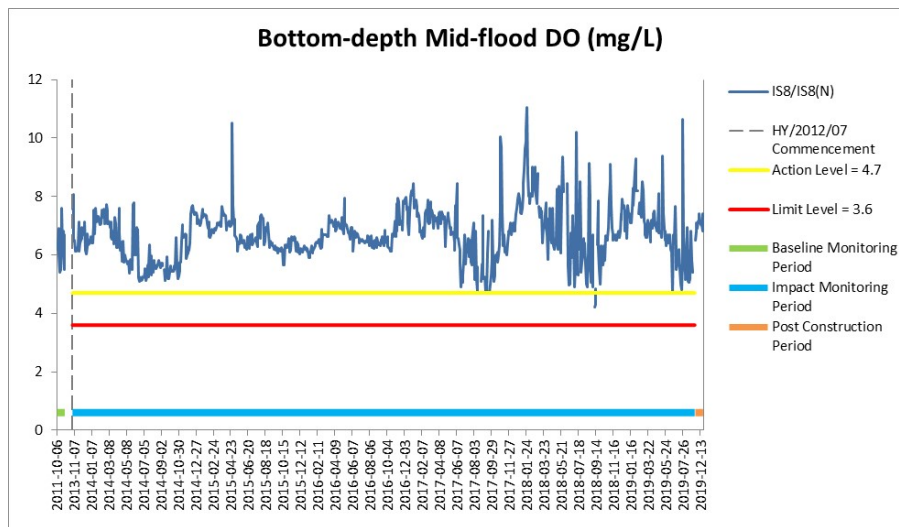
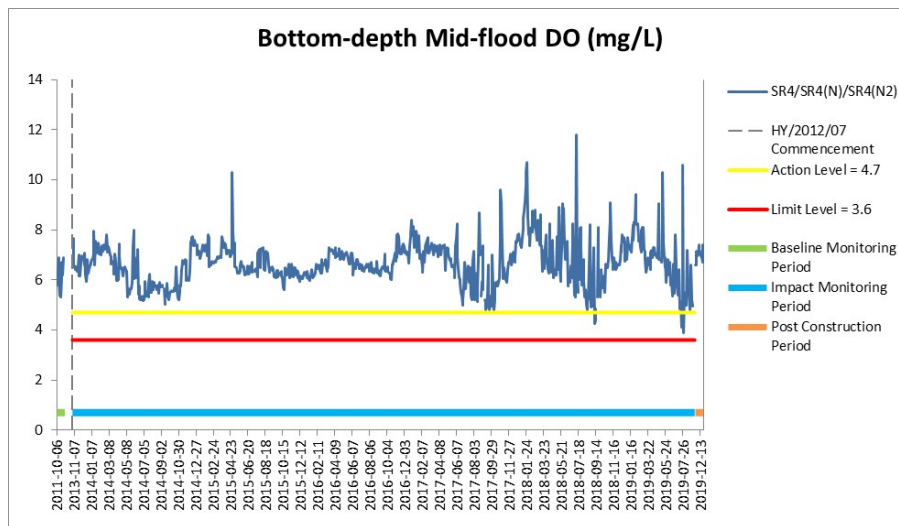
Figure F19 Impact Monitoring – Mean Level of Dissolved Oxygen (mg/L) in bottom waters during mid-flood tide between 6 October 2011 and 23 December 2019 at IS8/IS8(N) and SR4/SR4(N)/SR4(N2).
