**Contract No. HY/2012/07
Tuen Mun - Chek Lap Kok Link -
Southern Connection Viaduct Section**

***Final Environmental Monitoring & Audit (EM&A)
Report***

22 December 2020

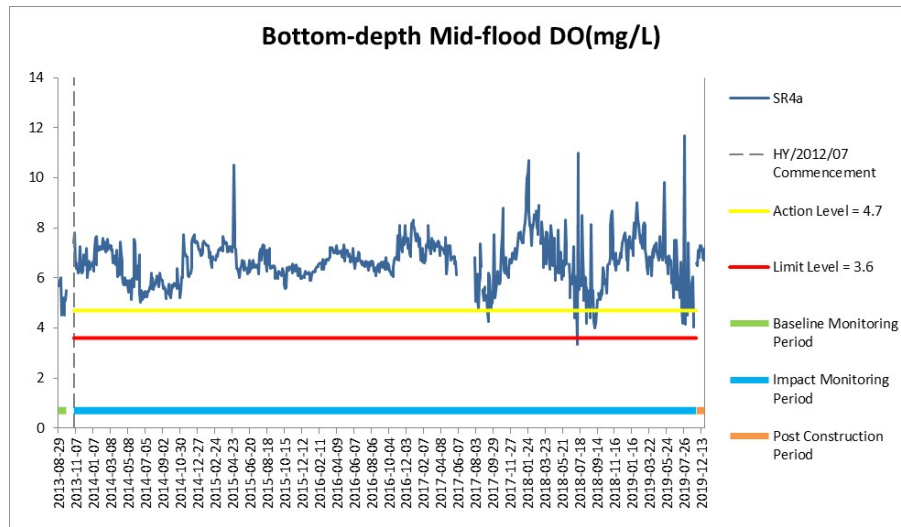
Figure F20 Impact Monitoring - Mean Level of Dissolved Oxygen (mg/L) in bottom waters during mid-flood tide between 29 August 2013 and 23 December 2019 at SR4a.

(Weather condition varied between sunny to rainy during the course of the Project.) Overall monitoring results were not affected by weather conditions. In-situ monitoring is taken according to the requirement specified in the EM&A Manual, i.e. 3 water depth namely 1m below sea surface, mid-depth and 1m above sea bed. If the water depth is less than 3m, mid-depth sampling only. If water depth less than 6m, mid-depth may be omitted.

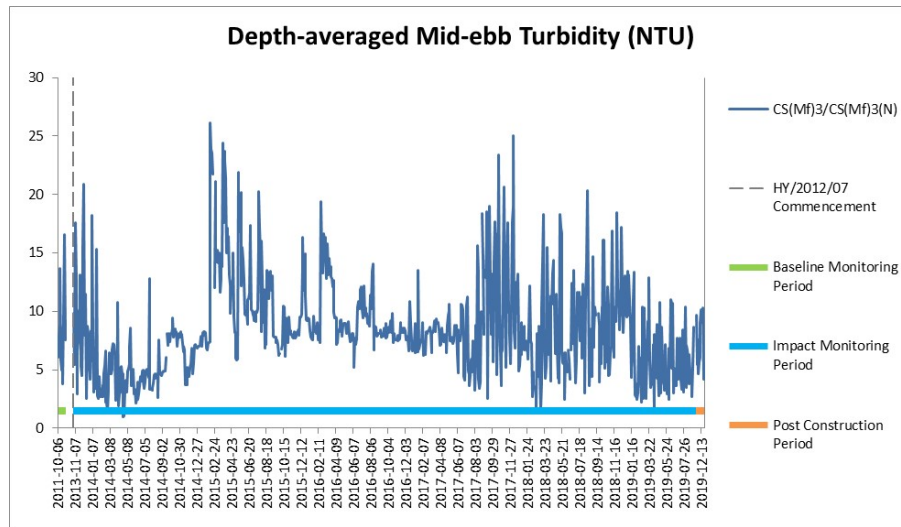
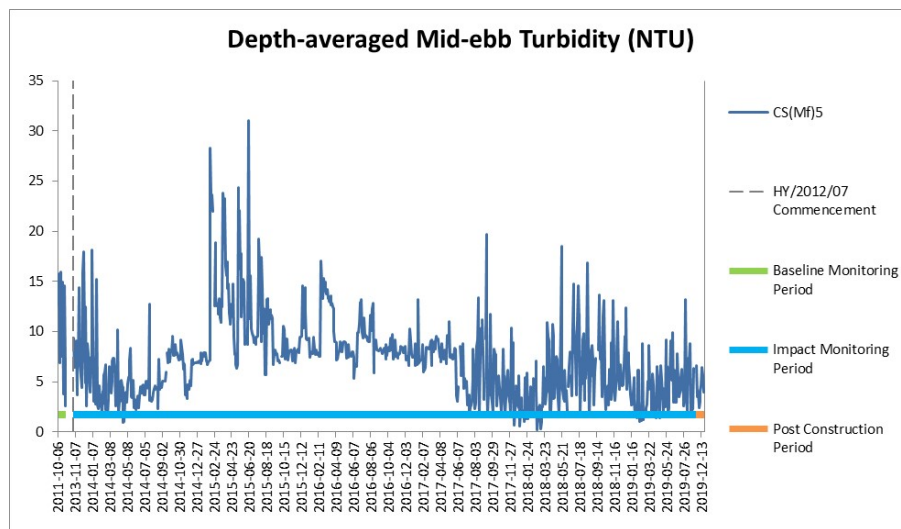
Figure F21 Impact Monitoring - Mean Level of depth-averaged Turbidity (NTU) during mid-ebb tide between 6 October 2011 and 23 December 2019 at CS(Mf)3/CS(Mf)3(N) and CS(Mf)5.

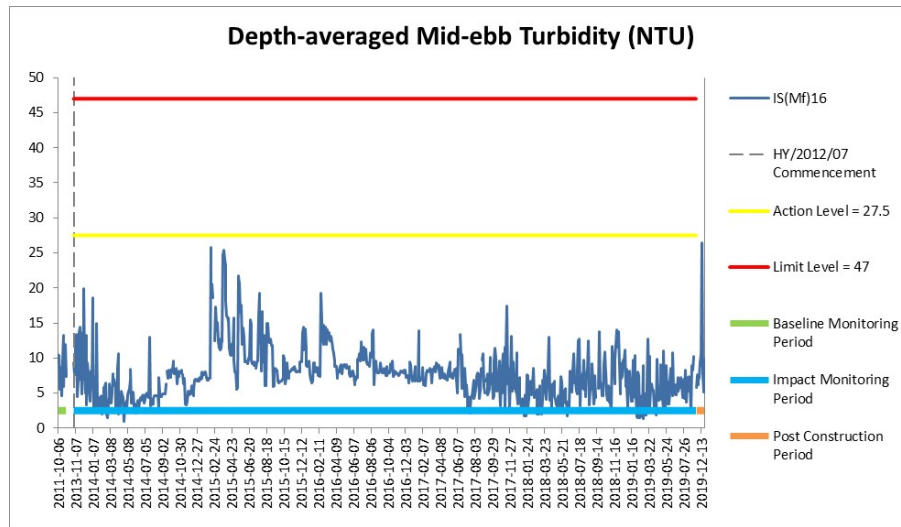
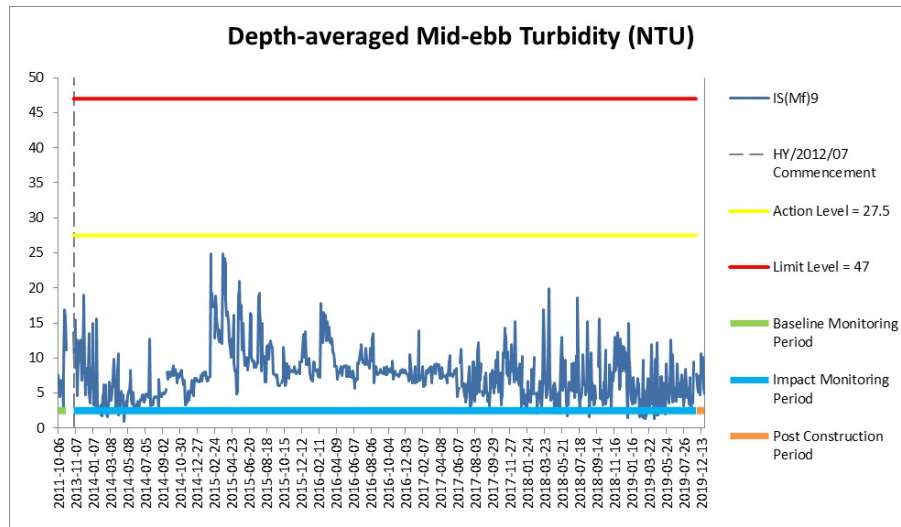
Figure F22 Impact Monitoring – Mean Level of depth-averaged Turbidity (NTU) during mid-ebb tide between 6 October 2011 and 23 December 2019 at IS(Mf)16 and IS(Mf)9.

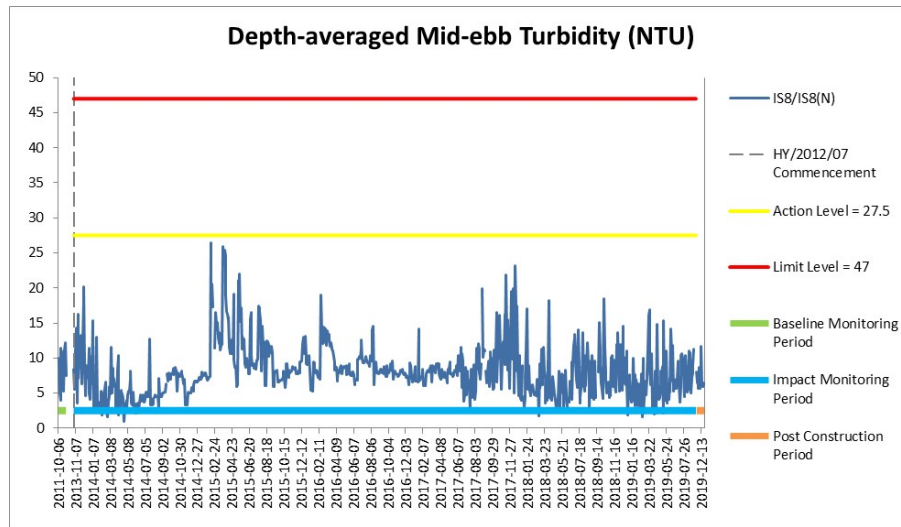
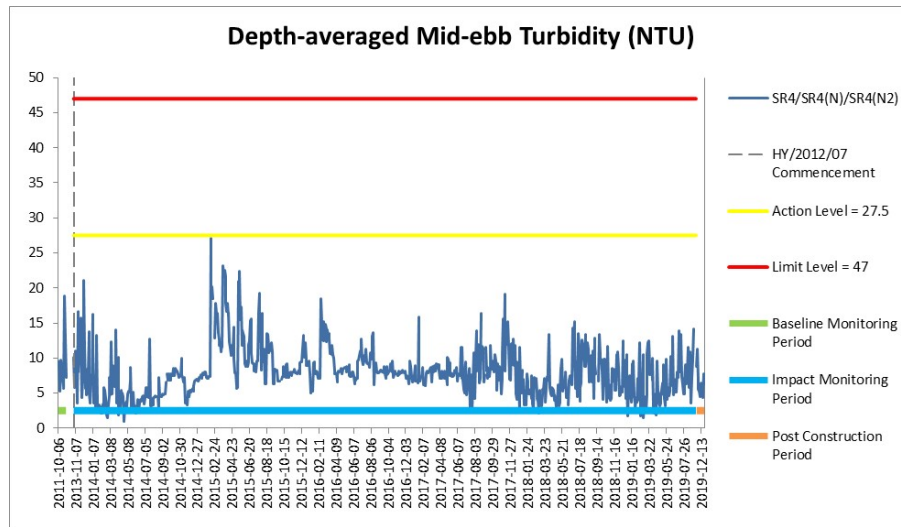
Figure F23 Impact Monitoring – Mean Level of depth-averaged Turbidity (NTU) during mid-ebb tide between 6 October 2011 and 23 December 2019 at IS8/IS8(N) and SR4/SR4(N)/SR4(N2).

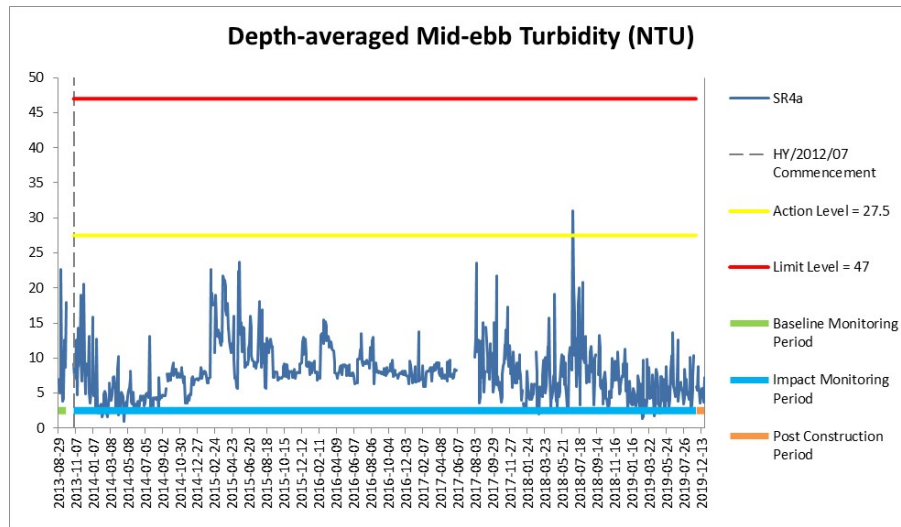
Figure F24 Impact Monitoring – Mean Level of depth-averaged Turbidity (NTU) during mid-ebb tide between 29 August 2013 and 23 December 2019 at SR4a.

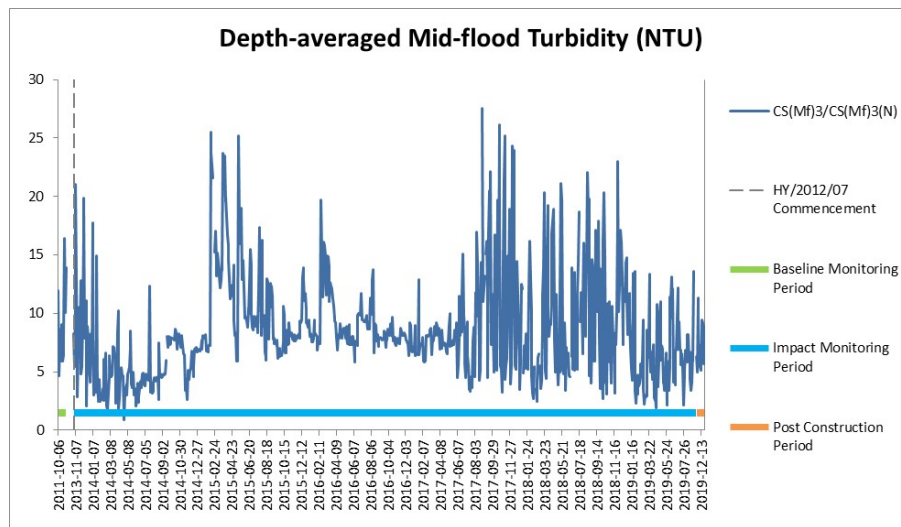
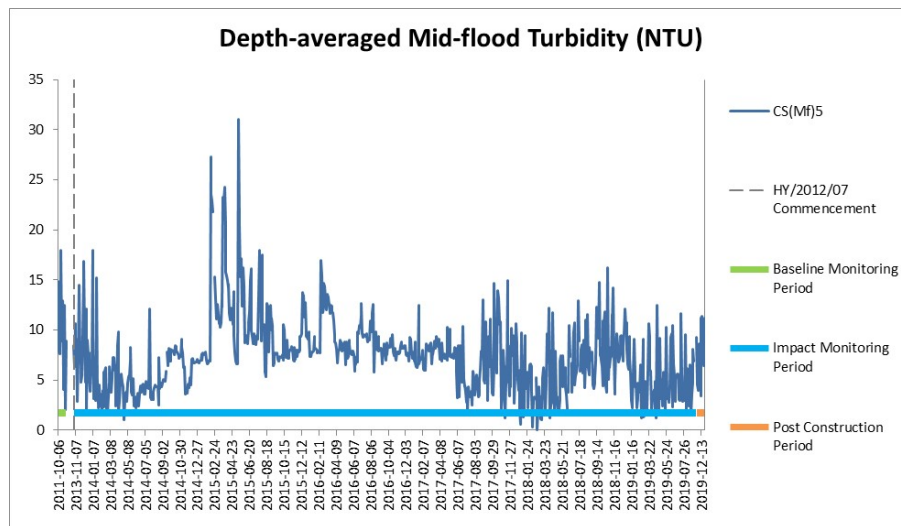
Figure F25 Impact Monitoring – Mean Level of depth-averaged Turbidity (NTU) during mid-flood tide between 6 October 2011 and 23 December 2019 at CS(Mf)3/CS(Mf)3(N) and CS(Mf)5.

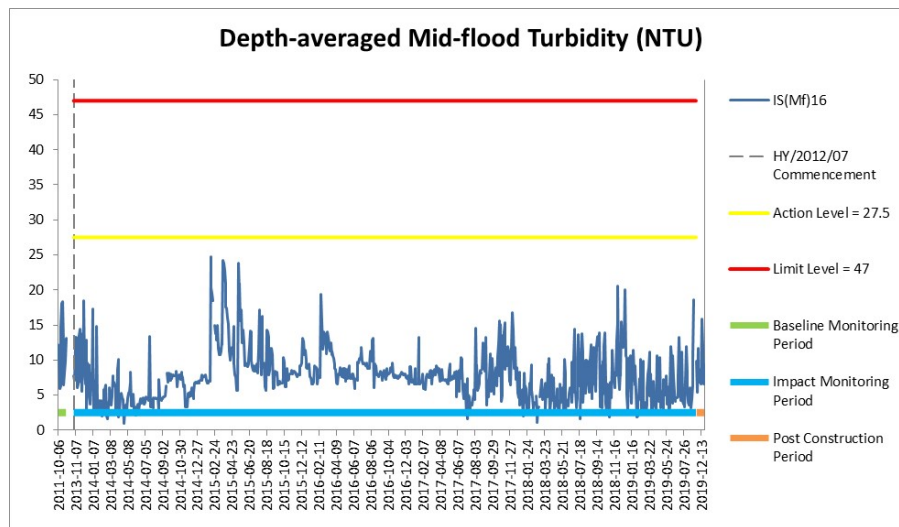
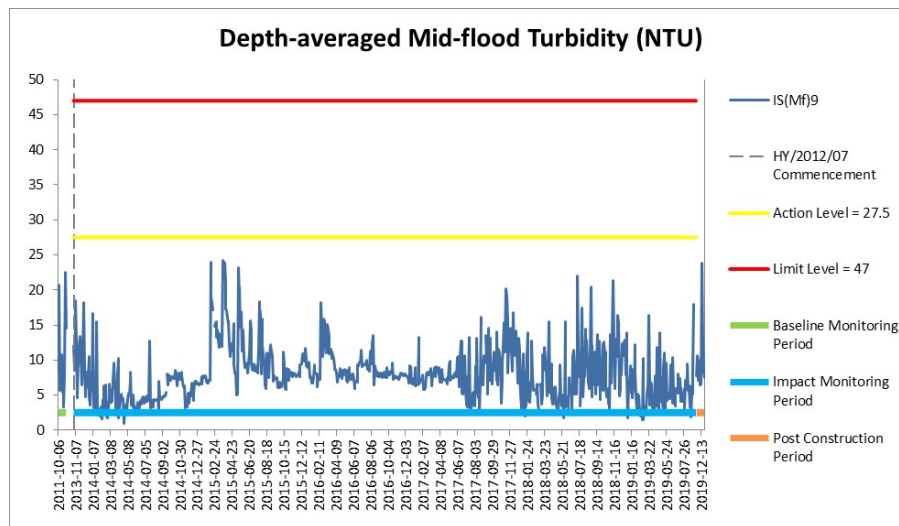
Figure F26 Impact Monitoring – Mean Level of depth-averaged Turbidity (NTU) during mid-flood tide between 6 October 2011 and 23 December 2019 at IS(Mf)16 and IS(Mf)9.

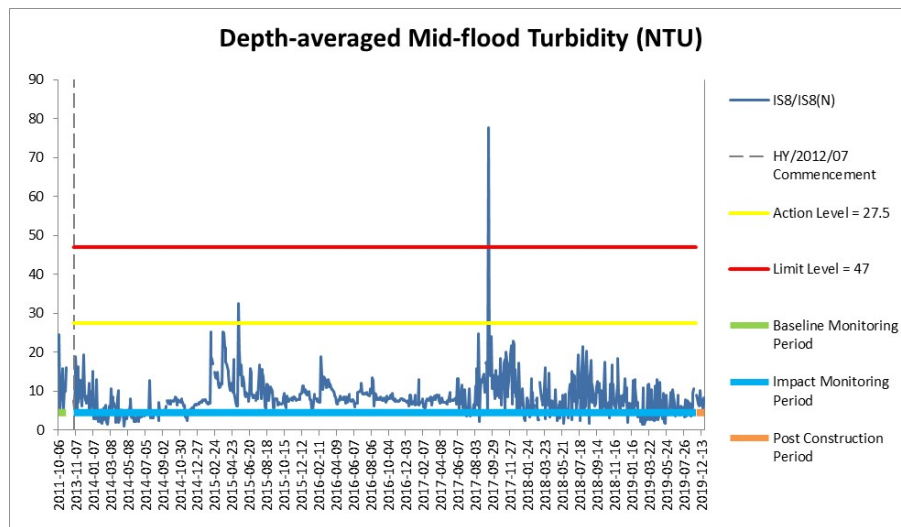
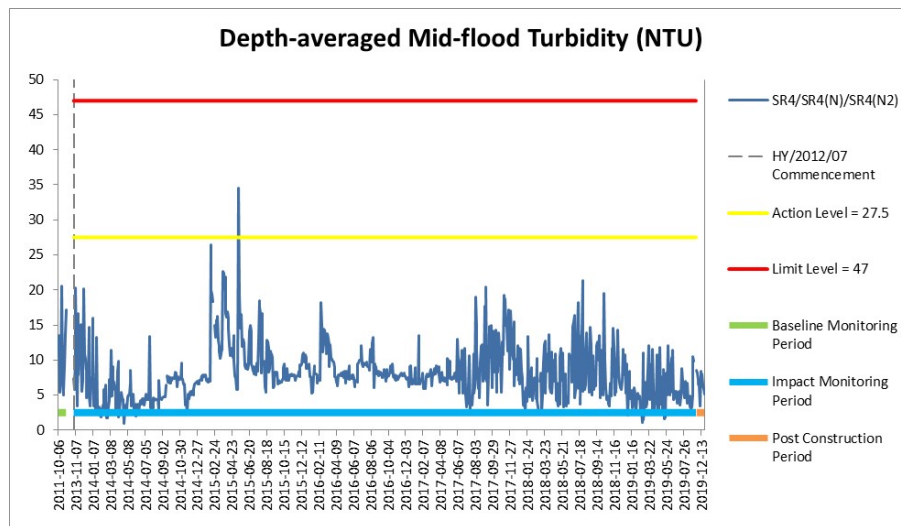
Figure F27 Impact Monitoring – Mean Level of depth-averaged Turbidity (NTU) during mid-flood tide between 6 October 2011 and 23 December 2019 at IS8/IS8(N) and SR4/SR4(N)/SR4(N2).

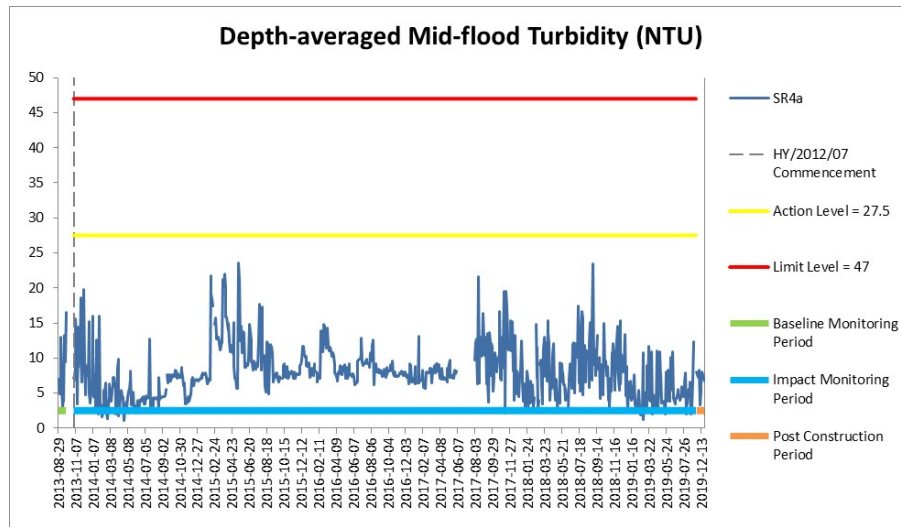
Figure F28 Impact Monitoring - Mean Level of depth-averaged Turbidity (NTU) during mid-flood tide between 29 August 2013 and 23 December 2019 at SR4a.

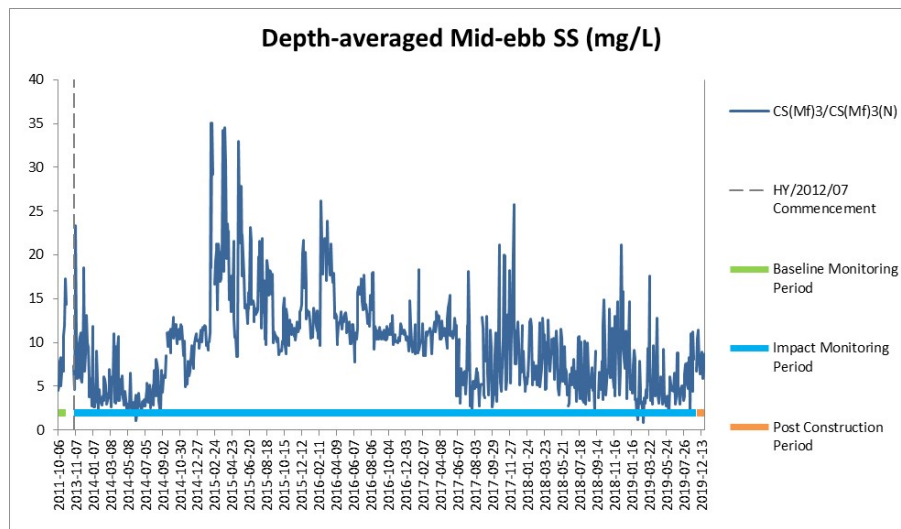
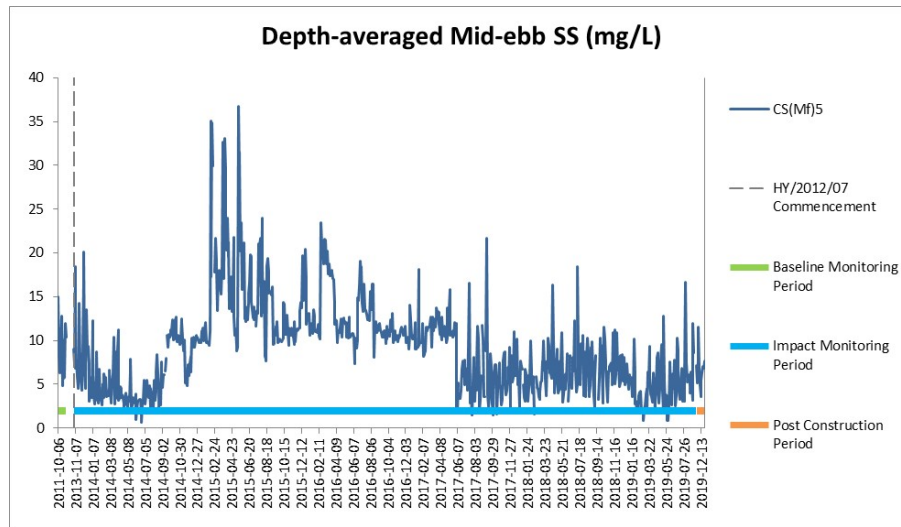
Figure F29 Impact Monitoring – Mean Level of depth-averaged Suspended Solids (mg/L) during mid-ebb tide between 6 October 2011 and 23 December 2019 at CS(Mf)3/CS(Mf)3(N) and CS(Mf)5.

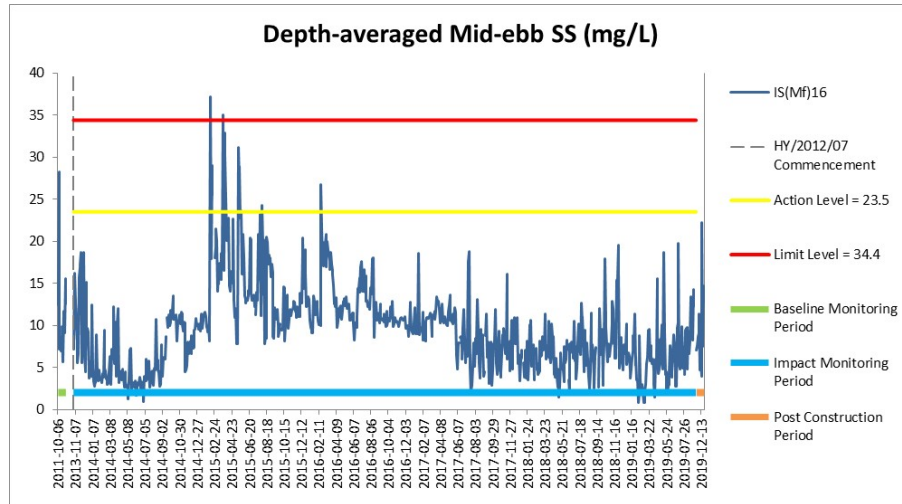
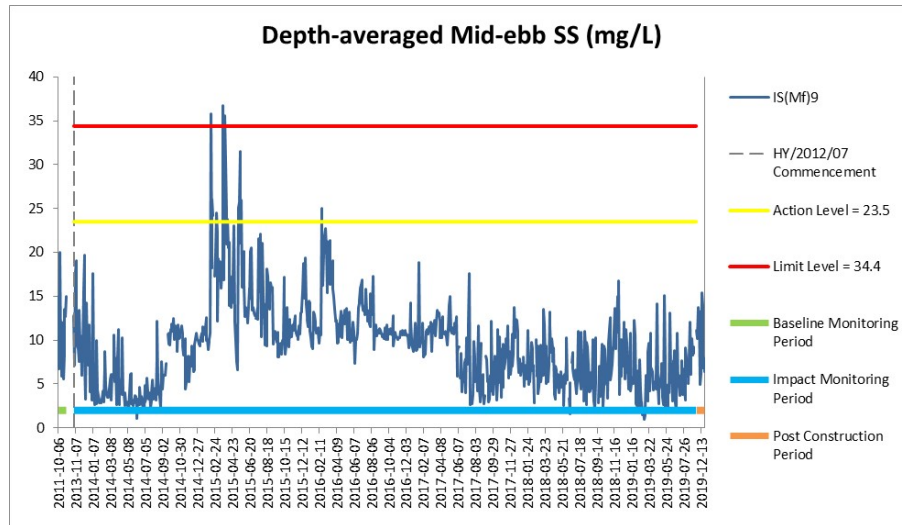
Figure F30 Impact Monitoring - Mean Level of depth-averaged Suspended Solids (mg/L) during mid-ebb tide between 6 October 2011 and 23 December 2019 at IS(Mf)16 and IS(Mf)9.

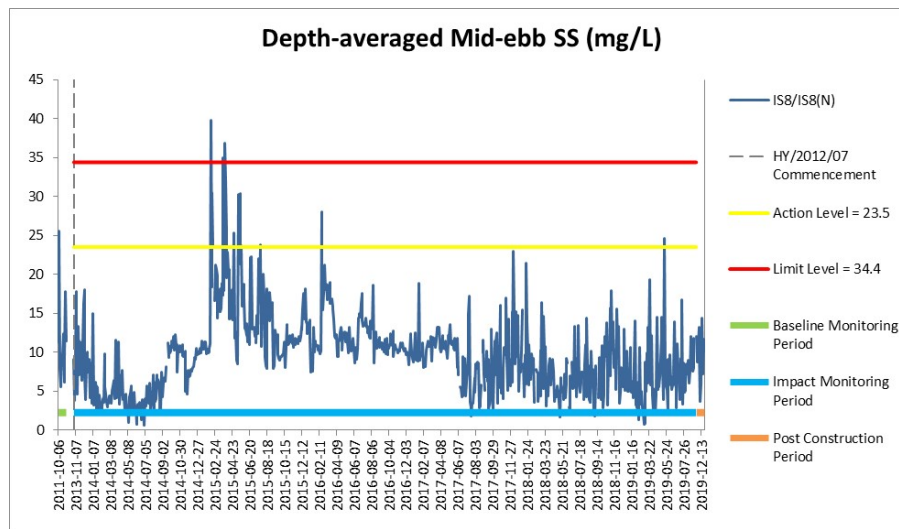
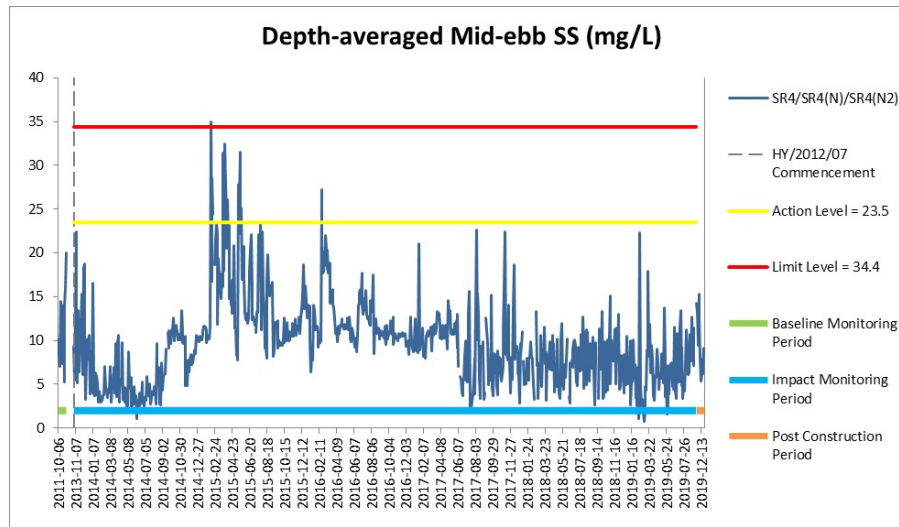
Figure F31 Impact Monitoring – Mean Level of depth-averaged Suspended Solids (mg/L) during mid-ebb tide between 6 October 2011 and 23 December 2019 at IS8/IS8(N) and SR4/SR4(N)/SR4(N2).

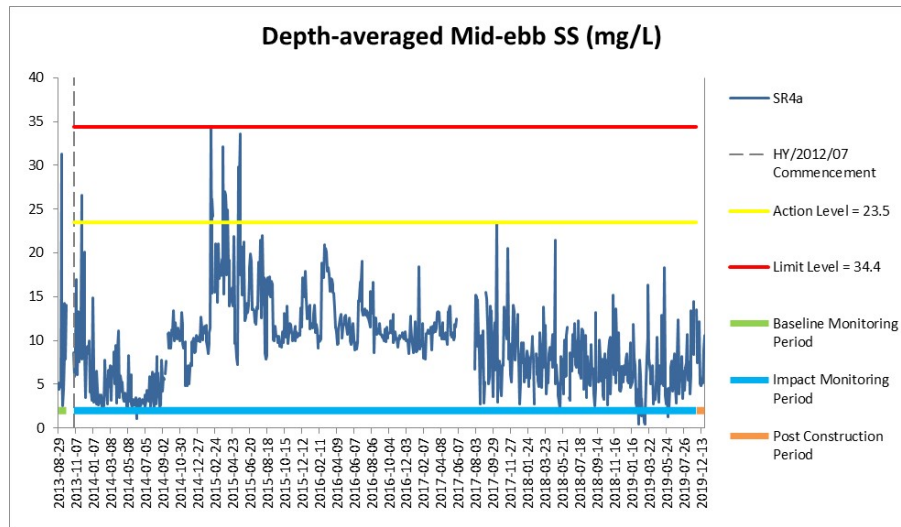
Figure F32 Impact Monitoring - Mean Level of depth-averaged Suspended Solids (mg/L) during mid-ebb tide between 29 August 2013 and 23 December 2019 at SR4a.

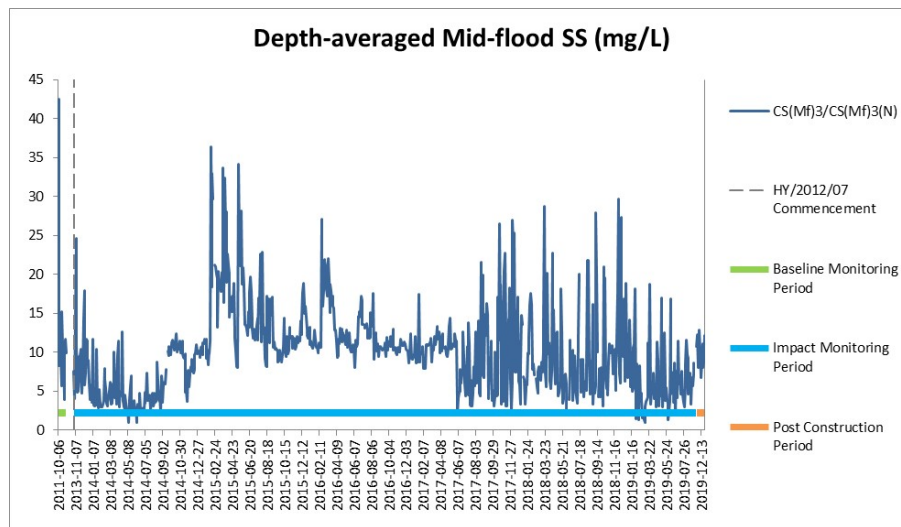
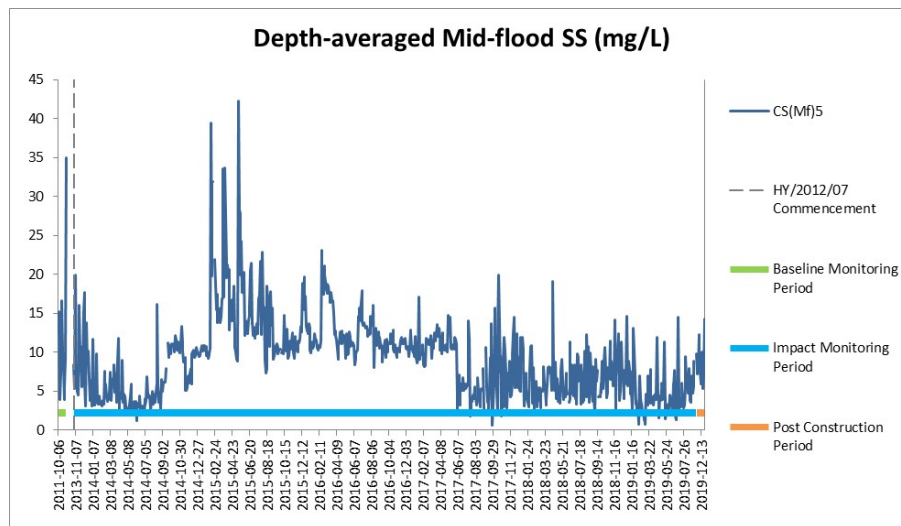
Figure F33 Impact Monitoring – Mean Level of depth-averaged Suspended Solids (mg/L) during mid-flood tide between 6 October 2011 and 23 December 2019 at CS(Mf)3/CS(Mf)3(N) and CS(Mf)5.

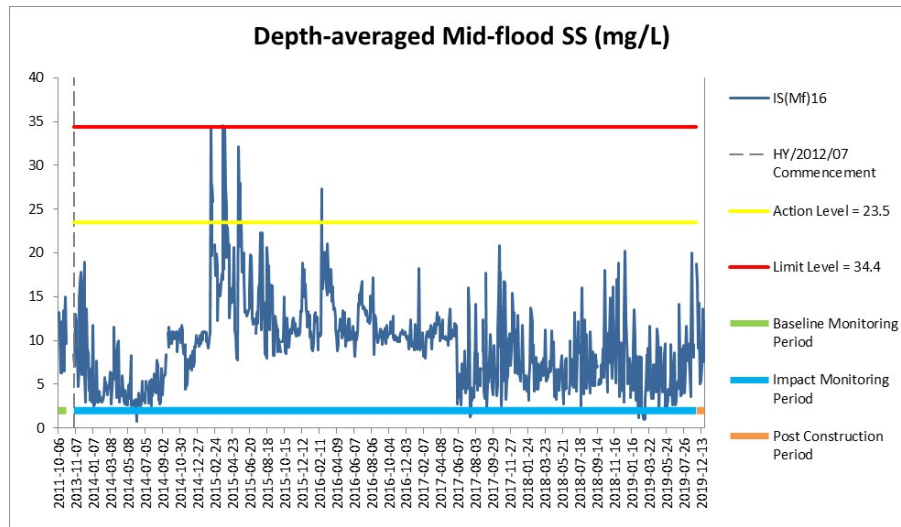
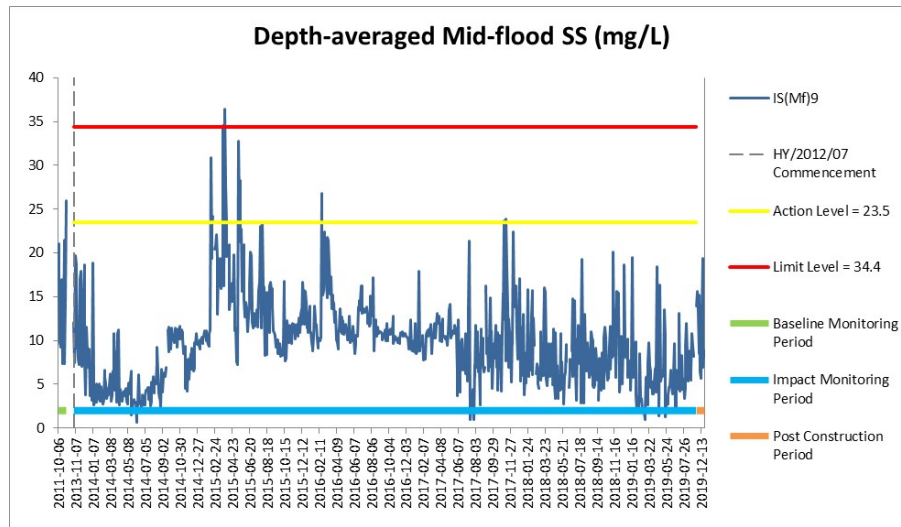
Figure F34 Impact Monitoring – Mean Level of depth-averaged Suspended Solids (mg/L) during mid-flood tide between 6 October 2011 and 23 December 2019 at IS(Mf)16 and IS(Mf)9 .

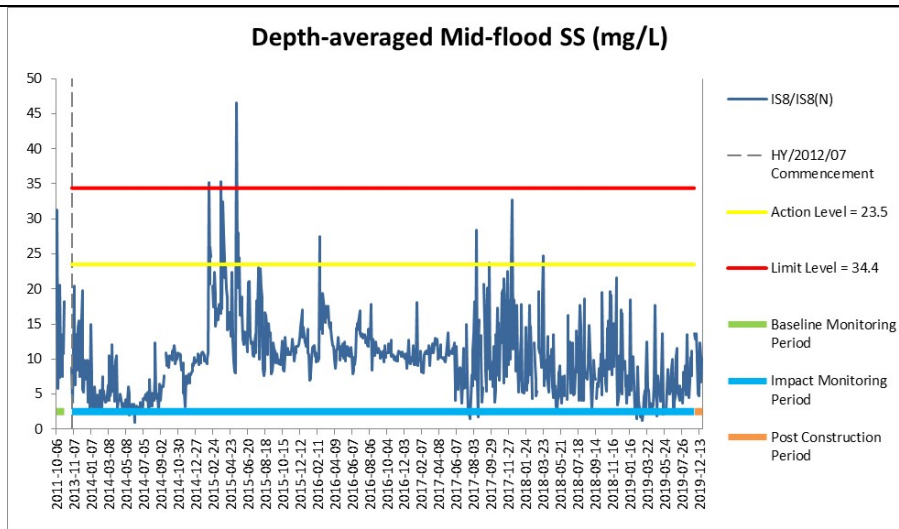
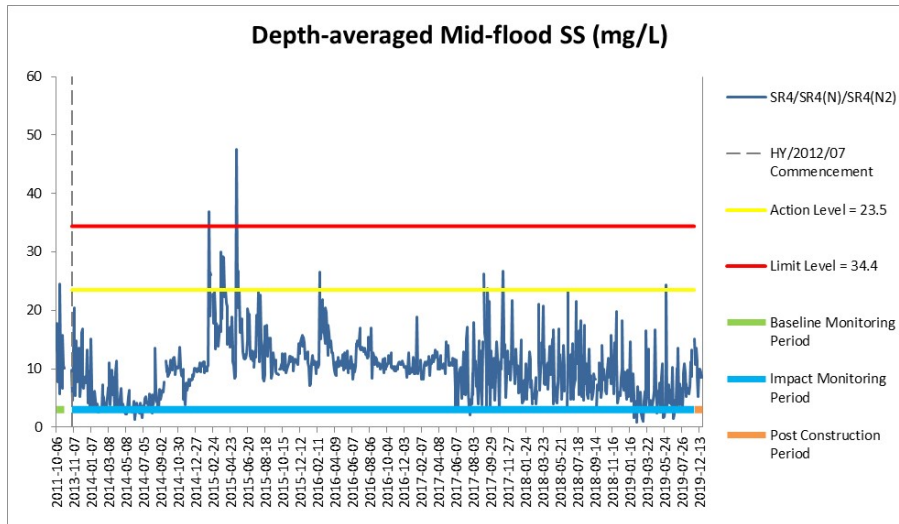
Figure F35 Impact Monitoring – Mean Level of depth-averaged Suspended Solids (mg/L) during mid-flood tide between 6 October 2011 and 23 December 2019 at IS8/IS8(N) and SR4/SR4(N)/SR4(N2). (Weather condition varied between sunny to rainy during the course of the Project.) Overall monitoring results were not affected by weather conditions. In-situ monitoring is taken according to the requirement specified in the EM&A Manual, i.e. 3 water depth namely 1m below sea surface, mid-depth and 1m above sea bed. If the water depth is less than 3m, mid-depth sampling only. If water depth less than 6m, mid-depth may be omitted.

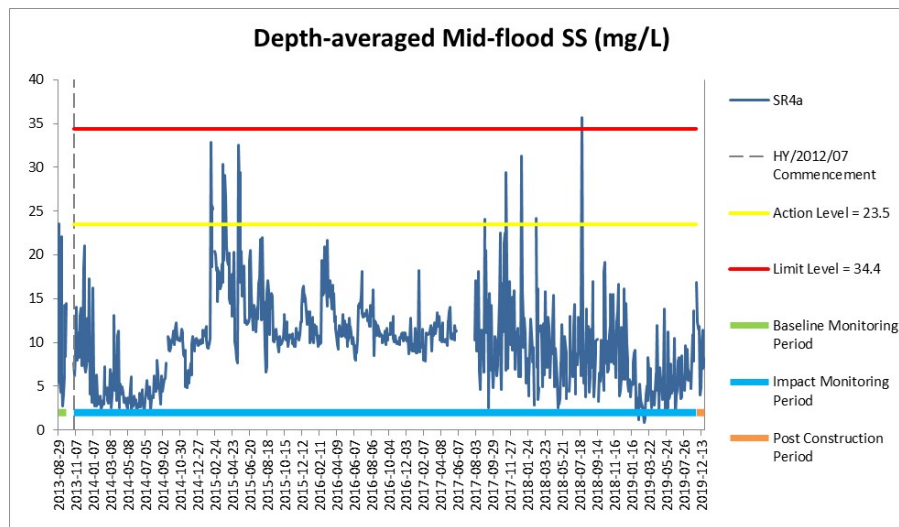
Figure F36 Impact Monitoring - Mean Level of depth-averaged Suspended Solids (mg/L) during mid-flood tide between 29 August 2013 and 23 December 2019 at SR4a.
