**AGREEMENT NO. CE 45/2008 (CE)
LIANTANG/HEUNG YUEN WAI
BOUNDARY CONTROL POINT AND ASSOCIATED WORKS**

**MONITORING REPORT FOR WETLAND
COMPENSATION AREA (No.12) – SEPTEMBER 2021**

**PREPARED FOR
CIVIL ENGINEERING AND DEVELOPMENT DEPARTMENT**

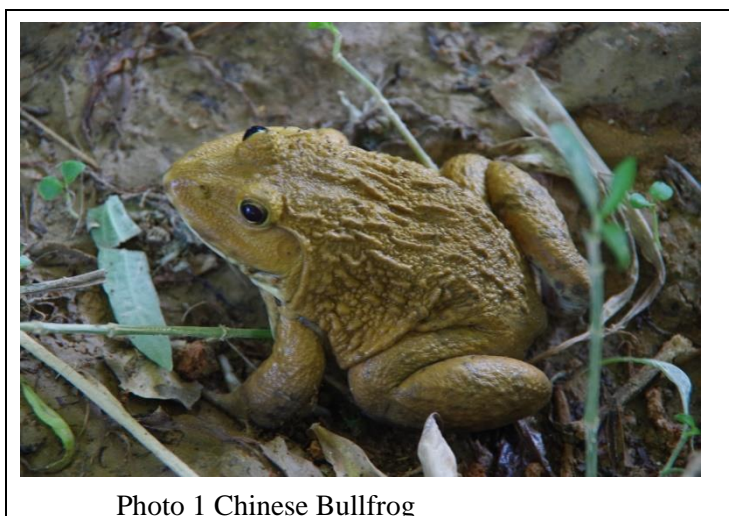
Photo 1 Chinese Bullfrog

- 3.1.8 Day-time and night-time monitoring of amphibian were undertaken within the WCA on **30th September 2021**. Including the sightings made during the dragonfly monitoring of the month, 3 amphibian species were recorded in the reporting month - include a total of 2 sightings of Günther's Frog *Sylvirana guentheri* and 2 sightings of Chinese Bullfrog *Hoplobatrachus rugulosus* in the daytime monitoring, as well as 1 sighting of the Günther's Frog and Chinese Bullfrog at night time. On the other hand, vocal calls of Brown Tree Frog *Polypedates megacephalus* has also recorded during the night time monitoring. On the other hand, no records of juvenile or larvae have not been made during the sweep netting or bottle trapping. Photo of the Chinese Bullfrog recorded is shown in below.

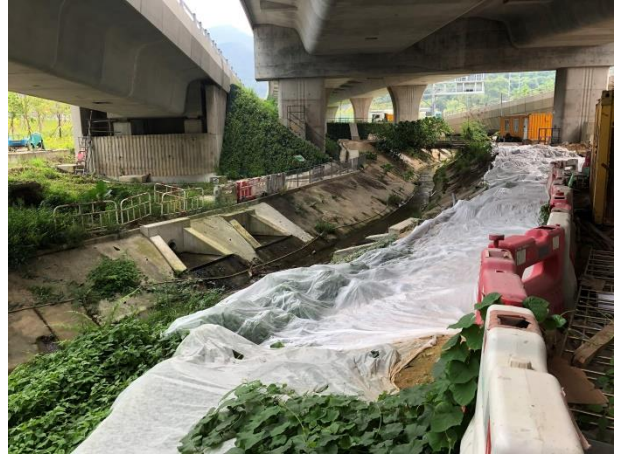
Pond G

- 3.3.2 In the Reporting Month, the repairs works for the WCA were completed and photographic records showing the condition of the WCA (general view of the existing vegetation) in the Reporting Month are shown in *Appendix E*.

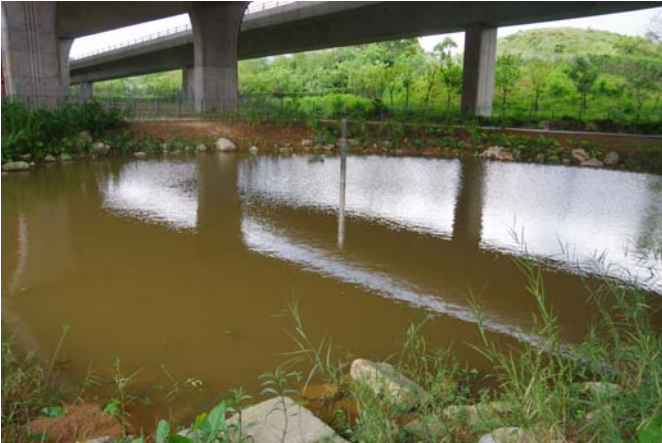
Pond A

Overview of the Pond Condition

- 3.1.1 Monitoring of vegetation cover at the end of the wet season, i.e., at the reporting month of September, has been undertaken in Ponds A to G on **30th September 2021**. However, placement of quadrats in “permanent open water designed last during dry season”, i.e., the “wet zone” +mPD 9.5 defined in Table 3.1 of the HCMP, was found to be infeasible because the water level of the pond was ranged from + mPD 10.6 to 11.1 during the time of monitoring. Nonetheless, since floating plant within this wet zone only be noted around the meter pole in Pond G in the whole constructed wetland system, it is believed the action and limit level set for this monitoring parameters, i.e., area with >10% or >20% vegetation cover at +mPD 9.5, would not be triggered. An overview of the open water area in each of the pond is shown in **Appendix F**.

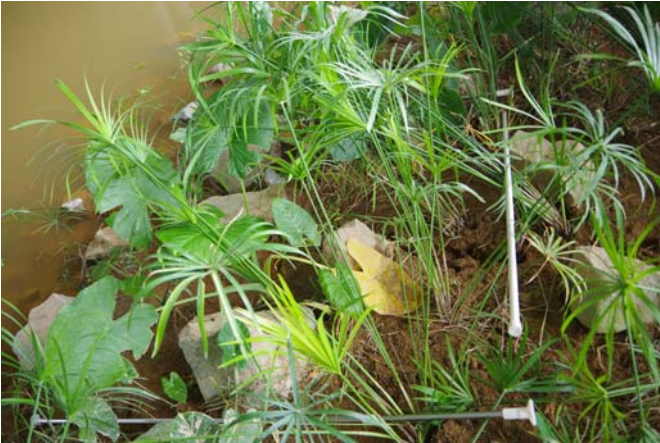
Pond A

General View of the Quadrat in "Seasonal Water Level Fluctuation Area"

- 3.1.2 Detail findings of the monitoring at the “seasonal water level fluctuation area”, i.e., the semi-dry zone ranged from +mPD 9.5 to +mPD 11.5 as defined in Table 3.1 of the HCMP, is presented in **Appendix G**, with the general view of the quadrat shown in **Appendix H**. A summary is shown in the following table.
