AGREEMENT NO. CE 45/2008 (CE)
LIANTANG/HEUNG YUEN WAI
BOUNDARY CONTROL POINT AND ASSOCIATED WORKS

MONTHLY ENVIRONMENTAL MONITORING AND AUDIT
REPORT (NO.51) – OCTOBER 2017

PREPARED FOR
CIVIL ENGINEERING AND DEVELOPMENT DEPARTMENT
(CEDD)

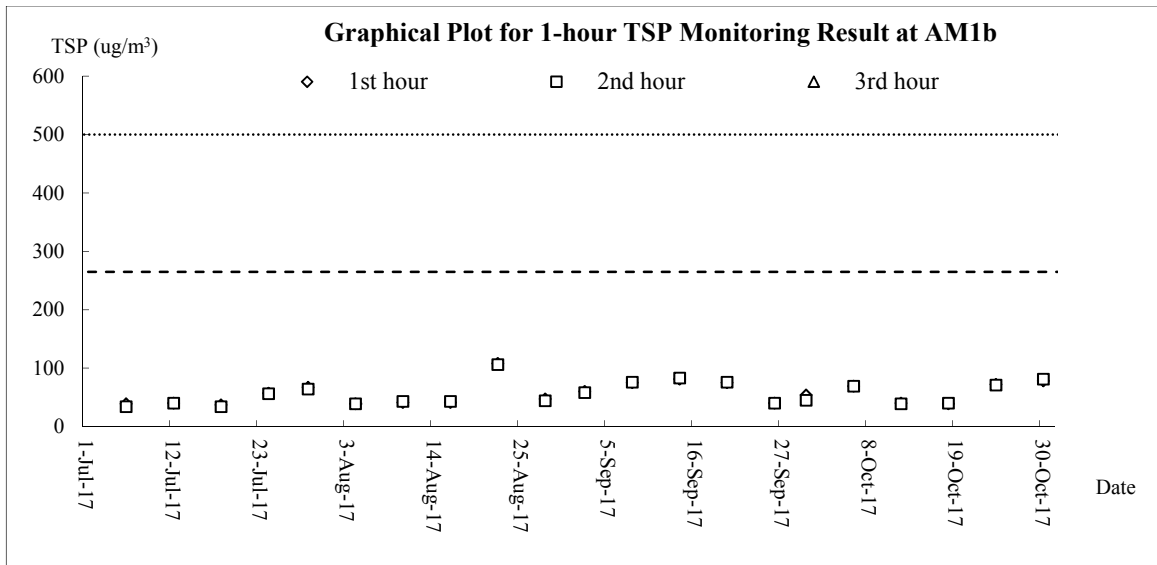
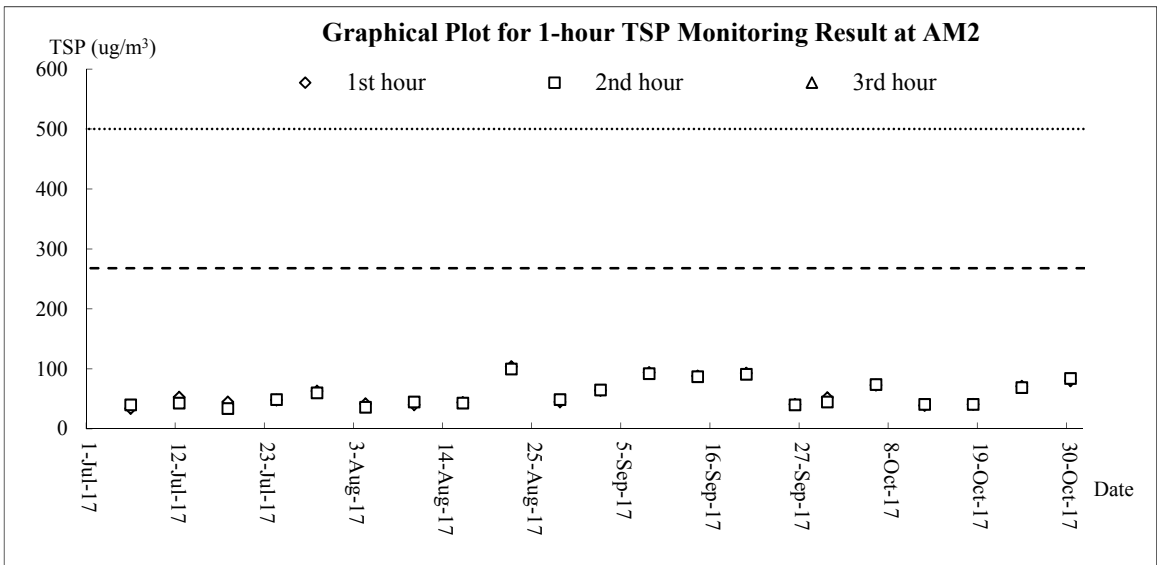
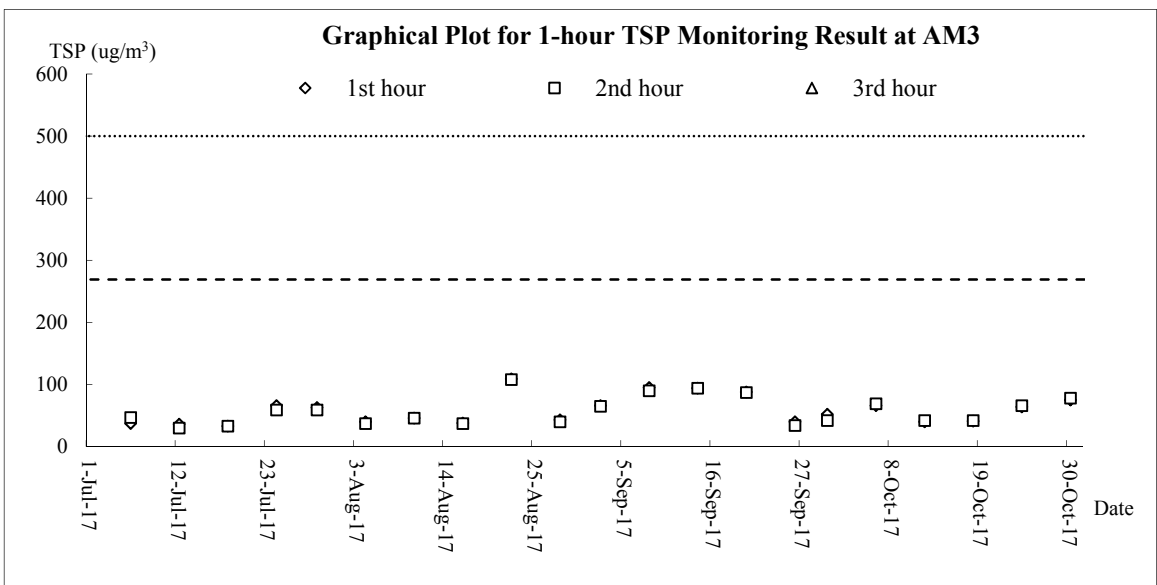
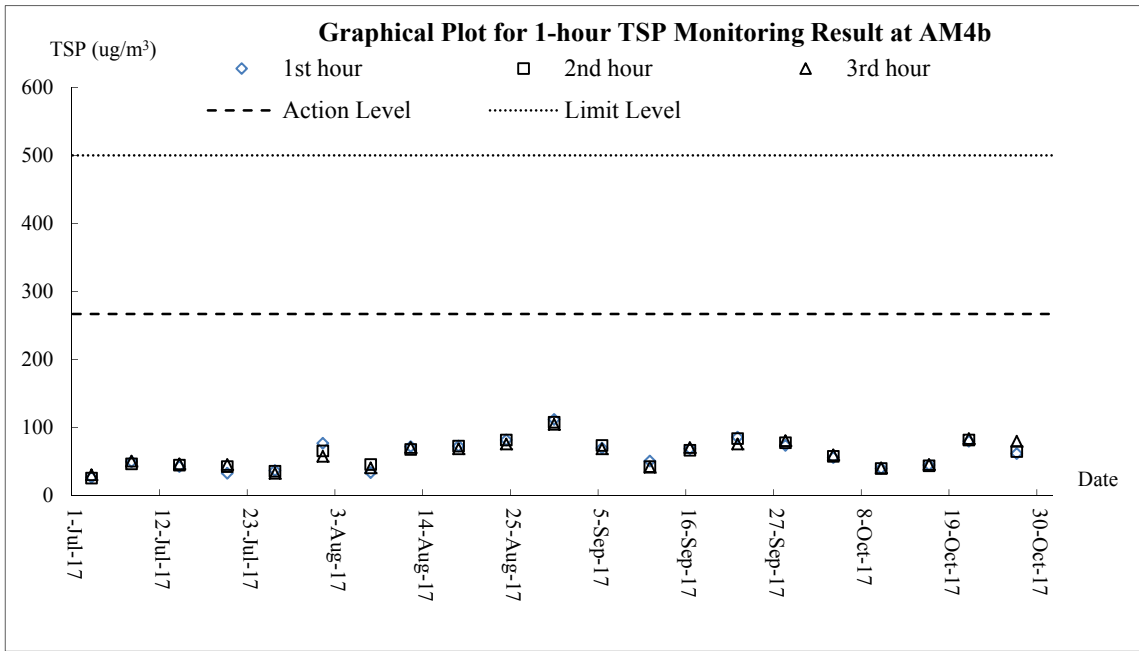
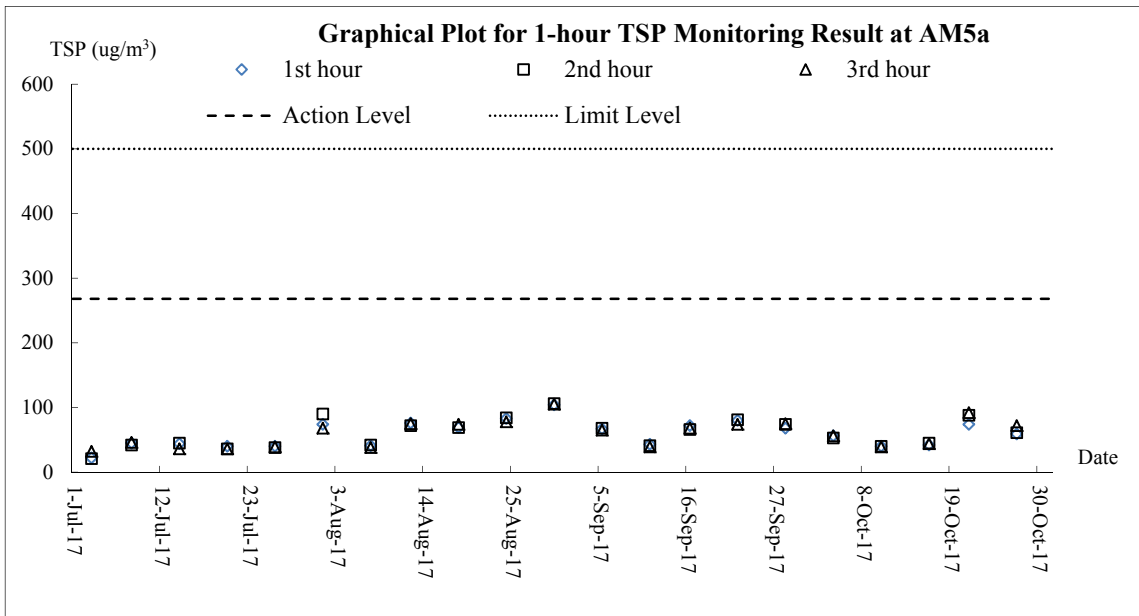
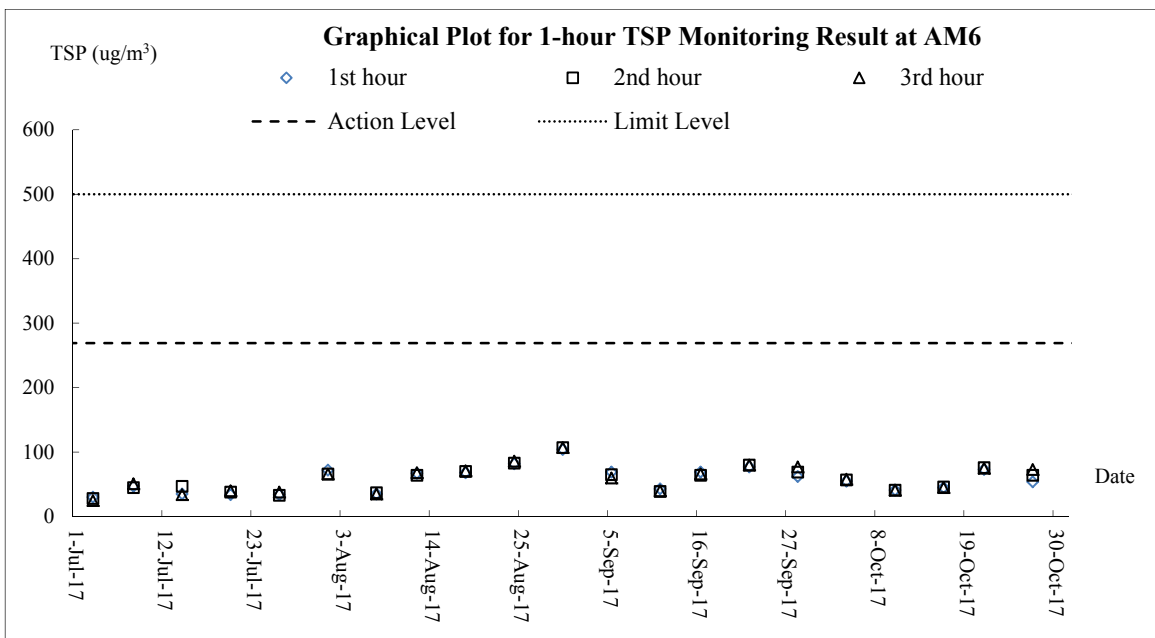
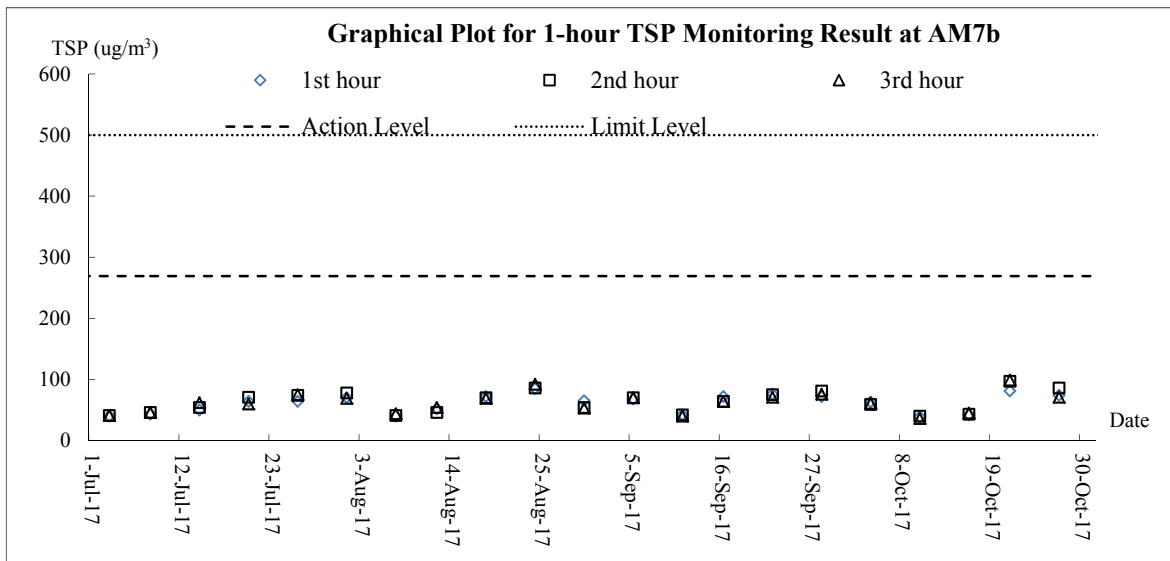
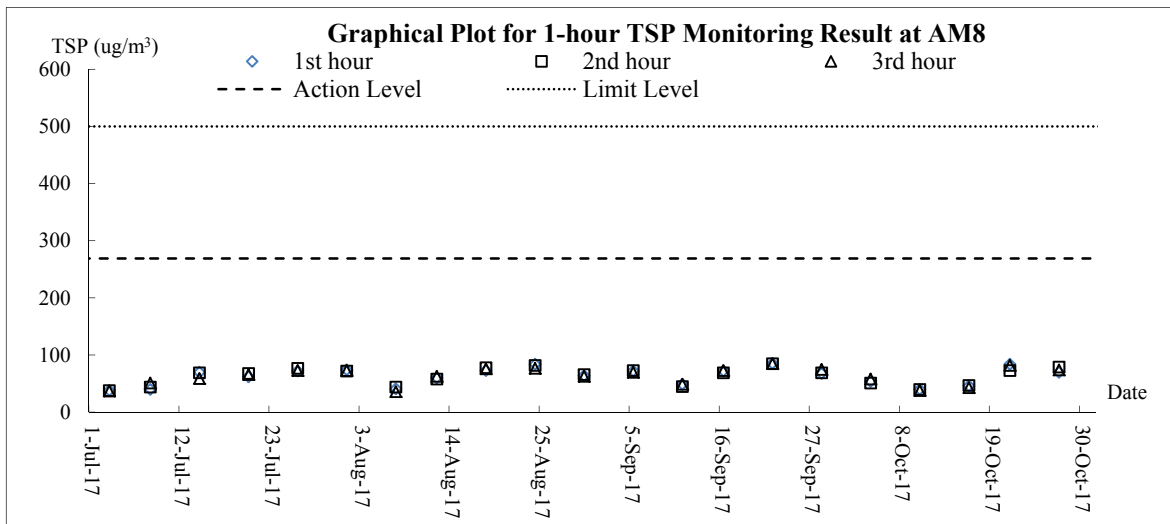
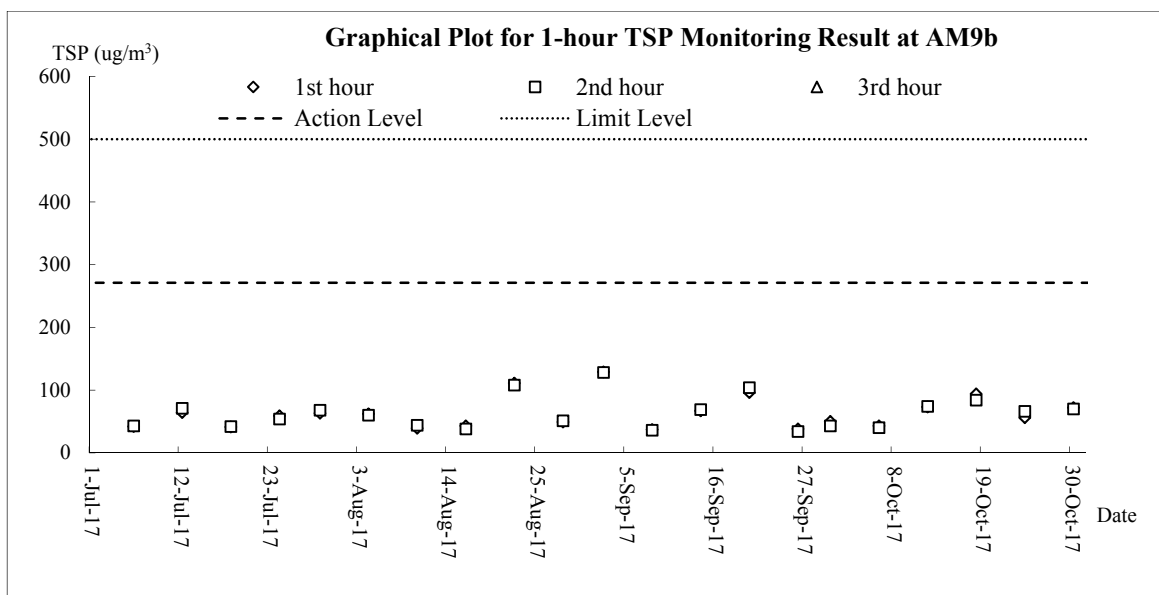
Air Quality – 1-hour TSP

Graphical Plots for Monitoring Result

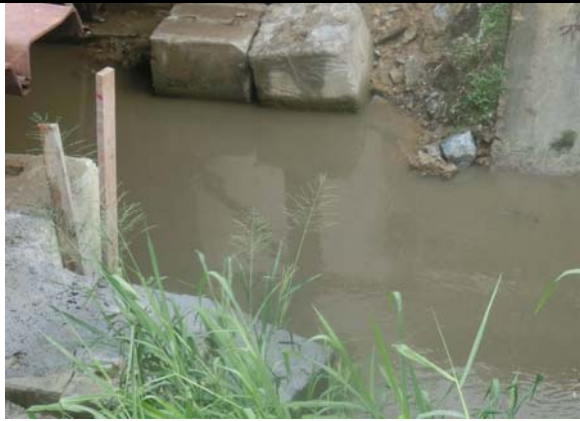
Photo 1

On 30 September 2017, turbid water was observed at WM1 and the water sampling was conducted during rainstorm.

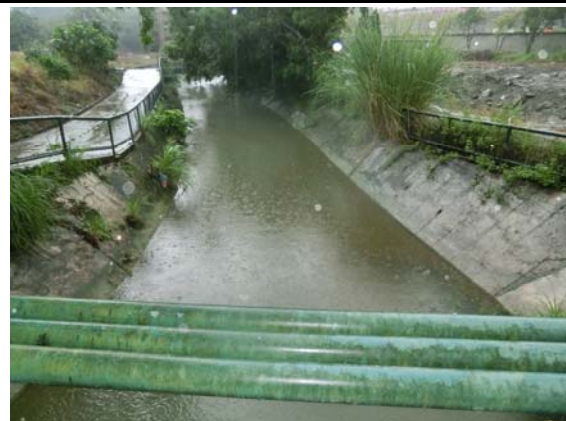
Photo 2

On 30 September 2017, the water quality at WM1-C was slightly turbid the water sampling was conducted during rainstorm.

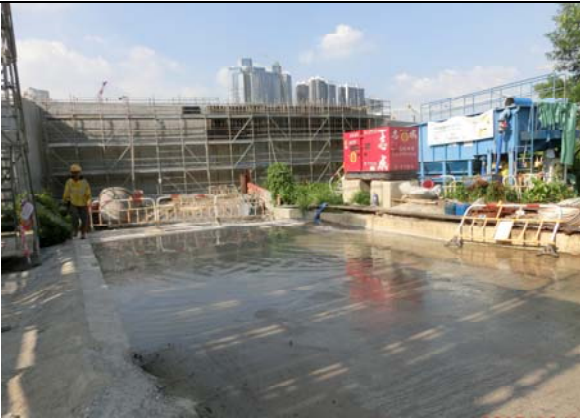
Photo 3

During site inspection on 3 and 12 October 2017, it was observed that construction of underpass and depressed road was conducted at Bridge Y and wastewater generated from the works was limited. It was observed that wheel washing facilities were implemented properly and wastewater treatment facilities (AquaSed SH-20) were functioned properly to treat the wastewater generated on site.

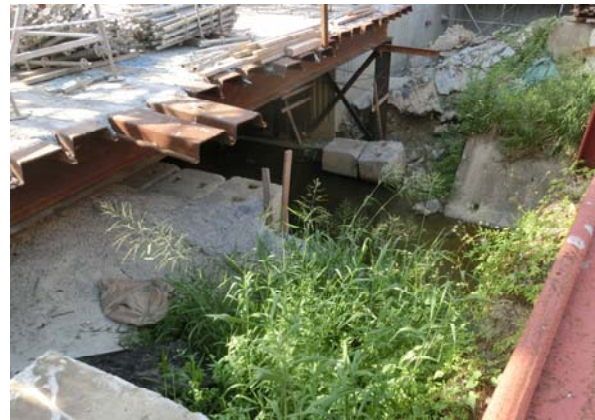
Photo 4

During site inspection on 3 and 12 October 2017, no adverse water quality impact was observed and contributed to WM1.

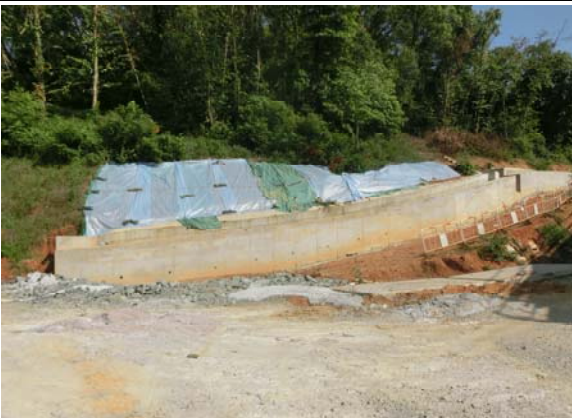
Photo 5

As water quality mitigation measures, the slope was covered with tarpaulin sheet to minimize muddy runoff.

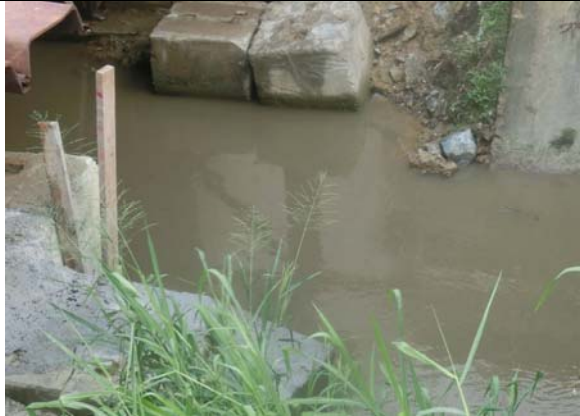
Photo 1
On 30 September 2017, turbid water was observed at WM1 and the water sampling was conducted during rainstorm.

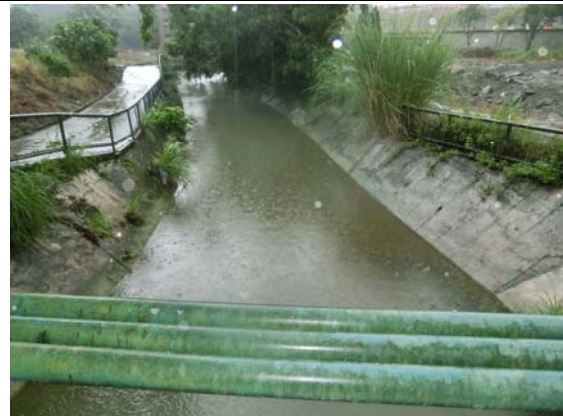
Photo 2
On 30 September 2017, the water quality at WM1-C was slightly turbid the water sampling was conducted during rainstorm.

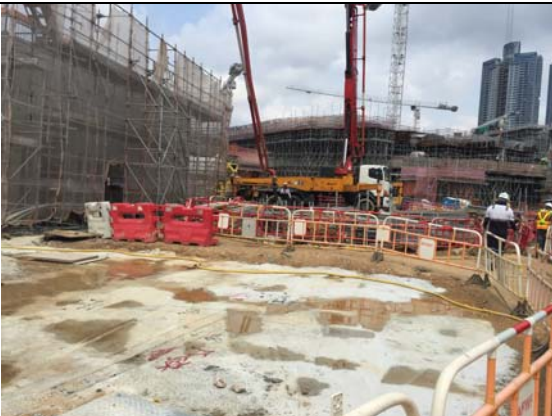
Photo 3
During site inspection on 4 October 2017, it was observed that wastewater generated from the active construction activities was limited.

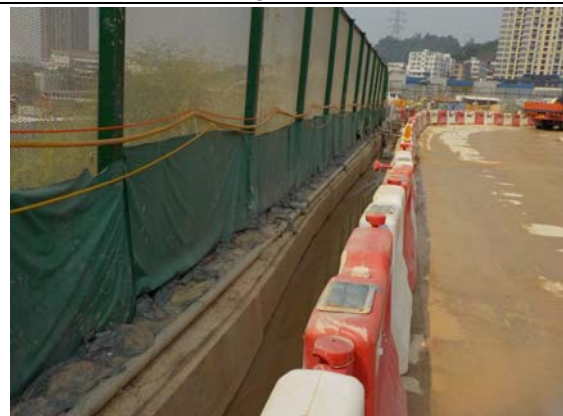
Photo 4
During rainy day, the surface runoff would be collected by the temporary drainage and all the wastewater generated from the site including runoff would be passing through the perimeter channel and diverted to the wastewater treatment plant for treatment before discharge.

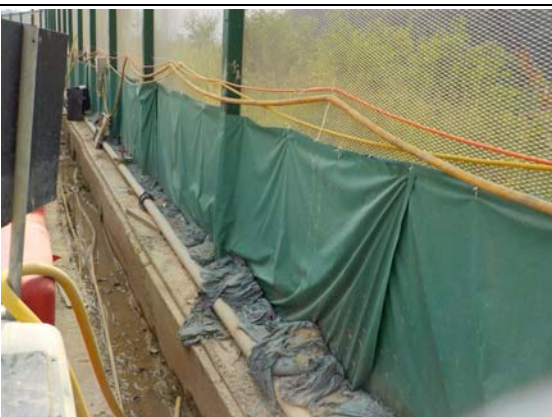
Photo 5
During rainy day, the surface runoff would be collected by the temporary drainage and all the wastewater generated from the site including runoff would be passing through the perimeter channel and diverted to the wastewater treatment plant for treatment before discharge.

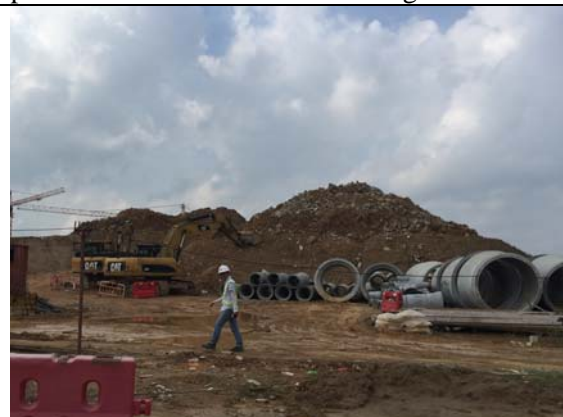
Photo 6
Exportation of the stockpile was in progress in which the stockpile was compacted after excavation and the runoff generation from the stockpile would be collected by the temporary site drainage as well.

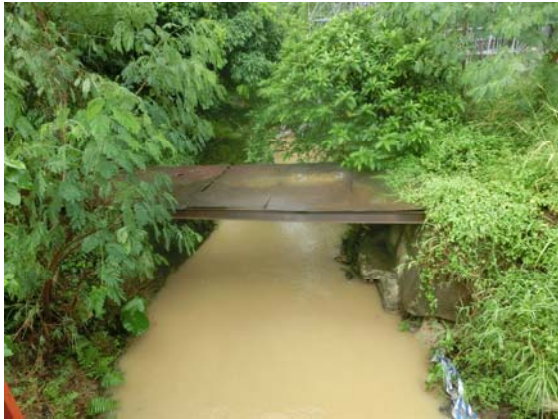
Photo 1

On 16 October 2017, muddy water was observed at WM2A(a) and there was heavy rainstorm.

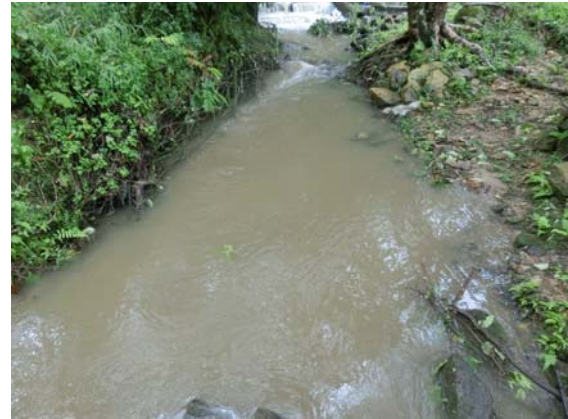
Photo 2

On 16 October 2017, muddy water was observed at WM2A-C and there was heavy rainstorm.

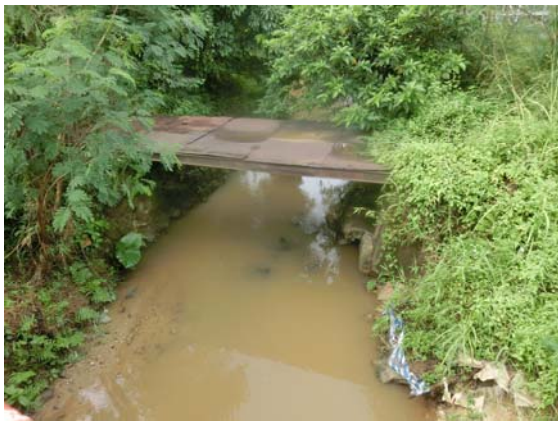
Photo 3

On 17 October 2017, muddy water was observed at WM2A(a).

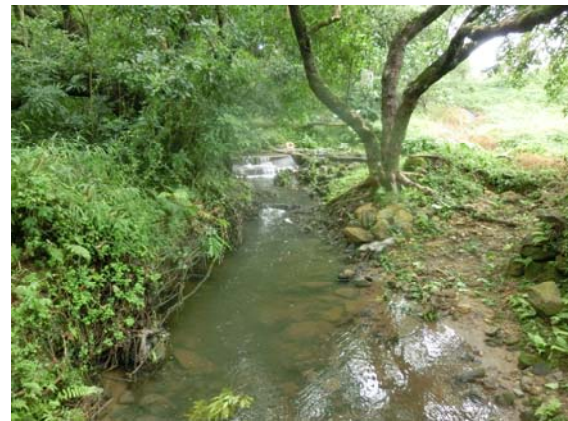
Photo 4

On 17 October 2017, the water quality observed at WM2A-C was clear.

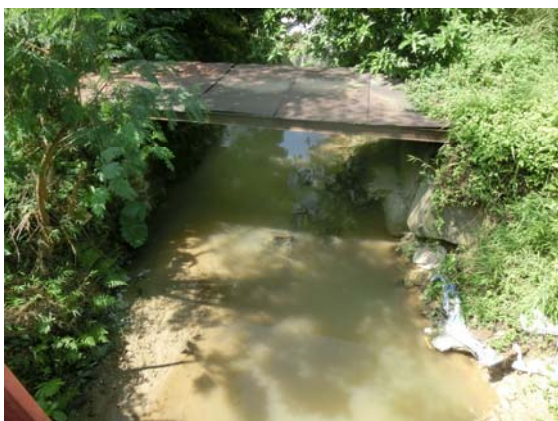
Photo 5

On 18 October 2017, muddy water was observed at WM2A(a).

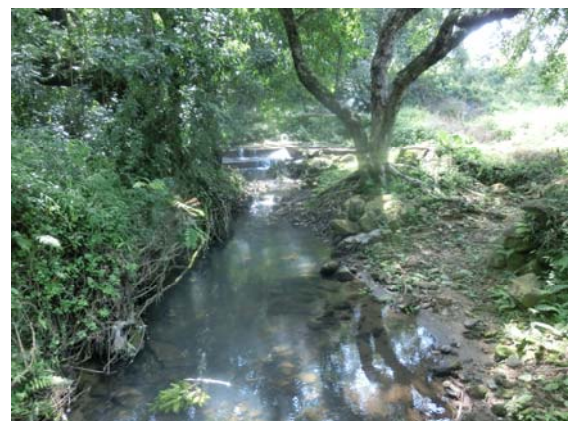
Photo 6

On 18 October 2017, the water quality observed at WM2A-C was clear.

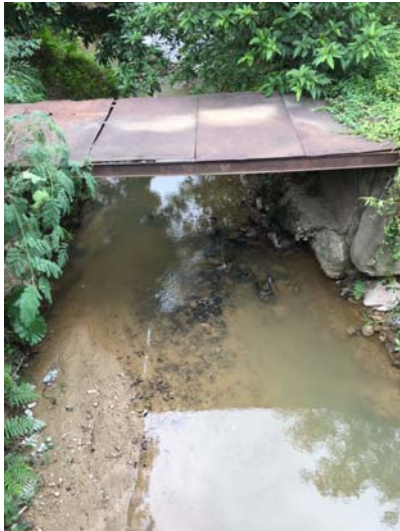
Photo 7

On 19 October 2017, the water quality observed at WM2A(a) was clear.

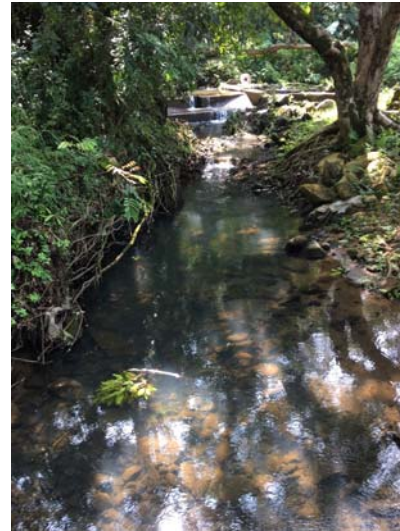
Photo 8

On 19 October 2017, the water quality observed at WM2A-C was clear.

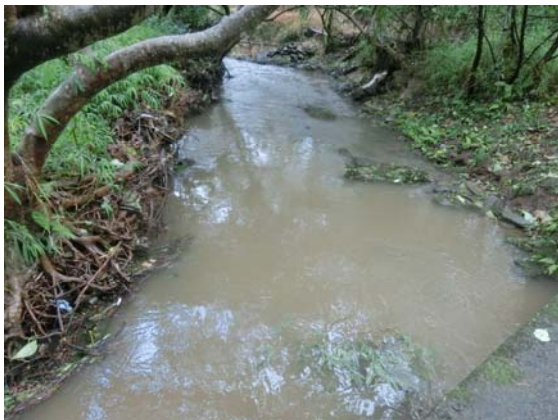
Photo 9

Muddy water was also observed at the upstream area in early morning of 16 October 2017 due to the rainstorm.

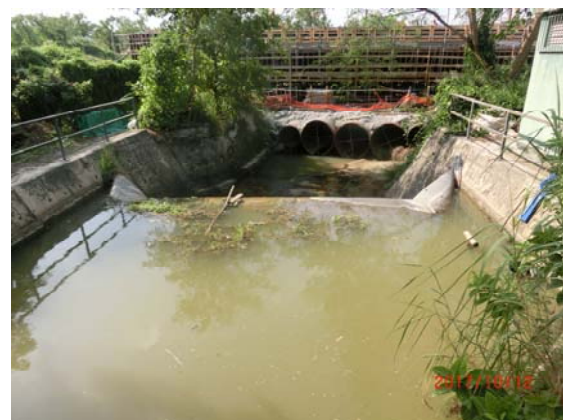
Photo 10

During site inspection on 12 October 2017, deflated of Nylon Dam was observed, muddy water due to rain trapped in the dam would be flowing to downstream and stirred up the sediment at the river bed.

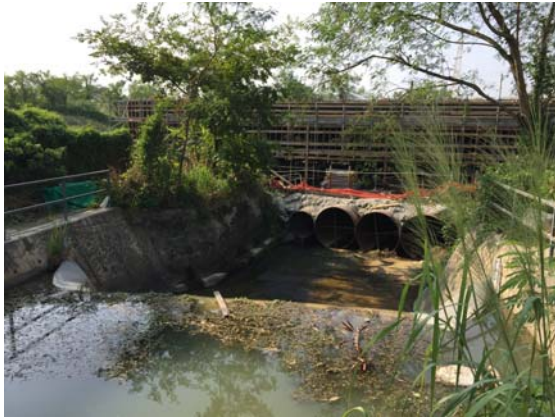
Photo 11

During site inspection on 26 October 2017, deflated of Nylon Dam was observed, muddy water due to rain trapped in the dam would be flowing to downstream and stirred up the sediment at the river bed.

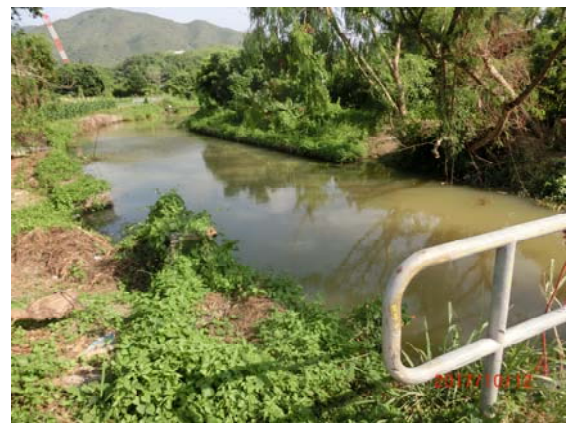
Photo 12

During site inspection on 12 October 2017, it was observed that the existing river water was slightly turbid even without the impact from the construction work.

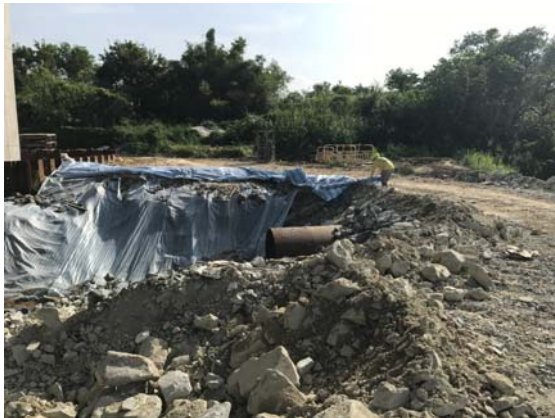
Photo 13

As water quality mitigation measures, the slope adjacent to river course was entirely covered with tarpaulin sheet.

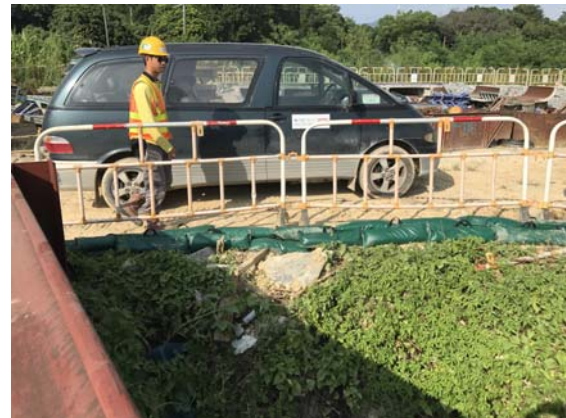
Photo 14

As water quality mitigation measures, sand bags were placed along the construction area to avoid muddy runoff flowing to public area.

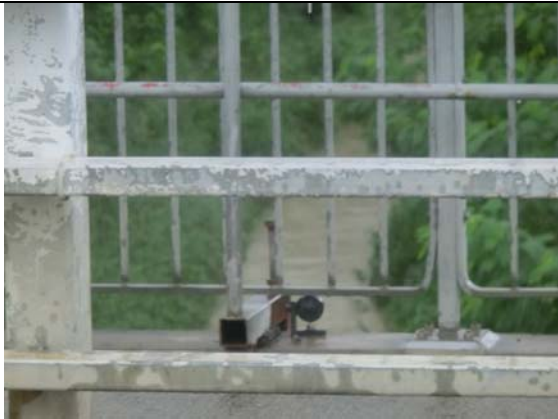
Photo 1

During water quality monitoring on 16 October 2017, turbid water was observed at WM4 and monitoring was carried out during rain.

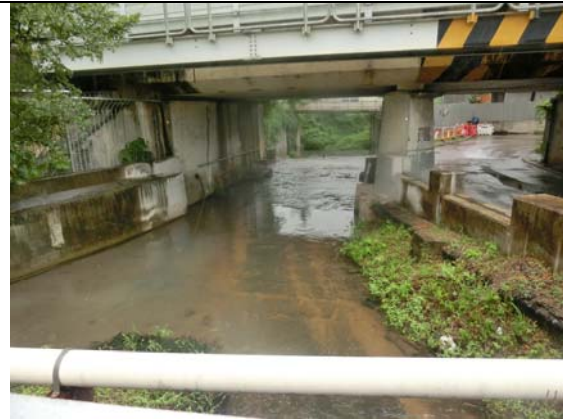
Photo 2

During water quality monitoring on 16 October 2017, the water quality at WM4-CA was clear. However, inflow of unknown source of muddy water was observed from the edge of the channel.

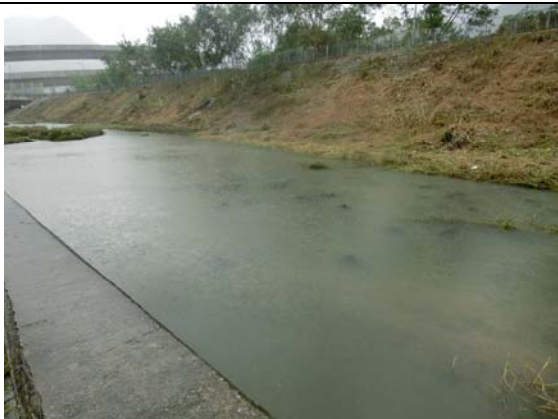
Photo 3

During water quality monitoring on 16 October 2017, it was observed that the water quality at WM4-CB was slightly turbid.

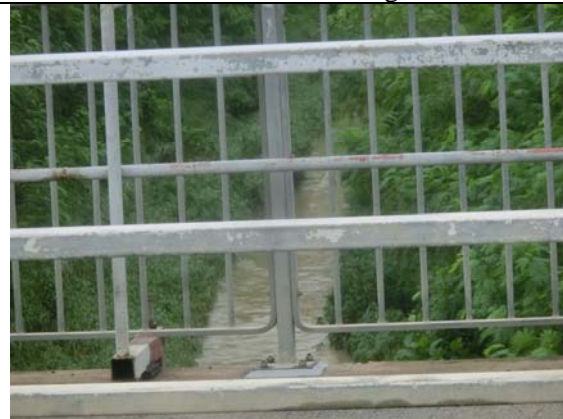
Photo 4

During water quality monitoring on 17 October 2017, it was observed that the water quality at WM4 was slightly turbid.

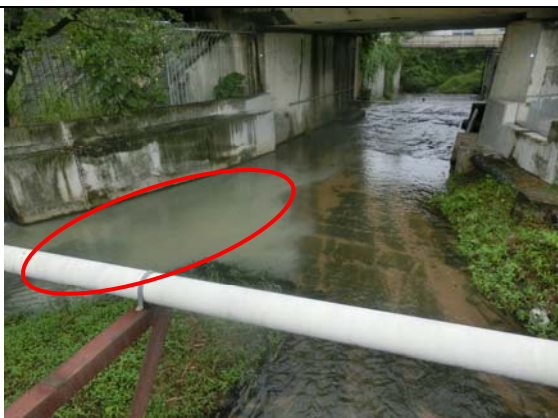
Photo 5

During water quality monitoring on 17 October 2017, the water quality at WM4-CA was clear. However, inflow of unknown source of muddy water was observed from the edge of the channel.

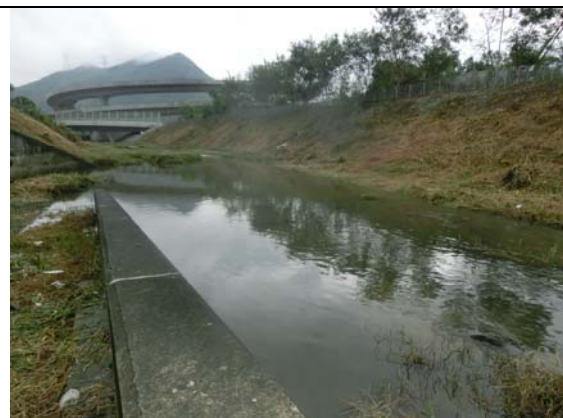
Photo 6

During water quality monitoring on 17 October 2017, the water quality at WM4-CB was clear.

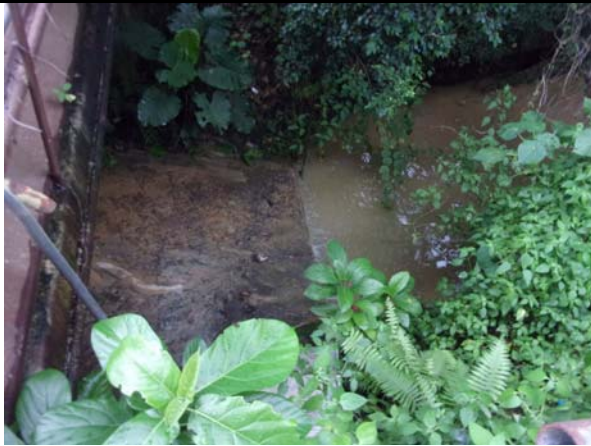
Photo 7

On 16 October 2017, Chun Wo reported to us that unknown source of muddy water attributed to site area and the muddy water was finally entered Ma Wat River and got detected at WM4. It was suspected that the muddy water was via an underground pipe which connecting the box culvert in Kiu Tau Road (outside C3) to BC02 (under Contract 3).

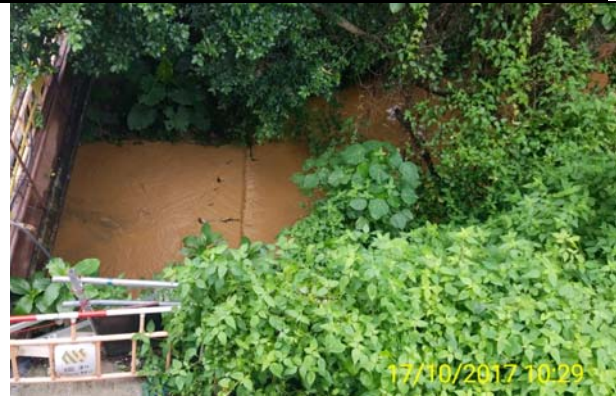
Photo 8

On 17 October 2017, Chun Wo reported to us that unknown source of muddy water attributed to site area and the muddy water was finally entered Ma Wat River and got detected at WM4. It was suspected that the muddy water was via an underground pipe which connecting the box culvert in Kiu Tau Road (outside C3) to BC02 (under Contract 3).

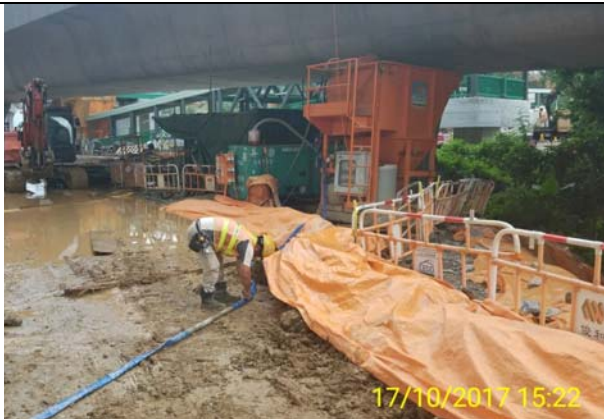
Photo 9

Surprise site inspection was carried out by IEC on 17 October 2017 and an observation regarding muddy runoff from construction site near BC02 was recorded. Chun Wo immediately enhanced the bund at the edge of the concern area and the covered entire expose slope with tarpaulin sheet to minimize the muddy runoff.

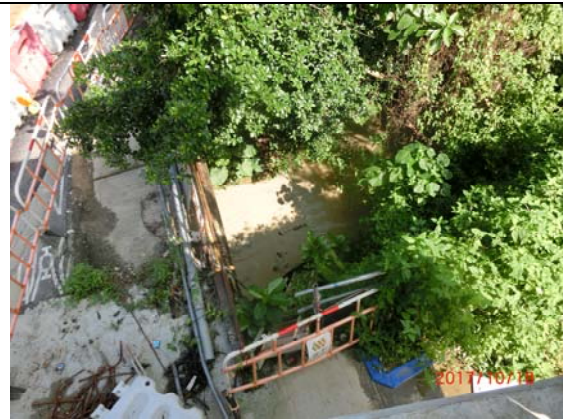
Photo 10

During site inspection on 18 October 2017, it was observed that muddy water flowing via an underground pipe from box culvert in Kiu Tau Road(outside C3) to BC02 and the source of muddy water was unknown.

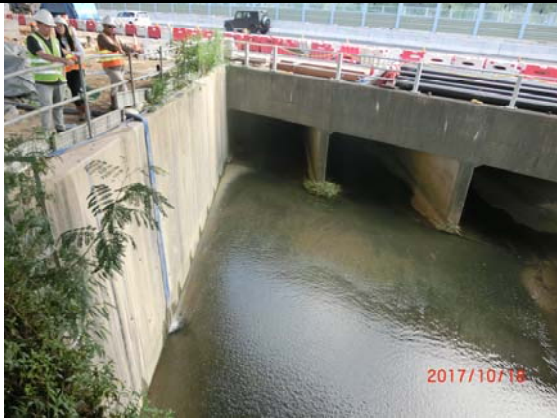
Photo 11

During site inspection on 18 October 2017, turbid discharge was observed from an AquaSed and it has been stopped by the Contractor immediately. The Contractor was requested to check the condition of the wastewater treatment facilities regularly and ensure the effluent was complied with the licence requirement.

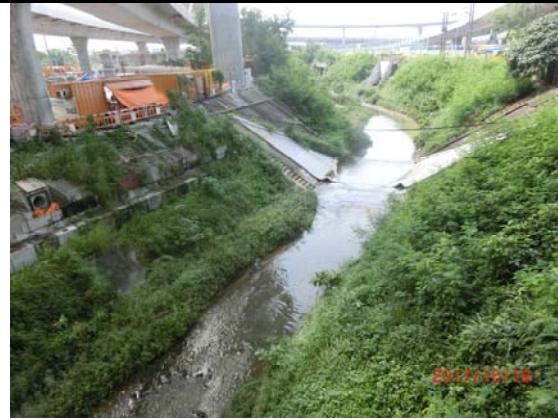
Photo 12

During site inspection on 18 October 2017, it was observed that the water quality in the channel was generally in good condition.

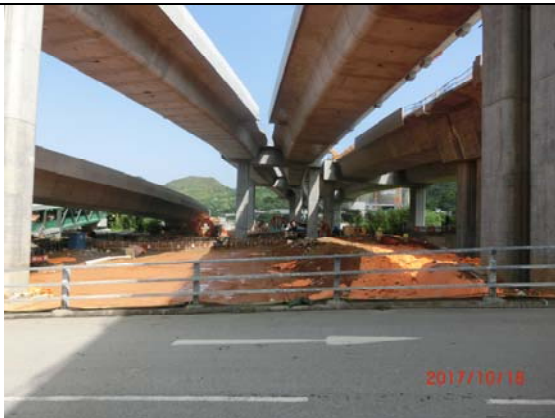
Photo 13

As water quality mitigation measures to minimize muddy runoff, the slope adjacent to the river course was covered with tarpaulin sheet.

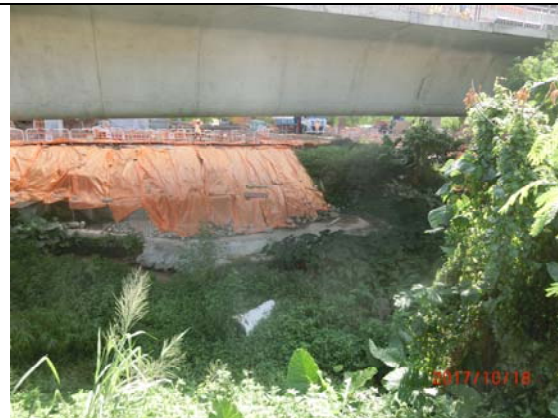
Photo 14

As water quality mitigation measures to minimize muddy runoff, the slope adjacent to the river course was covered with tarpaulin sheet.

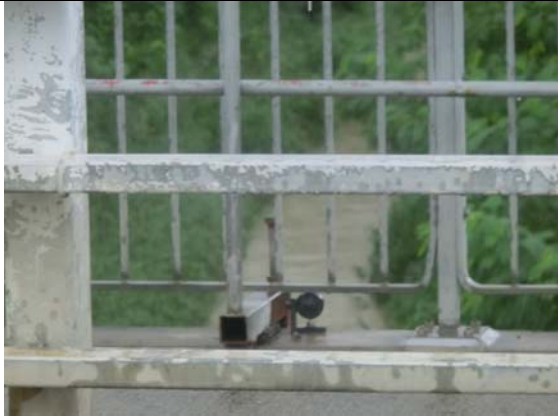
Photo 1

During water quality monitoring on 16 October 2017, turbid water was observed at WM4 and monitoring was carried out during rain.

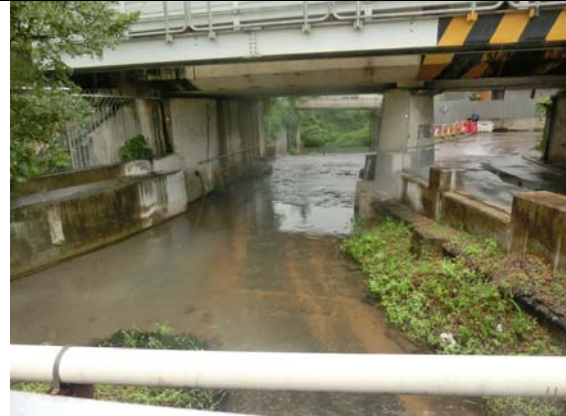
Photo 2

During water quality monitoring on 16 October 2017, the water quality at WM4-CA was clear. However, inflow of unknown source of muddy water was observed from the edge of the channel.

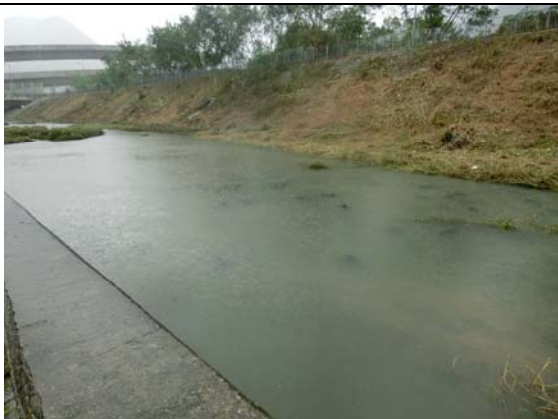
Photo 3

During water quality monitoring on 16 October 2017, it was observed that the water quality at WM4-CB was slightly turbid.

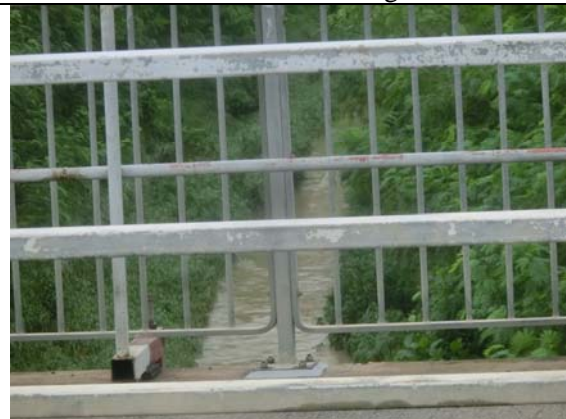
Photo 4

During water quality monitoring on 17 October 2017, it was observed that the water quality at WM4 was slightly turbid.

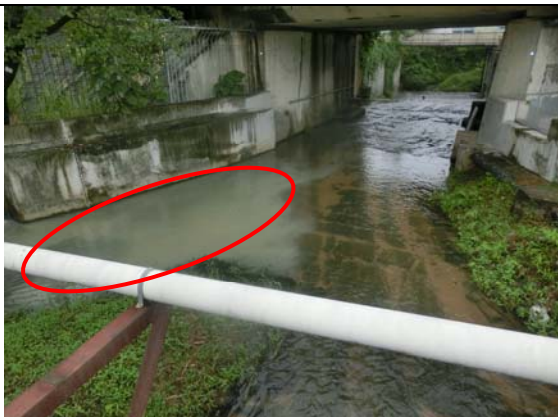
Photo 5

During water quality monitoring on 17 October 2017, the water quality at WM4-CA was clear. However, inflow of unknown source of muddy water was observed from the edge of the channel.

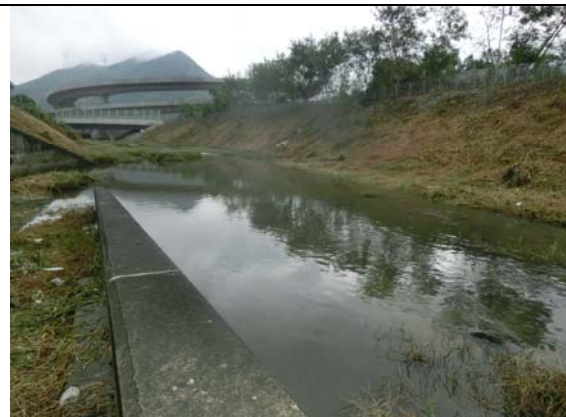
Photo 6

During water quality monitoring on 17 October 2017, the water quality at WM4-CB was clear.

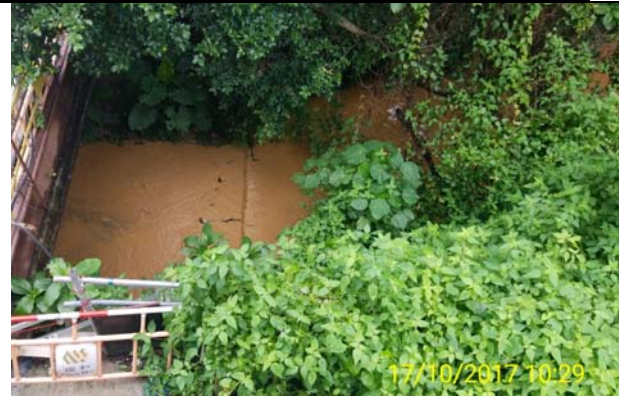
Photo 8

On 17 October 2017, Chun Wo reported to us that unknown source of muddy water attributed to site area and the muddy water was finally entered Ma Wat River and got detected at WM4. It was suspected that the muddy water was via an underground pipe which connecting the box culvert in Kiu Tau Road (outside C3) to BC02 (under Contract 3).

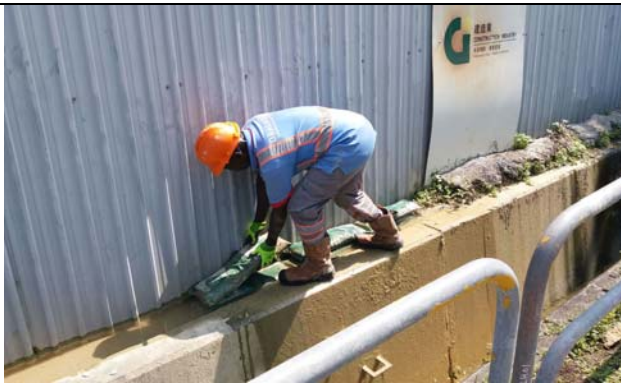
Photo 9

Surprise site inspection was carried out by IEC on 17 October 2017 and observation regarding muddy runoff through the site hoarding in SP was recorded. Follow up action was immediately taken by DHK including deploy sand bags to prevent leakage from the hoarding.

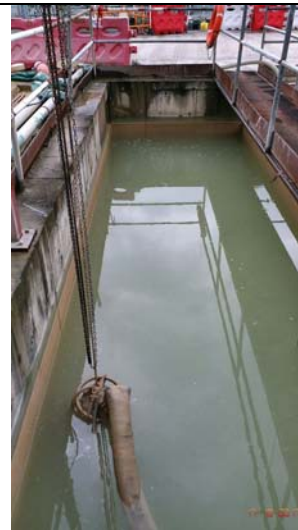
Photo 10

Surprise site inspection was carried out by IEC on 17 October 2017 and observations regarding muddy water from the wastewater treatment system were recorded. Follow up action was immediately taken by DHK including decrease the water level of the sedimentation tank.

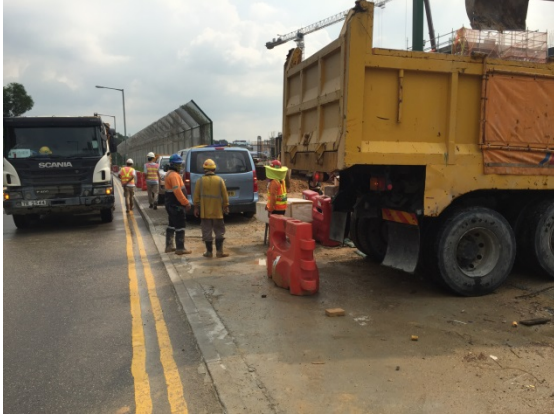
Photo 1 (Gate 1)

During site inspection on 11 September 2017, muddy trails were observed outside Gate 1 which a Grab Lorry was stopped at the entrance and silt was found at the footpath outside Gate 1.

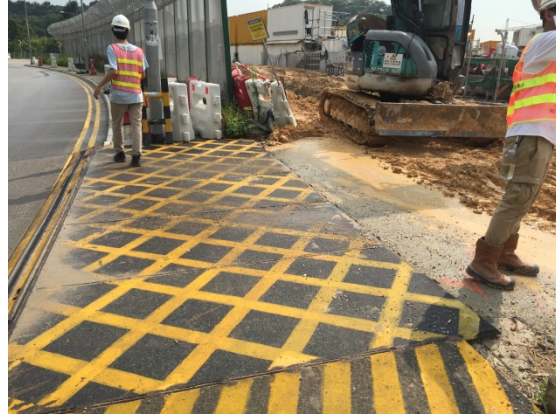
Photo 2 (Gate 2)

During site inspection on 11 September 2017, silt was found at the footpath outside Gate 2.

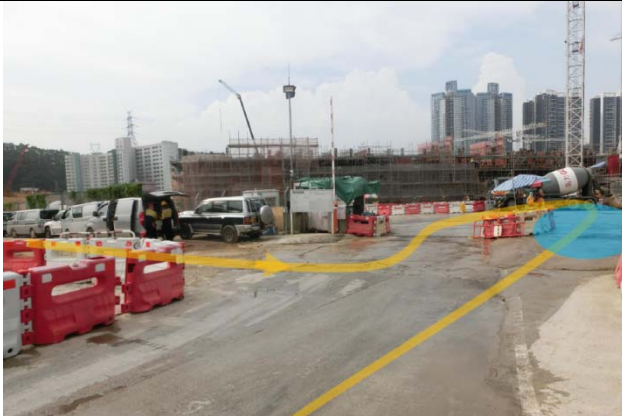
Photo 3 (Gate 3)

During the site inspection on 11 September 2017, wheel washing facilities was properly in place the main exit at Gate 3 and no muddy trails, debris and muddy water were observed.

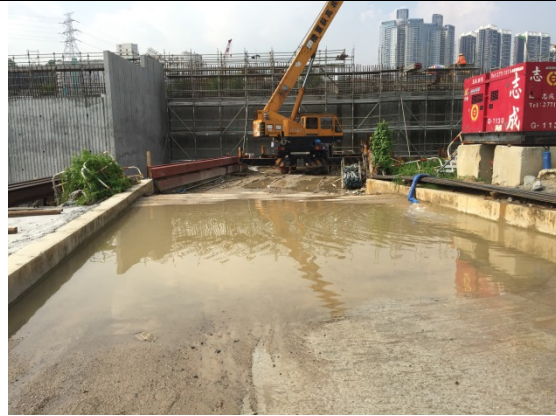
Photo 4 (Bridge Y)

During the site inspection on 11 September 2017, wheel washing facilities including wheel washing bay and water jet were provided for works area of Bridge Y.

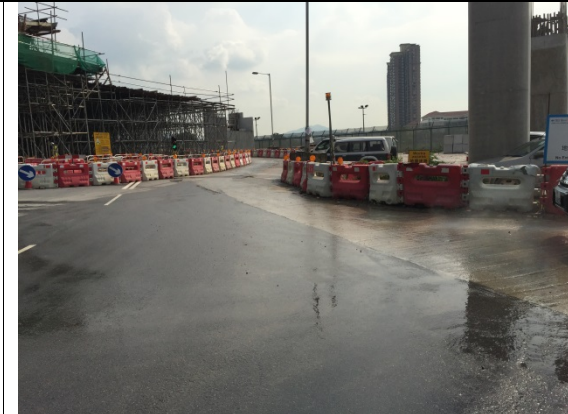
Photo 5 (Bridge Y)

During the site inspection on 11 September 2017, no muddy trails, debris and muddy water were observed at the exit of Bridge Y and adjoined LMH Road.

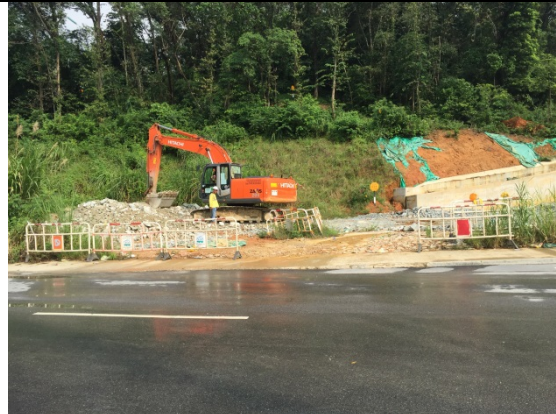
Photo 6 (opposite to Bridge Y)

At works area opposite to Bridge Y, silt and muddy water was observed at the site exit and footpath outside the exit.

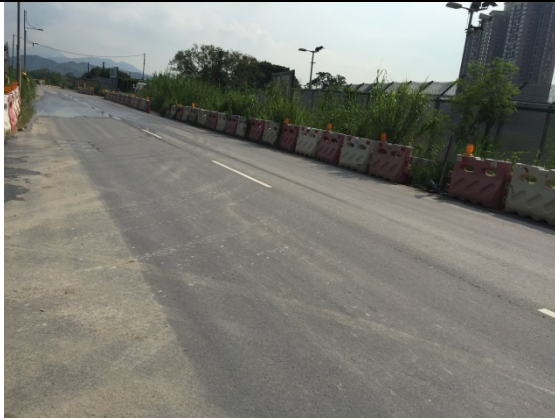
Photo 7 (Bridge D (D08))

During the site inspection on 11 September 2017, muddy trails were observed at the site exit of Bridge D (D08).

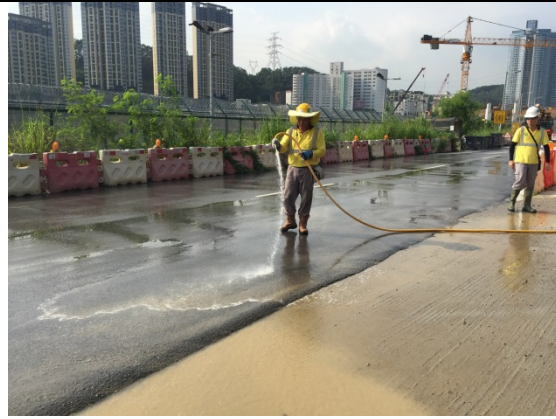
Photo 8 ((Bridge D (D08))

During the site inspection on 11 September 2017, wheel washing facilities was provided for works area of Bridge D (D08). However, muddy water was found accumulated on the footpath after washing of the site exit.

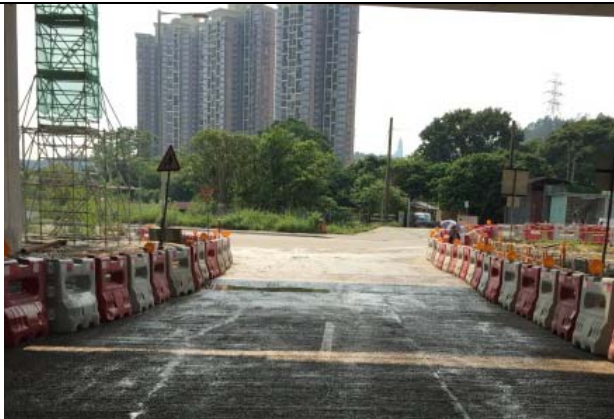
Photo 9 (Chuk Yuen Road)

During the site inspection on 11 September 2017, no muddy trails and debris and muddy water were observed at exit of Bridge Y and adjoined LMH Road.

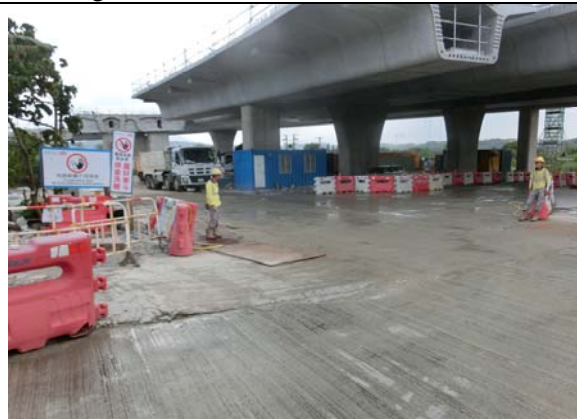
Photo 10 (Chuk Yuen Road)

During the site inspection on 11 September 2017, wheel washing facilities was provided for works area Chuk Yuen Road. No muddy trails and debris and muddy water were observed at the exit/

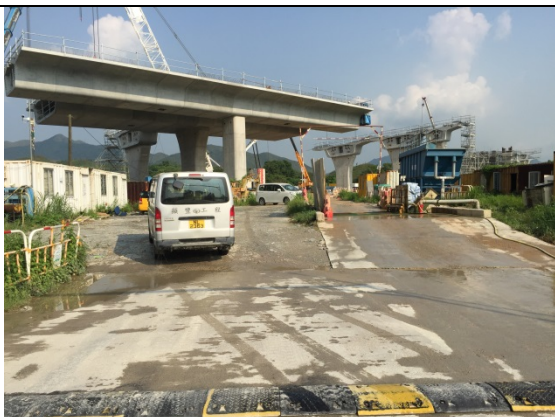
Photo 11 (Bridge D)

During site inspection on 11 September 2017, wheel washing facilities was provided for works area of Bridge D and a bund was provided at site exit to prevent muddy water from wheel washing flowing to the adjoined LMH Road.
