AGREEMENT NO. CE 45/2008 (CE)
LIANTANG/HEUNG YUEN WAI
BOUNDARY CONTROL POINT AND ASSOCIATED WORKS

MONTHLY ENVIRONMENTAL MONITORING AND AUDIT
REPORT (NO.51) – OCTOBER 2017

PREPARED FOR
CIVIL ENGINEERING AND DEVELOPMENT DEPARTMENT
(CEDD)

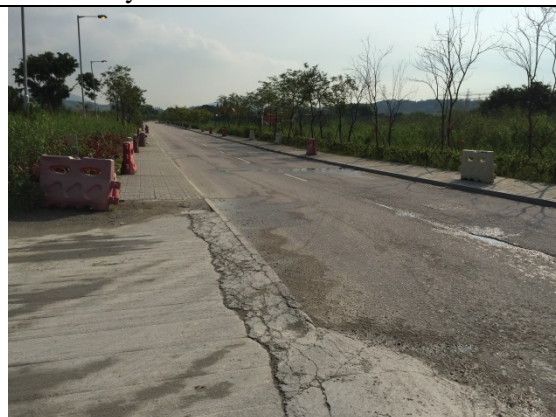
Photo 12 (Bridge D)

During site inspection on 11 September 2017, no muddy trails, debris and muddy water were observed at the exit of Bridge D and adjoined LMH Road.

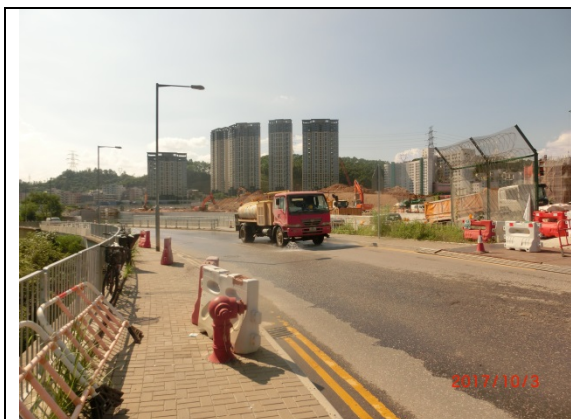
Photo 13

During the regular site inspection, it was observed that the road surface of LMH Road was wetted by water bowsers to suppress fugitive dust.

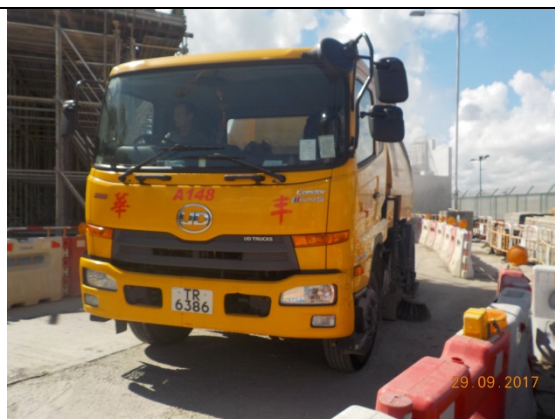
Photo 14

Since September 2017, road sweeper also deployed by CCKJV to enhance the road cleaning work in order to remove debris and gravels on road surface.

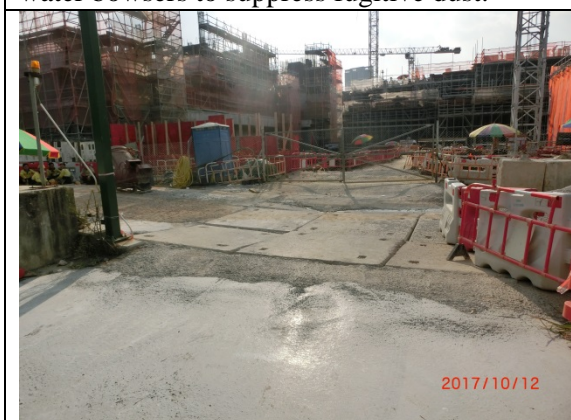
Photo 15 (Gate 1)

During site inspection on 12 October 2017, it was observed that the site access of Gate 1 was paved with concrete and clear of mud and debris. Wheel washing facilities was provided on concrete ground near the site exit.

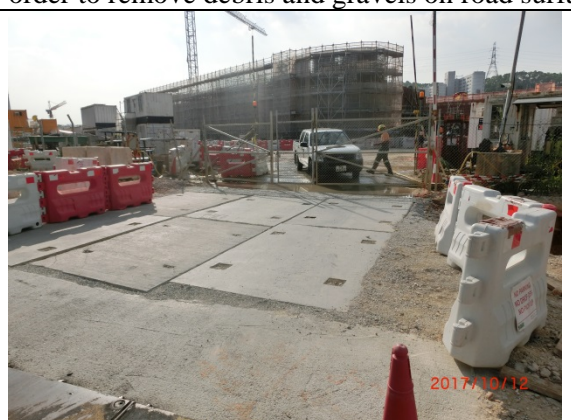
Photo 16 (Gate 2)

During site inspection on 12 October 2017, it was observed that the site access of Gate 2 was paved with concrete and clear of mud and debris. Wheel washing facilities was provided on concrete ground near the site exit.

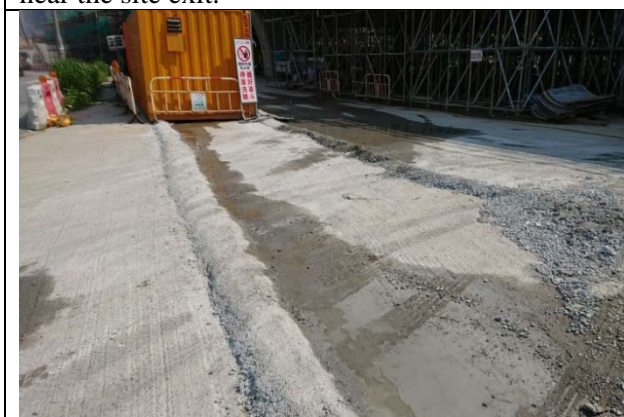
Photo 17 (Bridge D (D08))

A bund was constructed at the exit to prevent muddy water flowing from the construction site to public area. Moreover, a warning sign for stop and carry out wheel washing was provided at the site exit.

- (b) For site exit of Bridge D (D08), a bund was constructed at the exit to prevent muddy water flowing from the construction site and a warning sign for stop and carry out wheel washing was provided at the site exit. **(Photo 17)**

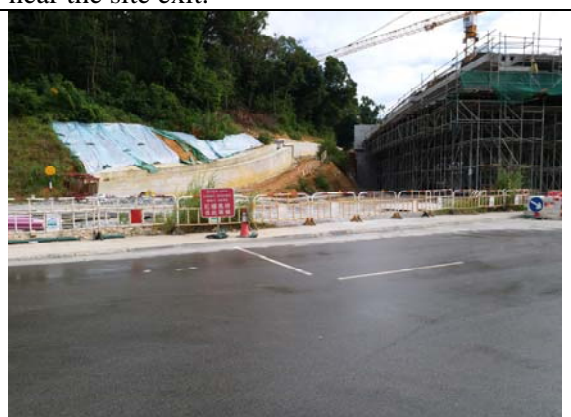
Photo 18 (opposite to Bridge Y)

For works area opposite to Bridge Y, the construction work with the concern area has been completed and the site exit was fenced off by barrier

- (c) For works area opposite to Bridge Y, the construction work with the concern area has been completed and the site exit was fenced off by barrier. **(Photo 18)**

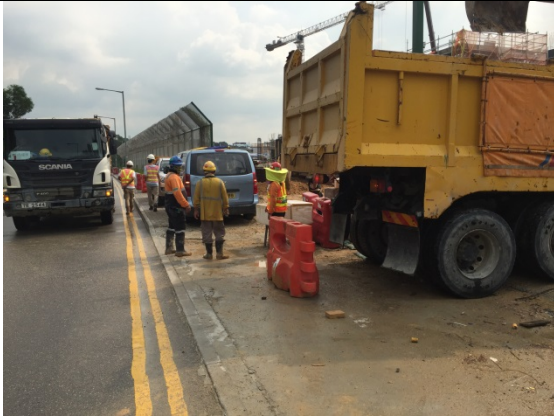
Photo 1 (Gate 1)

During site inspection on 11 September 2017, muddy trails were observed outside Gate 1 which a Grab Lorry was stopped at the entrance and silt was found at the footpath outside Gate 1.

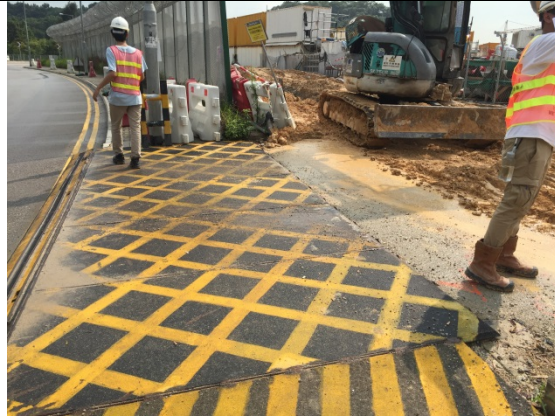
Photo 2 (Gate 2)

During site inspection on 11 September 2017, silt was found at the footpath outside Gate 2.

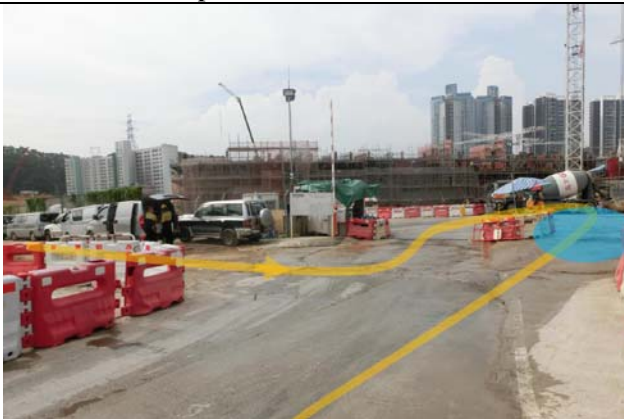
Photo 3 (Gate 3)

During the site inspection on 11 September 2017, wheel washing facilities was properly in place the main exit at Gate 3 and no muddy trails and debris were observed.

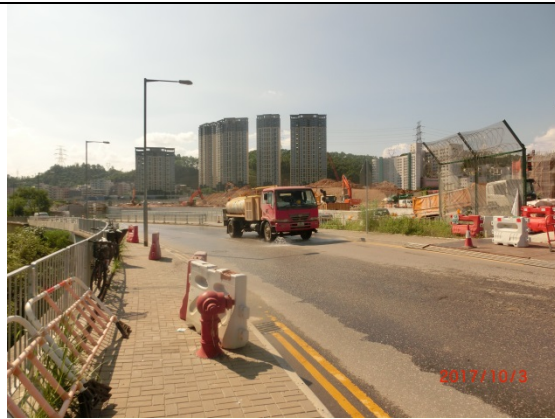
Photo 4

During the regular site inspection, it was observed that the road surface of LMH Road was wetted by water bowsers to suppress fugitive dust.

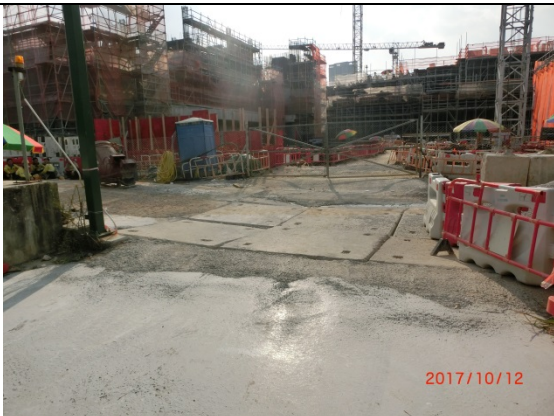
Photo 5 (Gate 1)

During site inspection on 12 October 2017, it was observed that the site access of Gate 1 was paved with concrete and clear of mud and debris. Wheel washing facilities was provided on concrete ground near the site exit.

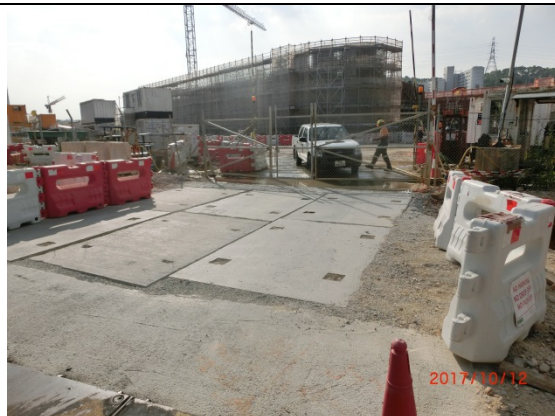
Photo 6 (Gate 2)

During site inspection on 12 October 2017, it was observed that the site access of Gate 2 was paved with concrete and clear of mud and debris. Wheel washing facilities was provided on concrete ground near the site exit.

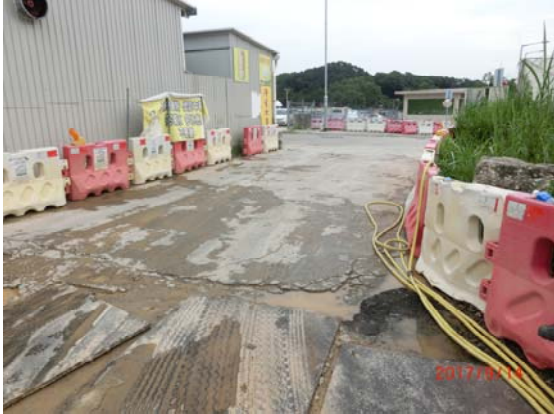
Photo 1

During site inspection on 14 September 2017, wheel washing facilities including water jet were provided at exit site and wheel washing was carried out on a concrete ground before leaving the site. However, it was observed that muddy water muddy accumulated on cracks of the concrete ground.

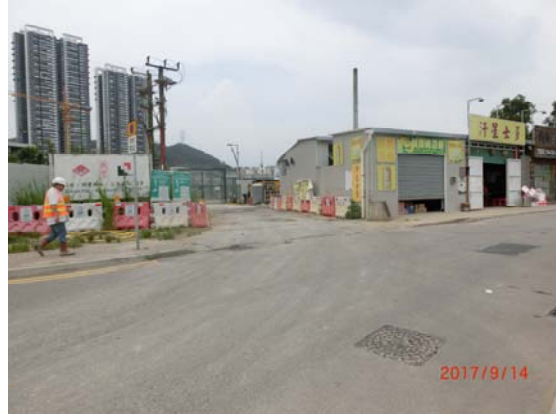
Photo 2

During site inspection on 14 September 2017, it was observed that muddy trails were observed at site exit the adjoining Lin Ma Hang Road.

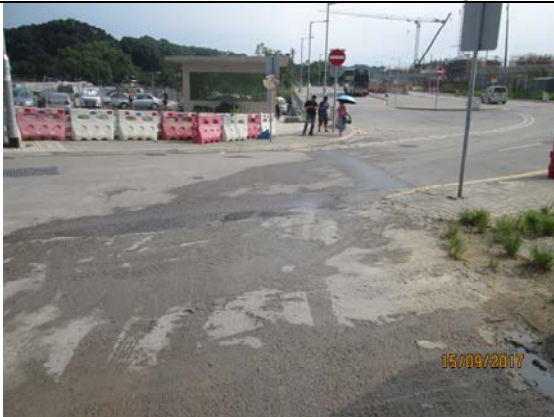
Photo 3

During site inspection on 15 September 2017, no muddy trails and debris was observed at the site exit and adjoining LMH Road.

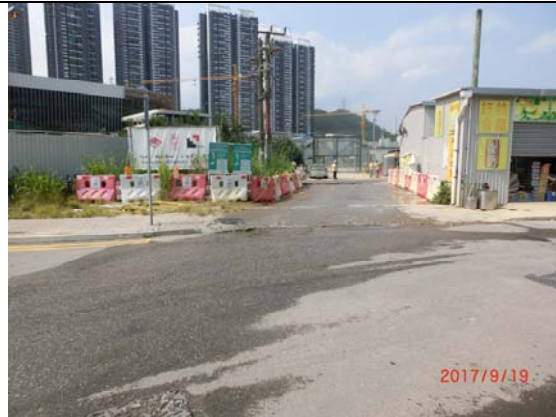
Photo 4

During site inspection on 19 September 2017, no muddy trails and debris was observed at the site exit and adjoining LMH Road.

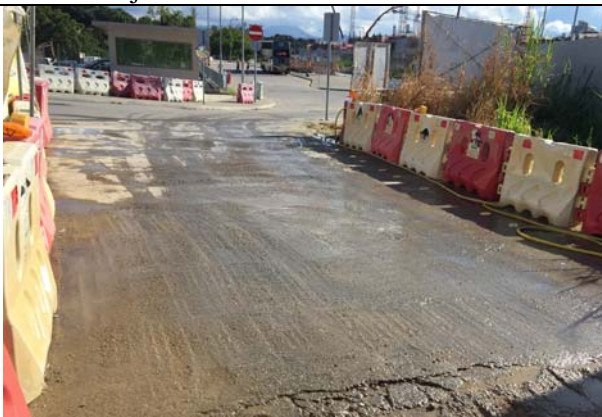
Photo 5

During site inspection on 29 September 2017, no muddy trails and debris was observed at the site exit and adjoining LMH Road.

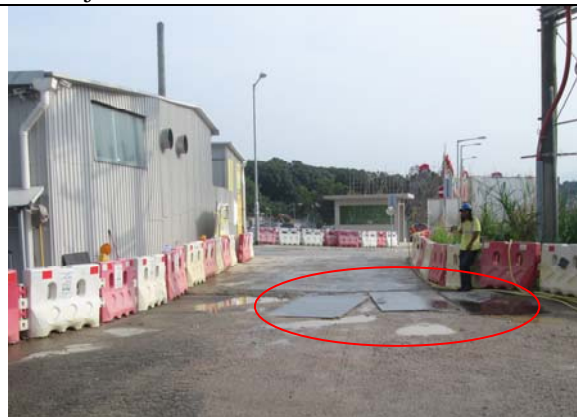
Photo 6

During site inspection on 6 October 2017, no muddy trails and debris was observed at the site exit and adjoining LMH Road.

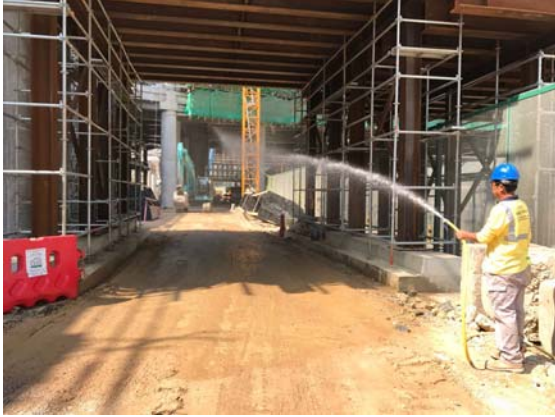
Photo 7

According to the observation during weekly site inspection, KRSJV has implemented air quality mitigation measures to minimize the dust impact arising from the contract works, such as water spraying on haul road to suppress the fugitive dust

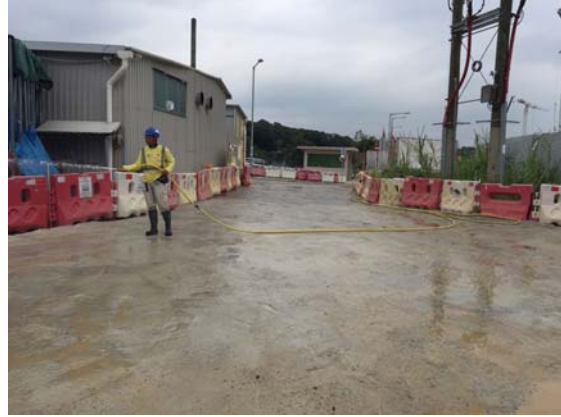
Photo 8

During site inspection on 17 October 2017, it was observed that the site access of Contract 7 was entirely paved with concrete and wheel washing facilities was provided on concrete ground near the site exit.

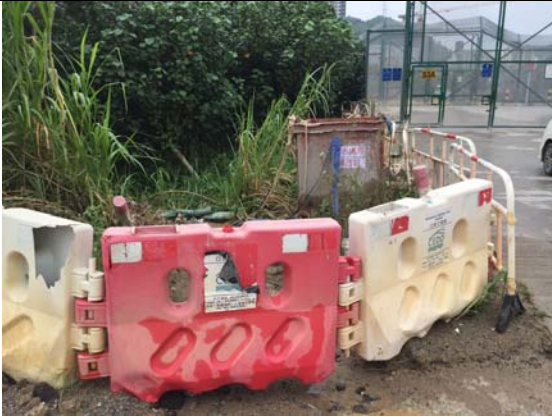
Photo 9

The wastewater from wheel washing was diverted to a sedimentation tank.

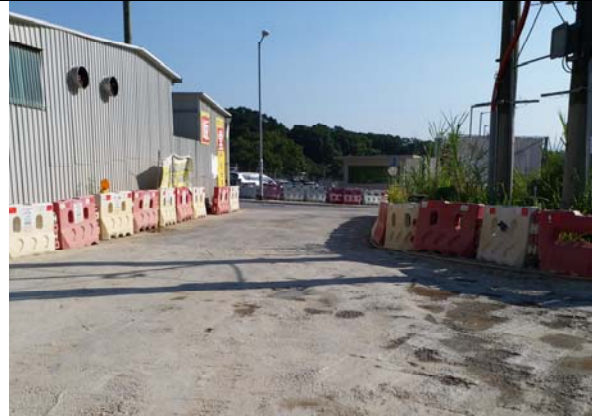
Photo 10

No muddy trails were observed at the site exit and the condition of site exit was satisfactory.

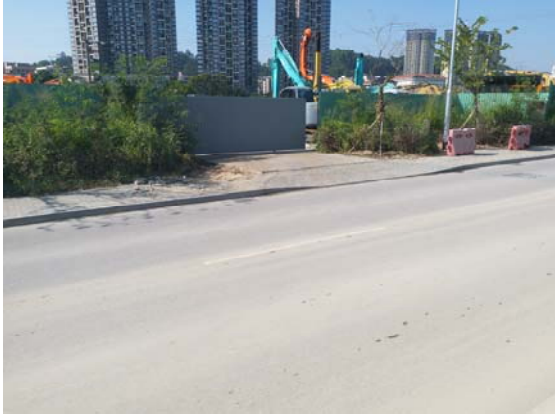
Photo 1 (Unknown Exit 1)

The condition of unknown site exit 1 and adjoined LMH road was dusty in which mud and debris were found. The maintenance party/ ownership of the site exit is unknown.

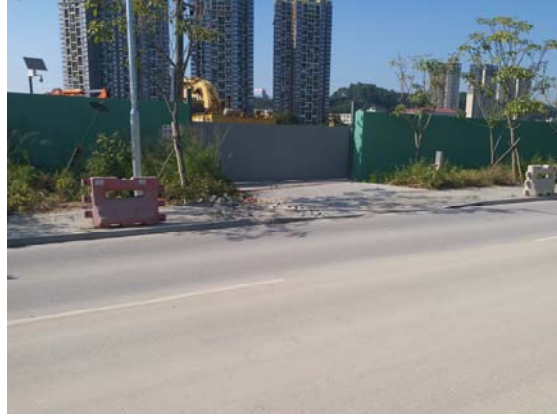
Photo 2 (Unknown Exit 2)

The condition of unknown site exit 2 and adjoined LMH road was dusty in which mud and debris were found. The maintenance party/ ownership of the site exit is unknown.

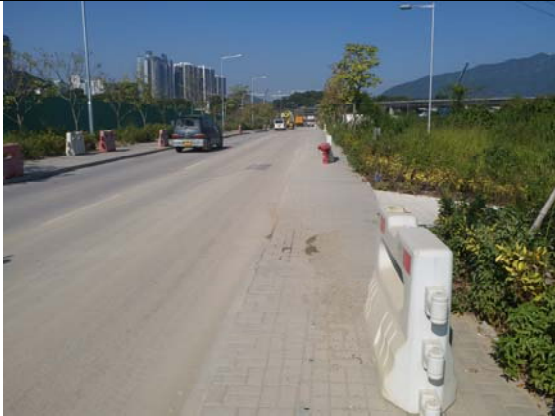
Photo 3 (Unknown Exit 3)

The condition of unknown site exit 3 and adjoined LMH road was dusty in which mud and debris were found. The maintenance party/ ownership of the site exit is unknown.

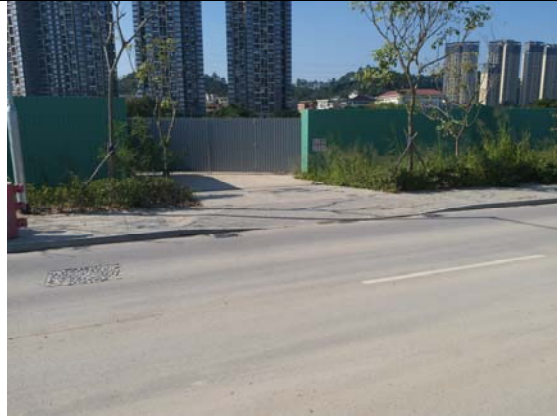
Photo 4 (Unknown Exit 4)

The condition of unknown site exit 4 and adjoined LMH road was dusty in which mud and debris were found. The maintenance party/ ownership of the site exit is unknown.

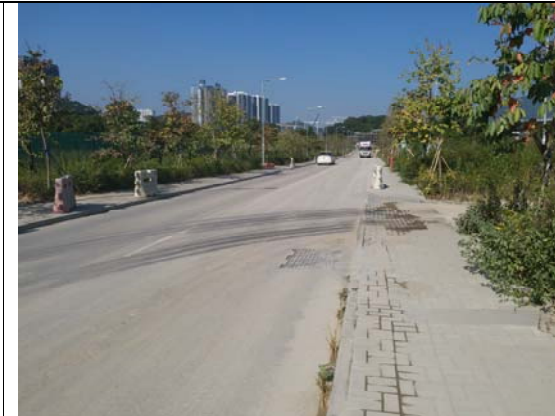
Photo 5 (Unknown Exit 5)

The condition of unknown site exit 5 and adjoined LMH road was dusty in which mud and debris were found. The maintenance party/ ownership of the site exit is unknown.

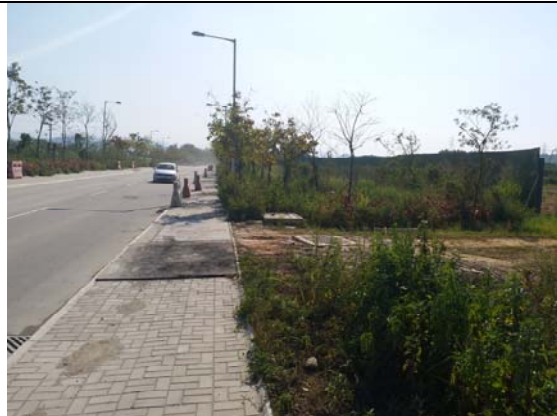
Photo 6 (Unknown Exit 6)

The condition of unknown site exit 6 and adjoined LMH road was dusty in which mud and debris were found. The maintenance party/ ownership of the site exit is unknown.

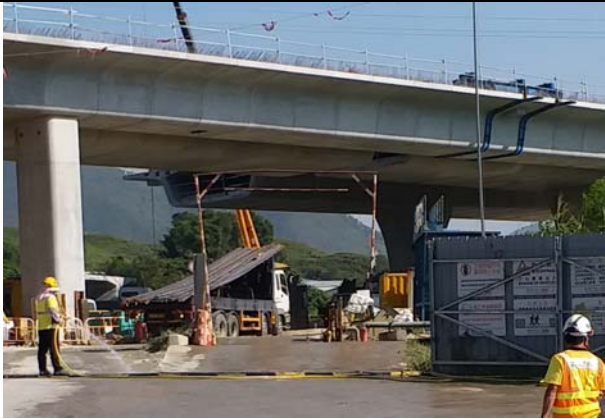
Photo 7 (Bridge D Site Exit under LT/C6)

Wheel washing facilities were provided and properly maintained by CCKJV. A bund was provided to prevent muddy water from flowing out of the site.

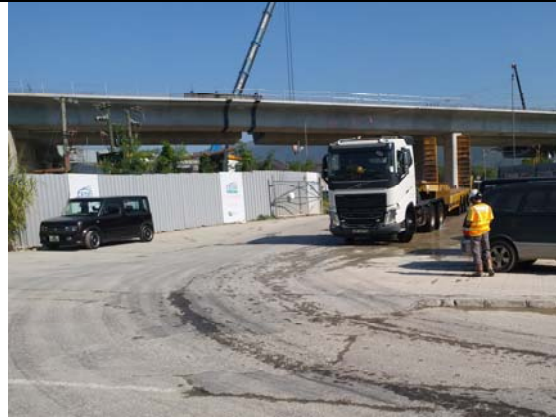
Photo 8 (Bridge D Site Exit under LT/C6)

The condition of Bridge D Site Exit under LT/C6 and adjoined LMH road was satisfactory without mud and debris.

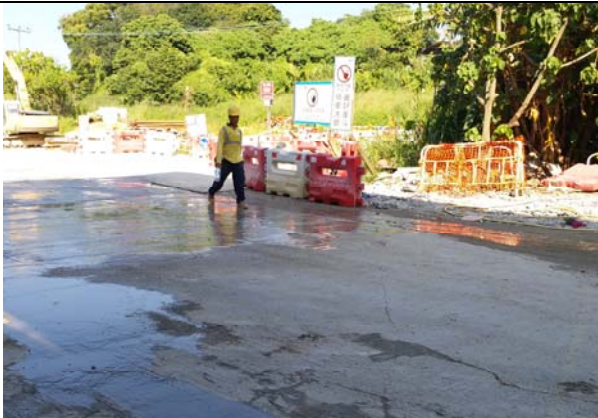
Photo 9 (Chuk Yuen Rd Site exit under LT/C6)

Wheel washing facilities were provided and properly maintained by CCKJV. The wastewater from wheel washing was directed to catchpit for soakaway.

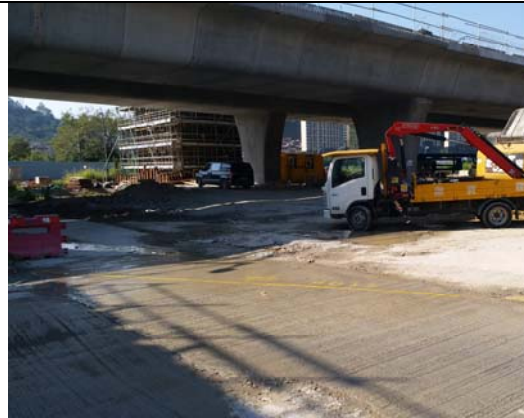
Photo 10 (Chuk Yuen Rd Site exit under LT/C6)

The condition of Chuk Yuen Rd Site Exit under LT/C6 and adjoined LMH road was satisfactory without mud and debris.

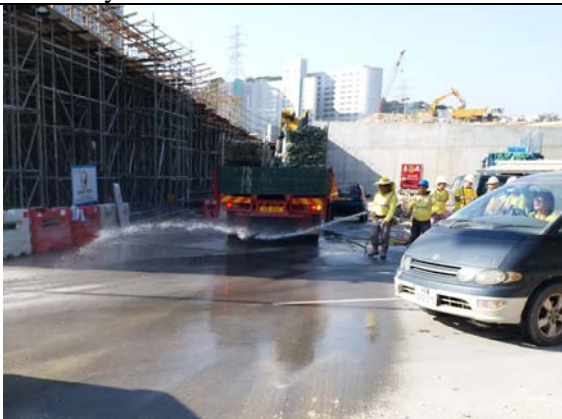
Photo 11 (Bridge Y Site Exit under LT/C6)

Wheel washing facilities were provided and properly maintained by CCKJV. The wastewater from wheel washing was directed to AquaSed for de-silting.

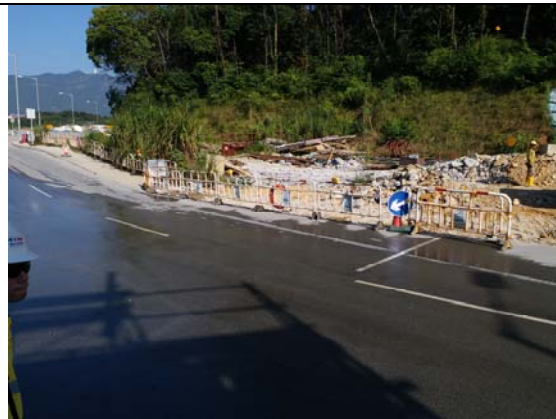
Photo 12 (Bridge Y Site Exit under LT/C6)

The condition of Bridge Y Site Exit under LT/C6 and adjoined LMH road was satisfactory without mud and debris.

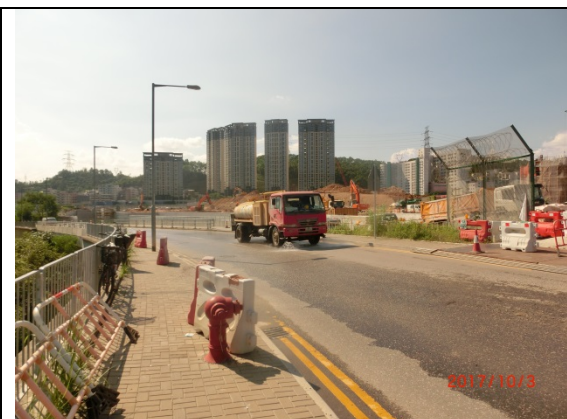
Photo 13

During the regular site inspection, it was observed that the road surface of LMH Road was wetted by water bowsers to suppress fugitive dust.

Road sweeper would also deploy by CCKJV to enhance the road cleaning work in order to remove debris and gravels on road surface.
