AGREEMENT NO. CE 45/2008 (CE)
LIANTANG/ HEUNG YUEN WAI
BOUNDARY CONTROL POINT AND ASSOCIATED WORKS

MONTHLY ENVIRONMENTAL MONITORING AND AUDIT
REPORT (NO.68) – MARCH 2019

PREPARED FOR
CIVIL ENGINEERING AND DEVELOPMENT DEPARTMENT
(CEDD)

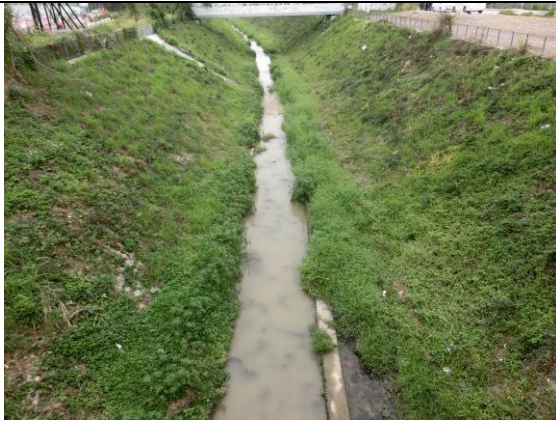
Photo 1

During water quality monitoring on 25 February 2019, turbid water was observed at WM4.

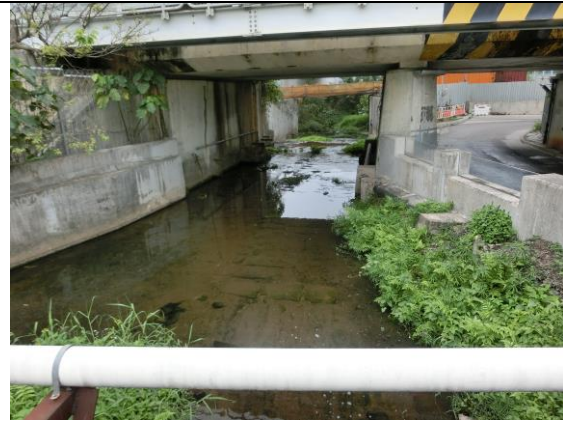
Photo 2

During water quality monitoring on 25 February 2019, it was observed that the water quality at WM4-CA was clear.

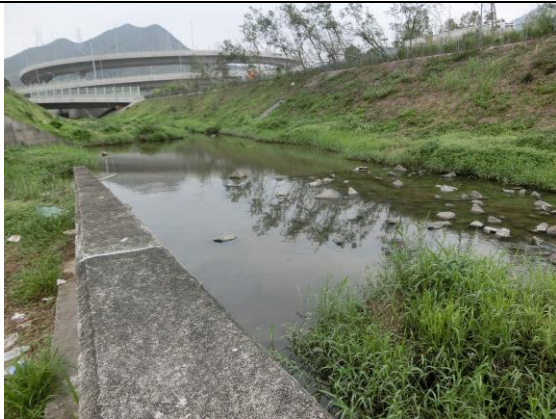
Photo 3

During water quality monitoring on 25 February 2019, it was observed that the water quality at WM4-CB was clear.

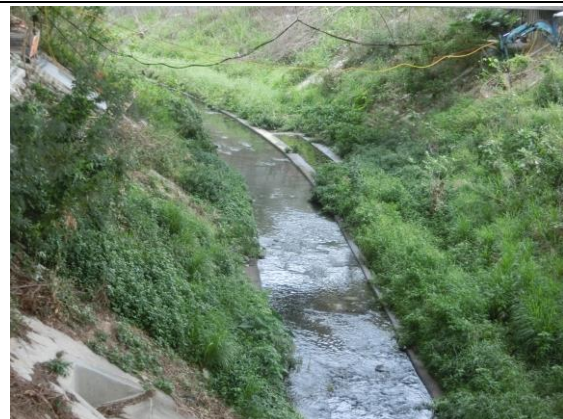
Photo 4

Upon detection of the exceedance, inspection was carried out at upstream and it was observed that the water flowing from upper part of the site (box culvert ID4 and ID5) was clear.

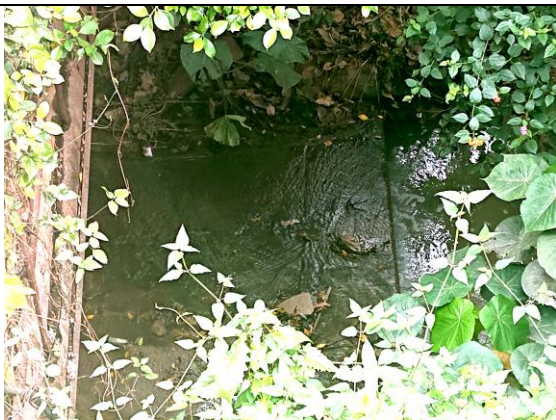
Photo 5

On 25 February 2019, Chun Wo reported that there was unknown source of turbid water attributed to site area via an underground pipe from box culvert in Kiu Tau Road (outside C3) to BC02.

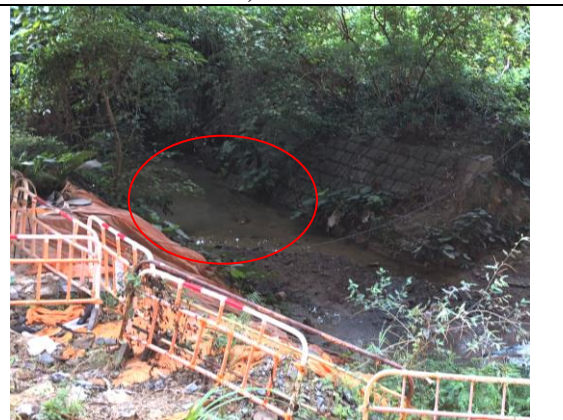
Photo 6

During site inspection on 20 February 2019, turbid water was observed from box culvert in Kiu Tau Road (outside C3) to BC02.

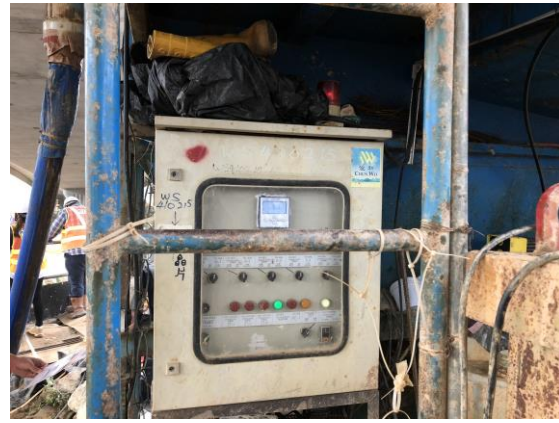
**Photo 8**

Wastewater treatment facilities implemented on-site were functioned properly and no adverse water quality impact was observed.

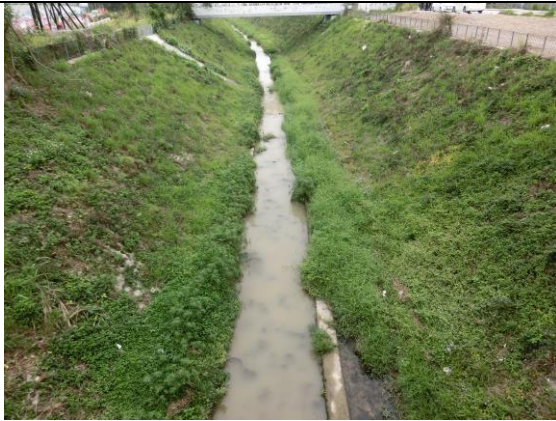
Photo 1

During water quality monitoring on 25 February 2019, turbid water was observed at WM4.

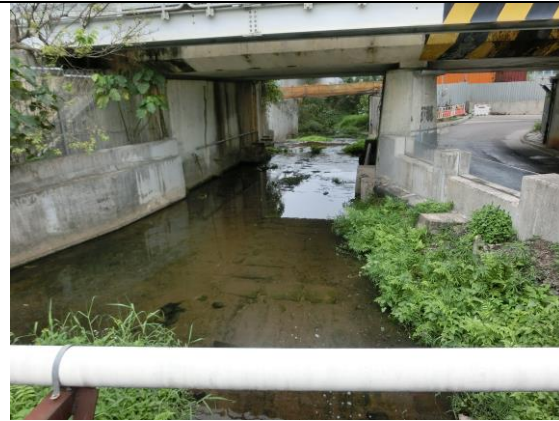
Photo 2

During water quality monitoring on 25 February 2019, it was observed that the water quality at WM4-CA was clear.

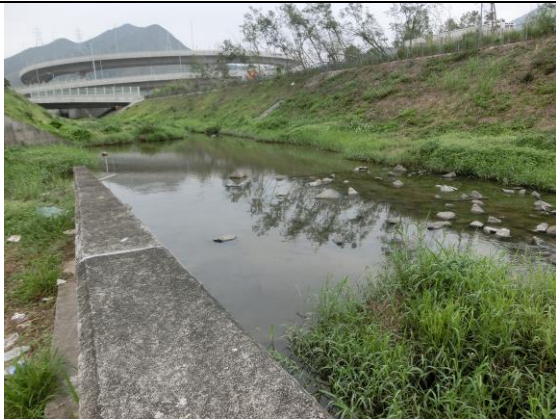
Photo 3

During water quality monitoring on 25 February 2019, it was observed that the water quality at WM4-CB was clear.

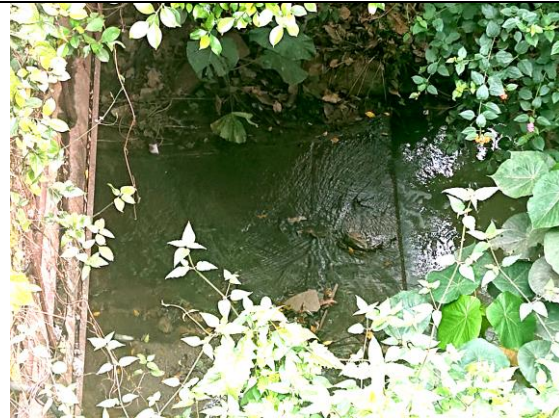
Photo 4

On 25 February 2019, the Contractor of Contract 3 reported that there was unknown source of turbid water attributed to site area via an underground pipe from box culvert in Kiu Tau Road (outside C3) to BC02.

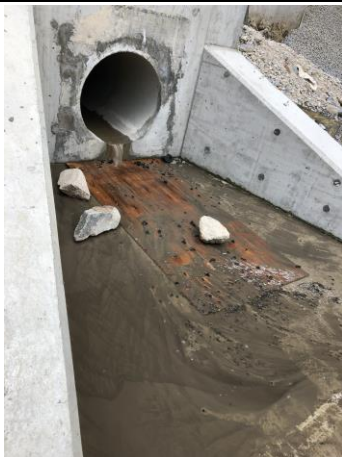
Photo 5

During site inspection on 1 March 2019, turbid water was observed at the discharge point of South Portal.

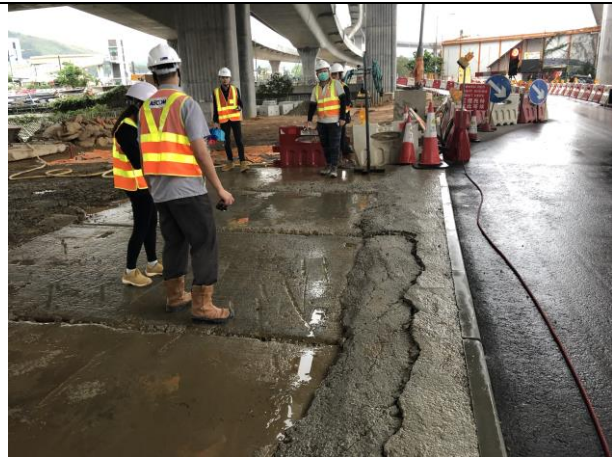
Photo 4

No mud and muddy water rushing out from the site to public road was observed at Entrance C.

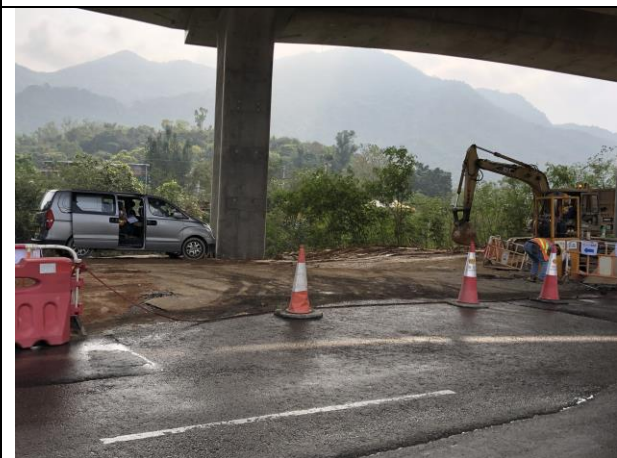
Photo 5

For easy management of site exit, traffic control was applied to Entrance B which for vehicles entry only.

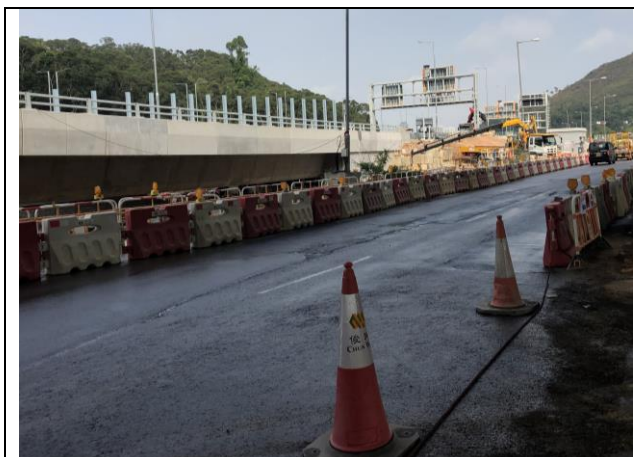
Photo 7

The cleanliness of site exits and TWSRE was satisfactory in which no mud and muddy water rushing out from the site to public road was observed.

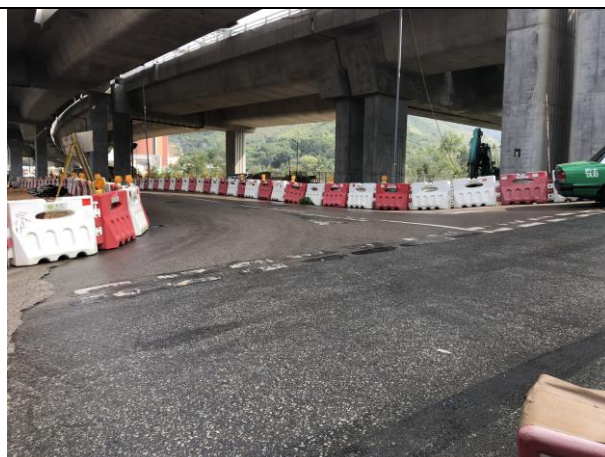
Photo 8

The cleanliness of site exits and TWSRE was satisfactory in which no mud and muddy water rushing out from the site to public road was observed.

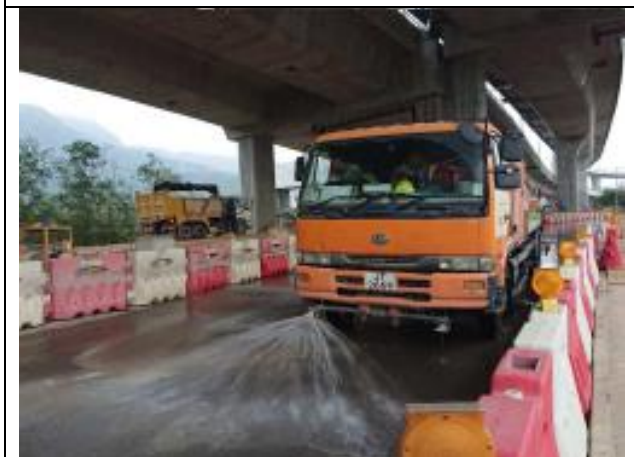
Photo 9

Water tanker was deployed on TWSRE to maintain to road clean.

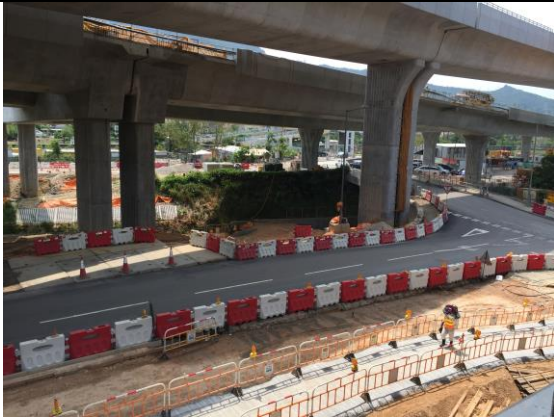
Photo 1
During site inspection on 3 May 2018, no adverse impact was observed on Tai Wo Service Road East and there was no site exit along the road under the Project.

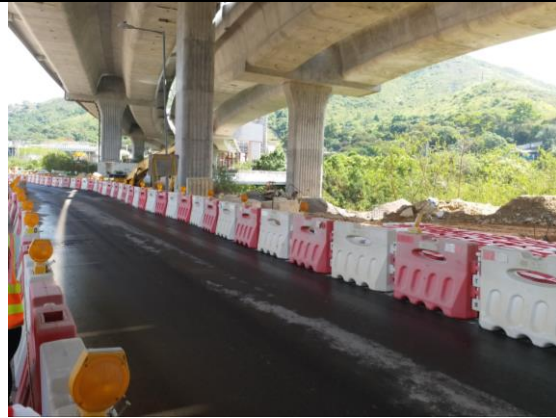
Photo 2
Road cleaning by water tanker as dust suppressive measure was observed on Tai Wo Service Road East.

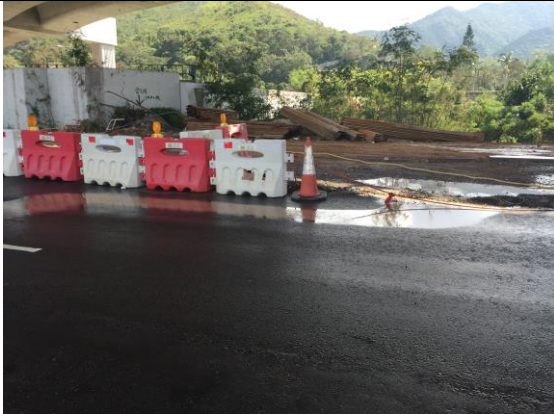
Photo 3
Based on ET's site inspection record in September 2018, overflow of wastewater from wheel washing to public road was observed at work area of site exit SA2. The Contractor was advised to clean the muddy water and provide proper mitigation to avoid muddy water flow out of site.

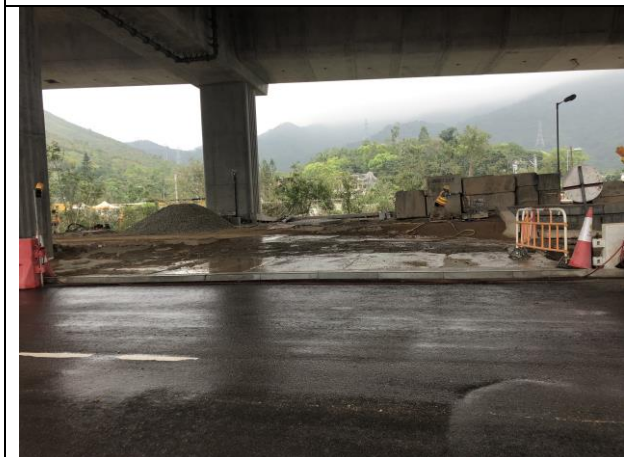
Photo 7

No mud and muddy water rushing out from the site to public road was observed at Entrance C.

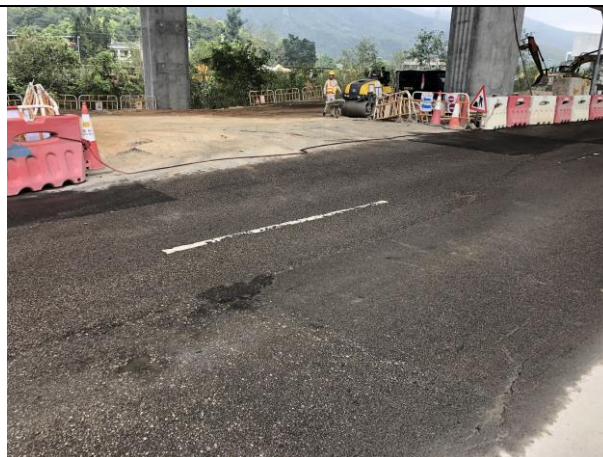
Photo 8

For ease of management of site exit, traffic control was applied to Entrance B which for vehicles entry only.

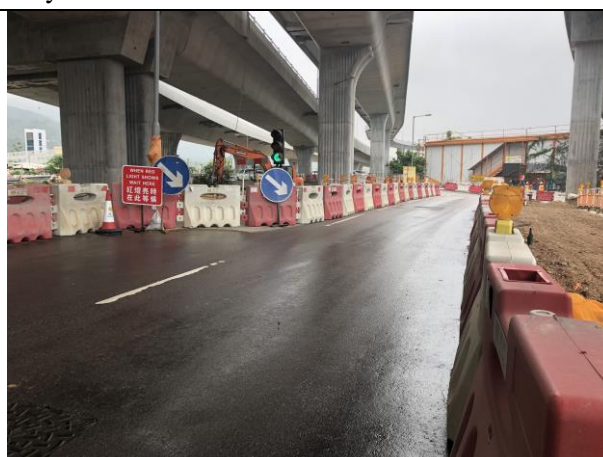
Photo 10

The cleanliness of site exits and TWSRE was satisfactory in which no mud and muddy water rushing out from the site to public road was observed. No ponding and mud trapped and piled up alongside the TWSRE was observed.

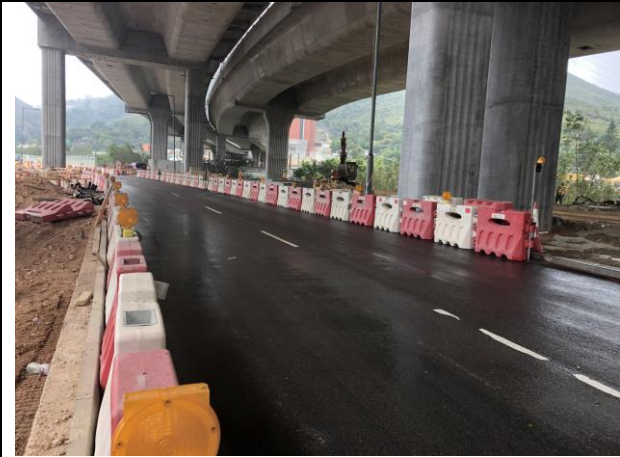
Photo 11

The cleanliness of site exits and TWSRE was satisfactory in which no mud and muddy water rushing out from the site to public road was observed. No ponding and mud trapped and piled up alongside the TWSRE was observed.

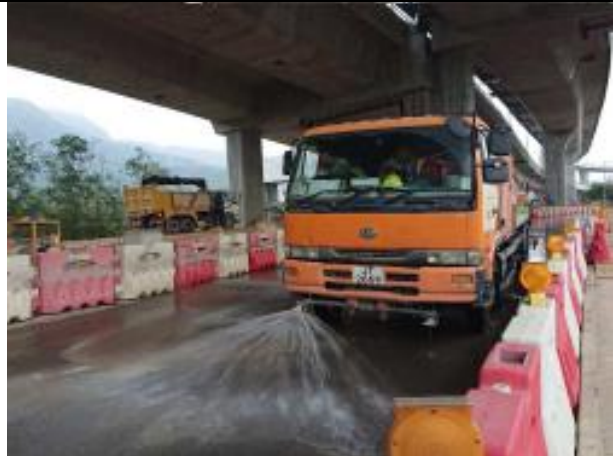
Photo 12

Water tanker was deployed on TWSRE to maintain to road clean.
