**AGREEMENT NO. CE 45/2008 (CE)
LIANTANG/HEUNG YUEN WAI
BOUNDARY CONTROL POINT AND ASSOCIATED WORKS**

**MONITORING REPORT FOR WETLAND
COMPENSATION AREA (No.4) – JANUARY 2021**

**PREPARED FOR
CIVIL ENGINEERING AND DEVELOPMENT DEPARTMENT**

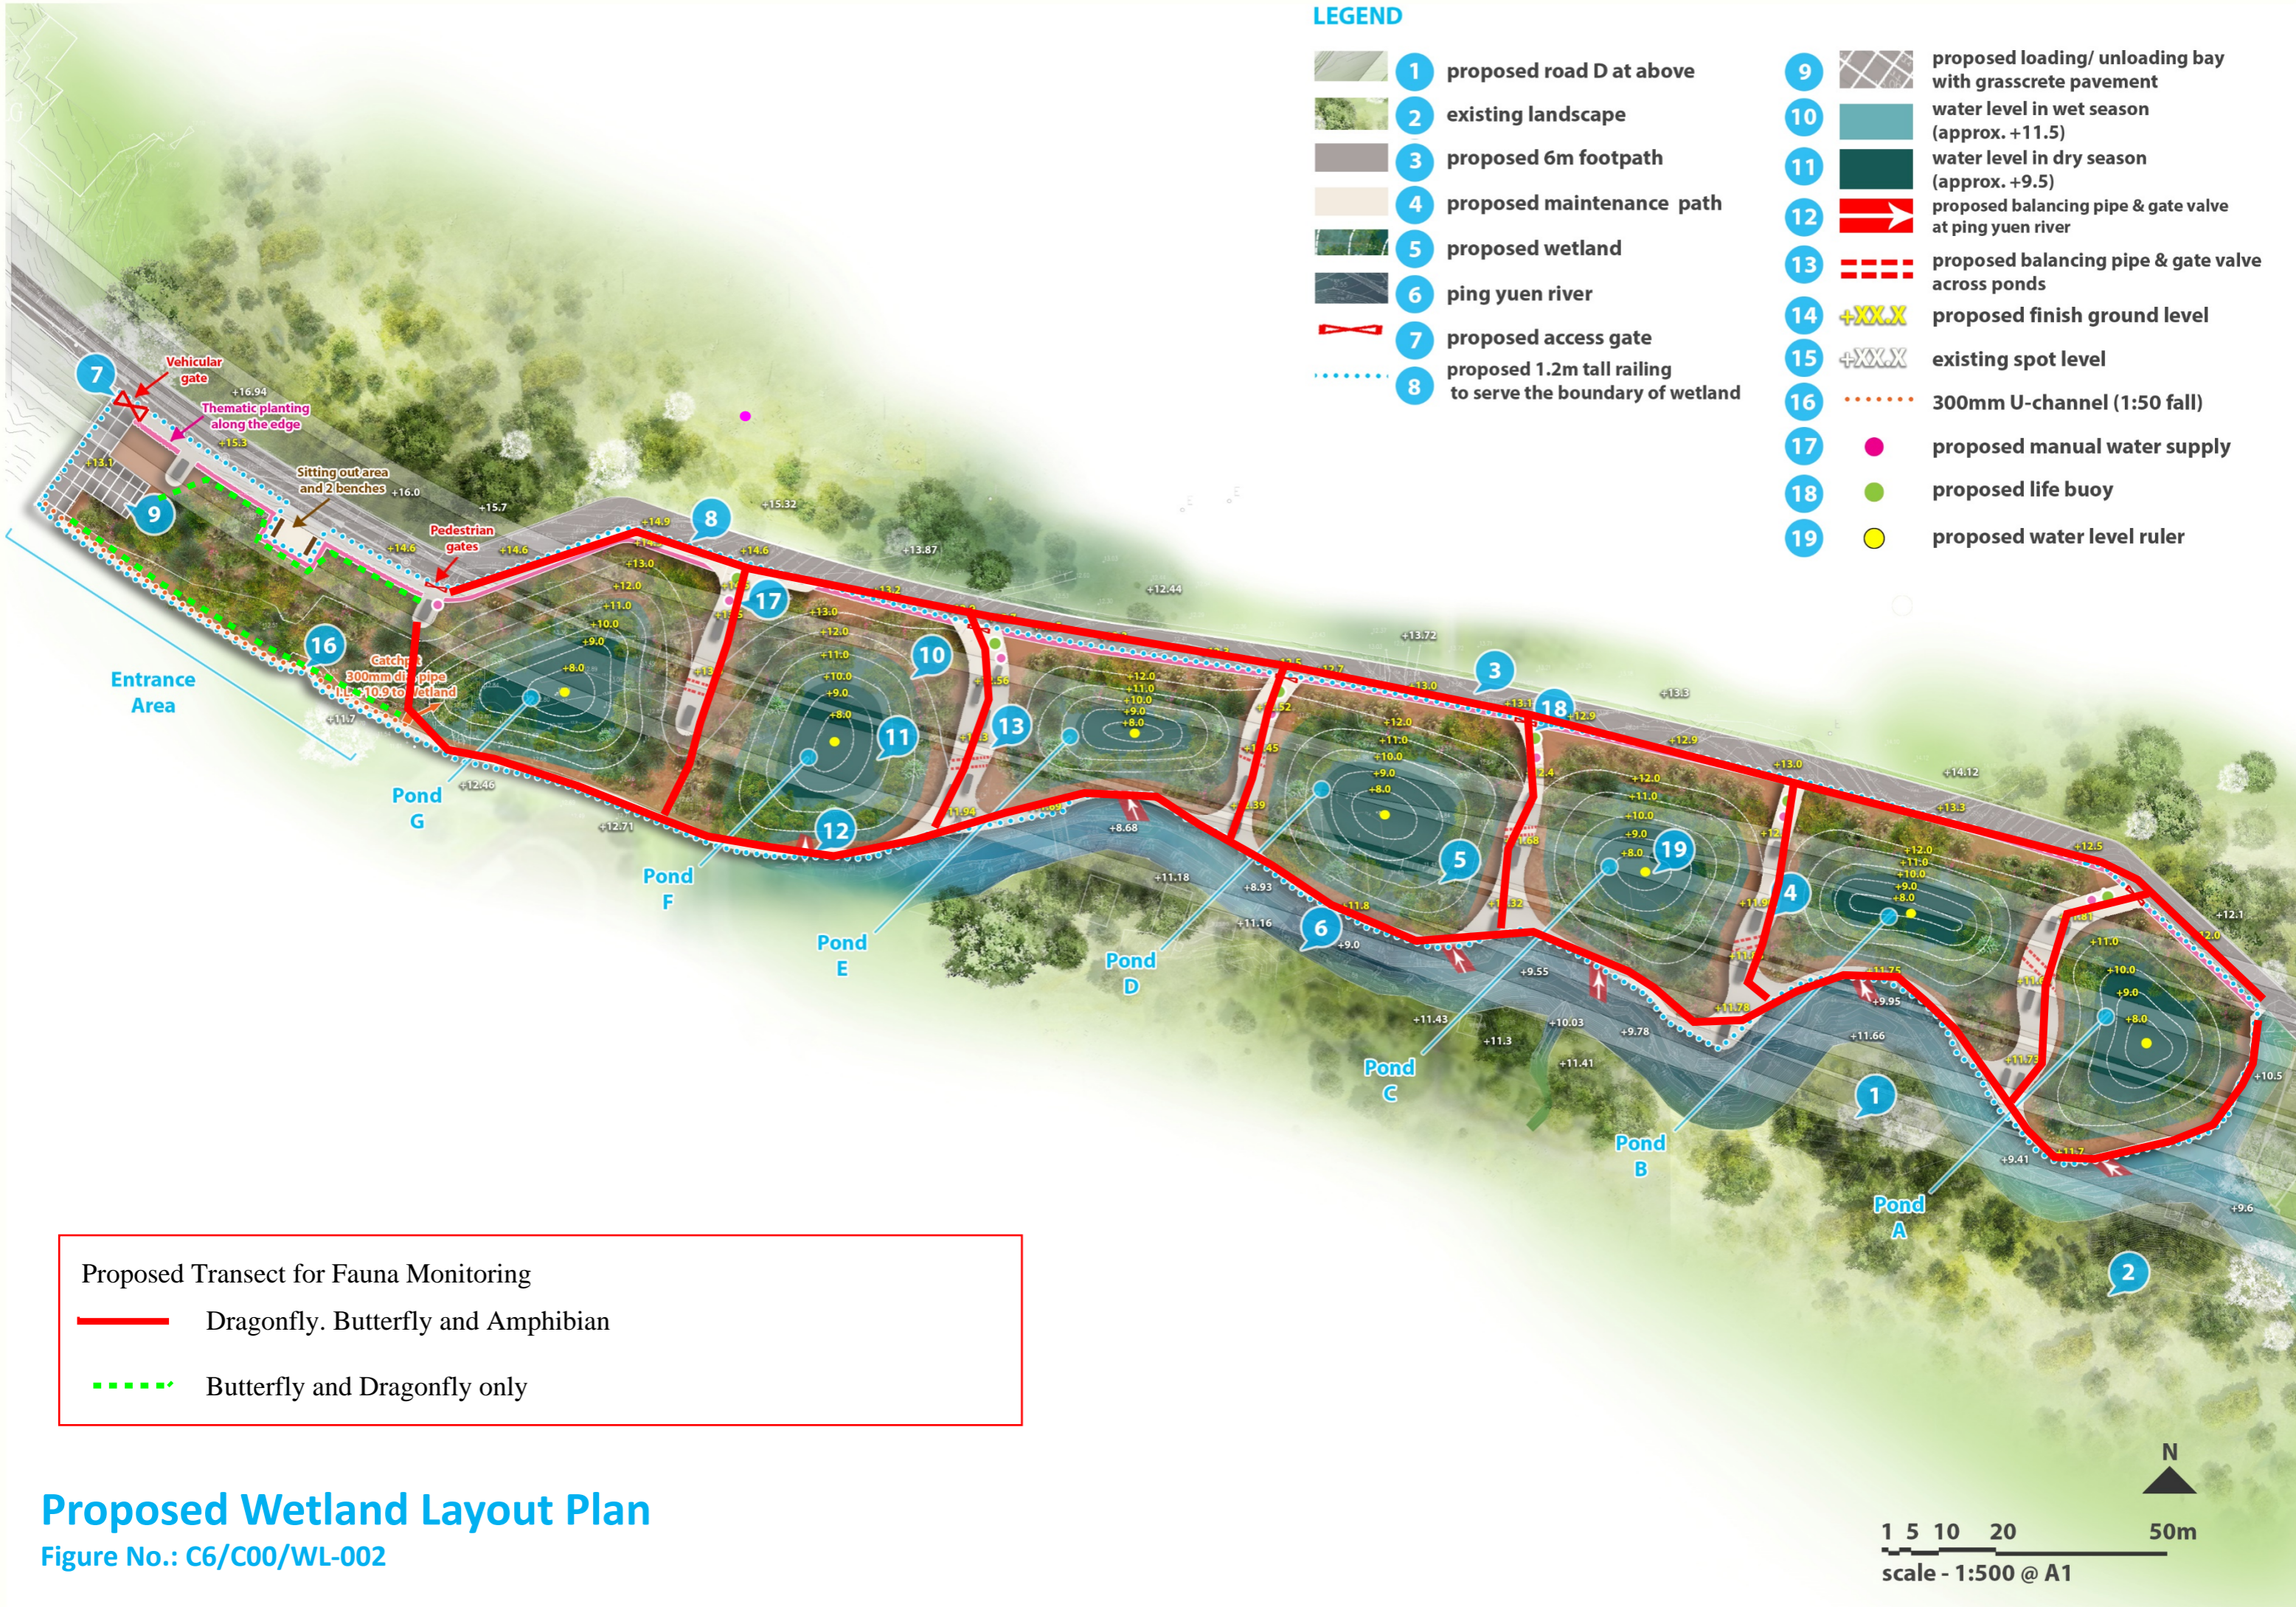
Figure No.: C6/C00/WL-002

Proposed Transect for Fauna Monitoring

- Dragonfly, Butterfly and Amphibian
- Butterfly and Dragonfly only

Proposed Wetland Layout Plan

- 2.2.5 The survey should be conducted during the middle of the day to coincide with the peak flight time for these species. The monitoring for dragonfly and butterfly should be undertaken on a monthly basis, but would be bi-monthly monitoring (i.e., twice per month) for dragonfly during the peak period of dragonfly emergency in April to August. The proposed transect routes are shown in the *Appendix A*.
