**AGREEMENT NO. CE 45/2008 (CE)
LIANTANG/HEUNG YUEN WAI
BOUNDARY CONTROL POINT AND ASSOCIATED WORKS**

**MONITORING REPORT FOR WETLAND
COMPENSATION AREA (No.10) – JULY 2021**

**PREPARED FOR
CIVIL ENGINEERING AND DEVELOPMENT DEPARTMENT**

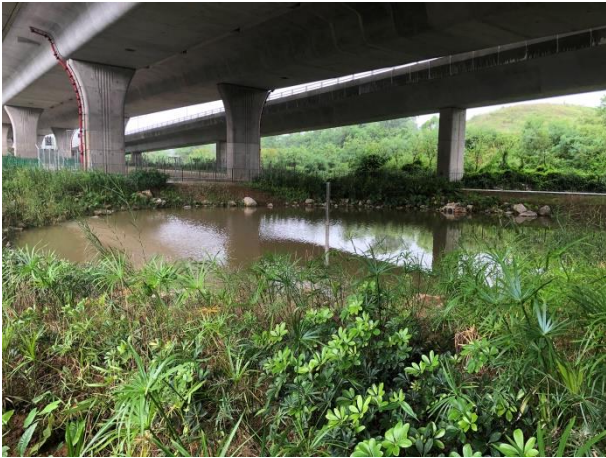
Pond A

3.3.1 Site inspection for the establishment of WCA was conducted by ET on **7th, 16th, 21st and 29th July 2021**. There was no sign of flooding/ storm damage observed. The planted vegetation in the WCA was visually in fair condition and no significant litter or vandalism were observed. Besides, it was noticed that greenish color appeared in the ponds, particularly in Ponds B and G, there was no pollution incident observed and color in pond water was considered as natural phenomenon. Photographic records showing the condition of the WCA and general view of the existing vegetation

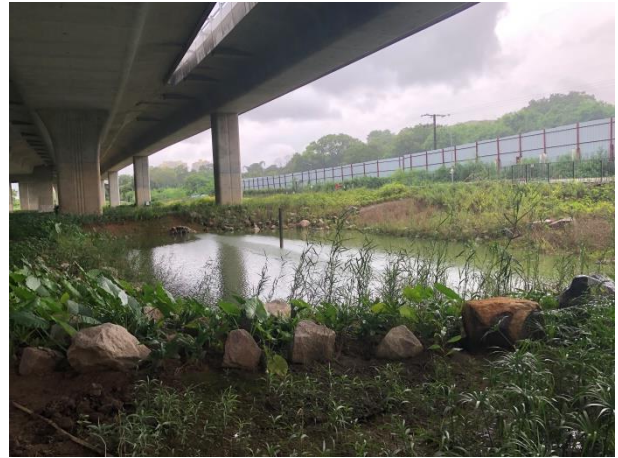
Pond B

3.2.2 In the Reporting Period, Action Level of pH was triggered at Pond B. The high pH may be driven by the local environmental, such as rain water and soil runoff. No pollution was observed and it was considered that the exceedance was caused by natural environment. No remedial action is required and the ET will keep monitoring the water quality in the pond in the next Reporting Period.
