**AGREEMENT NO. CE 45/2008 (CE)  
LIANTANG/HEUNG YUEN WAI  
BOUNDARY CONTROL POINT AND ASSOCIATED WORKS**

**MONITORING REPORT FOR WETLAND  
COMPENSATION AREA (No.11) – AUGUST 2021**

**PREPARED FOR  
CIVIL ENGINEERING AND DEVELOPMENT DEPARTMENT**

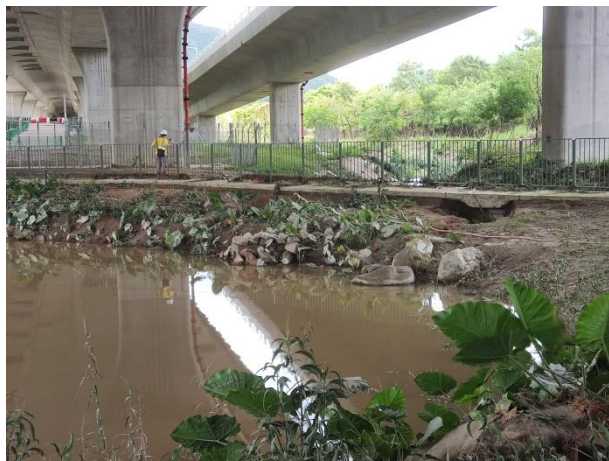
3.3.1 Site inspection for the establishment of WCA was conducted by ET on *5<sup>th</sup>, 12<sup>th</sup>, 20<sup>th</sup> and 26<sup>th</sup> August 2021*. During site inspection on *20<sup>th</sup> and 26<sup>th</sup> August 2021*, signs of flood/ storm damages were observed in Pond A to Pond E and some planted vegetation were damaged. According to the Hong Kong Observatory, Special Announcement on Flooding in the northern New Territories were issued on 18<sup>th</sup> and 19<sup>th</sup> August 2021 and the flood/ storm affected the WCA. According to the Action Plan, the Contractor and RE have reviewed the damages and some repairs works have been scheduled and undertaken subsequently as follow.

### Signs of Flood/ Storm Damages

- i. Shotcreting to cover up the holes near the damaged balancing pipes at Pond A and C;
- ii. Rectify the damaged planting soil;
- iii. Rectify the damaged rock channel;
- iv. Reinstatement the miss-positioned stones at planting matrix 3 and 4 as well as as-built planting; and
- v. Remove the dead plants and re-provide with same species
