**AGREEMENT NO. CE 45/2008 (CE)
LIANTANG/HEUNG YUEN WAI
BOUNDARY CONTROL POINT AND ASSOCIATED WORKS**

**ECOLOGICAL MONITORING REPORT FOR THE
WOODLAND COMPENSATION AREA
(MARCH TO APRIL 2017)**

**PREPARED FOR
CIVIL ENGINEERING AND DEVELOPMENT
DEPARTMENT (CEDD)**

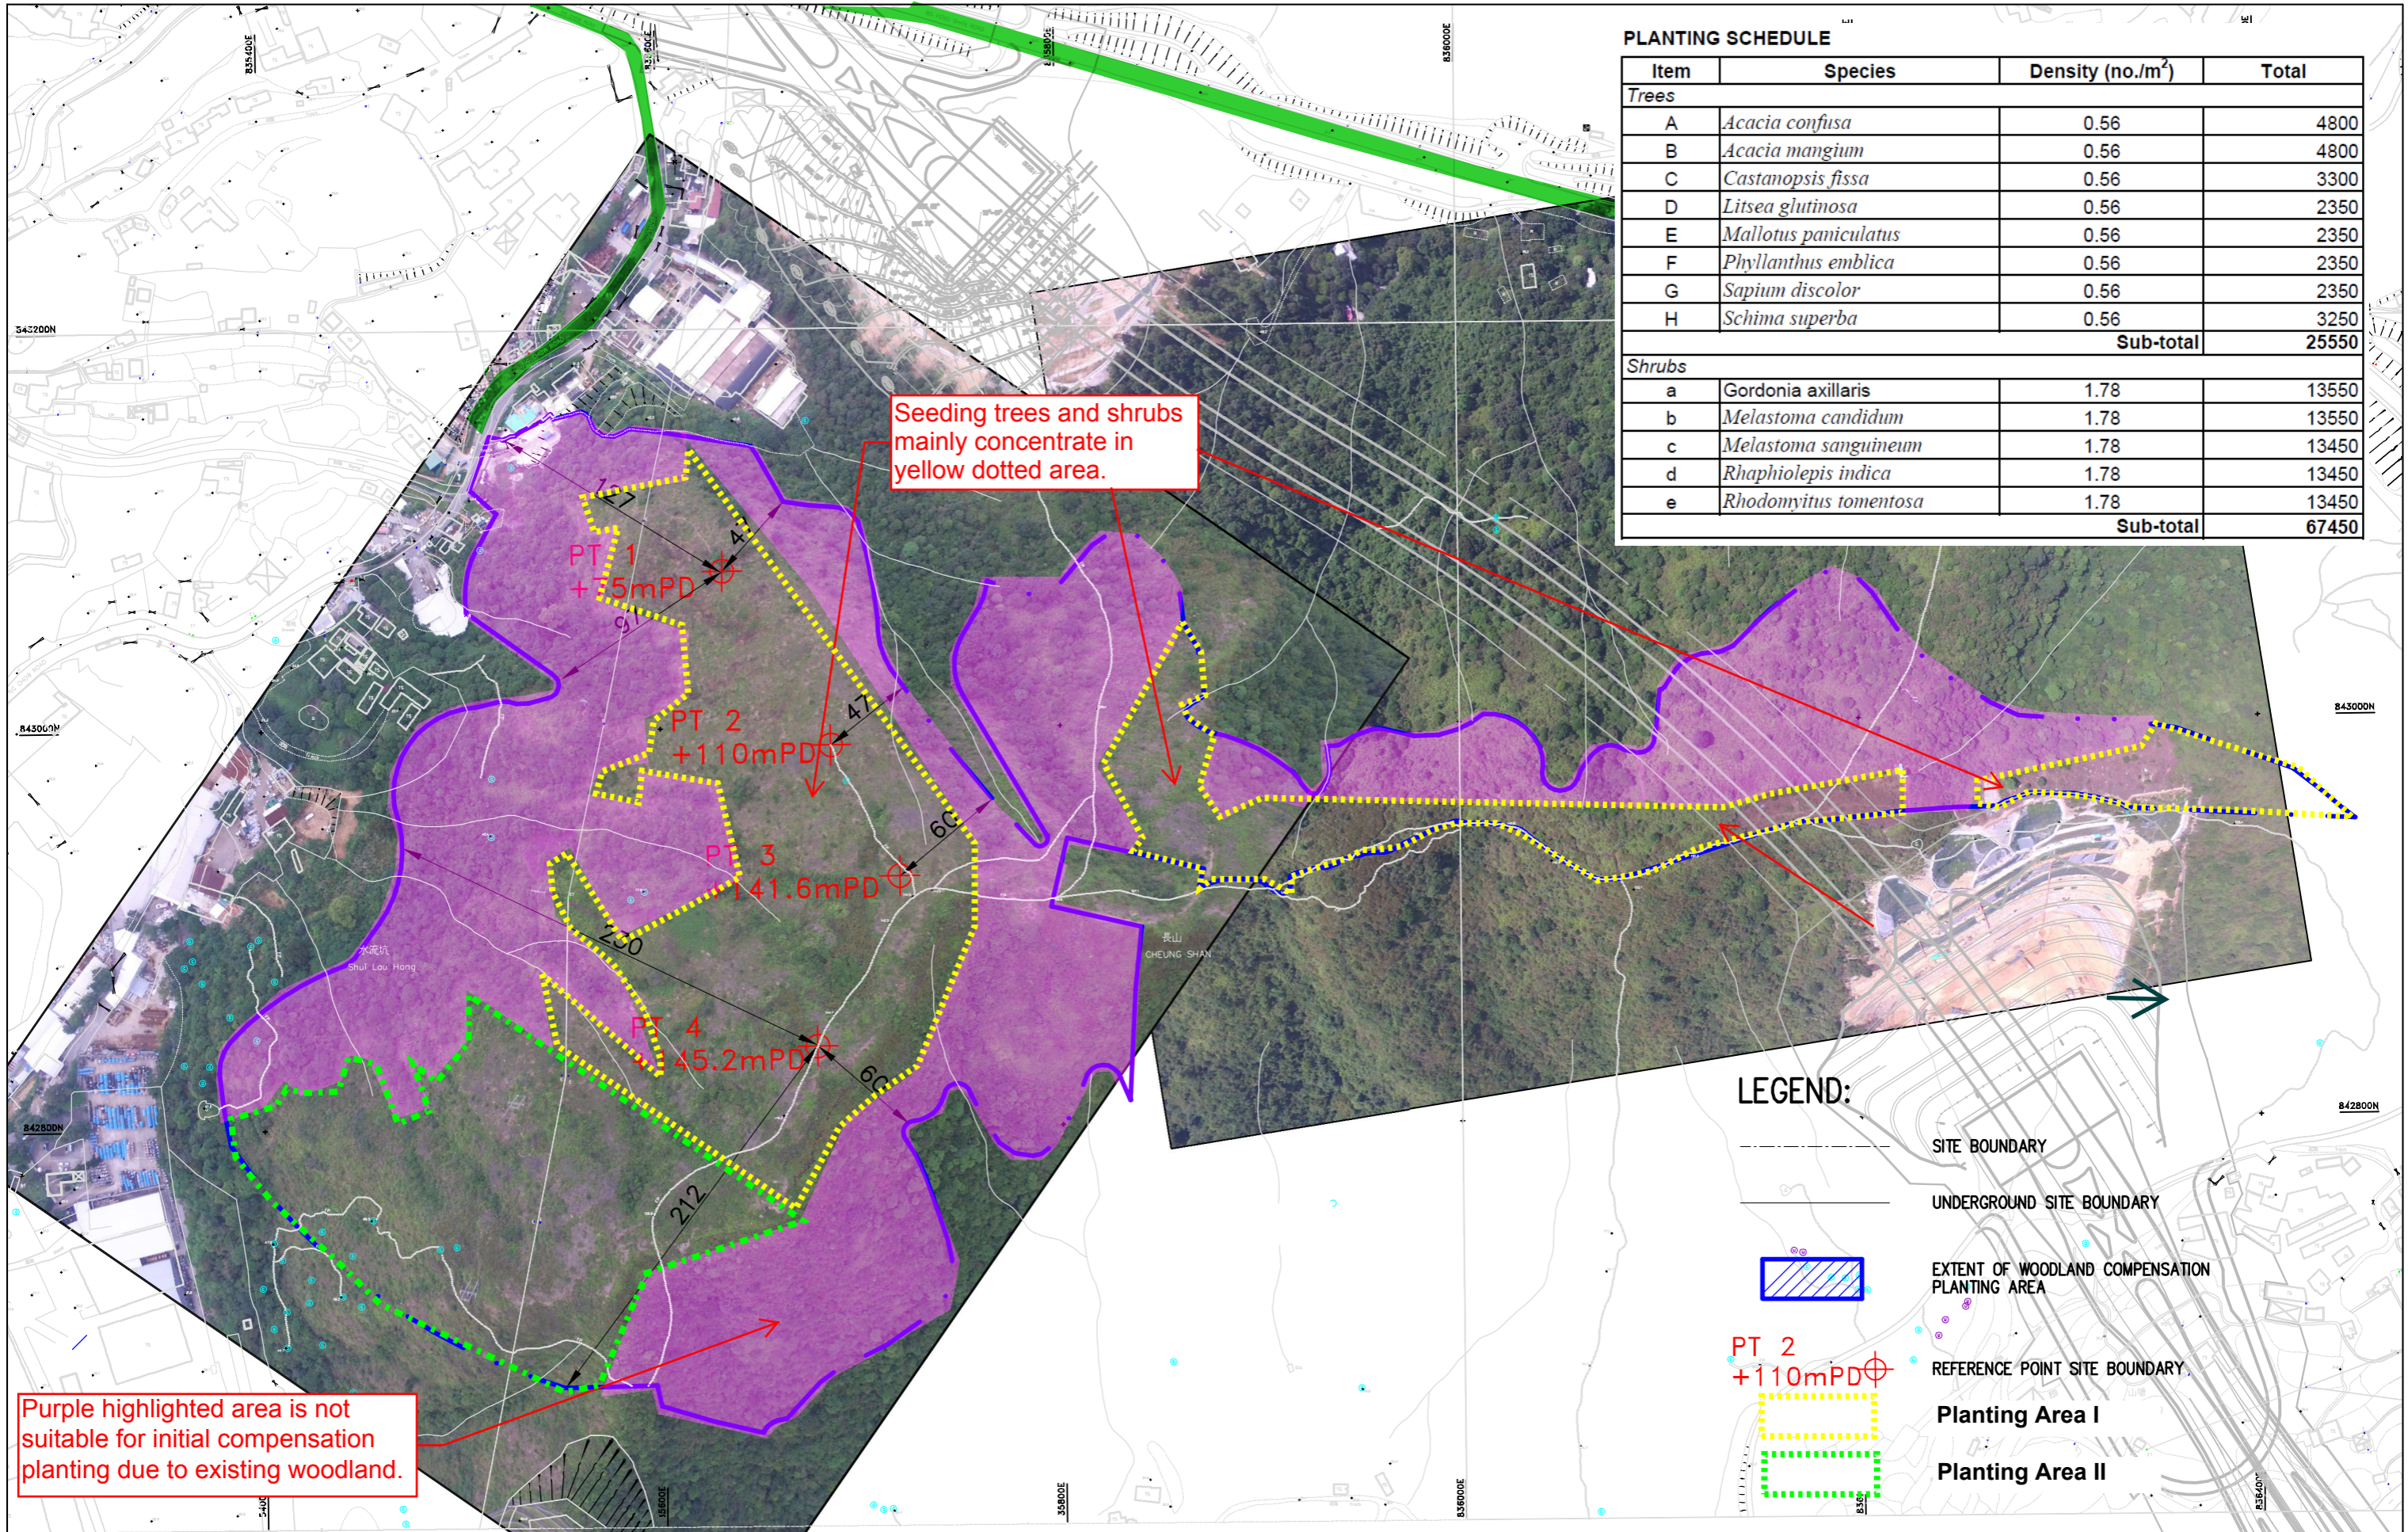
APPENDIX B - SITE CONSTRAINTS AND LATEST PLANTING ARRANGEMENT OF THE INITIAL PLANTING PHASE (2016)

Purple highlighted area is not suitable for initial compensation planting due to existing woodland.

Seeding trees and shrubs mainly concentrate in yellow dotted area.

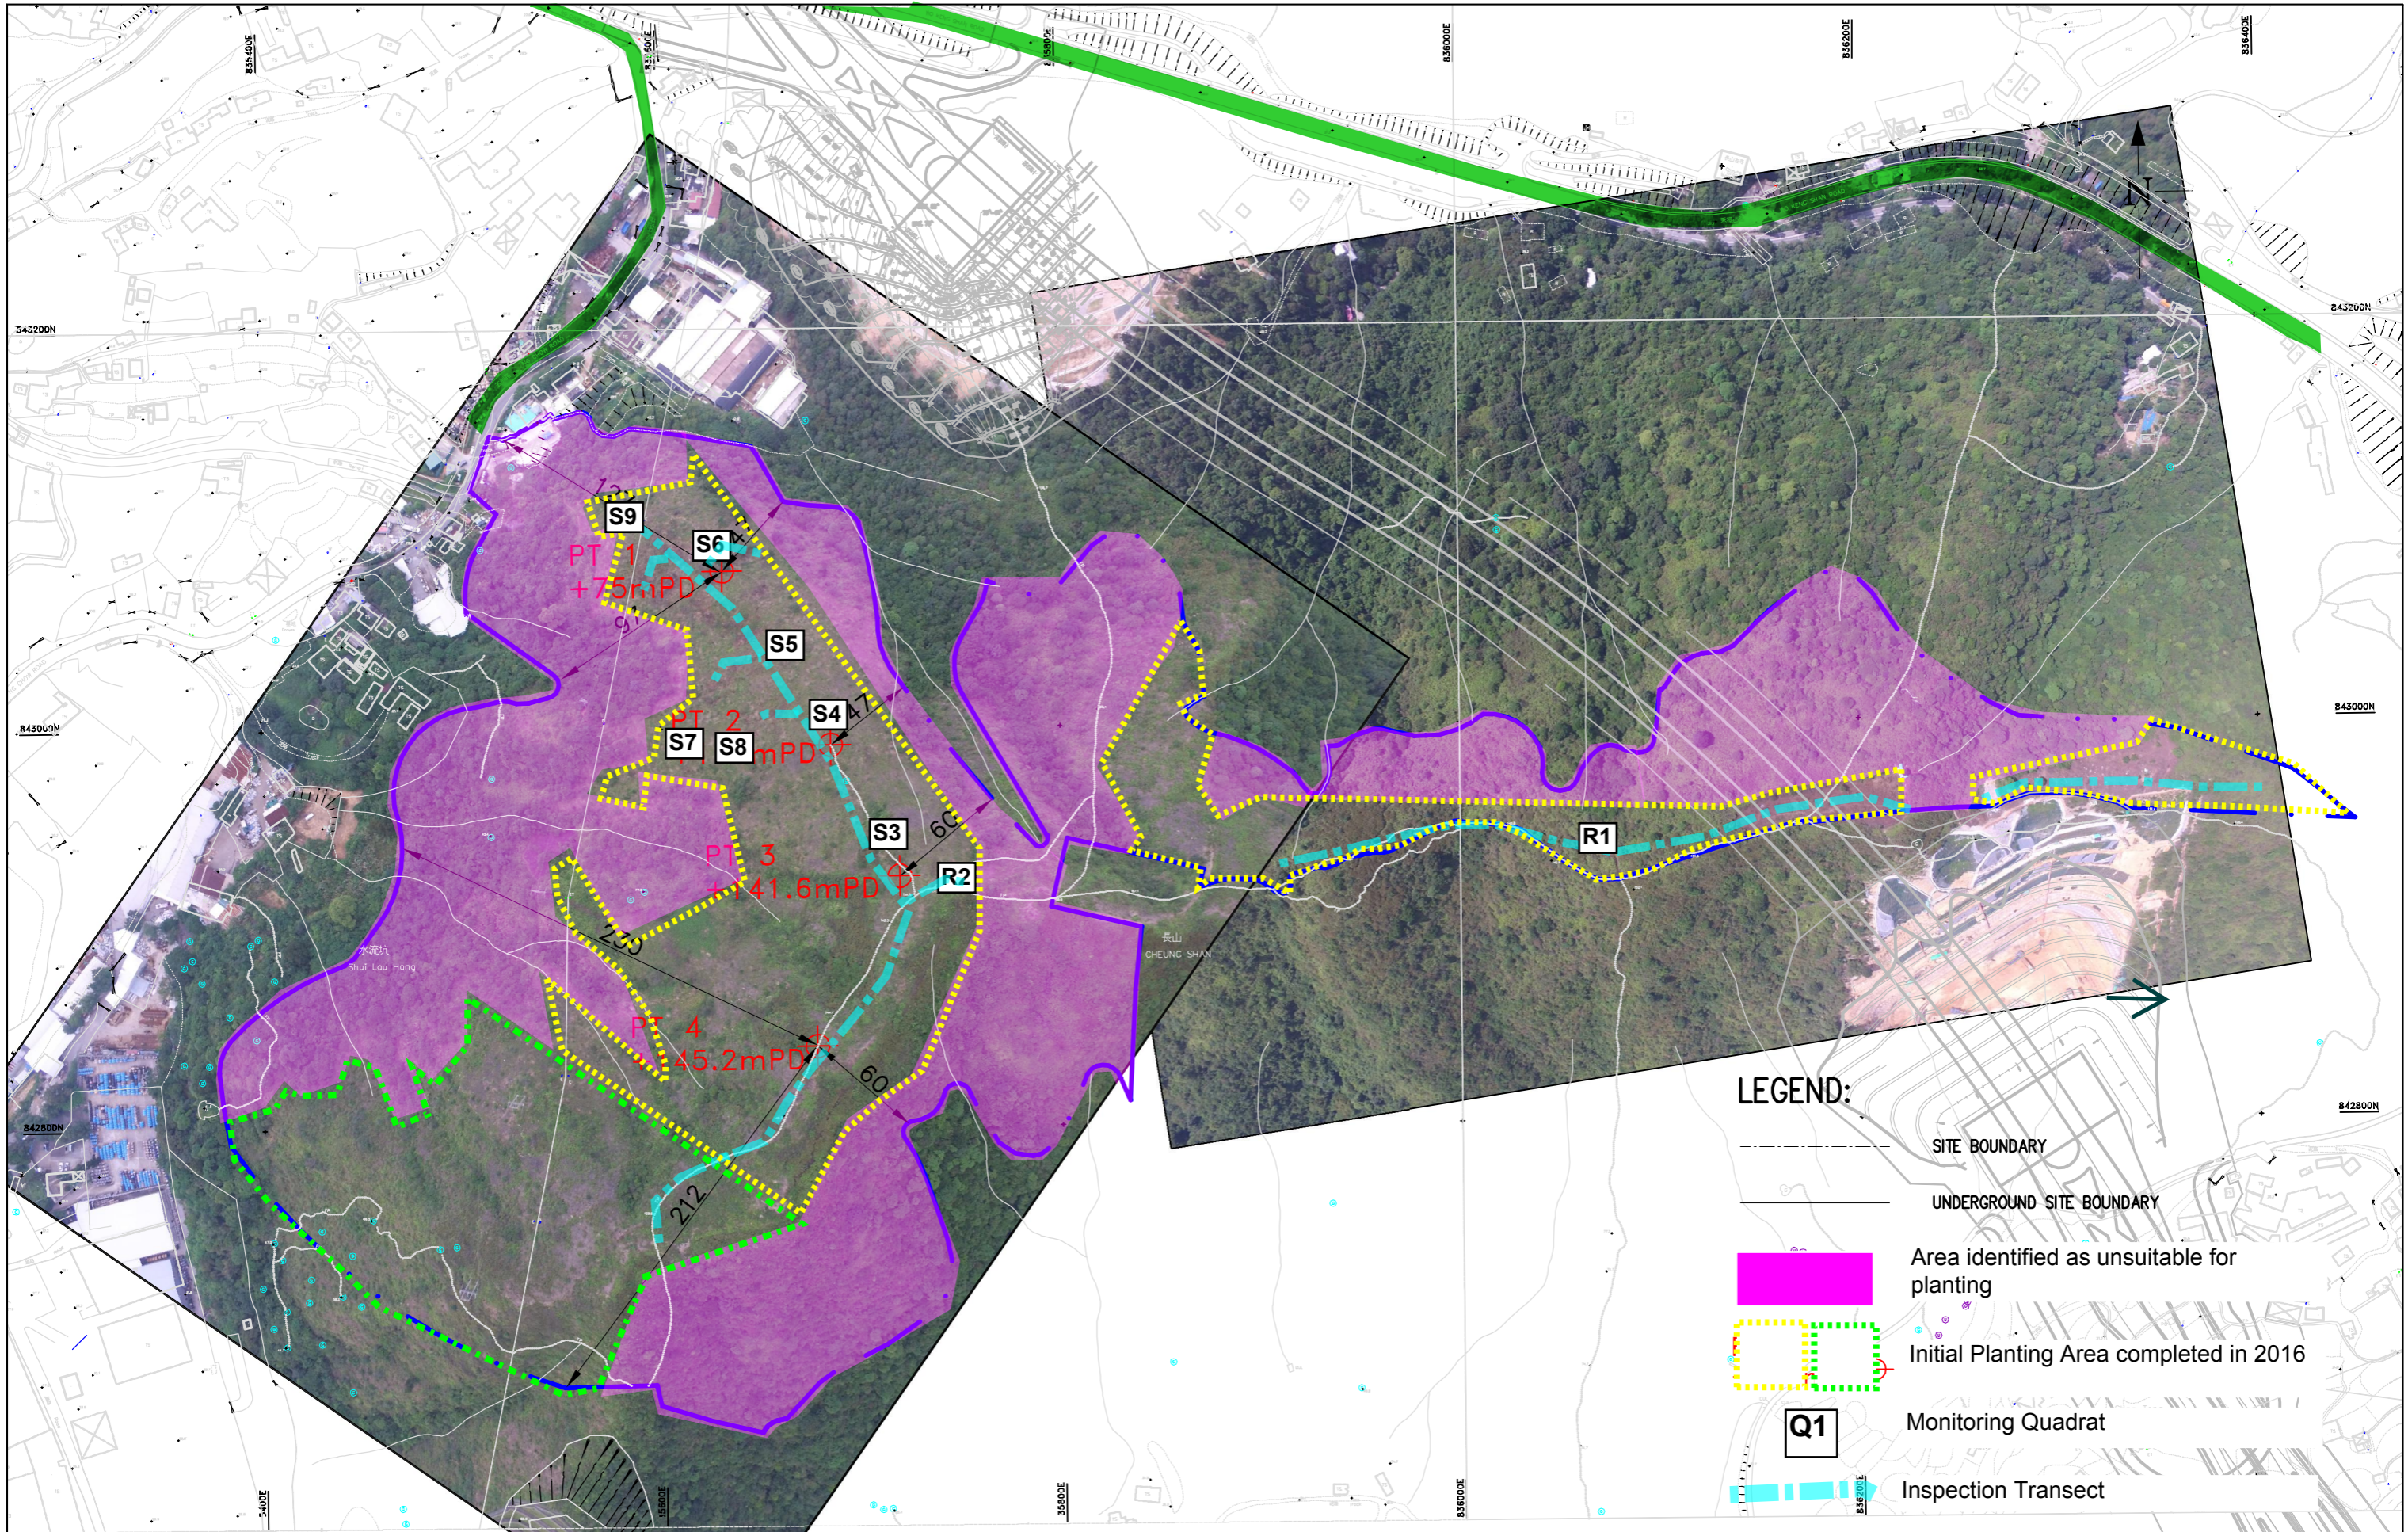
APPENDIX C - LOCATION OF THE THE INSPECTION TRANSECTS AND MONITORING QUADRATS, 2016

2.2.2 The transect routes are illustrated in **Appendix C**, and the following observations have been made during the inspection walk:

2.3.1 A sampling approach has been proposed in the WCP to monitor the survival rate of the planted seedlings by the use of nine 20mx20m quadrats which are to be evenly located within the planted area of the WCA. Based on the latest planting schedule and planting arrangement/pattern provided by the contractor (see **Appendix B**), as well as the local topography of the planted area within the WCA, the practicality in accessing, placing and monitoring nine 20m x 20m fixed quadrats within the planted area of the WCA has been extensively reviewed, 2 of the monitoring quadrats are fixed on the ridgeline of Cheung Shan and 7 of them are located on the north-facing slope of the WCA (see

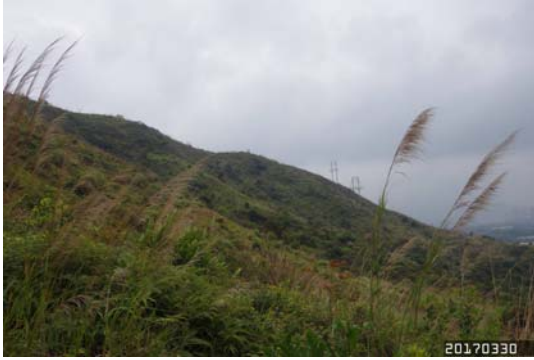
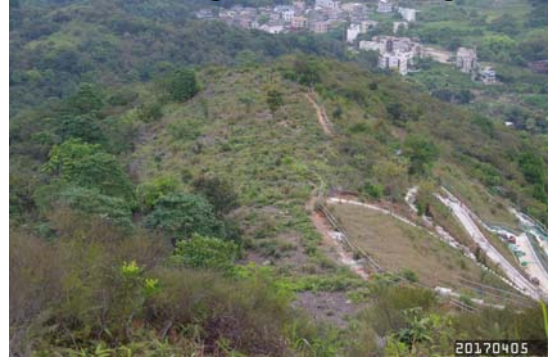
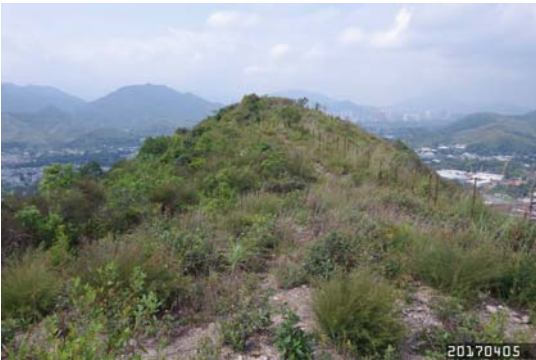
3.1.1 The transect inspection was carried out on 5th April 2017 with the ecological specialist of the IEC, an overview of the site condition is presented in **Figure 1** of the **Appendix D** and the following presents the observations made during the transect inspection:

- Vigorous regrowth of herbaceous vegetation cleared/cut during the pre-planting stage was noted in the whole WCA, especially on the northern slope of Cheung Shan.

- In addition, despite the re-growth of the natural vegetation as described above has impeded the range of observation that could be made along the transect; the density of the planted seedlings, including both of the tree and shrub species, were found to be poorer and sparser along the ridgeline at the eastern part of the WCA.

Fig-1a_North Facing Slope

Fig-1b_Eastern Ridgeline

Fig-1c_Western Ridgeline

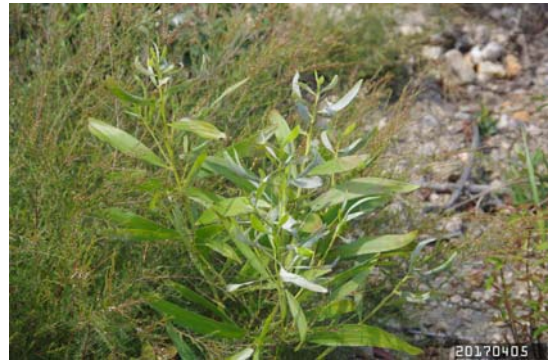
- The weather on the day of monitoring was generally cloudy and fairly windy within the WCA.
- Most of the seedlings noted were in fair condition, and re-sprouting was prominent in some of the planted species, in particularly the trees *Phyllanthus emblica*, *Litsea glutinosa*, *Sapium discolor*, *Schima superba* and *Mallotus paniculatus*, as well as the shrub *Melastoma sanguineum*. Moreover, some of the *Acacia mangium* planted on the western ridgeline was found infected by powdery mildew (e.g., **Appendix D - Figure 2**).

Fig-2_Powdery Mildew

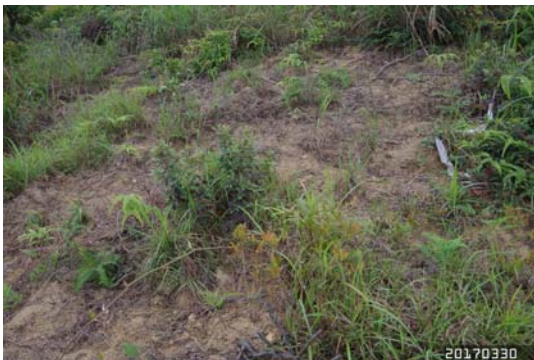
- No sign of additional anthropogenic disturbance besides those reported previously was noted within the planted area of the WCA; moreover, as reported previously, signs of disturbance from wild boar, i.e., vegetation trampling, earth ploughing, as well as uprooted seedlings (from planted/self-seeded vegetation) were noticeable all over the WCA, in particularly on the north-facing slope of Cheung Shan where the site was densely planted with tree/shrub seedlings.

- poor vigor of the planted seedling
- animal disturbance (such as trampling), in which signs of wild boar activities such as vegetation trampling and ground ploughing were noted all over the planted area within the WCA, in particularly within and in the proximity of Quadrat R1, S6, S7 and S8
- insufficient horticultural maintenance (such as watering/weeding)
- the seedlings of those species are out-competed (for light and space) by the adjacent planted, self-seeded or retained vegetation.

Fig-3_Animal Disturbance

Possible Cause	Remedial Action
Animal disturbance	The necessity for taking any remedial actions to avoid or minimize the impact of wild boar to the <i>Castanopsis fissa</i> seedlings, to be further reviewed from the monitoring data of the survival rate of this species after replanting.
Poor vigor of the planted seedlings	The Contractor should ensure the size of the seedlings fulfills the requirements of the pertinent specification
Vegetation maintenance	Review and if necessary strengthen the vegetation maintenance program within the WCA
Inter-specific competition	Undertake weeding of herbaceous plants in particularly the fern <i>Dicranopteris pedata</i> around the planted <i>Castanopsis fissa</i> within the WCA; and any replacement planting should be planted strategically to minimize the shading effect from other vegetation

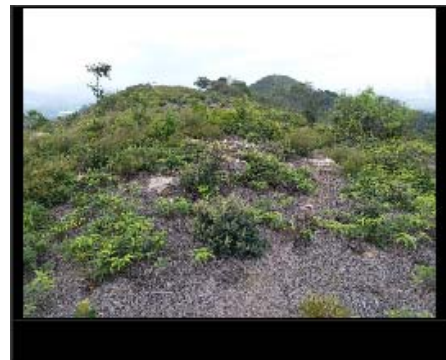
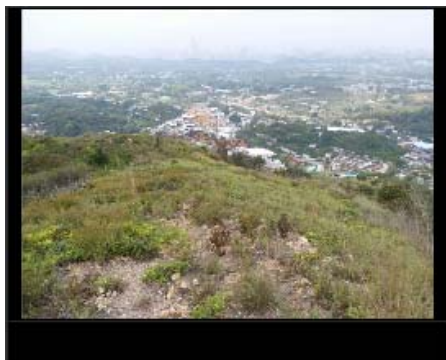
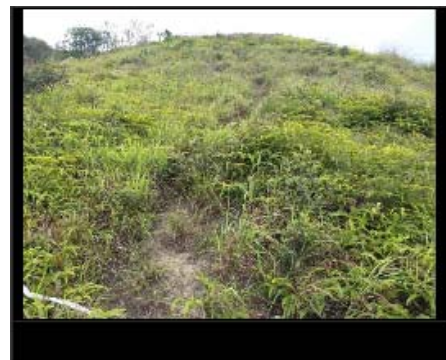
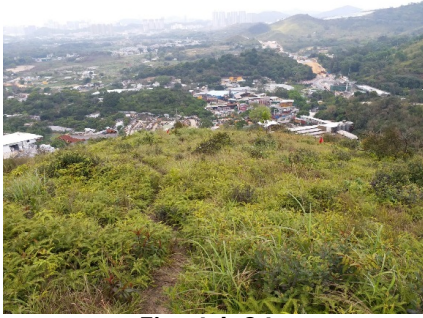
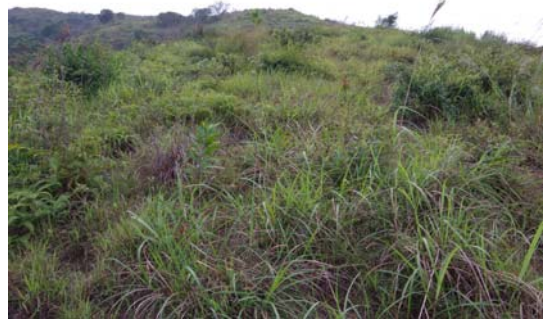
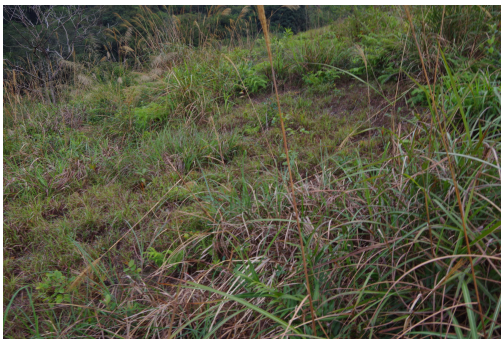
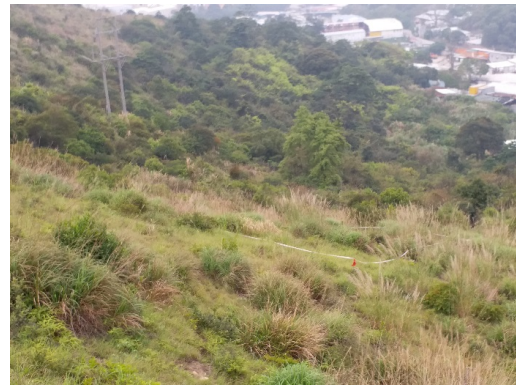
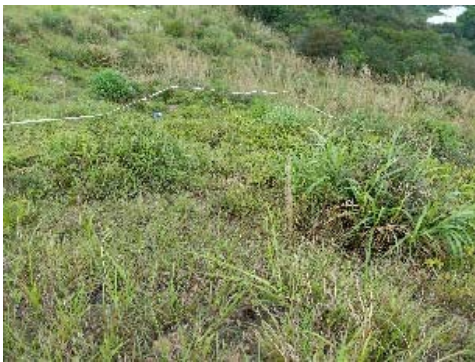
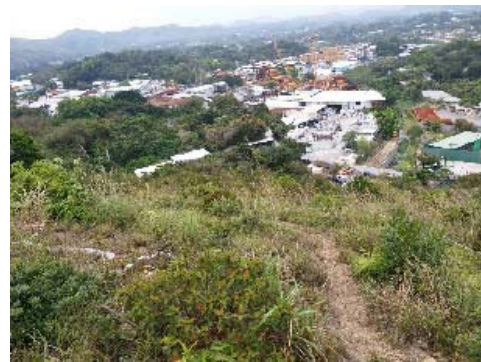
3.2.1 The nine 20m x 20m sampling quadrats have been placed within the planted area of the WCA, and at area where the majority of the seedlings were planted and considered suitable for long term monitoring; in which 2 of them were located on the ridgeline and the rest are located on the north-facing slope of Cheung Shan (see **Appendix C**). The quadrat monitoring was conducted on 30th March 2017 and 5th April 2017.

3.2.4 Based on the recorded data and observations made within the sampled quadrat and the data presented in **Table 3** and **Table 4**, the following summaries provide a brief account of the findings from the quadrat monitoring:

- Health condition: most of the recorded seedlings were found in fair to good condition.
- Survival Rate: When compared with the reference data collected in November 2016, the overall survival rate for the species planted is ~92%. The total
