**AGREEMENT NO. CE 45/2008 (CE)  
LIANTANG/HEUNG YUEN WAI  
BOUNDARY CONTROL POINT AND ASSOCIATED WORKS**

**ECOLOGICAL MONITORING REPORT FOR THE  
WOODLAND COMPENSATION AREA  
(MAY TO JUNE 2017)**

**PREPARED FOR  
CIVIL ENGINEERING AND DEVELOPMENT  
DEPARTMENT (CEDD)**

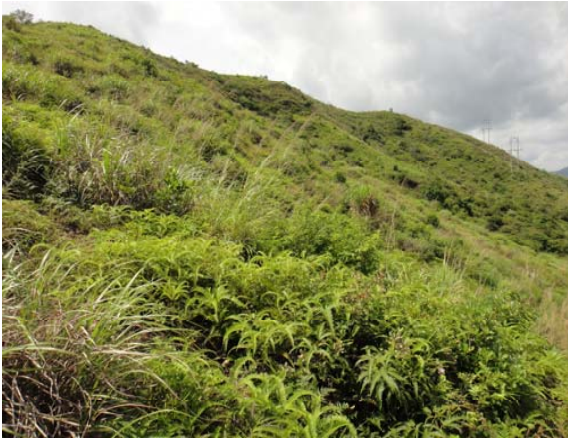
3.1.1 The transect inspection was carried out on 9<sup>th</sup> June 2017 with the ecological specialist of the IEC, an overview of the site condition is presented in **Figure 1** of the **Appendix D** and the following presents the observations made during the transect inspection:

**Fig-1a\_North Facing Slope**

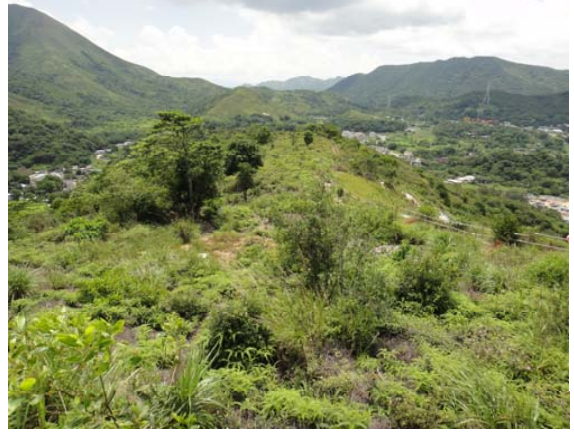
**Fig-1b\_Eastern Ridgeline**

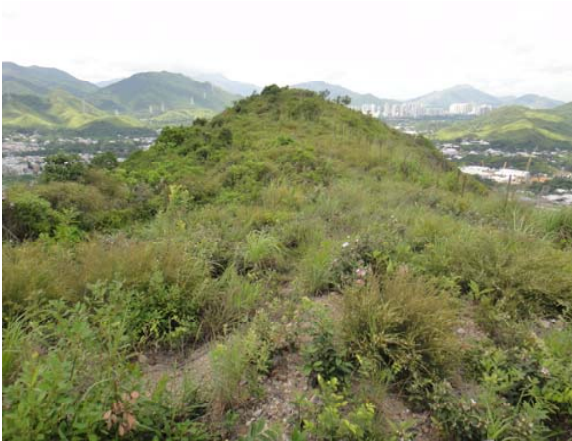
**Fig-1c\_Western Ridgeline**

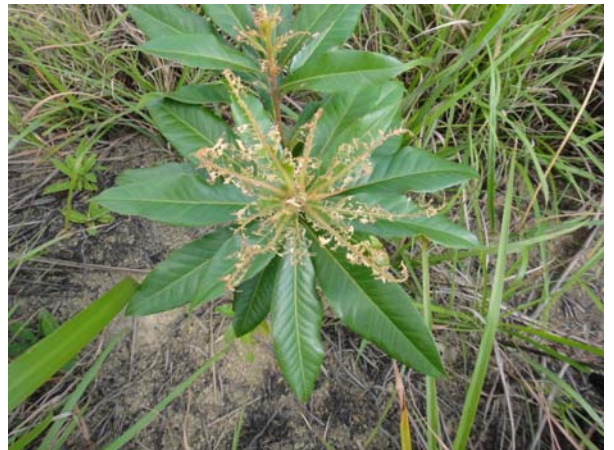
- Most of the seedlings noted were in fair condition, and the growth of some of the re-sprouted seedlings was found to be prominent, in particularly the trees *Phyllanthus emblica*, *Litsea glutinosa* and *Schima superba*. Moreover, as noted previously, most of the planted *Acacia mangium* was infected by powdery mildew in different degree and foliage loss from insect herbivory was noticeable on *Melastoma sanguineum*, *Mallotus paniculatus*, as well as *Castanopsis fissa* and *Litsea glutinosa* (see example photos in **Appendix D - Figure 2a1 and 2a2**).

**Fig-2a1\_Herbivory Damage**

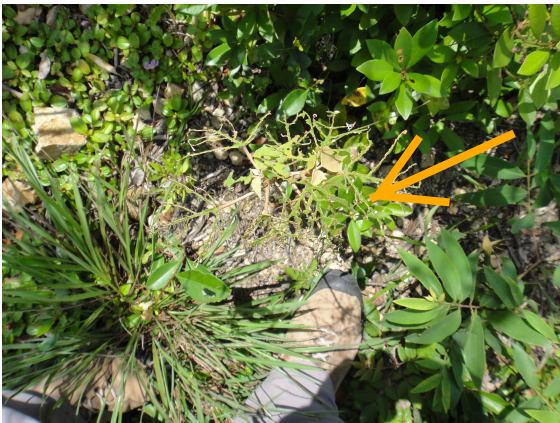
**Fig-2a2\_Herbivory Damage**

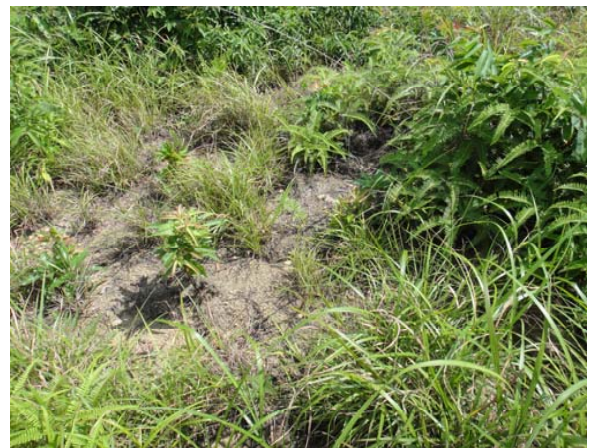
- On the other hand, as reported previously, signs of disturbance from wild boar, i.e., vegetation trampling, earth ploughing, as well as uprooted seedlings (from planted/self-seeded vegetation) were noticeable along the transect route, in particularly on the north-facing slope of Cheung Shan where the site was densely planted with tree/shrub seedlings (see **Appendix D - Figure 2b**).

**Fig-2b\_Animal Disturbance**

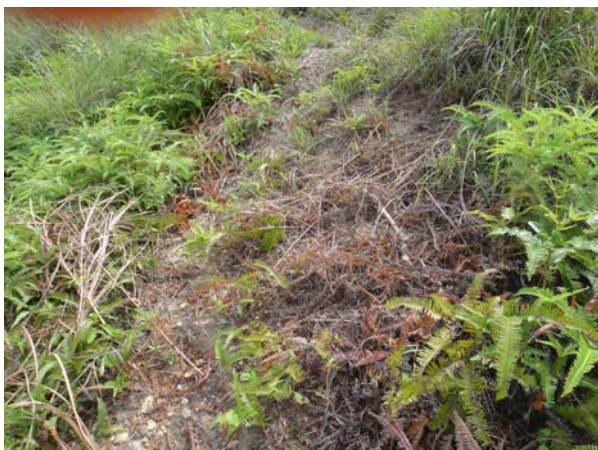
- No sign of additional anthropogenic disturbance besides those reported previously was noted within the planted area of the WCA, except the vegetation clearance in the immediate area along the footpath led to a power pole at the northwest corner of the WCA (see **Appendix D - Figure 3**); which may beneficial to the seedlings planted in the proximity area after the removal of the fern *Dicranopteris pedata*.

**Fig-3\_Vegetation Clearane by others**
