**AGREEMENT NO. CE 45/2008 (CE)  
LIANTANG/HEUNG YUEN WAI  
BOUNDARY CONTROL POINT AND ASSOCIATED WORKS**

**ECOLOGICAL MONITORING REPORT FOR THE  
WOODLAND COMPENSATION AREA  
(JUNE TO AUGUST 2018)**

**PREPARED FOR  
CIVIL ENGINEERING AND DEVELOPMENT  
DEPARTMENT (CEDD)**

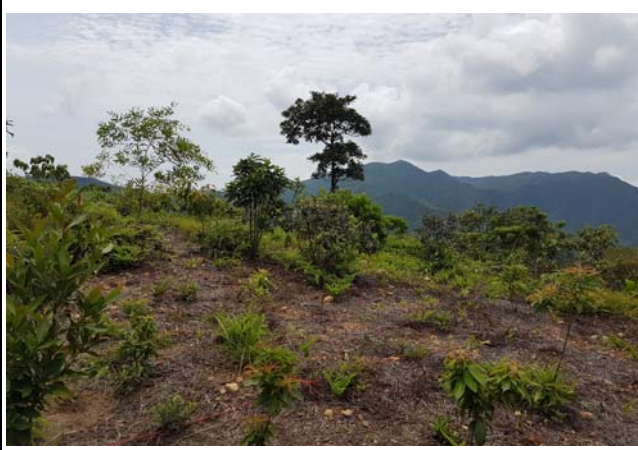
R1

3.2.2 The condition of the quadrats during the time of monitoring is shown in **Appendix D** and the monitoring result of the reporting period and the survival rate of the planted species since the commencement of the quarterly monitoring (initial planting phase) are shown in **Table 3** and **Table 4** respectively.

- Health condition: Generally speaking all of the planted plants were found in fair health condition, except some of the replacement plants which may suffer from the transplanting shock and appeared in poorer condition. On the other hand, the main trunk of several *Acacia mangium* trees which has a height >1.5m were found snapped in some of the monitored quadrats.

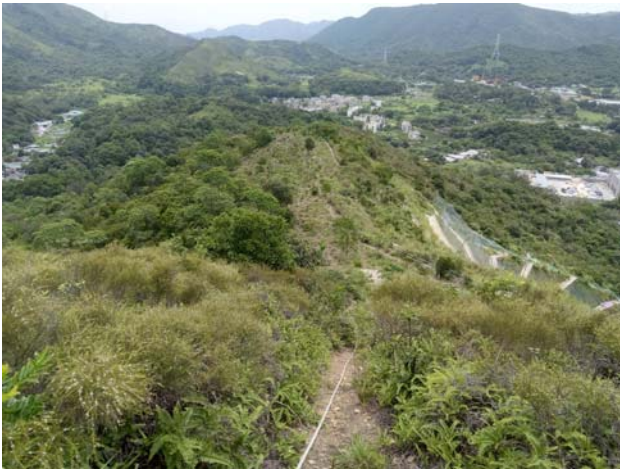
- It was sunny with cloudy period during the day of the transect inspection.
- The establishment of the seedlings planted in September 2017 along the eastern ridgeline was found to be fair and steady; and the overall health condition of the planted species noted along the transect were generally fair

Eastern ridgeline of Cheung Shan

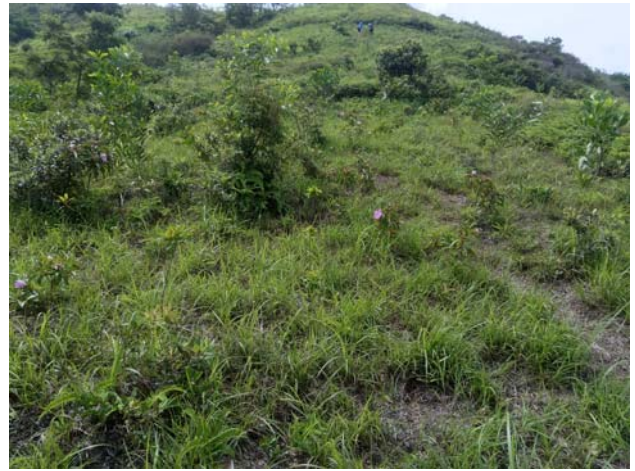
- Replanting was noted within the WCA; moreover, most of the newly planted plants, including the tree saplings, were <30cm in height.
- Signs of disturbance from wild boar, i.e., vegetation trampling, earth ploughing, as well as uprooted seedlings (from planted/self-seeded vegetation) were only occasionally noted on the north-facing slope of Cheung Shan.

Northern Slope of Cheung Shan

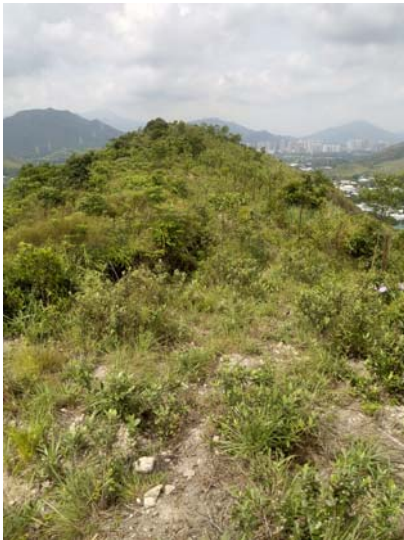
Western Ridgeline of Cheung Shan

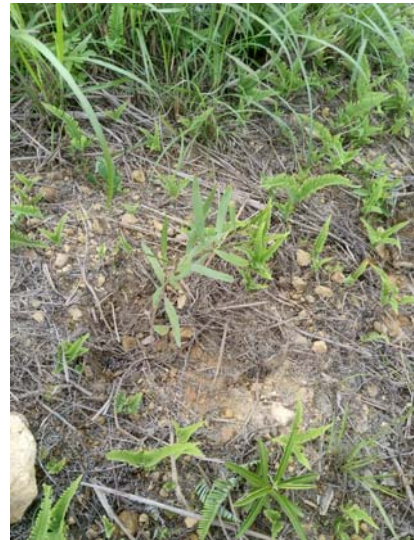
Replanted *Acacia confusa* seedling

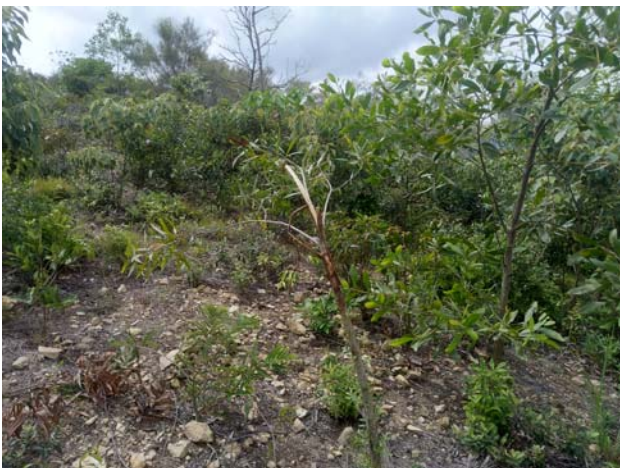
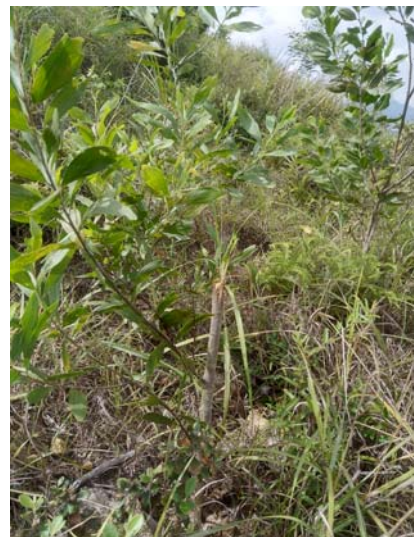
- The growth of the exotic tree *Acacia mangium* was found to be vigorous, but human disturbance, i.e., snapping of the main leader of the saplings ~2m in height were occasionally noted along the transect route.

Damaged *Acacia mangium* (1)

Damaged *Acacia mangium* (2)

3.2.7 Finally, despite the cause of the tree damage noted on the *Acacia mangium* is unknown during the time of reporting and the Contactor has claimed that such damage was occurred before the replanting works, the Contractor is recommended to undertake restoration/structural pruning and/or bark trimming to rectify the damage of the tree and promote woundwood formation and compartmentation process of the damaged trees; and investigate the cause and take necessary actions to avoid/prevent the re-occurrence of similar incidents.
