JOB No.: TCS00694/13

**AGREEMENT NO. CE 45/2008 (CE)
LIANTANG/HEUNG YUEN WAI
BOUNDARY CONTROL POINT AND ASSOCIATED WORKS**

**MONITORING REPORT FOR WETLAND
COMPENSATION AREA (No.6) – MARCH 2021**

**PREPARED FOR
CIVIL ENGINEERING AND DEVELOPMENT DEPARTMENT**

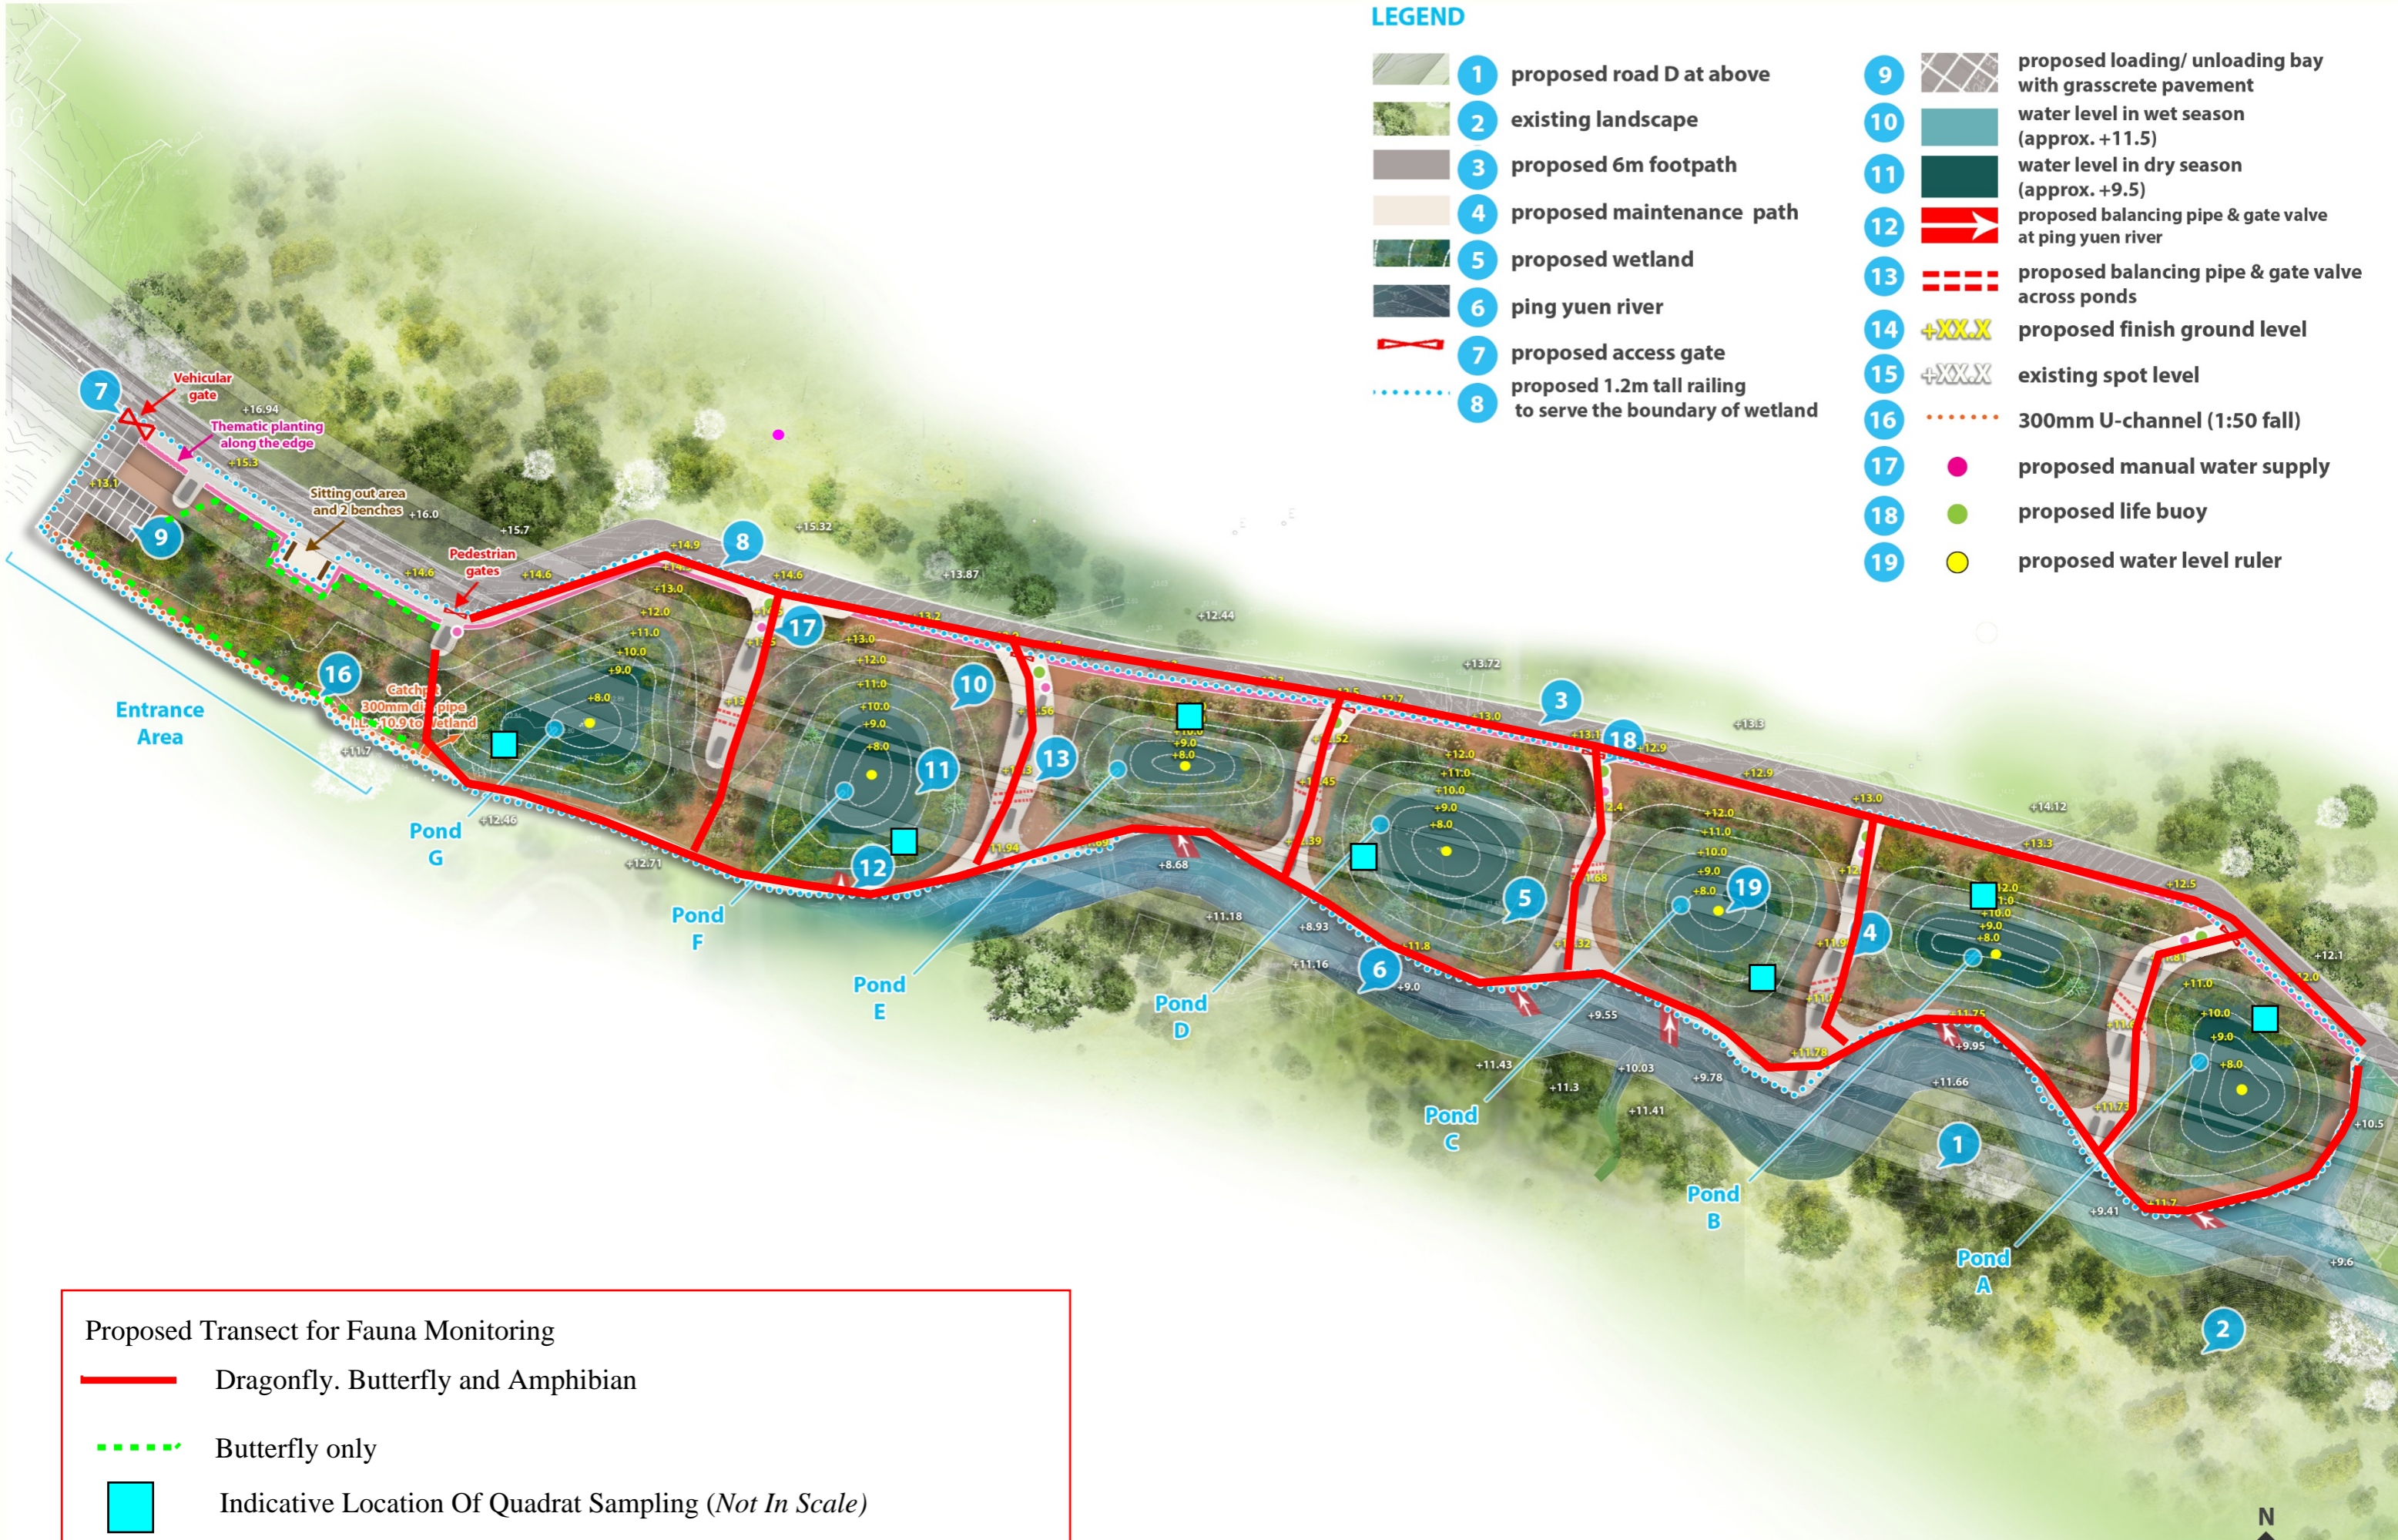
Figure No.: C6/C00/WL-002

Proposed Transect for Fauna Monitoring

- Dragonfly, Butterfly and Amphibian
- - - Butterfly only
- Indicative Location Of Quadrat Sampling (*Not In Scale*)

Proposed Wetland Layout Plan

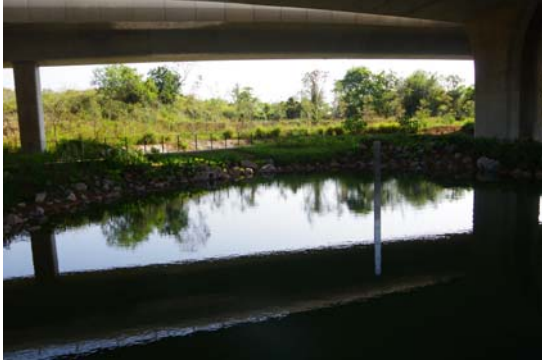
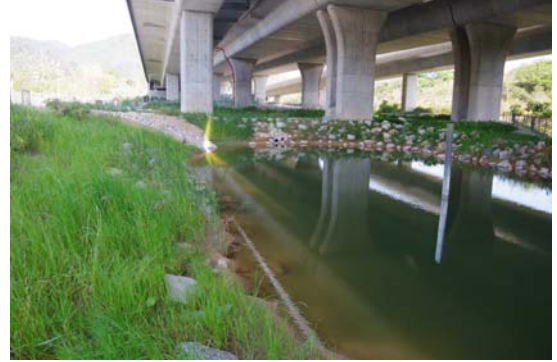
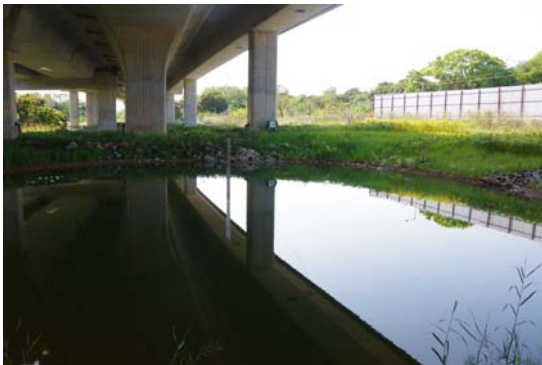
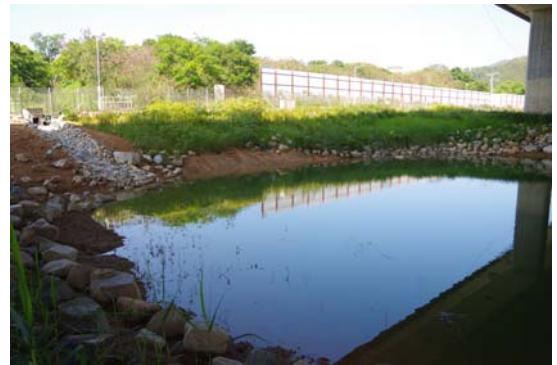
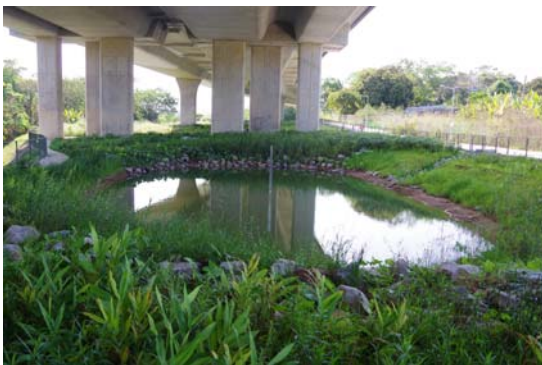
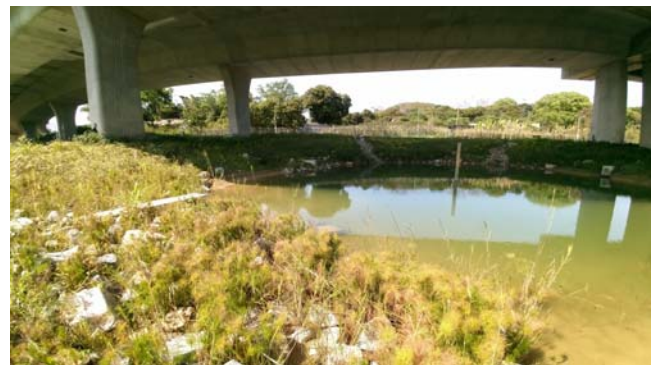
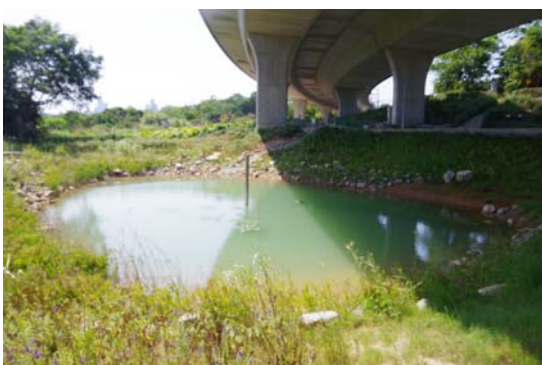
Overview of the Pond Condition - No or Limited Vegetation Cover over "Permanent Open Water Area"

- 3.1.1 Monitoring of vegetation cover at the end of the dry season, i.e., at the reporting month of March, has been undertaken in Ponds A to G on 27th March 2021. However, placement of quadrats in “permanent open water designed last during dry season”, i.e., the “wet zone” +mPD 9.5 defined in Table 3.1 of the HCMP, was found to be infeasible because the water level of the pond was ranged from + mPD 10.1 to 10.6 during the time of monitoring. Nonetheless, since floating plant only be sparsely noted in the Pond F and Pond G only, the action and limit level set for this monitoring parameters, i.e., area with >10% or >20% vegetation cover at +mPD 9.5, would not be triggered. An overview of the open water area in each of the pond is shown in **Appendix F**.

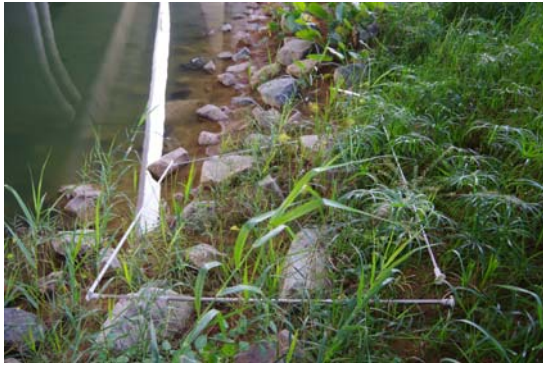
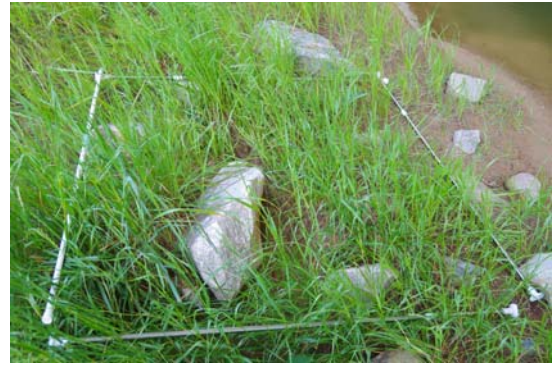
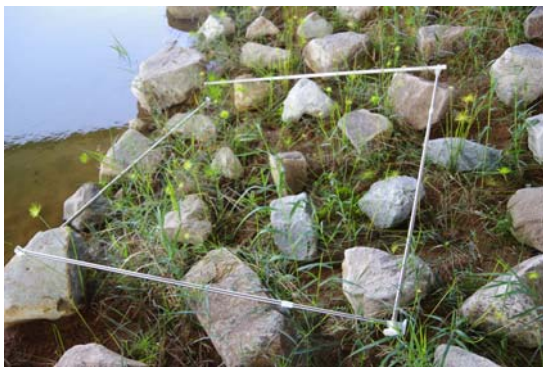
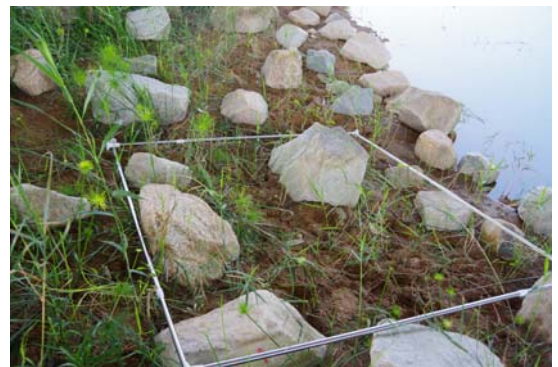
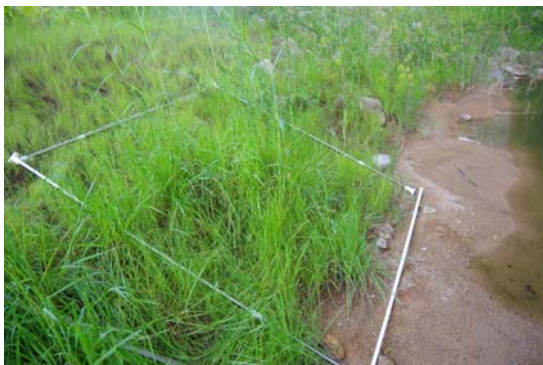
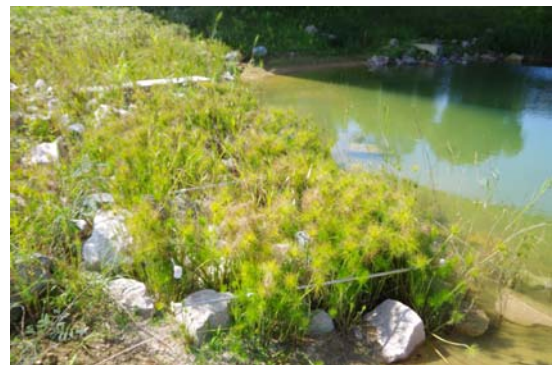
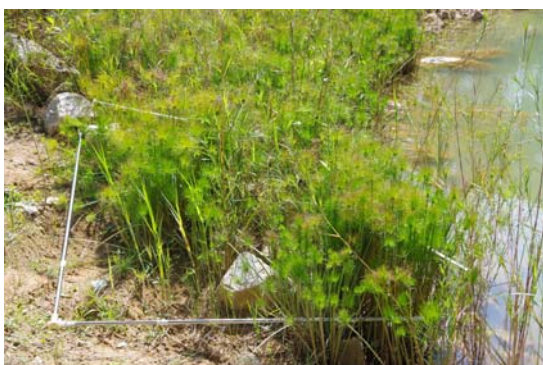
General View of the Quadrat in "Seasonal Water Level Fluctuation Area"

- 3.1.2 Details findings of the monitoring at the “seasonal water level fluctuation area”, i.e., the semi-dry zone ranged from +mPD 9.5 to +mPD 11.5 as defined in Table 3.1 of the HCMP, is presented in **Appendix G**, with the general view of the quadrat shown in **Appendix H**; and the table below summarize the key findings.
