**AGREEMENT NO. CE 45/2008 (CE)
LIANTANG/HEUNG YUEN WAI
BOUNDARY CONTROL POINT AND ASSOCIATED WORKS**

**MONITORING REPORT FOR WETLAND
COMPENSATION AREA (No.7) – APRIL 2021**

**PREPARED FOR
CIVIL ENGINEERING AND DEVELOPMENT DEPARTMENT**

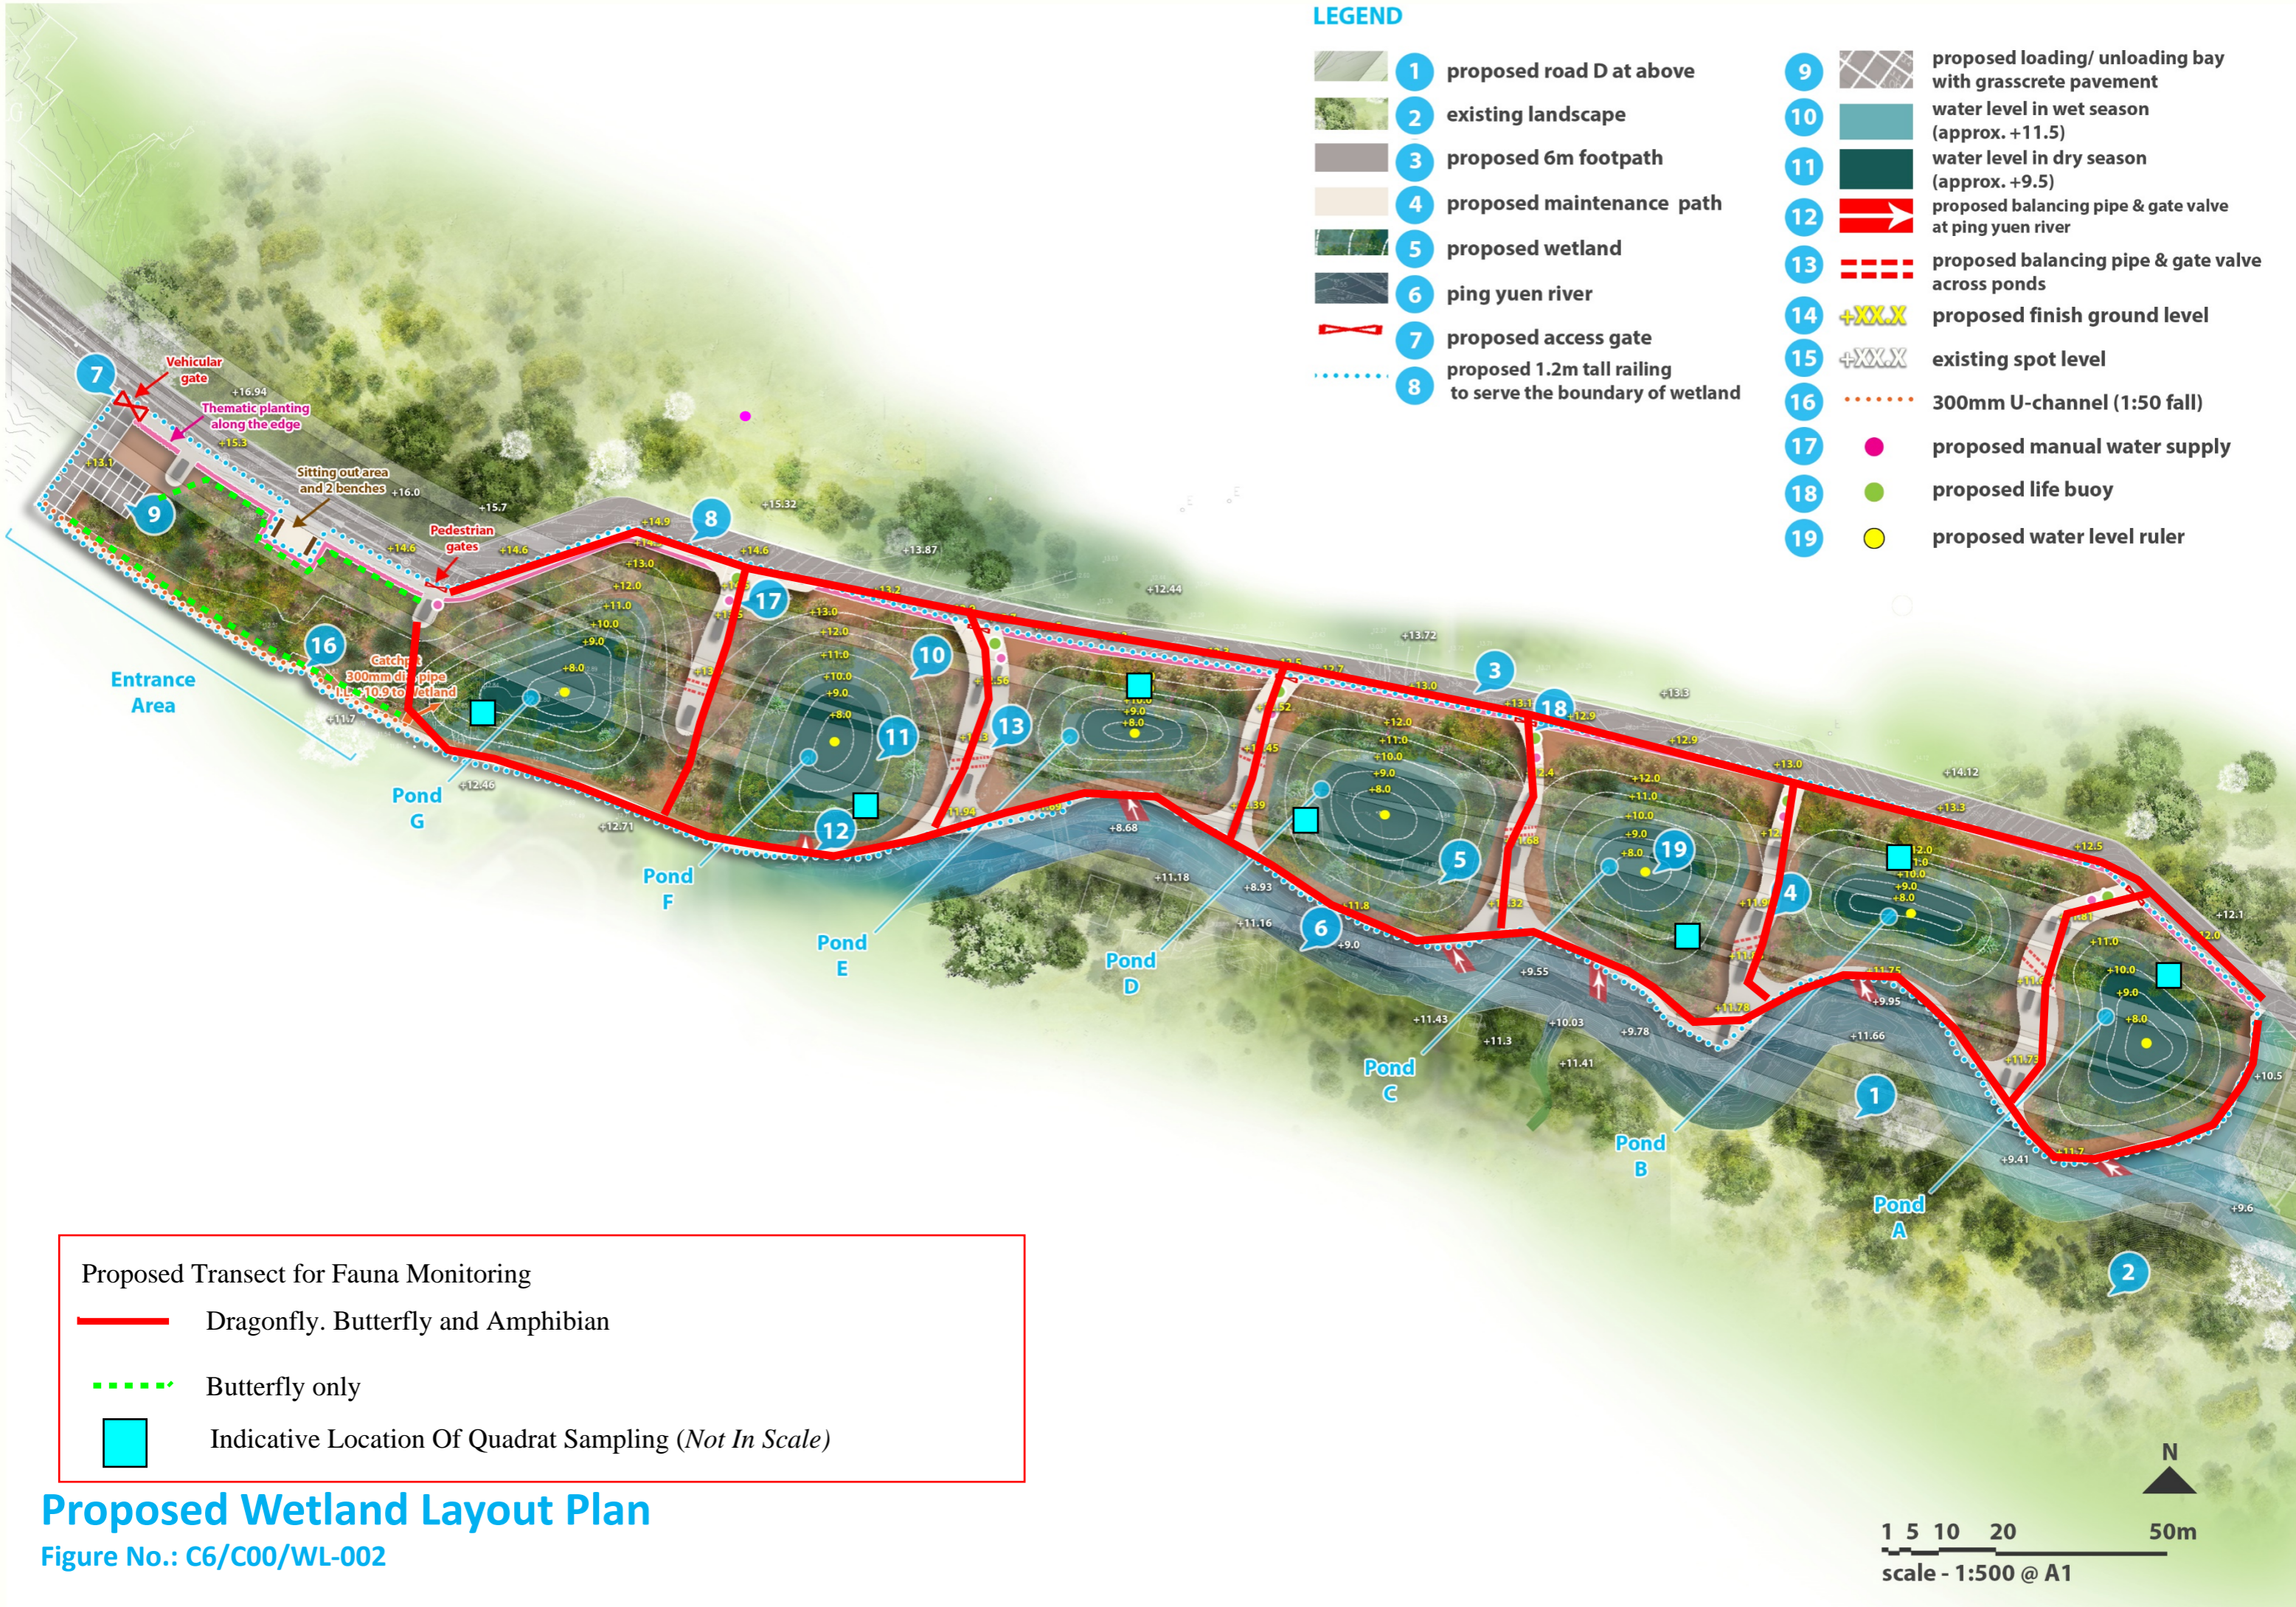
Figure No.: C6/C00/WL-002

Proposed Transect for Fauna Monitoring

- Dragonfly, Butterfly and Amphibian
- - - Butterfly only
- Indicative Location Of Quadrat Sampling (*Not In Scale*)

Proposed Wetland Layout Plan

- 2.2.5 The survey should be conducted during the middle of the day to coincide with the peak flight time for these species. The monitoring for dragonfly and butterfly should be undertaken on a monthly basis, but would be bi-monthly monitoring (i.e., twice per month) for dragonfly during the peak period of dragonfly emergency in April to August. The proposed transect routes are shown in the *Appendix A*.
