**AGREEMENT NO. CE 45/2008 (CE)  
LIANTANG/HEUNG YUEN WAI  
BOUNDARY CONTROL POINT AND ASSOCIATED WORKS**

**MONITORING REPORT FOR WETLAND  
COMPENSATION AREA (No.8) – MAY 2021**

**PREPARED FOR  
CIVIL ENGINEERING AND DEVELOPMENT DEPARTMENT**

<b>Date</b>	<b>Reference No.</b>	<b>Prepared By</b>	<b>Certified By</b>
21 June 2021	TCS00694/13/600/R2650v2

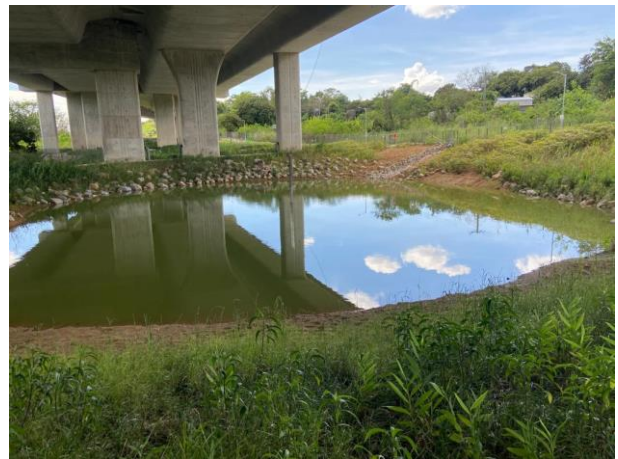
Pond D

- 3.2.3 It is noted that Action Level exceedances were triggered in Ponds D, E and G, which areas of water coverage of each pond as calculated by conversion were less than 50% in wet season. According to the weather data from HKO+, May 2021 continued to be much warmer than usual in Hong Kong and May 2021 was also much drier than usual with a total rainfall of only 65.0 millimetres, about 22 percent of the normal figure of 290.6 millimetres (or 21 percent of the 1981-2010 normal of 304.7 millimetres).
- 3.2.4 Owing to the natural phenomenon, it is concluded that the exceedances were not related to the project. The ET will keep on monitoring the water depth on each pond and action will be undertaken (such as manual water adding subject to agree by ER and the Contractor) when further deterioration is observed in the subsequent month.

- 3.3.1 Site inspection for the establishment of WCA was conducted by ET on **5<sup>th</sup>, 12<sup>th</sup>, 20<sup>th</sup> and 27<sup>th</sup> May 2021**. There was no sign of flooding/ storm damage observed. The planted vegetation in the WCA was visually in fair condition and no significant litter or vandalism were observed. Besides, it was noticed that greenish color appeared in the ponds, particularly in Ponds E, F and G, there was no pollution incident observed and color in pond water was considered as natural phenomenon. Photographic records showing the condition of the WCA and general view of the existing vegetation in the Reporting Month are shown in **Appendix E**.
