**AGREEMENT NO. CE 45/2008 (CE)
LIANTANG/HEUNG YUEN WAI
BOUNDARY CONTROL POINT AND ASSOCIATED WORKS**

**MONITORING REPORT FOR WETLAND
COMPENSATION AREA (No.9) – JUNE 2021**

**PREPARED FOR
CIVIL ENGINEERING AND DEVELOPMENT DEPARTMENT**

Date	Reference No.	Prepared By	Certified By
16 July 2021	TCS00694/13/600/R2665v2

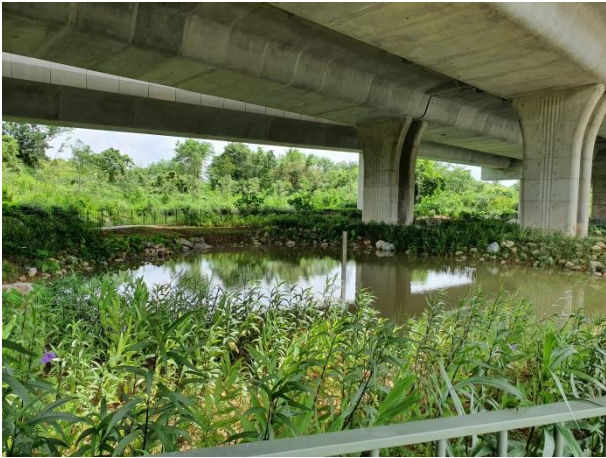
Pond A

3.3.1 Site inspection for the establishment of WCA was conducted by ET on **2nd, 11th, 18th, 24th and 30th June 2021**. There was no sign of flooding/ storm damage observed. The planted vegetation in the WCA was visually in fair condition and no significant litter or vandalism were observed. Besides, it was noticed that greenish color appeared in the ponds, particularly in Ponds B and G, there was no pollution incident observed and color in pond water was considered as natural phenomenon. Photographic records showing the condition of the WCA and general view of the existing vegetation in the Reporting Month are shown in *Appendix E*.
