JOB No.: TCS00694/13

**AGREEMENT NO. CE 45/2008 (CE)
LIANTANG/HEUNG YUEN WAI
BOUNDARY CONTROL POINT AND ASSOCIATED WORKS**

**ECOLOGICAL MONITORING REPORT FOR THE
WOODLAND COMPENSATION AREA
(MARCH TO MAY 2018)**

**PREPARED FOR
CIVIL ENGINEERING AND DEVELOPMENT
DEPARTMENT (CEDD)**

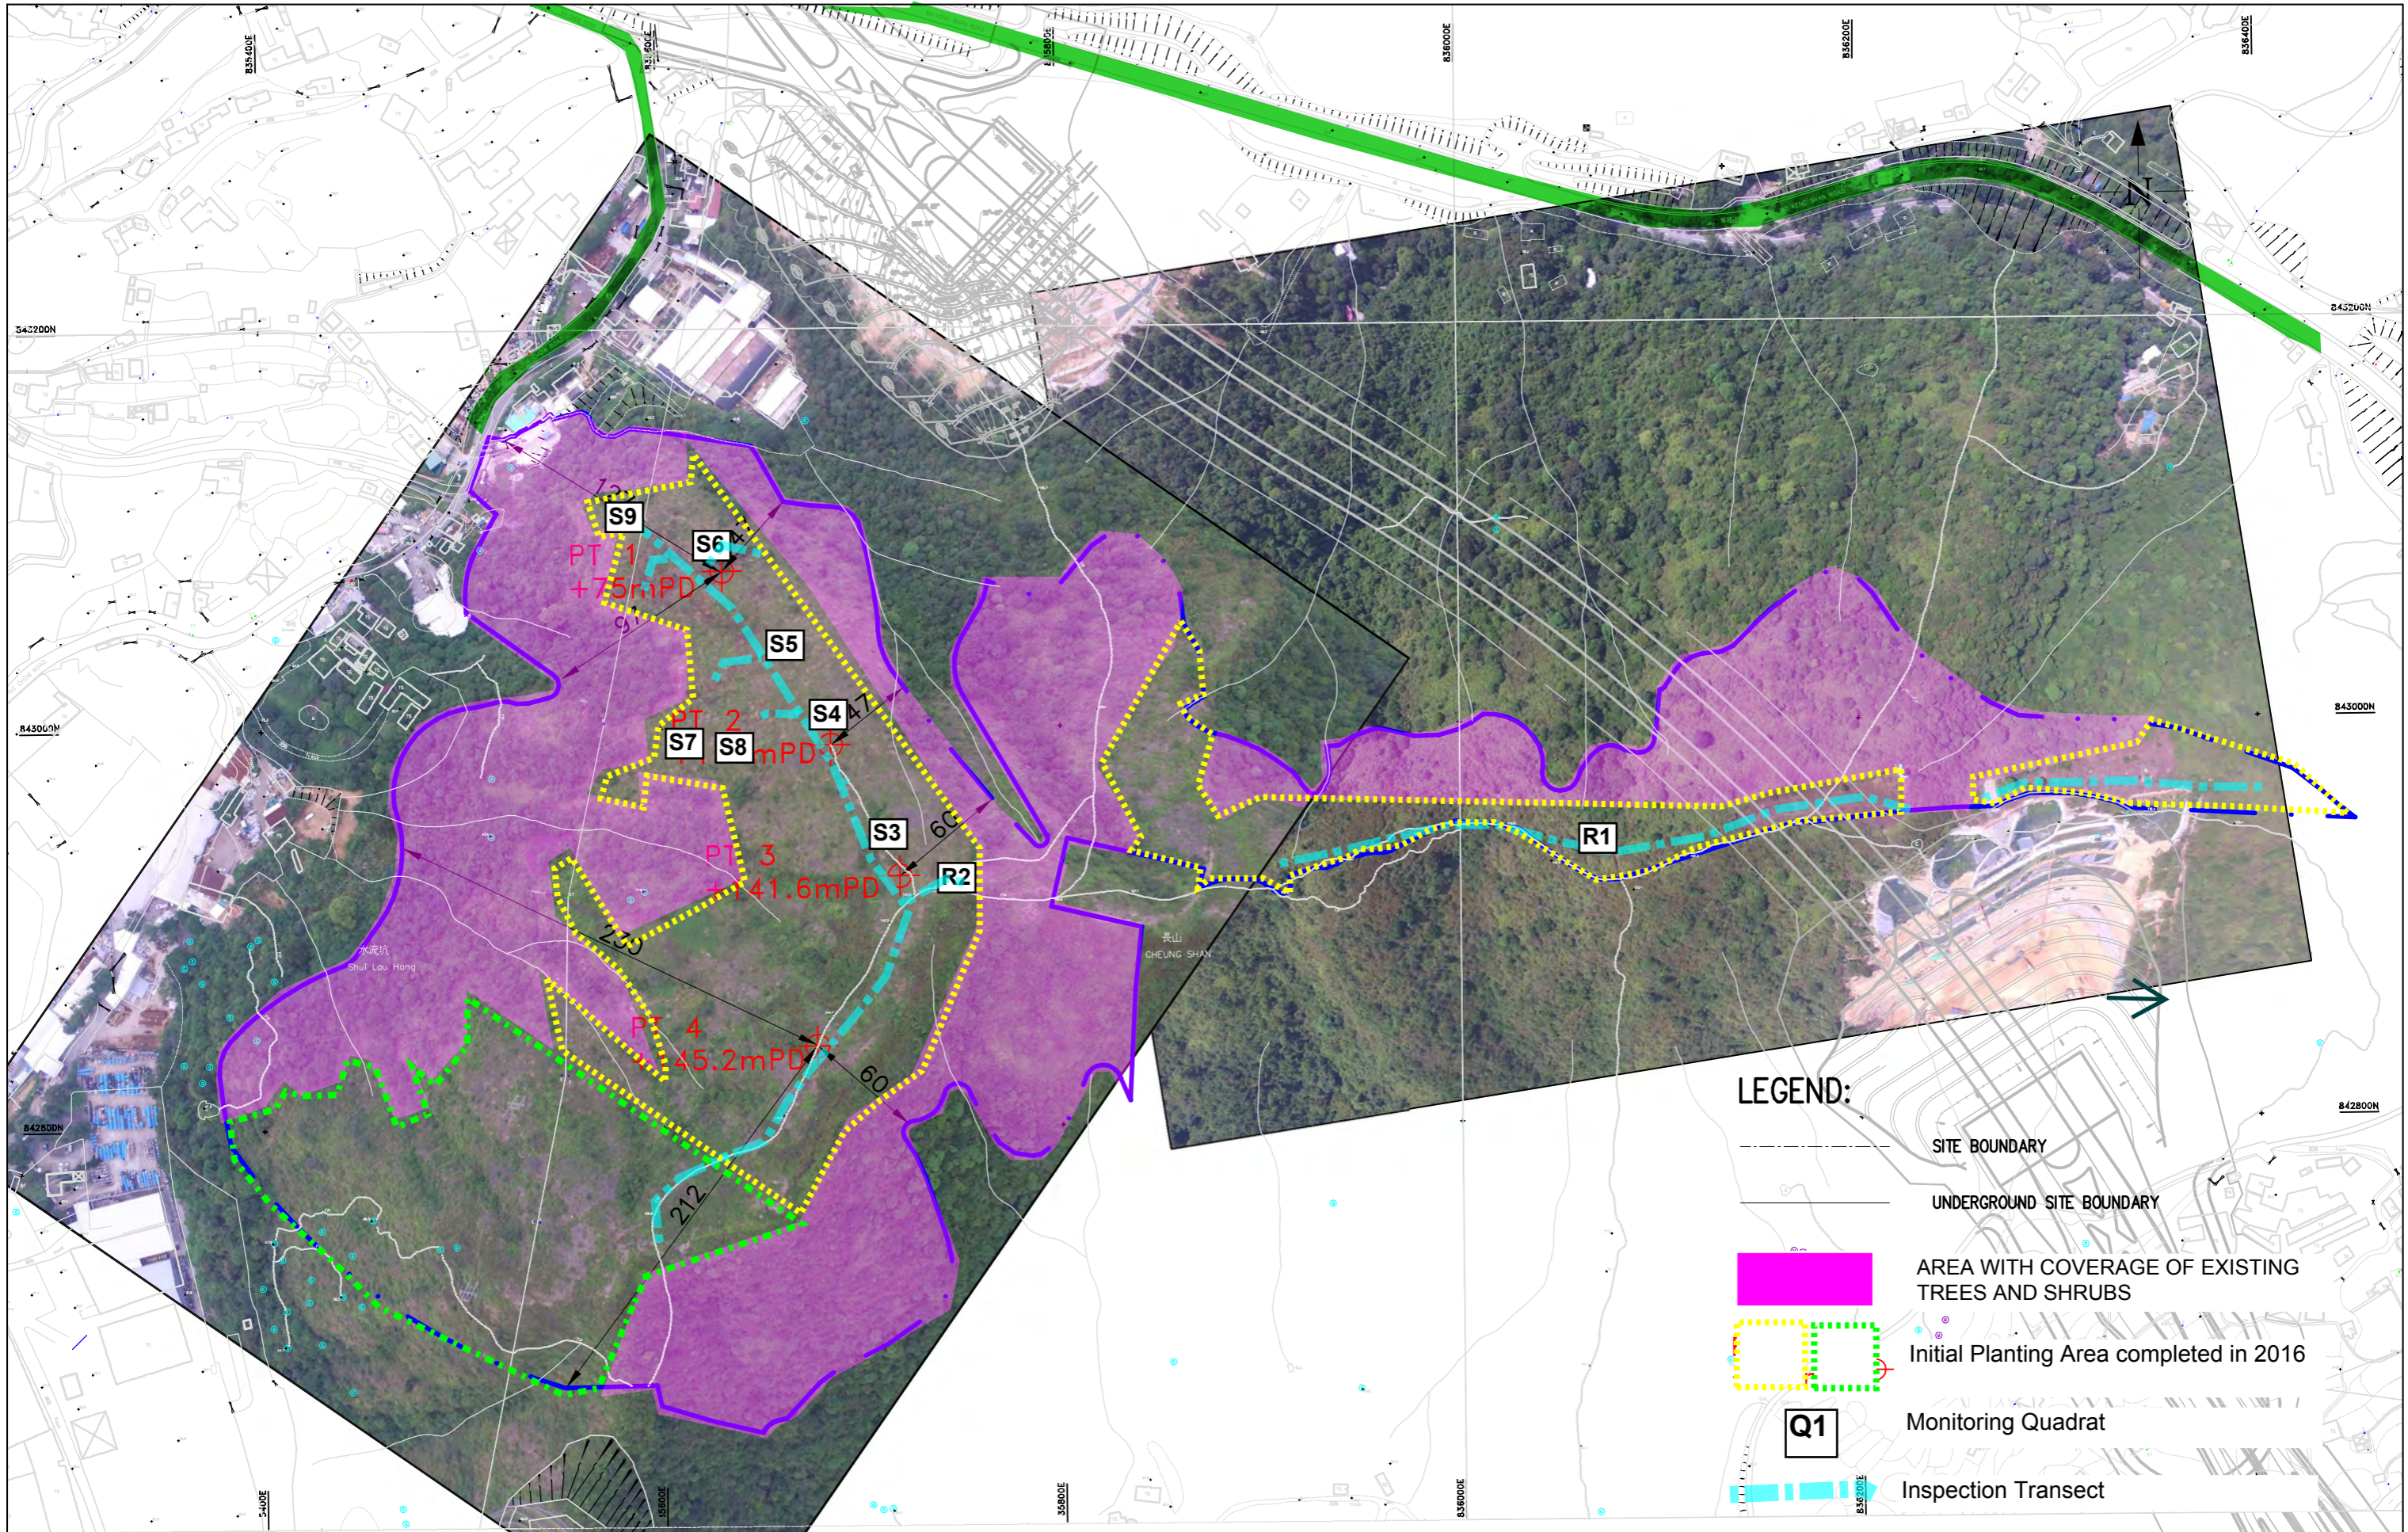
Transect Routes and Sampling Quadrats of Woodland Compensation Monitoring

2.3.1 A sampling approach has been proposed in the WCP to monitor the survival rate of the planted seedlings by the use of nine 20mx20m quadrats which are to be evenly located within the planted area of the WCA. Based on the as-built planting plan provided by the contractor (see **Appendix B**), as well as the local topography of the planted area within the WCA, the practicality in accessing, placing and monitoring nine 20m x 20m fixed quadrats within the planted area of the WCA has been extensively reviewed, 2 of the monitoring quadrats are fixed on the ridgeline of Cheung Shan and 7 of them are located on the north-facing slope of the WCA (see **Appendix C**).

APPENDIX C - LOCATION OF THE THE INSPECTION TRANSECTS AND MONITORING QUADRATS, 2016

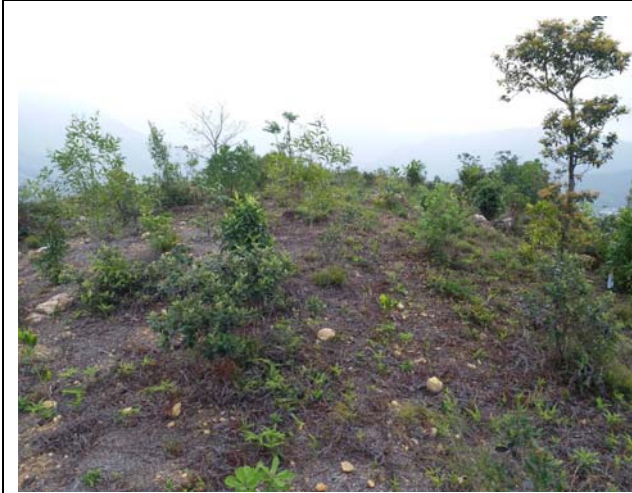
R1

3.2.2 The condition of the quadrats during the time of monitoring is shown in **Appendix D** and the monitoring result of the reporting period and the survival rate of the planted species since the commencement of the quarterly monitoring (initial planting phase) are shown in **Table 3** and **Table 4** respectively.

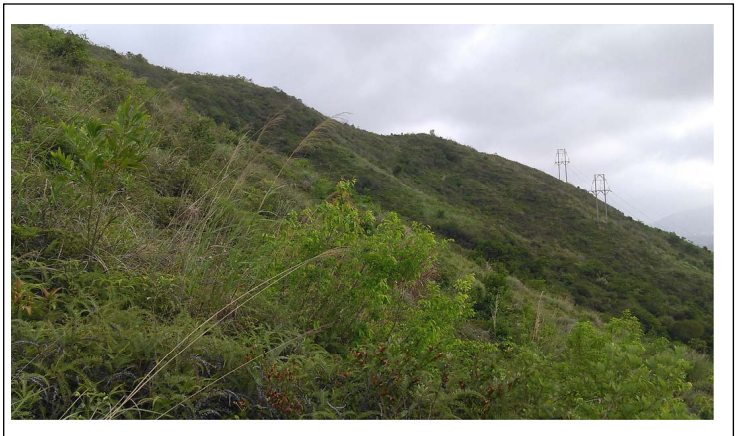
- Weeding of herbaceous plants was noted among the monitoring quadrats.
- Signs of disturbance from wild boar, i.e., vegetation trampling, earth ploughing, as well as uprooted seedlings (from planted/self-seeded vegetation) were occasionally noted on the north-facing slope of Cheung Shan.

Overview of the Northern Slope of Cheung Shan

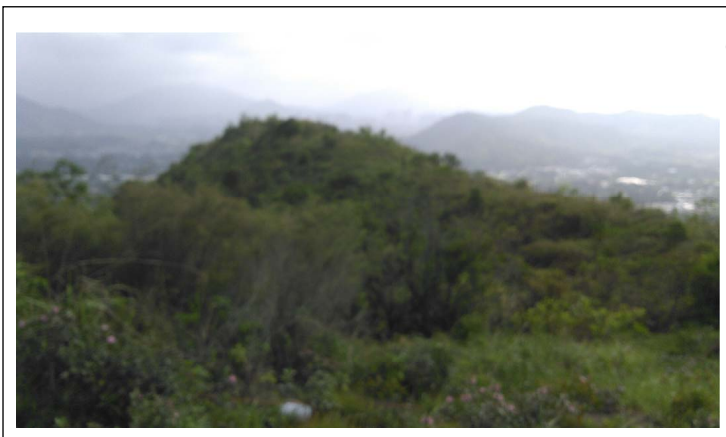
- Re-sprouting of *Sapium discolor*, *Phyllanthus emblica* and *Rhahiolepis indica* was noted along the transect
- The establishment of the seedlings planted in September 2017 along the eastern ridgeline and on the northern hillslope of the Cheung Shan was found to be fair and steady.

Overview of the Ridgeline of Cheung Shan
