**Contract No.: CV/2015/07
Handling of Surplus Public Fill
(2016-2018)**

**TSEUNG KWAN O AREA 137 FILL BANK
MONTHLY EM&A REPORT NO.54**

(OCTOBER 2021)

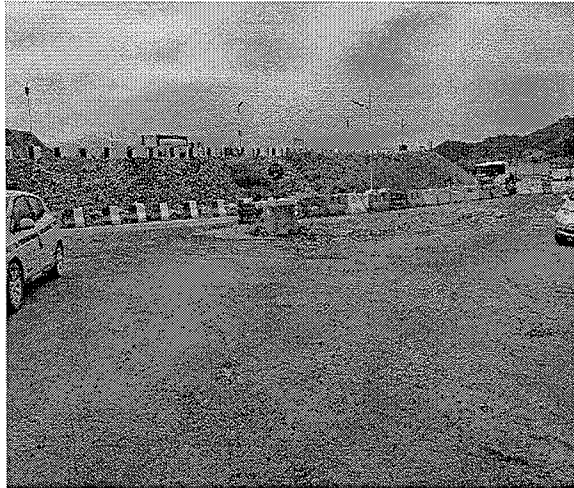
Photo 211015_001 (Near Workshop) (Improved)

Item	Details of defective works or observations	Proposed Follow Up Action	Photo Ref.	Further Action Required (Yes/No)	Follow up Date
1	Follow up action to item no.1 on 06/10/21, water sprays were provided.	---	211015_001	No	---
