**China Harbour – Zhen Hua Joint Venture**

**Contract No.: CV/2015/07  
Handling of Surplus Public Fill  
(2016-2018)**

**TSEUNG KWAN O AREA 137 FILL BANK  
MONTHLY EM&A REPORT NO.55**

**(NOVEMBER 2021)**

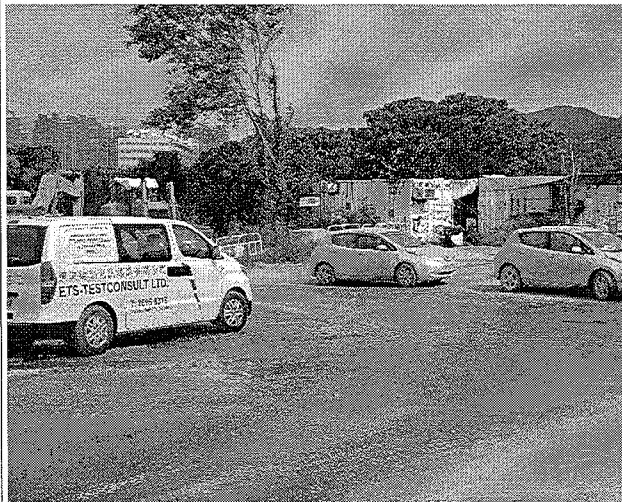
Photo 211102\_001 (Near Workshop) (Improved)

Date	Key Findings	Action(s) Taken recommended by ET	Action(s) Taken by the Contractor during the ET weekly site audit	Rectification Status by ET
02 November 2021	Dust emission were observed near workshop	Provide water spray to control dust emission properly.	Water sprays were provided.	Closed
10 November 2021	Oil stain were observed near Workshop	To clean the oil stain properly	---	Follow-up
17 November 2021	Oil stain were observed near Workshop	To clean the oil stain properly	Oil stain were cleaned	Closed
24 November 2021	No defective work or observation was recorded during the weekly ET site inspection			
29 November 2021	No defective work or observation was recorded during the weekly ET site inspection
