**Contract No.: CV/2021/09
Handling of Surplus Public Fill
(2022-2023)**

TSEUNG KWAN O AREA 137 FILL BANK

MONTHLY EM&A REPORT NO.13

(JANUARY 2023)

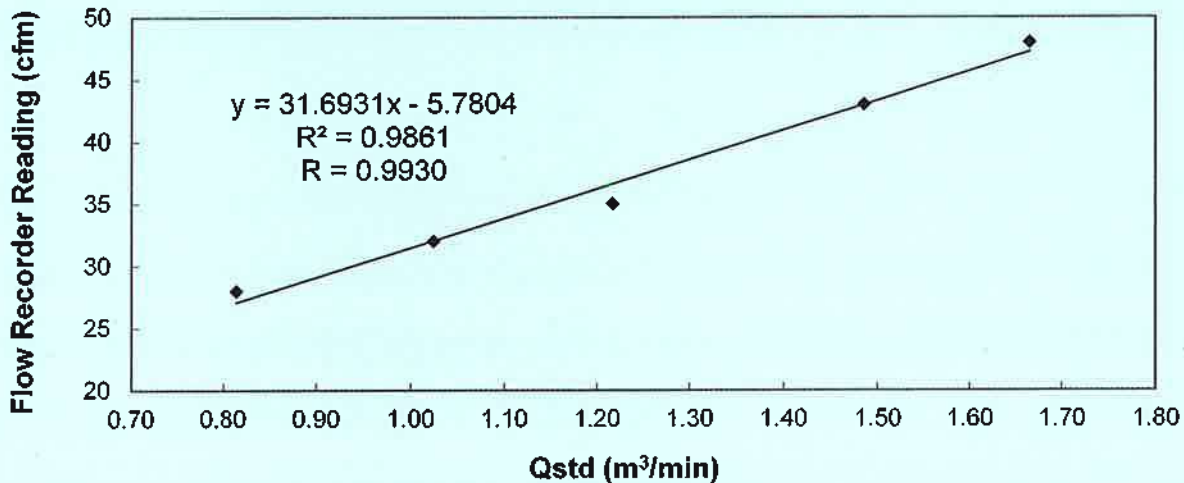
Sampler 9795 Calibration Curve
Site: Tseung Kwan O 137 (TKO-A1)

Results	Flow recorder reading (cfm)	49	42	35	30	23
	Qstd (Actual flow rate, m ³ /min)	1.69	1.56	1.26	1.15	0.90
	Pressure : 768.81 mm Hg	Temp. : 288 K

Acceptance Criteria : Correlation coefficient (r) of the calibration curve greater than 0.990 after a 5-point calibration

The high volume sampler complies* / ~~does not comply*~~ with the specified requirements and is deemed acceptable* / unacceptable* for use.

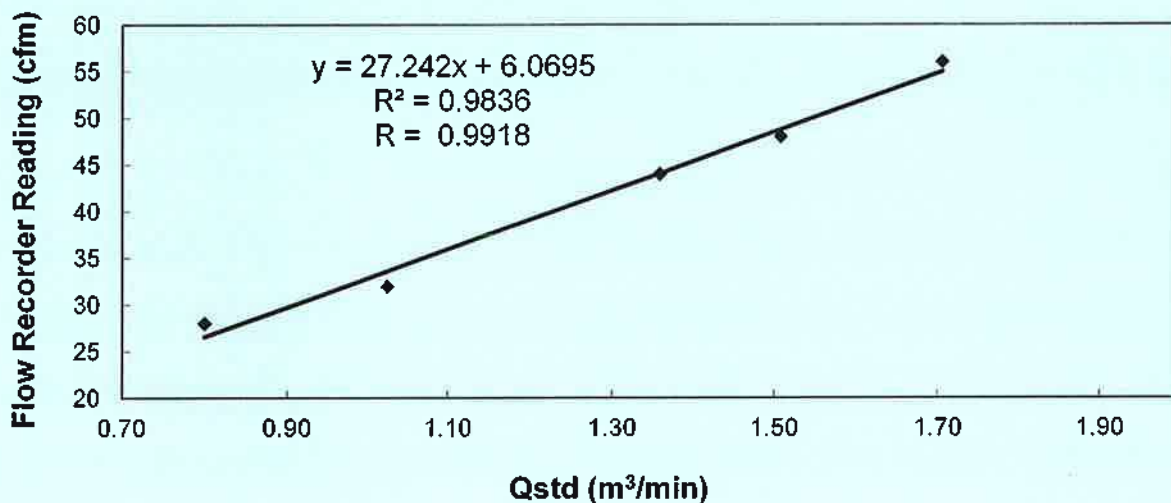
Sampler 1176 Calibration Curve
Site: Tseung Kwan O 137 (TKO-A2a)

Results	Flow recorder reading (cfm)	55	47	46	35	28
	Qstd (Actual flow rate, m ³ /min)	1.73	1.58	1.47	1.05	0.80
Pressure :		768.81 mm Hg		Temp. :		288 K

Acceptance Criteria : Correlation coefficient (r) of the calibration curve greater than 0.990 after a 5-point calibration

The high volume sampler complies* / does not comply* with the specified requirements and is deemed acceptable* / unacceptable* for use.
