**Service Contract No. NDO 04/2019
Environmental Team for Environmental
Monitoring and Audit Works in
Construction Phase for the First Phase
Development of Kwu Tung North and
Fanling North New Development Areas**

**Monthly Environmental Monitoring and
Audit Report for March 2024**

(Version 1.2)

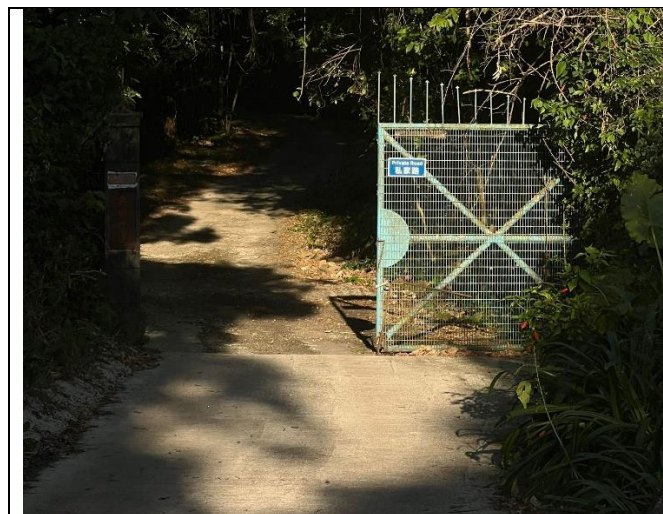
Photo 1. Inaccessible part of transect T5 located within a private property.

9.54 For the monitoring conducted on 5 March 2024 at Transect T5, a section of the transect route was found located within a private property and hence not accessible. The inaccessible part are shown in **Photo 1** below. The adjusted accessible transect route is shown in **Figure 11**.

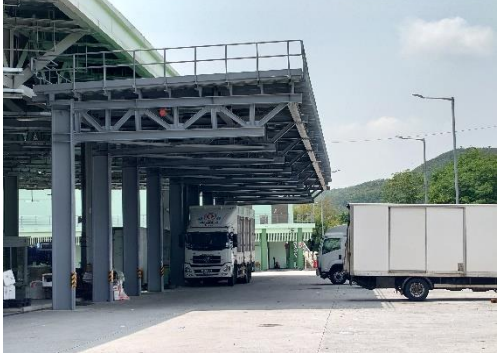
<p>Hard paved exposed haul road</p>

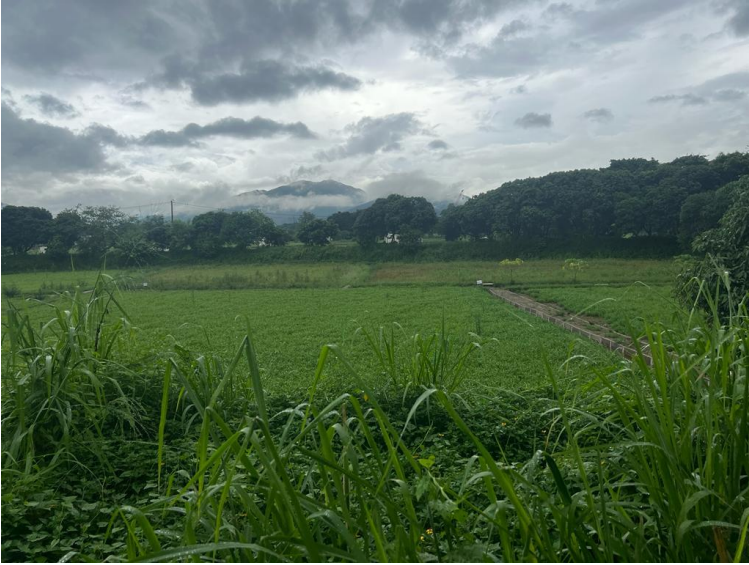
Table 10.6 Photographic Records of Site Activities in LVNP

<p>Continuing agricultural practice in existing farmland to maintain habitats in Long Valley</p>

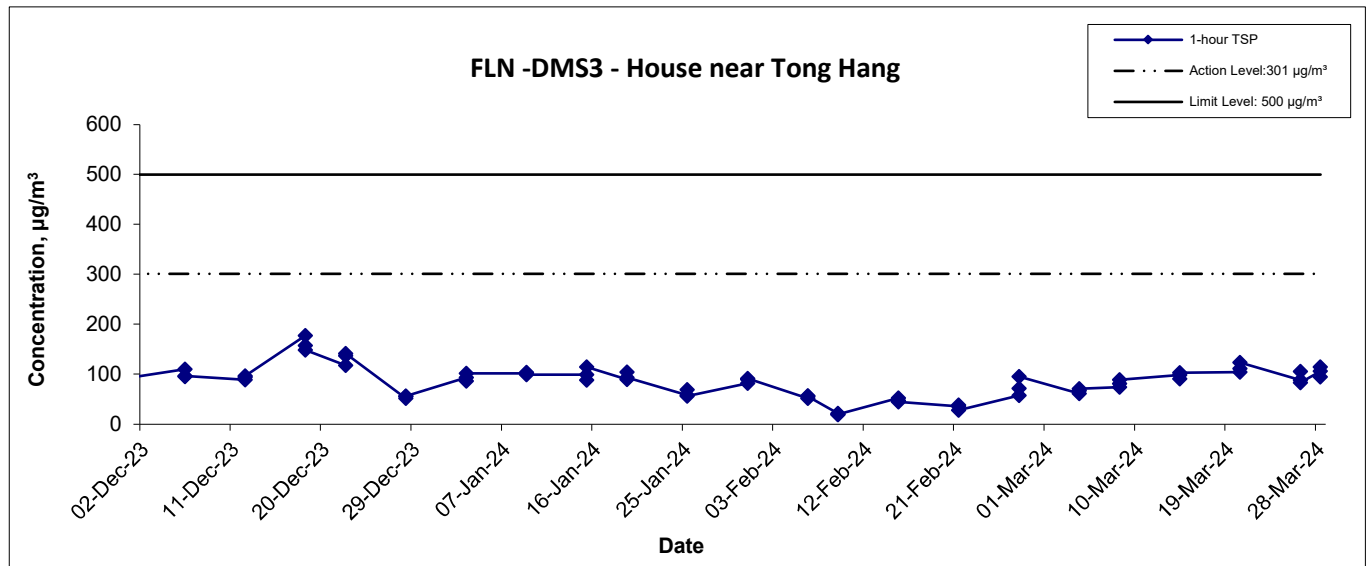
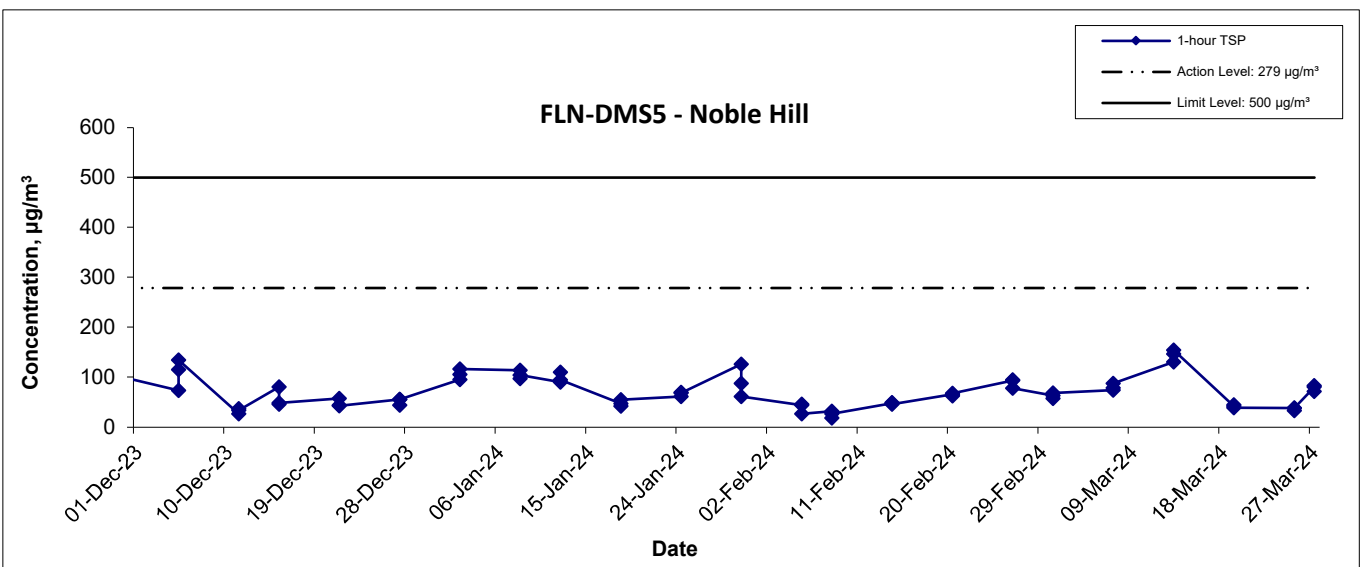
1-hr TSP Concentration Levels

Title Service Contract No. NDO 04/2019 Environmental Team for Environmental Monitoring and Audit Works in Construction Phase for the First Phase Development of Kwu Tung North and Fanling North New Development Areas Graphical Presentation of 1-hour TSP Monitoring Results	Scale	Project No.	
	Date	Appendix	
	N.T.S	WMA20002	
	Mar 24	E

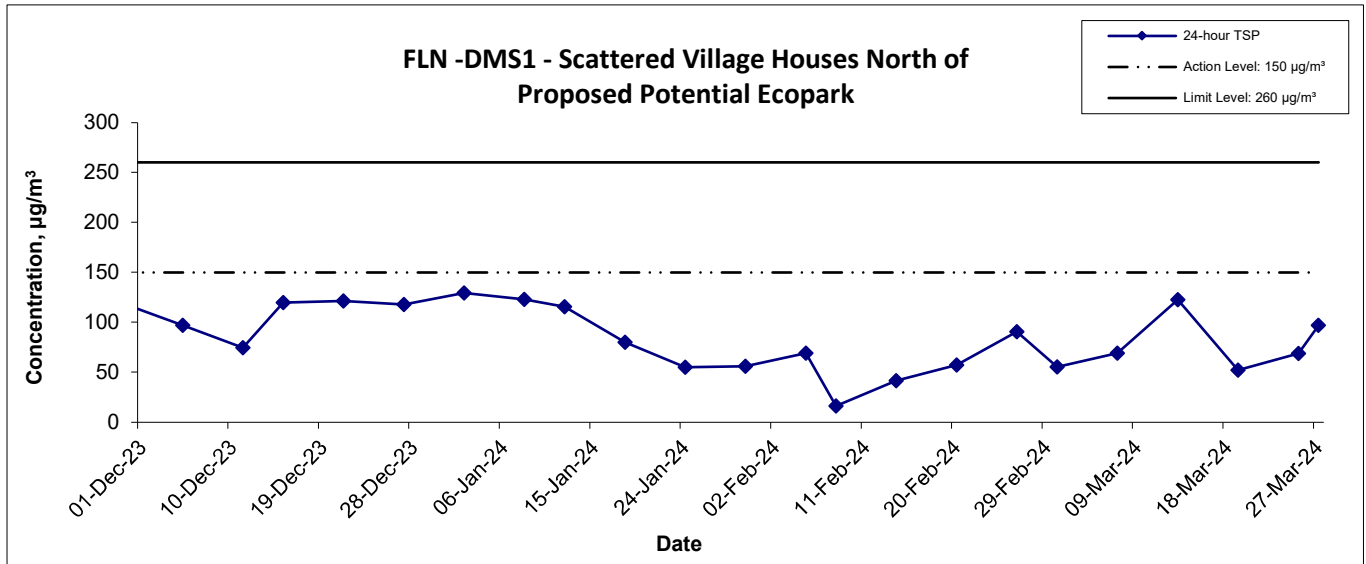
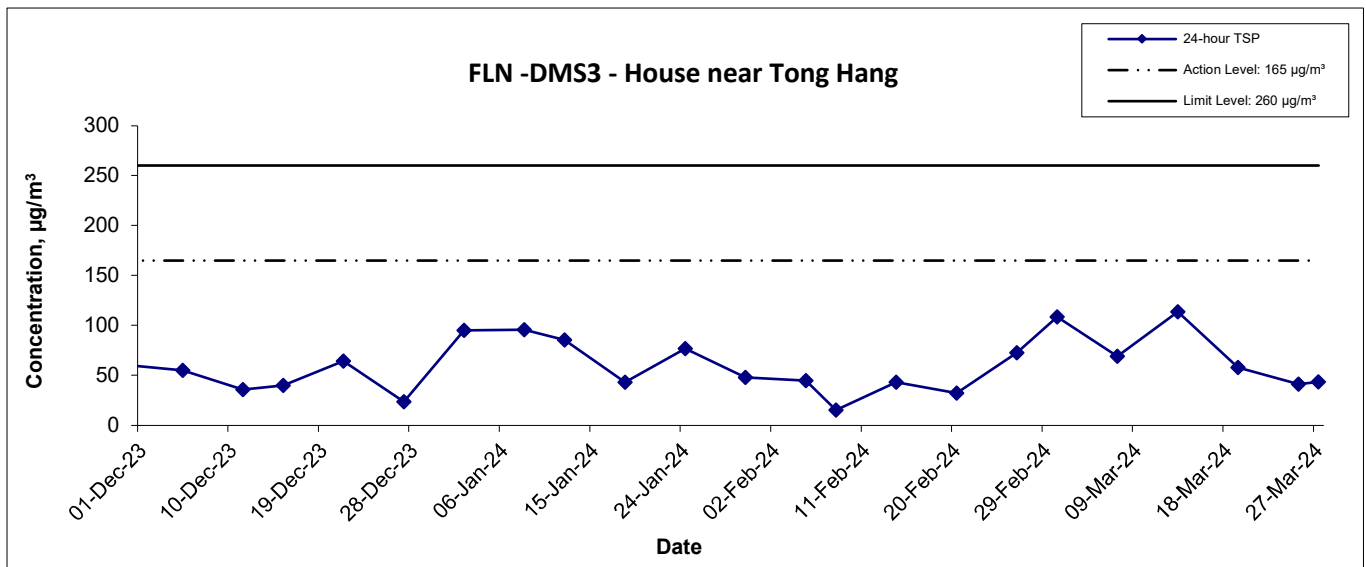
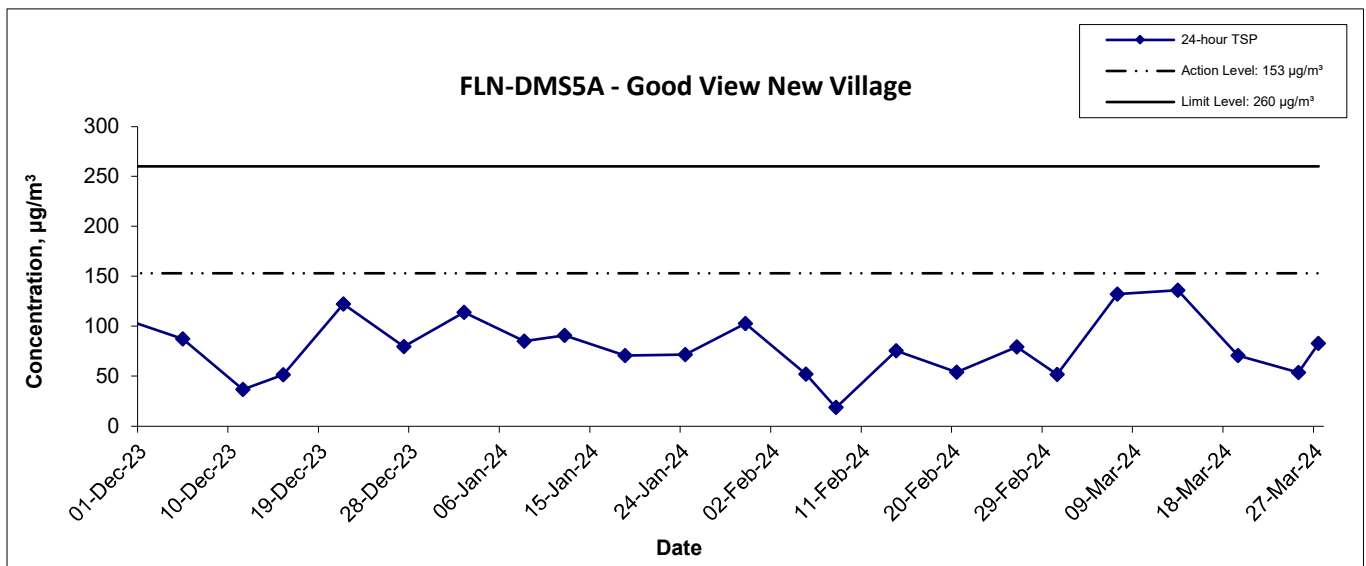
24-hr TSP Concentration Levels

Title Service Contract No. NDO 04/2019 Environmental Team for Environmental Monitoring and Audit Works in Construction Phase for the First Phase Development of Kwu Tung North and Fanling North New Development Areas Graphical Presentation of 24-hour TSP Monitoring Results	Scale	Project No.

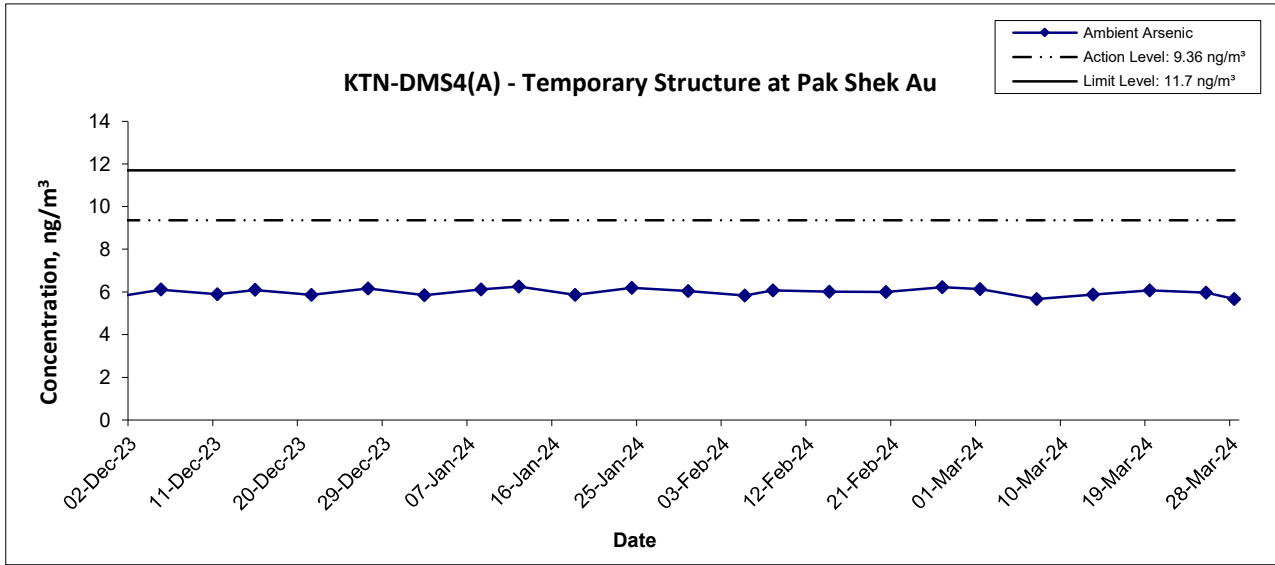
Title Service Contract No. NDO 04/2019 Environmental Team for Environmental Monitoring and Audit Works in Construction Phase for the First Phase Development of Kwu Tung North and Fanling North New Development Areas Graphical Presentation of Ambient Arsenic Monitoring Results	Scale N.T.S	Project No. WMA20002

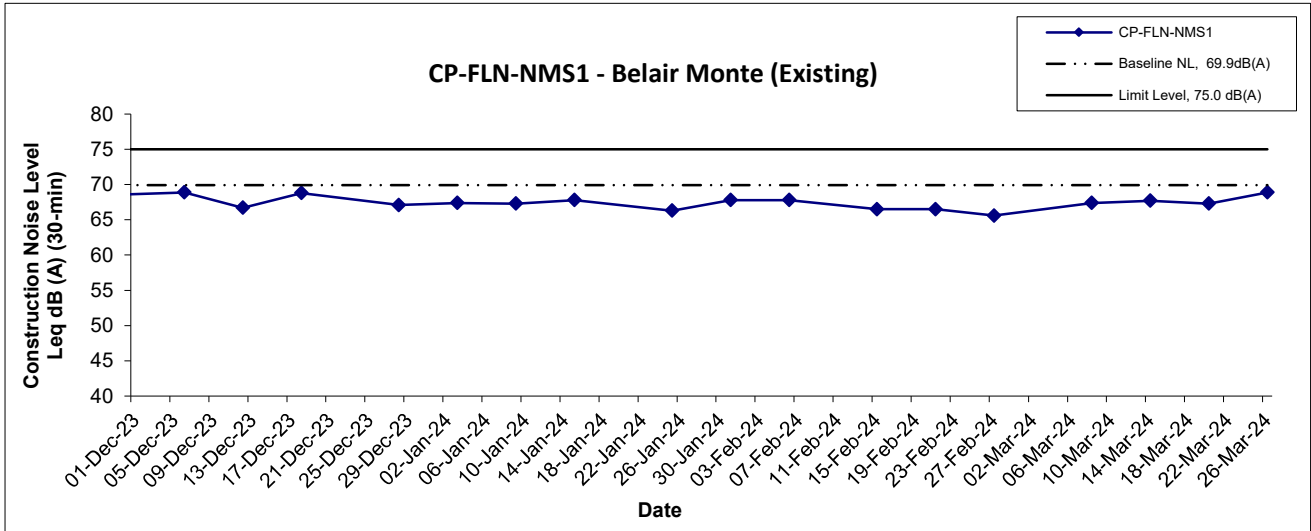
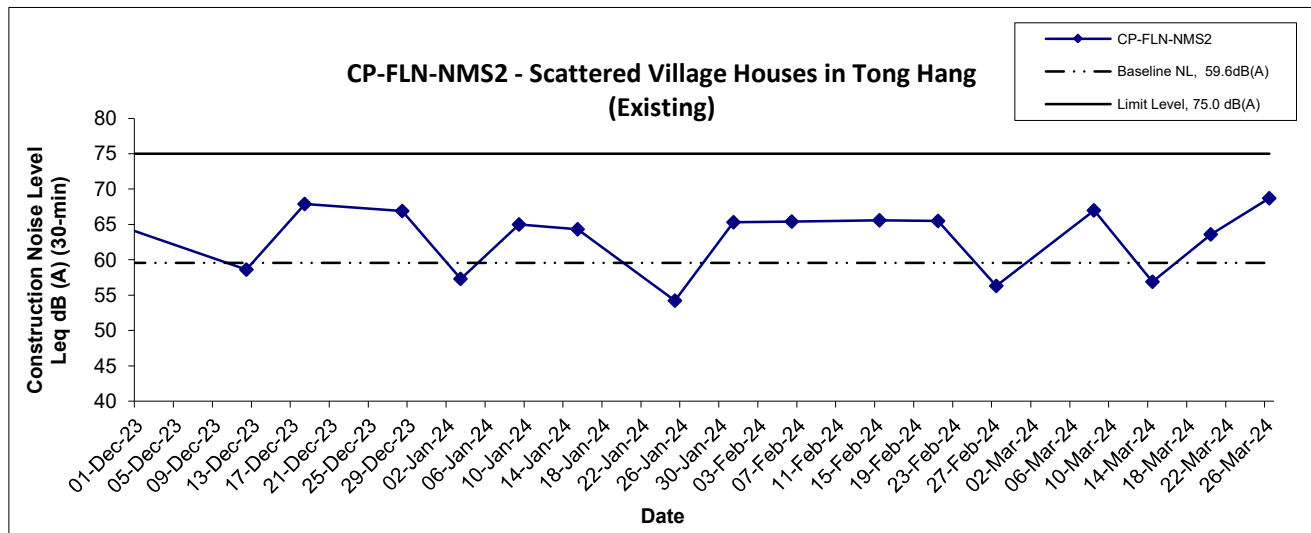
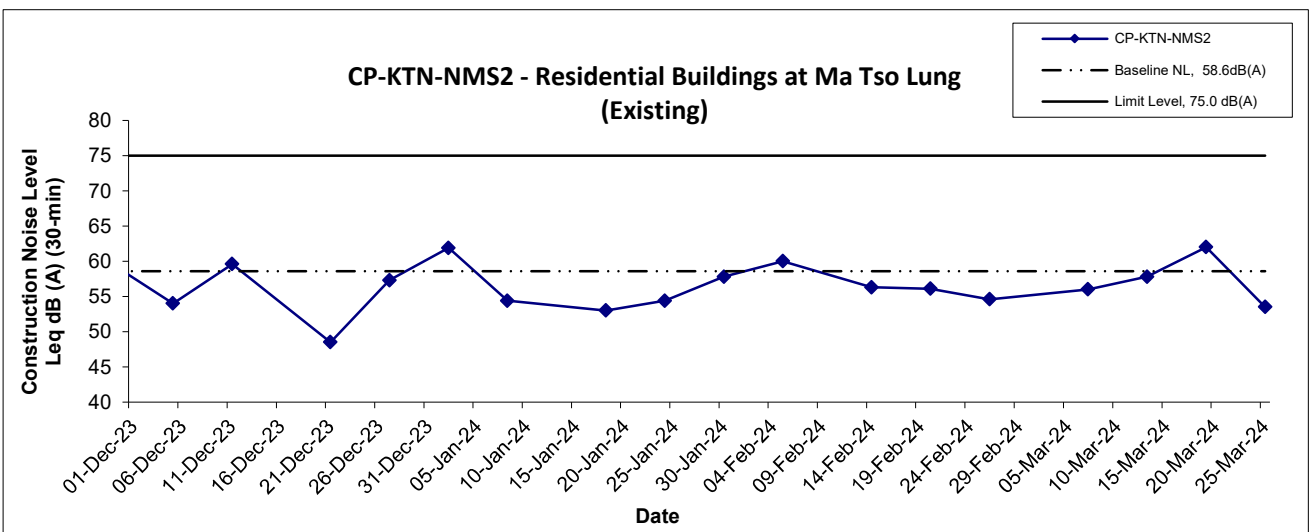
Noise Levels

Title Service Contract No. NDO 04/2019 Environmental Team for Environmental Monitoring and Audit Works in Construction Phase for the First Phase Development of Kwu Tung North and Fanling North New Development Areas Graphical Presentation of Construction Noise Monitoring Results	Scale N.T.S	Project No. WMA20002	
	Date Mar 24	Appendix F

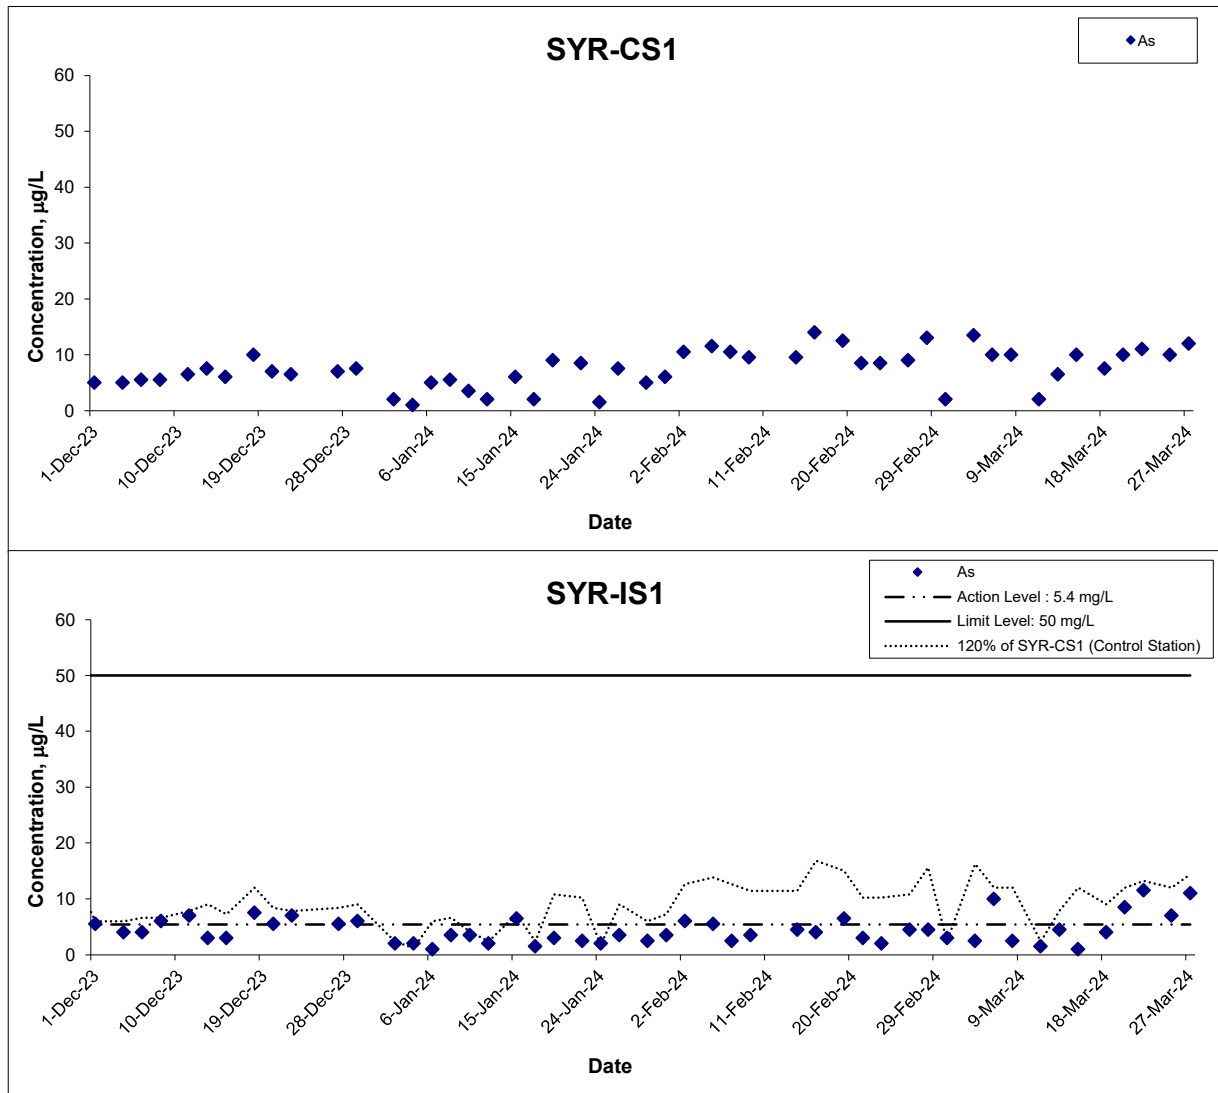
Arsenic (Depth-averaged)

Title Contract No. NDO 04/2019 Advance and First Stage Works of Kwu Tung North and Fanling North New Development Areas Graphical Presentation of Water Quality Monitoring Results	Scale N.T.S	Project No. WMA20002	consulting . testing . research
	Date Mar 24	Appendix G
